NC School District/430 Harnett County/Elementary School

# Anderson Creek Primary

## Campus Assessment Report

March 11, 2017

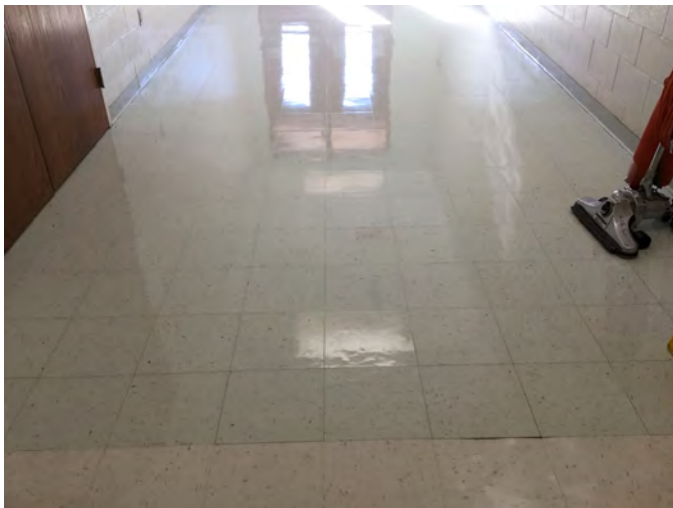
#### System: C3020 - Floor Finishes

**Location:** Corridor-Class Rooms  
**Distress:** Damaged  
**Category:** Deferred Maintenance  
**Priority:** 3 - Necessary/Not Yet Critical (Years 2-5)  
**Correction:** Replace vinyl tile flooring  
**Qty:** 2,349.00  
**Unit of Measure:** S.Y.  
**Estimate:** \$252,550.39  
**Assessor Name:** Terence Davis  
**Date Created:** 12/08/2016

**Notes:** The VCT is damaged and discolored.

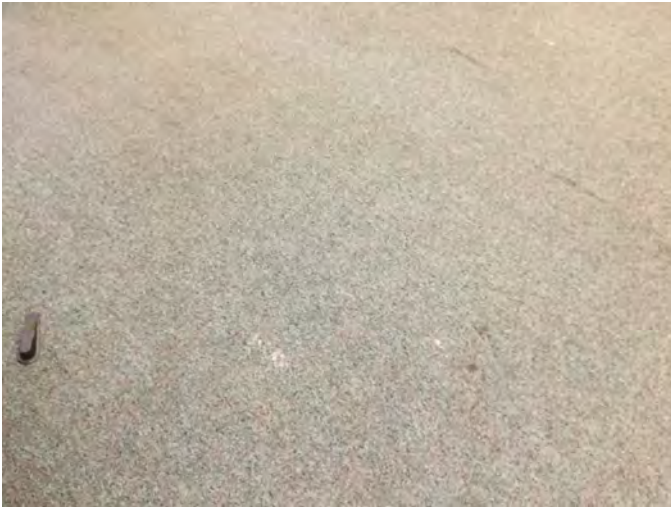
**System: C3020 - Floor Finishes**

**Location:** Office  
**Distress:** Damaged  
**Category:** Deferred Maintenance  
**Priority:** 3 - Necessary/Not Yet Critical (Years 2-5)  
**Correction:** Replace carpet  
**Qty:** 167.00  
**Unit of Measure:** S.Y.  
**Estimate:** \$14,275.69  
**Assessor Name:** Terence Davis  
**Date Created:** 12/08/2016

**Notes:** The carpet is damaged and a trip hazard.

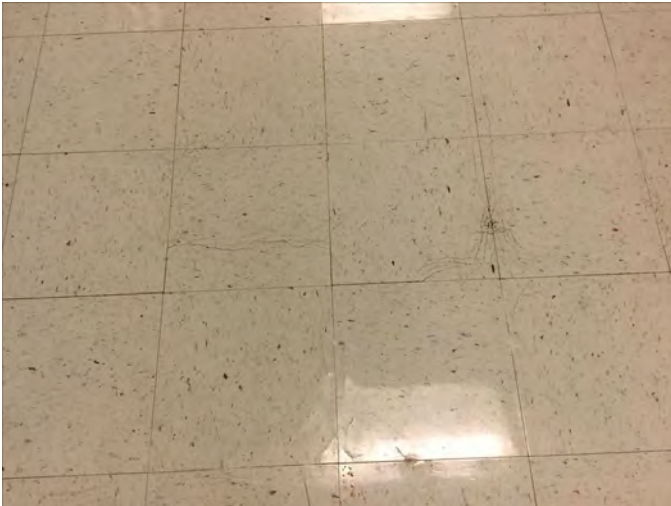
**System: C3020 - Floor Finishes**

**Location:** Throughout  
**Distress:** Damaged  
**Category:** Deferred Maintenance  
**Priority:** 3 - Necessary/Not Yet Critical (Years 2-5)  
**Correction:** Replace vinyl tile flooring  
**Qty:** 40.00  
**Unit of Measure:** S.Y.  
**Estimate:** \$4,300.56  
**Assessor Name:** Terence Davis  
**Date Created:** 12/05/2016

**Notes:** VCT in separating and cracking on the edges

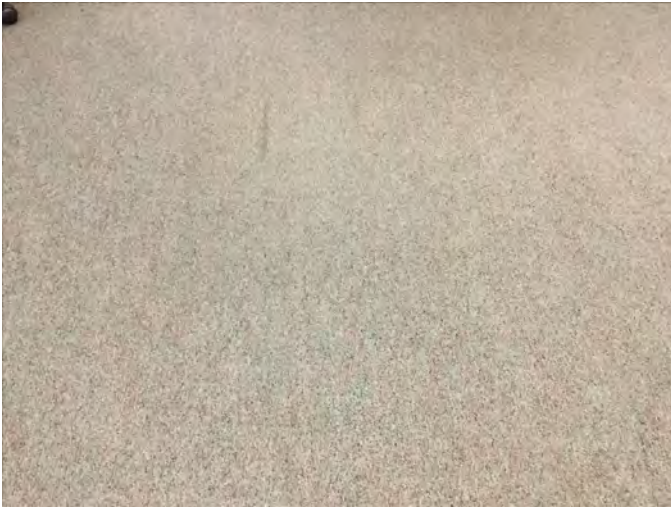
**System: C3020 - Floor Finishes**

**Location:** Office Area  
**Distress:** Damaged  
**Category:** Deferred Maintenance  
**Priority:** 3 - Necessary/Not Yet Critical (Years 2-5)  
**Correction:** Replace carpet  
**Qty:** 40.00  
**Unit of Measure:** S.Y.  
**Estimate:** \$3,419.33  
**Assessor Name:** Terence Davis  
**Date Created:** 12/05/2016

**Notes:** Carpet is worn and damaged.

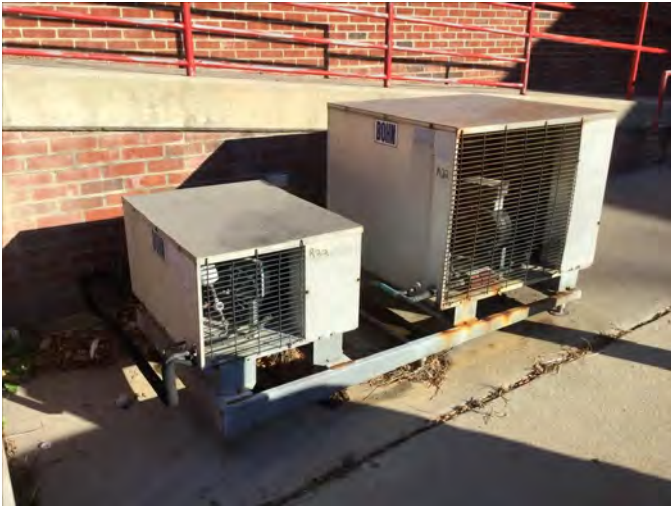
**System: D3050 - Terminal & Package Units**

**Location:** Exterior  
**Distress:** Beyond Service Life  
**Category:** Deferred Maintenance  
**Priority:** 3 - Necessary/Not Yet Critical (Years 2-5)  
**Correction:** Renew System  
**Qty:** 90,642.00  
**Unit of Measure:** S.F.  
**Estimate:** \$89,736.00  
**Assessor Name:** Terence Davis  
**Date Created:** 12/07/2016

**Notes:** The refrigeration units are at the end of their service life and need to be replaced.
