**NC School District/430 Harnett County/Elementary School**

# **Angier Elementary**

## **Campus Assessment Report**

**March 20, 2017**

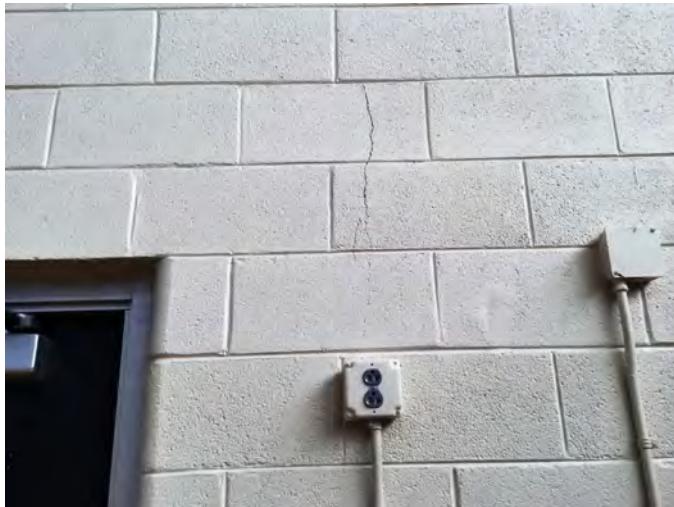
#### System: C1010 - Partitions

<b>Location:</b>	Gymnasium
<b>Distress:</b>	Failing
<b>Category:</b>	Safety
<b>Priority:</b>	1 - Currently Critical (Immediate)
<b>Correction:</b>	Engineering Study
<b>Qty:</b>	1.00
<b>Unit of Measure:</b>	Ea.
<b>Estimate:</b>	\$13,200.00
<b>Assessor Name:</b>	Somnath Das
<b>Date Created:</b>	11/16/2016

**Notes:** There are visible cracks on the partition walls and they should be studied by a professional engineer.
