NC School District/040 Anson County/Middle School

Anson Middle

Campus Assessment Report

March 10, 2017

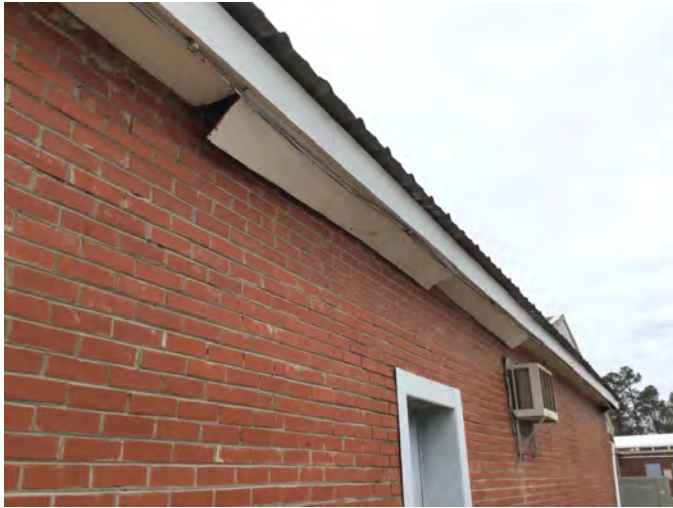
System: B3010130 - Preformed Metal Roofing

Location: Roof
Distress: Beyond Service Life
Category: Deferred Maintenance
Priority: 3 - Necessary/Not Yet Critical (Years 2-5)
Correction: Renew System
Qty: 2,250.00
Unit of Measure: S.F.
Estimate: \$33,192.00
Assessor Name: Eduardo Lopez
Date Created: 01/11/2017

Notes: The metal roof covering is aged, showing signs of failure and should be replaced.

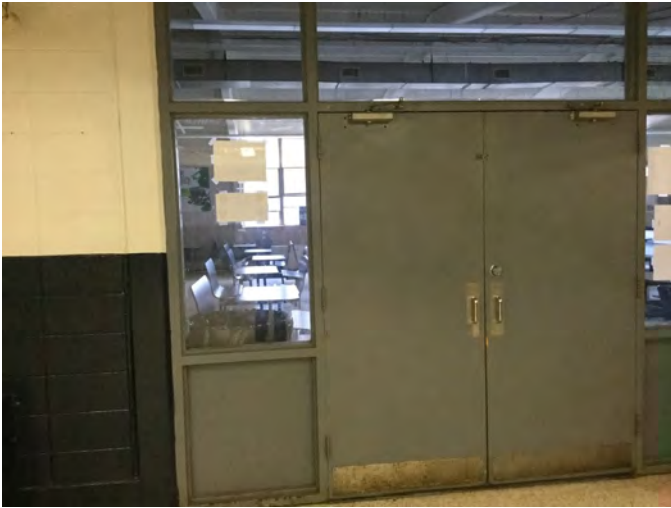
System: C1020 - Interior Doors

Location: Throughout the Building
Distress: Beyond Service Life
Category: Deferred Maintenance
Priority: 3 - Necessary/Not Yet Critical (Years 2-5)
Correction: Renew System
Qty: 28,376.00
Unit of Measure: S.F.
Estimate: \$84,901.00
Assessor Name: Eduardo Lopez
Date Created: 01/11/2017

Notes: The interior doors are aged, failing, most hardware is not ADA or code compliant and should be replaced.

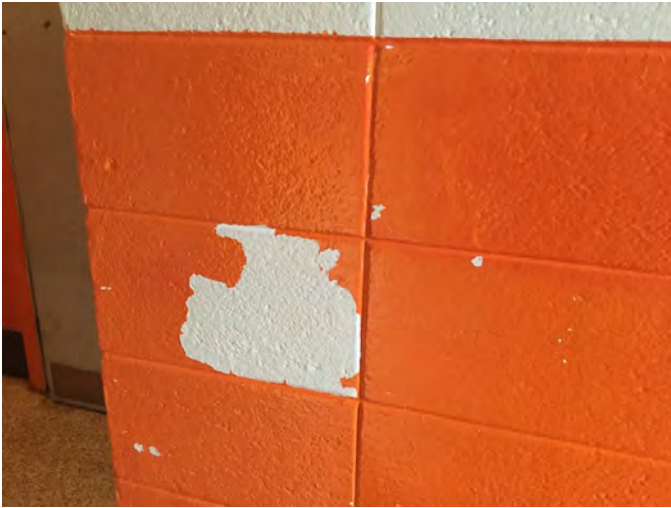
System: C3010 - Wall Finishes

Location: Throughout the Building
Distress: Beyond Service Life
Category: Deferred Maintenance
Priority: 3 - Necessary/Not Yet Critical (Years 2-5)
Correction: Renew System
Qty: 28,376.00
Unit of Measure: S.F.
Estimate: \$115,802.00
Assessor Name: Eduardo Lopez
Date Created: 01/11/2017

Notes: The wall finishes are aged, scuffed, fading, stained and should be replaced.

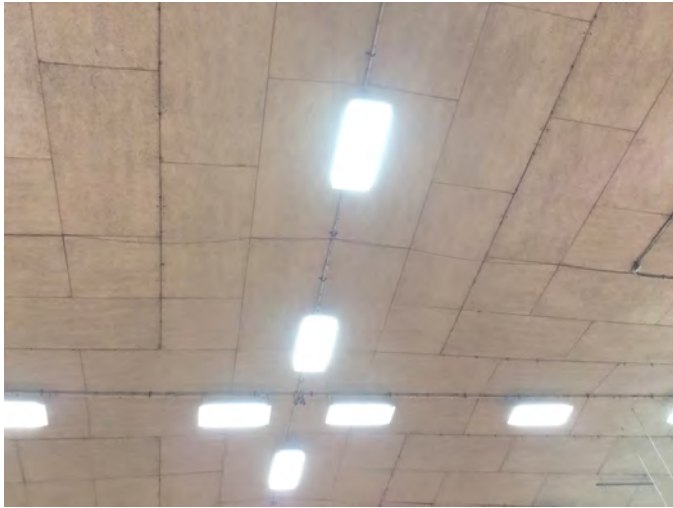
System: C3030 - Ceiling Finishes

Location: Throughout the Building
Distress: Beyond Service Life
Category: Deferred Maintenance
Priority: 3 - Necessary/Not Yet Critical (Years 2-5)
Correction: Renew System
Qty: 28,376.00
Unit of Measure: S.F.
Estimate: \$392,667.00
Assessor Name: Eduardo Lopez
Date Created: 01/11/2017

Notes: The original ceiling finishes are aged, failing and should be replaced.

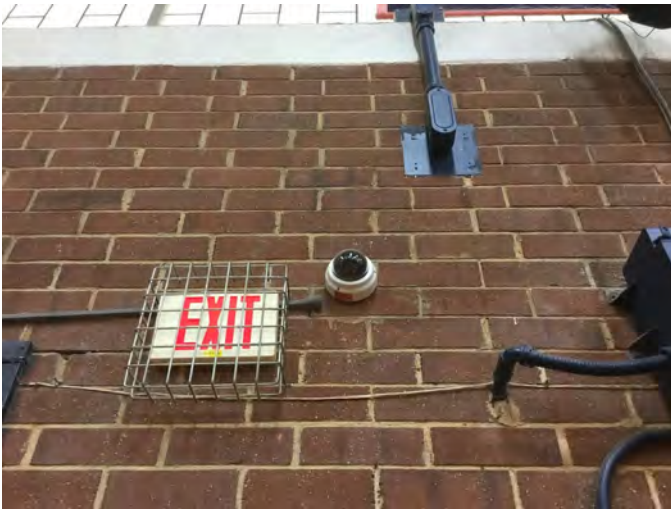
System: D5030810 - Security & Detection Systems

Location: Throughout the Building
Distress: Beyond Service Life
Category: Deferred Maintenance
Priority: 3 - Necessary/Not Yet Critical (Years 2-5)
Correction: Renew System
Qty: 28,376.00
Unit of Measure: S.F.
Estimate: \$78,346.00
Assessor Name: Eduardo Lopez
Date Created: 01/11/2017

Notes: The security and CCTV system is beyond its expected service life and should be scheduled for replacement.

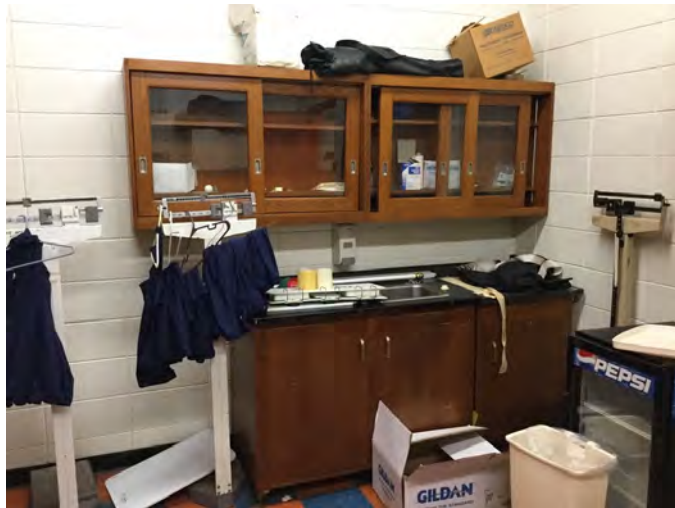
System: E2010 - Fixed Furnishings

Location: Throughout the Building
Distress: Beyond Service Life
Category: Deferred Maintenance
Priority: 3 - Necessary/Not Yet Critical (Years 2-5)
Correction: Renew System
Qty: 28,376.00
Unit of Measure: S.F.
Estimate: \$188,218.00
Assessor Name: Eduardo Lopez
Date Created: 01/11/2017

Notes: The fixed furnishings are aged, in marginal condition, and should be replaced.

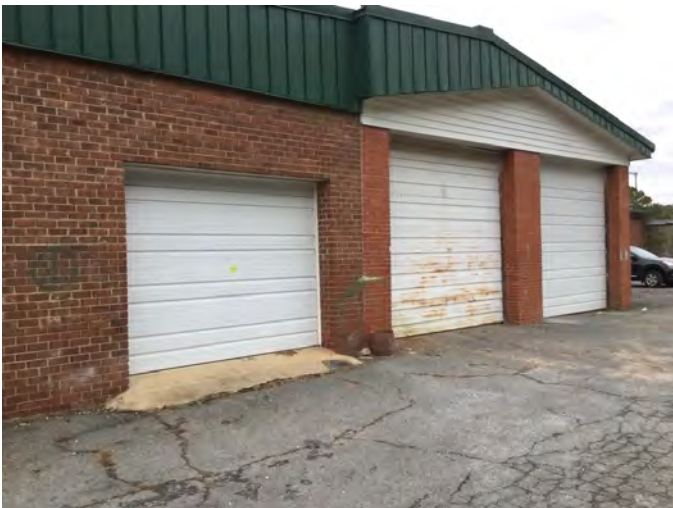
System: B2030 - Exterior Doors

Location: Exterior Walls
Distress: Beyond Service Life
Category: Deferred Maintenance
Priority: 3 - Necessary/Not Yet Critical (Years 2-5)
Correction: Renew System
Qty: 78,257.00
Unit of Measure: S.F.
Estimate: \$98,995.00
Assessor Name: Eduardo Lopez
Date Created: 01/13/2017

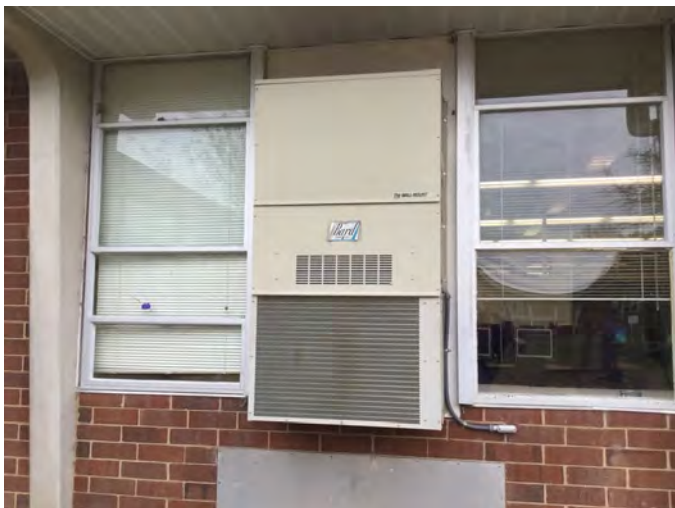
System: D3050 - Terminal & Package Units

Location: Throughout the Building
Distress: Beyond Service Life
Category: Deferred Maintenance
Priority: 3 - Necessary/Not Yet Critical (Years 2-5)
Correction: Renew System
Qty: 78,257.00
Unit of Measure: S.F.
Estimate: \$2,206,300.00
Assessor Name: Eduardo Lopez
Date Created: 01/13/2017

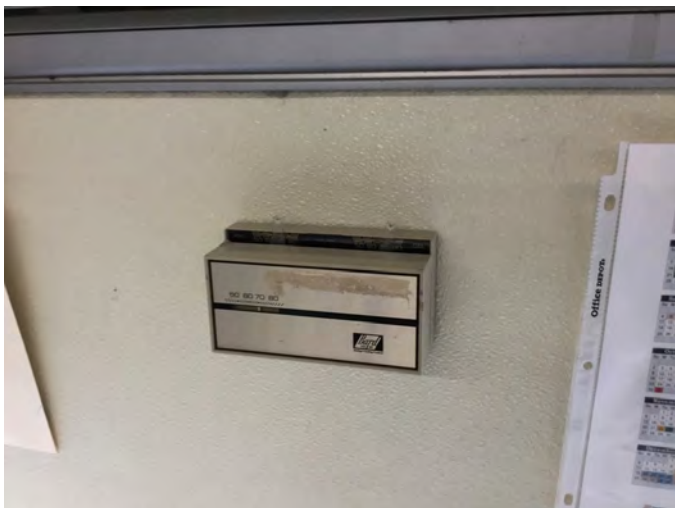
System: D3060 - Controls & Instrumentation

Location: Throughout the Building
Distress: Beyond Service Life
Category: Deferred Maintenance
Priority: 3 - Necessary/Not Yet Critical (Years 2-5)
Correction: Renew System
Qty: 78,257.00
Unit of Measure: S.F.
Estimate: \$325,393.00
Assessor Name: Eduardo Lopez
Date Created: 01/13/2017

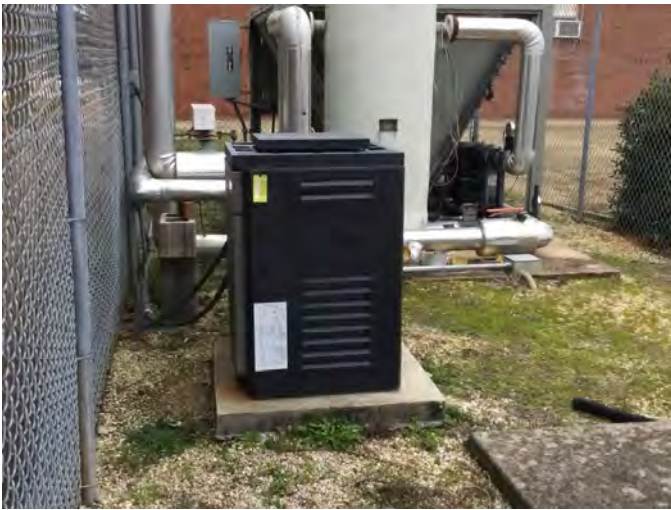
System: D3020 - Heat Generating Systems

Location: Throughout the Building
Distress: Beyond Service Life
Category: Deferred Maintenance
Priority: 3 - Necessary/Not Yet Critical (Years 2-5)
Correction: Renew System
Qty: 10,443.00
Unit of Measure: S.F.
Estimate: \$116,711.00
Assessor Name: Eduardo Lopez
Date Created: 02/06/2017

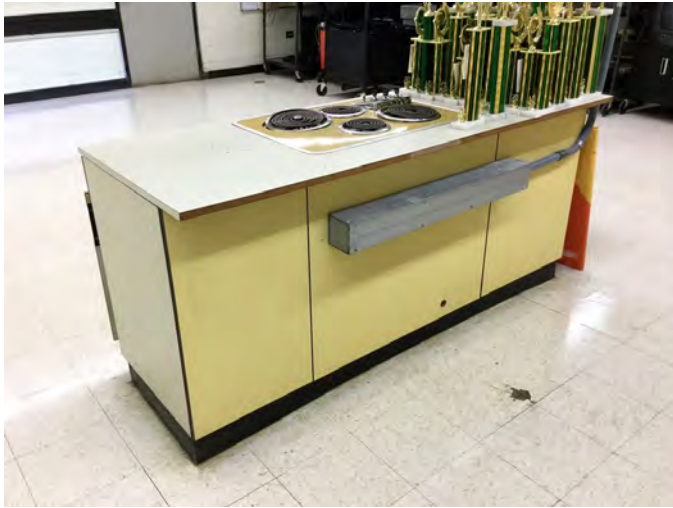
System: E2010 - Fixed Furnishings

Location: Throughout the Building
Distress: Beyond Service Life
Category: Deferred Maintenance
Priority: 3 - Necessary/Not Yet Critical (Years 2-5)
Correction: Renew System
Qty: 10,443.00
Unit of Measure: S.F.
Estimate: \$73,404.00
Assessor Name: Eduardo Lopez
Date Created: 02/06/2017

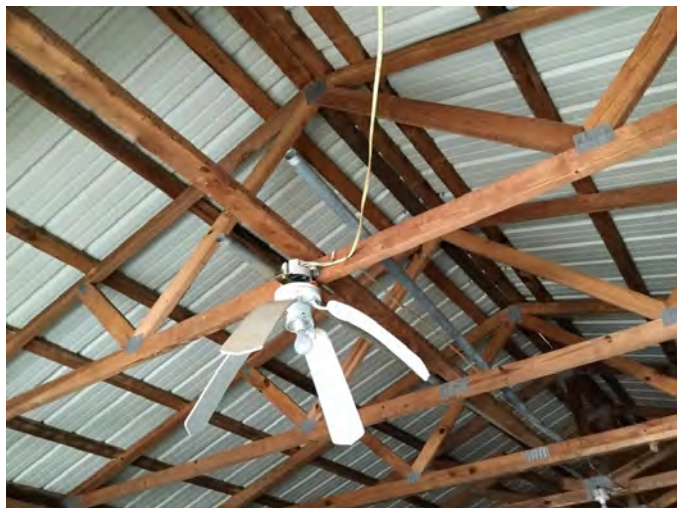
System: D5020 - Lighting

Location: Throughout the Building
Distress: Beyond Service Life
Category: Deferred Maintenance
Priority: 3 - Necessary/Not Yet Critical (Years 2-5)
Correction: Renew System
Qty: 856.00
Unit of Measure: S.F.
Estimate: \$1,563.00
Assessor Name: Eduardo Lopez
Date Created: 01/12/2017

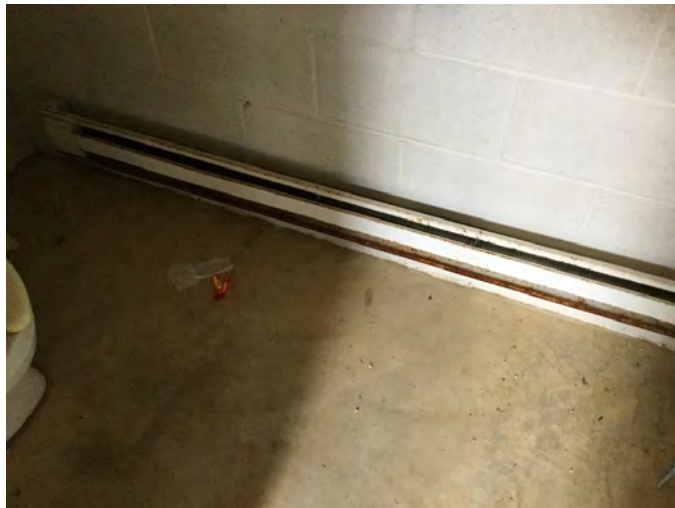
System: D3050 - Terminal & Package Units

Location: Throughout the Building
Distress: Beyond Service Life
Category: Deferred Maintenance
Priority: 3 - Necessary/Not Yet Critical (Years 2-5)
Correction: Renew System
Qty: 800.00
Unit of Measure: S.F.
Estimate: \$10,226.00
Assessor Name: Eduardo Lopez
Date Created: 01/12/2017

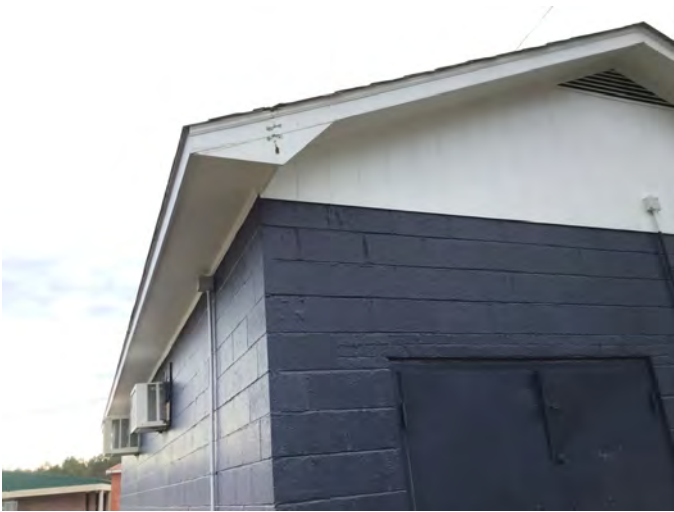
Location: Roof
Distress: Beyond Service Life
Category: Deferred Maintenance
Priority: 3 - Necessary/Not Yet Critical (Years 2-5)
Correction: Renew System
Qty: 800.00
Unit of Measure: S.F.
Estimate: \$5,046.00
Assessor Name: Eduardo Lopez
Date Created: 01/12/2017

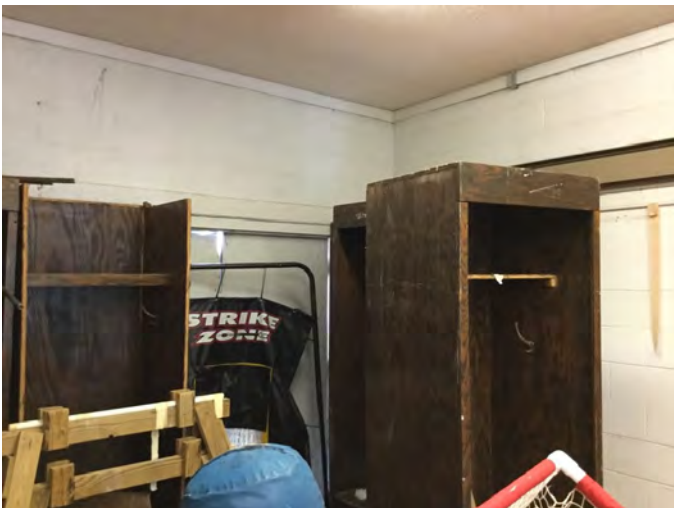
Location: Throughout the Building
Distress: Beyond Service Life
Category: Deferred Maintenance
Priority: 3 - Necessary/Not Yet Critical (Years 2-5)
Correction: Renew System
Qty: 800.00
Unit of Measure: S.F.
Estimate: \$6,565.00
Assessor Name: Eduardo Lopez
Date Created: 01/12/2017

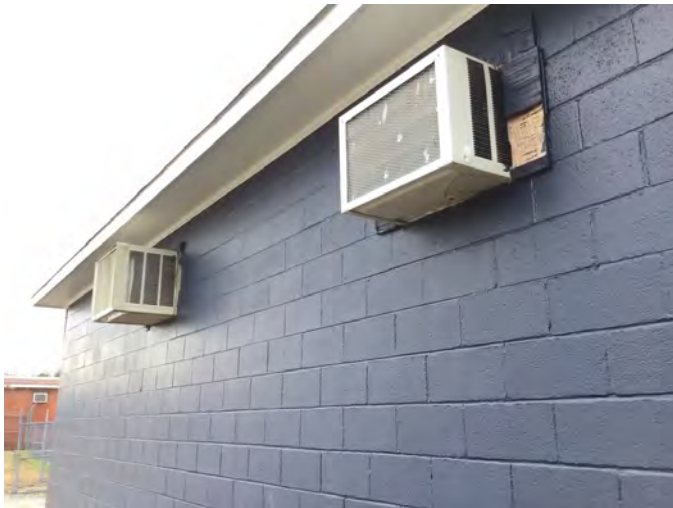
Location: Throughout the Building
Distress: Beyond Service Life
Category: Deferred Maintenance
Priority: 3 - Necessary/Not Yet Critical (Years 2-5)
Correction: Renew System
Qty: 800.00
Unit of Measure: S.F.
Estimate: \$14,925.00
Assessor Name: Eduardo Lopez
Date Created: 01/12/2017

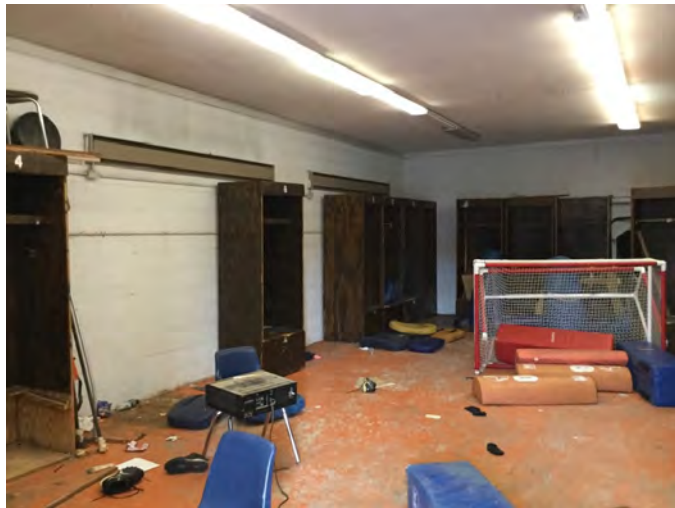
Location: Throughout the Building
Distress: Beyond Service Life
Category: Deferred Maintenance
Priority: 3 - Necessary/Not Yet Critical (Years 2-5)
Correction: Renew System
Qty: 800.00
Unit of Measure: S.F.
Estimate: \$4,470.00
Assessor Name: Eduardo Lopez
Date Created: 01/12/2017

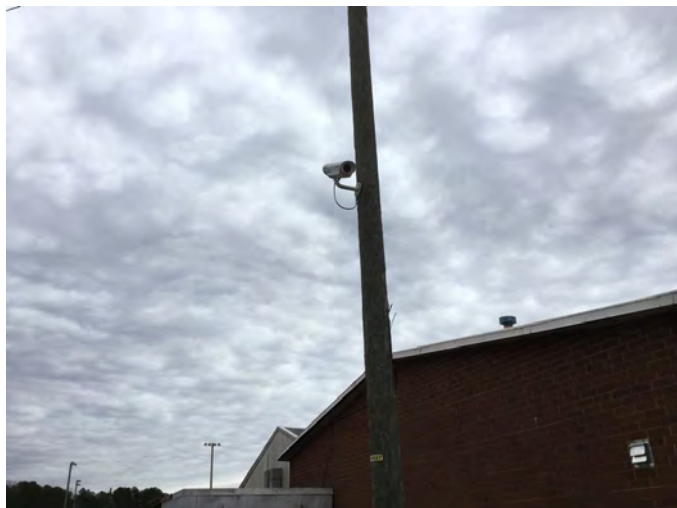
Location: Site
Distress: Beyond Service Life
Category: Deferred Maintenance
Priority: 3 - Necessary/Not Yet Critical (Years 2-5)
Correction: Renew System
Qty: 120,423.00
Unit of Measure: S.F.
Estimate: \$116,569.00
Assessor Name: Eduardo Lopez
Date Created: 02/06/2017
