NC School District/040 Anson County/Elementary School

Ansonville Elementary

Campus Assessment Report

March 11, 2017

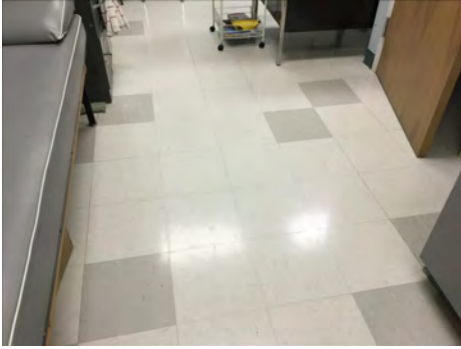
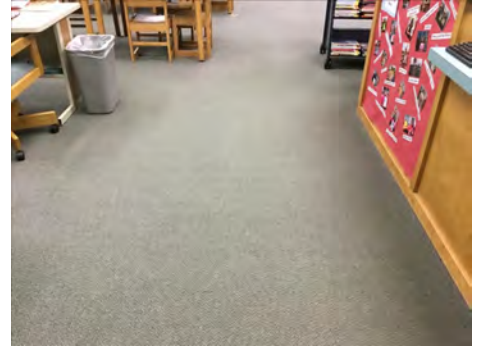
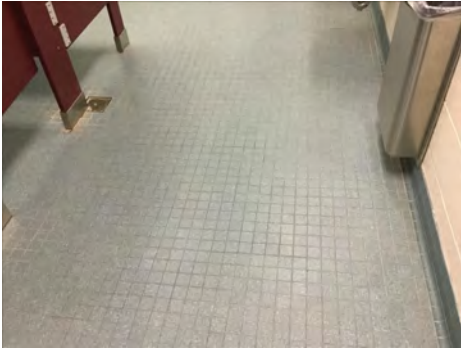
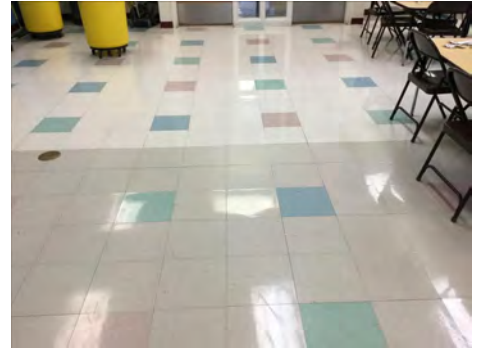
System: C3020 - Floor Finishes

Note: Carpet needs to be replaced. 2% of VCT needs to be replaced.

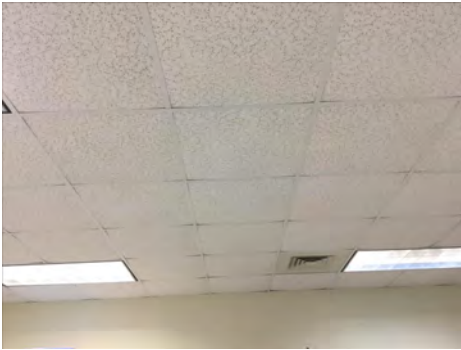
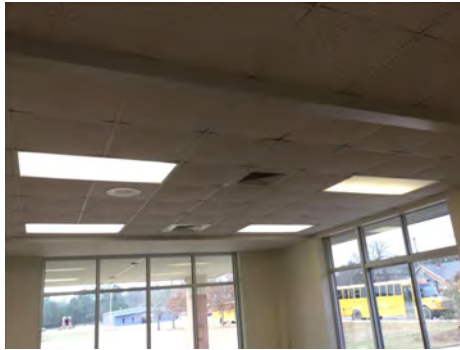
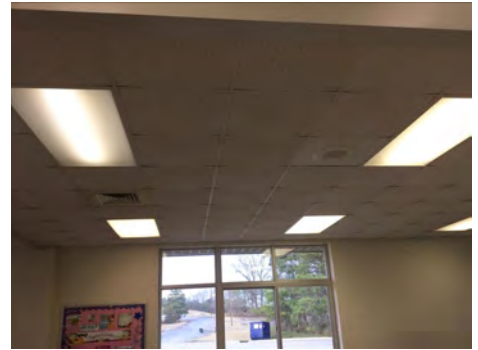
System: C3030 - Ceiling Finishes

Note: The acoustical ceiling tiles are beyond their service life and should be replaced.

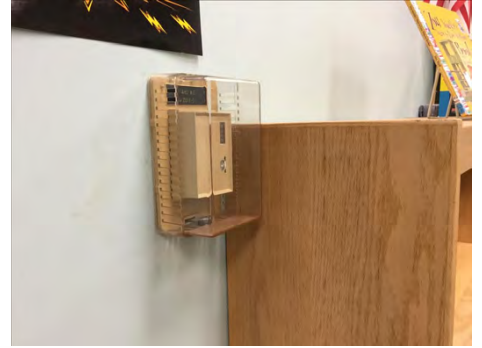
System: D3060 - Controls & Instrumentation

Note: The controls and instrumentation system is beyond its service life and should be replaced.

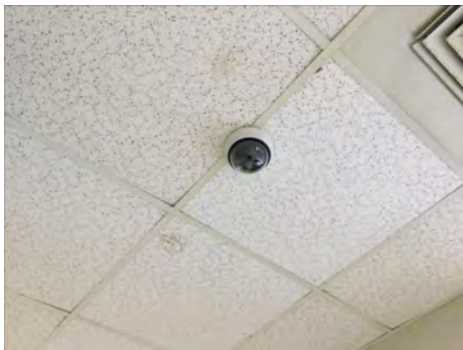
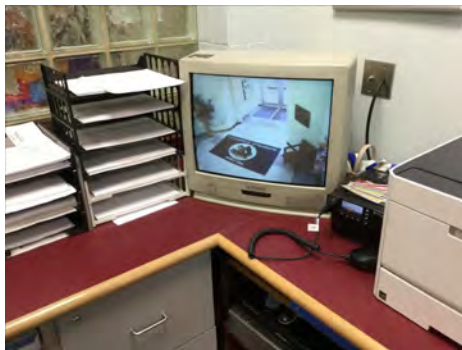
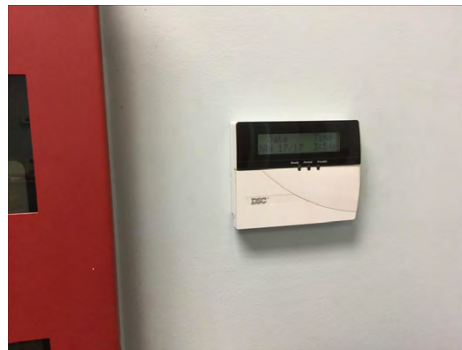
System: D5030810 - Security & Detection Systems

Note: The security and detection system is beyond its service life and should be replaced.

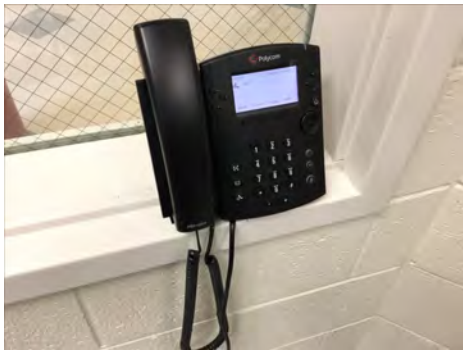
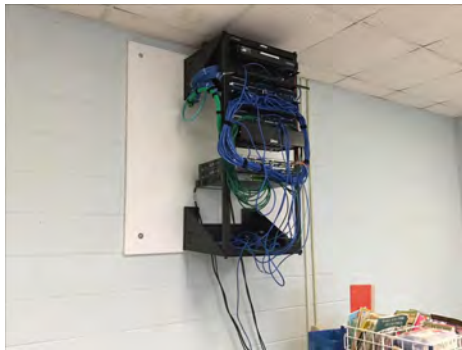
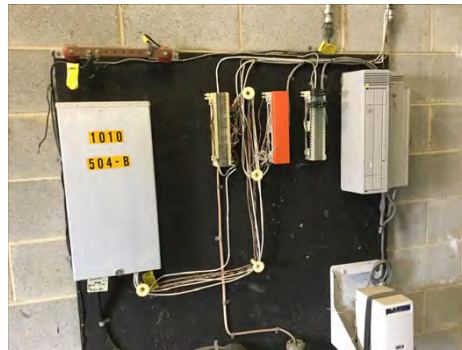
System: D5030920 - Data Communication

Note: The data and communications system is beyond its service life and should be replaced.

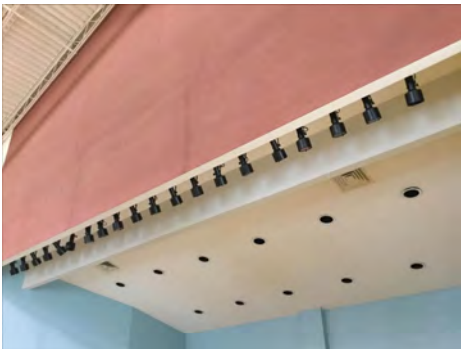
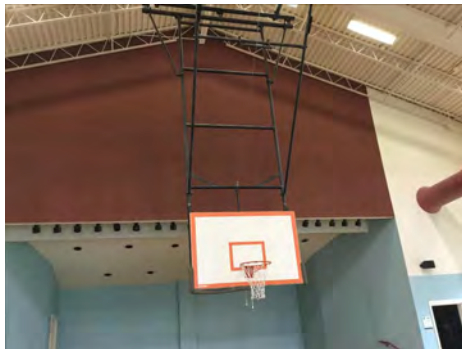
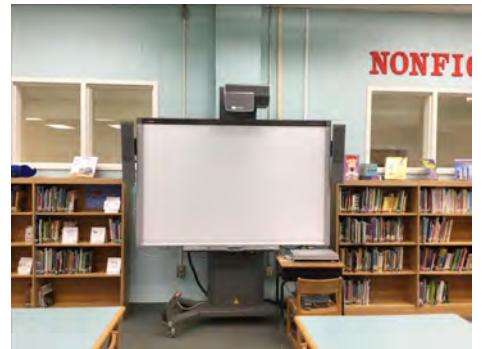
System: E1020 - Institutional Equipment

Note: The institutional equipment is beyond its service life and should be replaced.

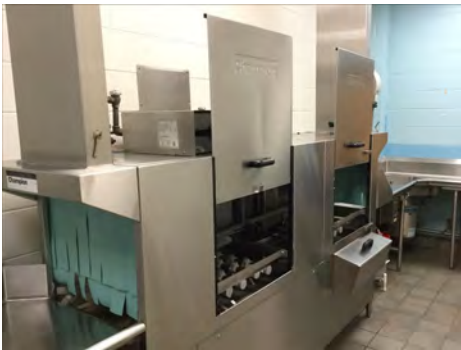
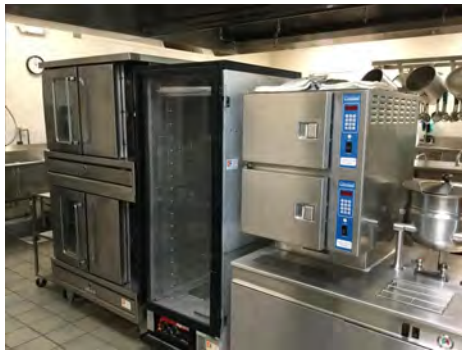
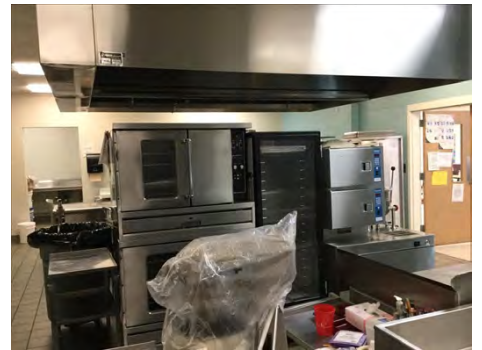
System: E1090 - Other Equipment

Note: The kitchen equipment is beyond its service life and should be replaced.

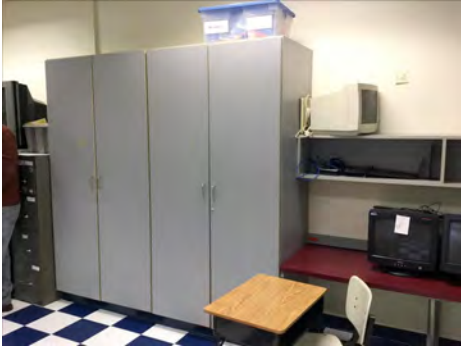
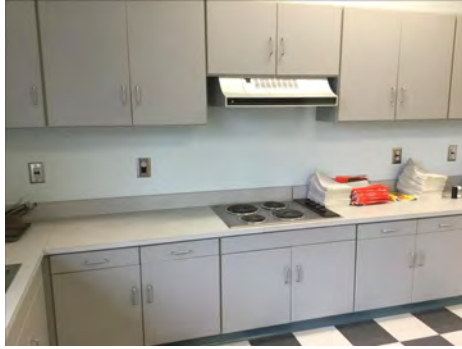
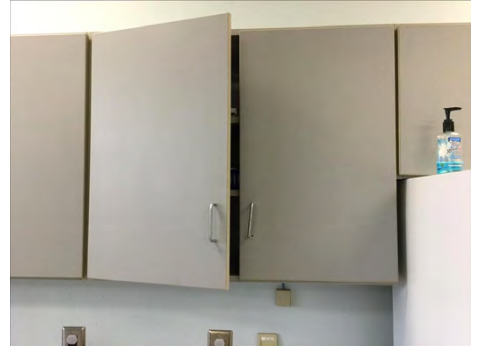
System: E2010 - Fixed Furnishings

Note: The fixed furnishings are beyond their service life and should be replaced.

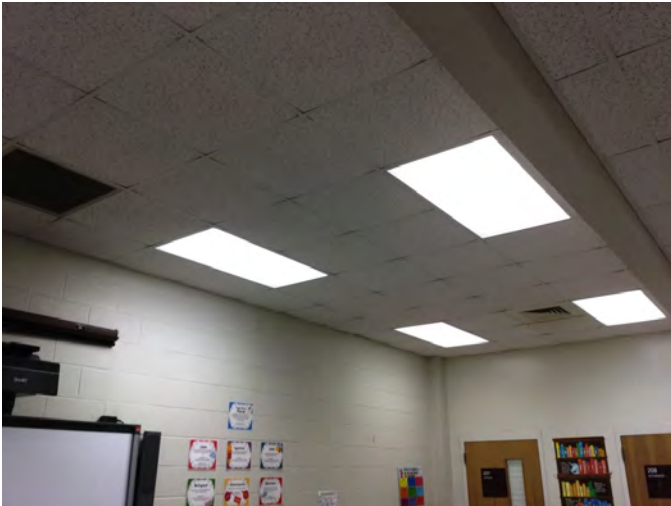
System: C3030 - Ceiling Finishes

Location: Throughout Building
Distress: Beyond Service Life
Category: Deferred Maintenance
Priority: 3 - Necessary/Not Yet Critical (Years 2-5)
Correction: Renew System
Qty: 45,000.00
Unit of Measure: S.F.
Estimate: \$543,015.00
Assessor Name: Eduardo Lopez
Date Created: 01/18/2017

Notes: The acoustical ceiling tiles are beyond their service life and should be replaced.

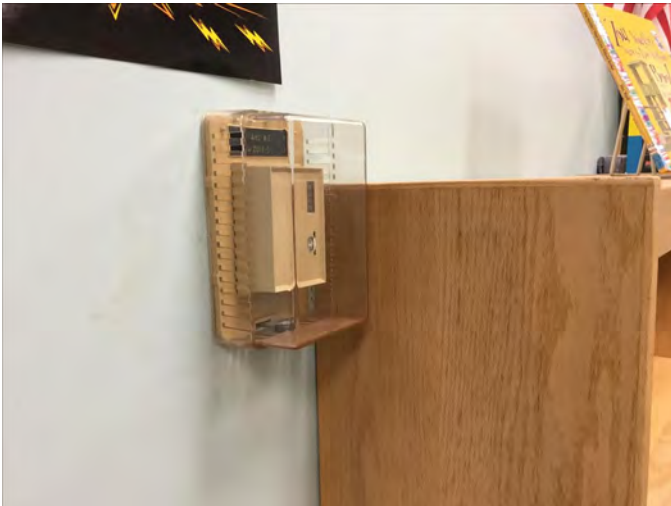
System: D3060 - Controls & Instrumentation

Location: Throughout Building
Distress: Beyond Service Life
Category: Deferred Maintenance
Priority: 3 - Necessary/Not Yet Critical (Years 2-5)
Correction: Renew System
Qty: 45,000.00
Unit of Measure: S.F.
Estimate: \$96,030.00
Assessor Name: Eduardo Lopez
Date Created: 01/17/2017

Notes: The controls and instrumentation system is beyond its service life and should be replaced.

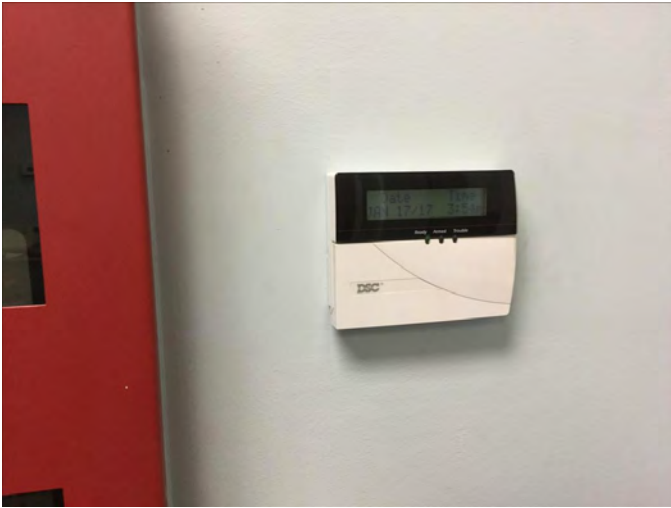
System: D5030810 - Security & Detection Systems

Location: Throughout Building
Distress: Beyond Service Life
Category: Deferred Maintenance
Priority: 3 - Necessary/Not Yet Critical (Years 2-5)
Correction: Renew System
Qty: 45,000.00
Unit of Measure: S.F.
Estimate: \$92,565.00
Assessor Name: Eduardo Lopez
Date Created: 01/17/2017

Notes: The security and detection system is beyond its service life and should be replaced.

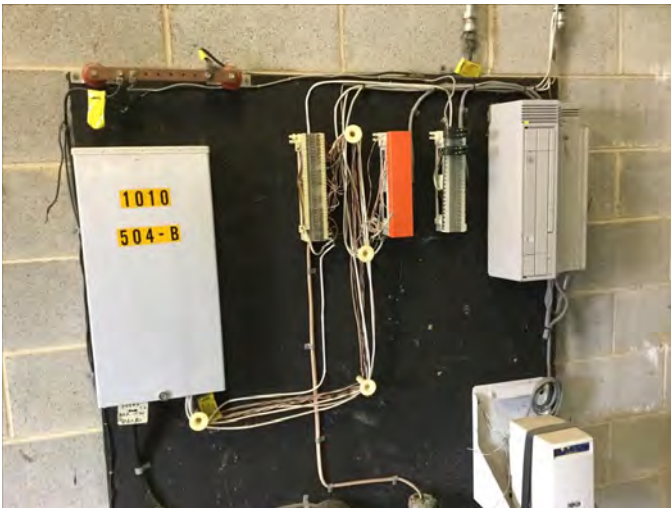
System: D5030920 - Data Communication

Location: Throughout Building
Distress: Beyond Service Life
Category: Deferred Maintenance
Priority: 3 - Necessary/Not Yet Critical (Years 2-5)
Correction: Renew System
Qty: 45,000.00
Unit of Measure: S.F.
Estimate: \$217,800.00
Assessor Name: Eduardo Lopez
Date Created: 01/17/2017

Notes: The data and communications system is beyond its service life and should be replaced.

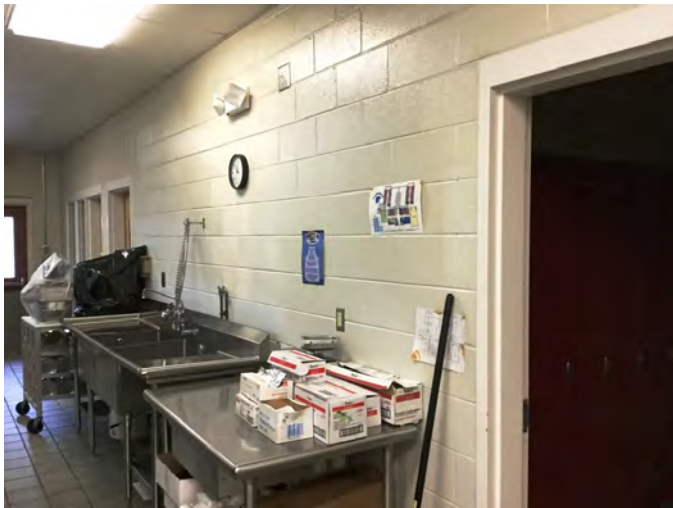
System: D5090 - Other Electrical Systems

Location: Throughout Building
Distress: Beyond Service Life
Category: Deferred Maintenance
Priority: 3 - Necessary/Not Yet Critical (Years 2-5)
Correction: Renew System
Qty: 45,000.00
Unit of Measure: S.F.
Estimate: \$5,940.00
Assessor Name: Eduardo Lopez
Date Created: 02/24/2017

Notes: The emergency light system is beyond its service life and should be replaced.

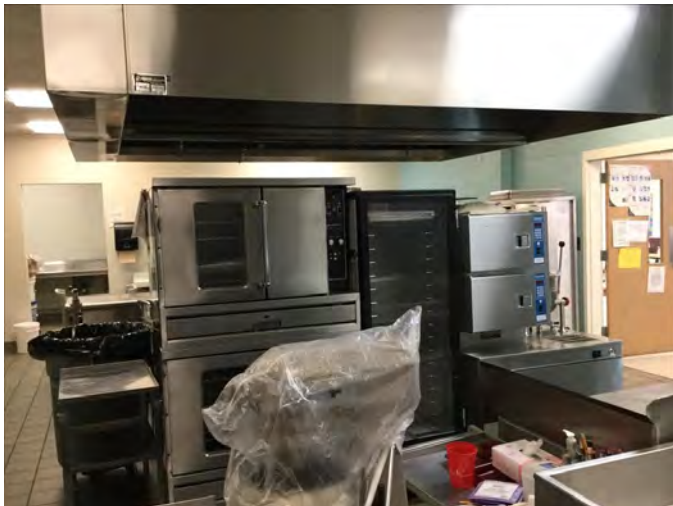
System: E1090 - Other Equipment

Location: Kitchen
Distress: Beyond Service Life
Category: Deferred Maintenance
Priority: 3 - Necessary/Not Yet Critical (Years 2-5)
Correction: Renew System
Qty: 45,000.00
Unit of Measure: S.F.
Estimate: \$94,050.00
Assessor Name: Eduardo Lopez
Date Created: 01/17/2017

Notes: The kitchen equipment is beyond its service life and should be replaced.

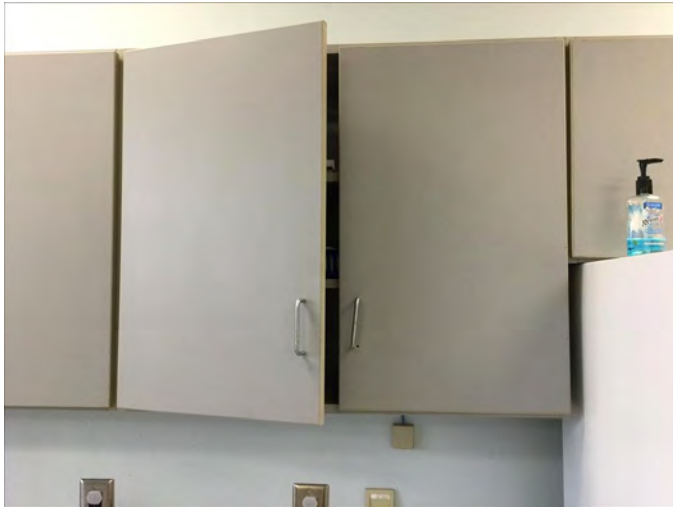
System: E2010 - Fixed Furnishings

Location: Throughout Building
Distress: Beyond Service Life
Category: Deferred Maintenance
Priority: 3 - Necessary/Not Yet Critical (Years 2-5)
Correction: Renew System
Qty: 45,000.00
Unit of Measure: S.F.
Estimate: \$288,585.00
Assessor Name: Eduardo Lopez
Date Created: 01/17/2017

Notes: The fixed furnishings are beyond their service life and should be replaced.

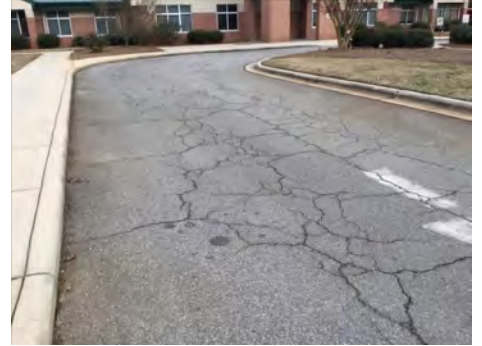
System: G2010 - Roadways

Note: The roadways are beyond their service life and should be replaced.

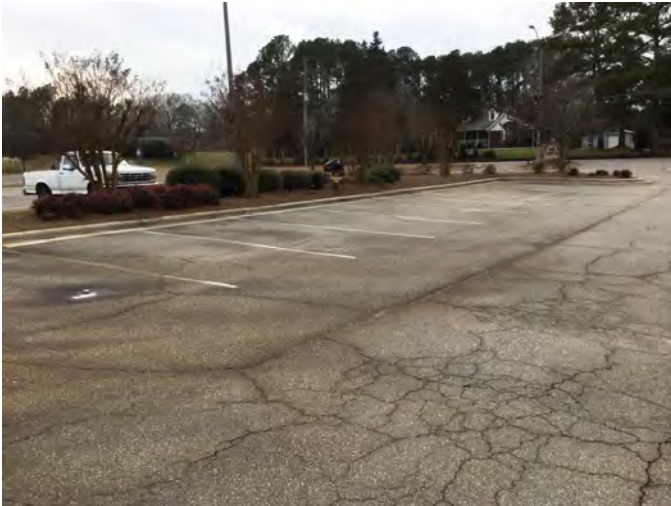
System: G2010 - Roadways

Location: Site
Distress: Failing
Category: Deferred Maintenance
Priority: 3 - Necessary/Not Yet Critical (Years 2-5)
Correction: Renew System
Qty: 45,540.00
Unit of Measure: S.F.
Estimate: \$190,858.00
Assessor Name: Eduardo Lopez
Date Created: 01/18/2017

Notes: The roadways are beyond their service life and should be replaced.

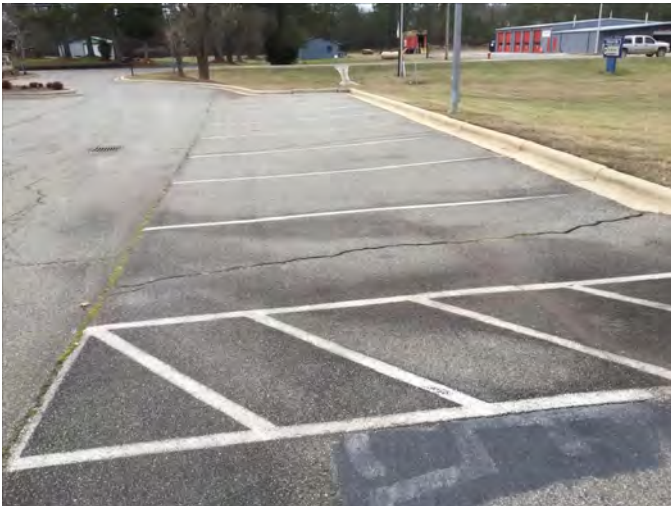
System: G2020 - Parking Lots

Location: Site
Distress: Inadequate
Category: Deferred Maintenance
Priority: 3 - Necessary/Not Yet Critical (Years 2-5)
Correction: Parking lot repair and sealcoating
Qty: 120.00
Unit of Measure: M.S.F.
Estimate: \$99,734.98
Assessor Name: Eduardo Lopez
Date Created: 01/18/2017

Notes: The parking area striping is in poor condition and needs to be restriped, and the parking area needs to be seal coated.
