NC School District/430 Harnett County/Elementary School

# Boone Trail Elementary

## Campus Assessment Report

March 11, 2017

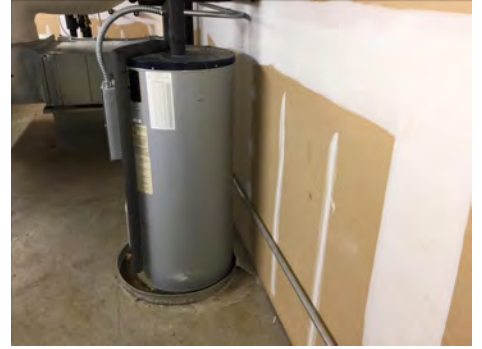
**System:** D2020 - Domestic Water Distribution

**Note:** 4 - water heaters are at the end of there life cycle.

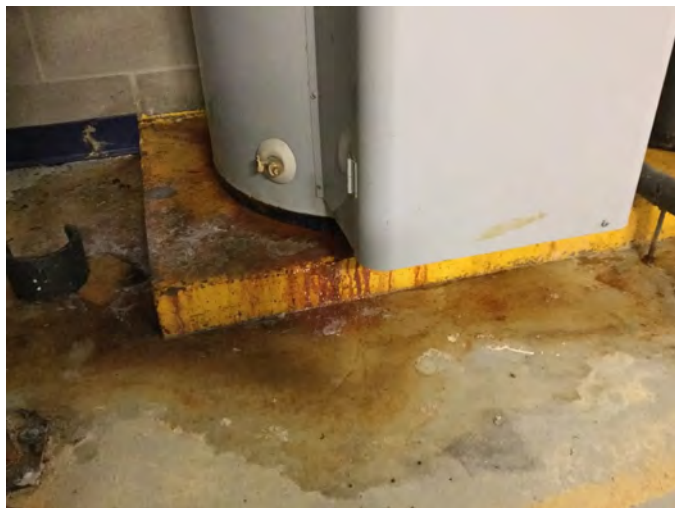
#### System: D2020 - Domestic Water Distribution

**Location:** Mechanical Room  
**Distress:** Beyond Service Life  
**Category:** Deferred Maintenance  
**Priority:** 3 - Necessary/Not Yet Critical (Years 2-5)  
**Correction:** Replace water heater, gas / oil, 70 gallon  
**Qty:** 2.00  
**Unit of Measure:** Ea.  
**Estimate:** \$20,631.60  
**Assessor Name:** Terence Davis  
**Date Created:** 12/13/2016

**Notes:** The water heaters are leaking and need to be replaced.

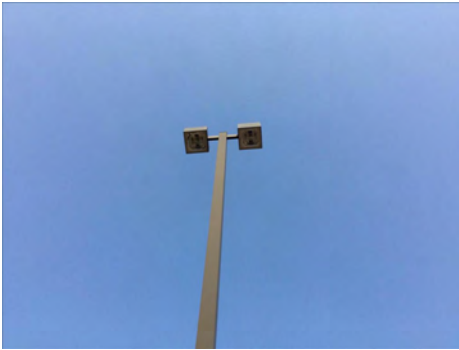
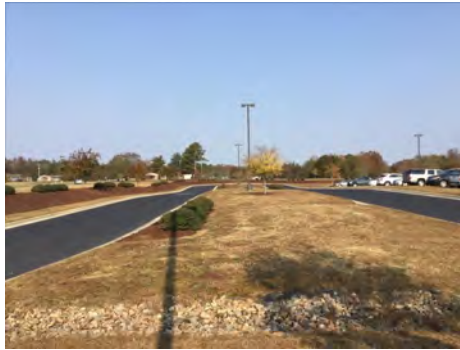
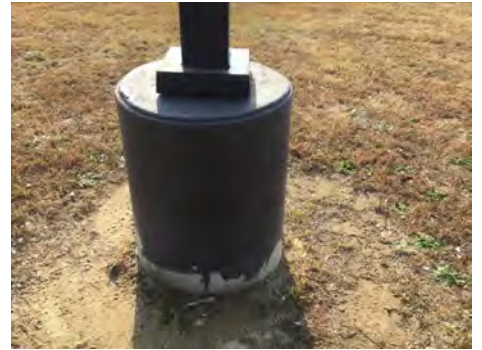
**System:** G4020 - Site Lighting

**Note:** Wind causes light fixture screws to loosen and light bulbs fall out.

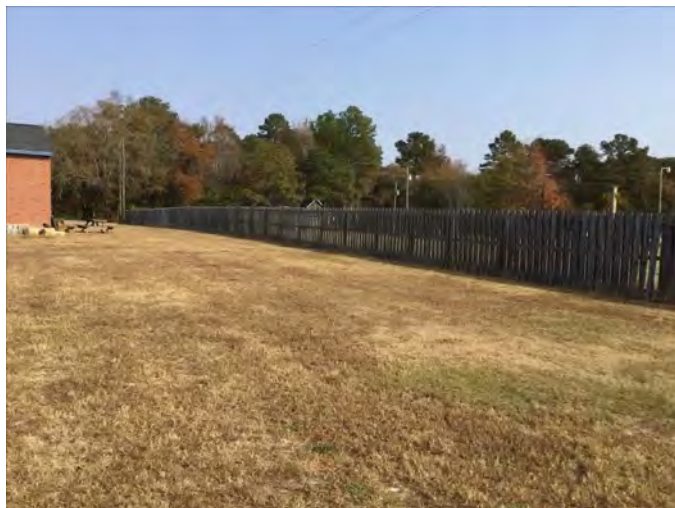
#### System: G2040105 - Fence & Guardrails

**Location:** Site  
**Distress:** Damaged  
**Category:** Deferred Maintenance  
**Priority:** 3 - Necessary/Not Yet Critical (Years 2-5)  
**Correction:** Renew System  
**Qty:** 125,992.00  
**Unit of Measure:** S.F.  
**Estimate:** \$170,467.00  
**Assessor Name:** Eduardo Lopez  
**Date Created:** 12/13/2016

**Notes:** The fence is damaged and need to be replaced.
