NC School District/430 Harnett County/Middle School

Coats-Erwin Middle

Campus Assessment Report

March 11, 2017

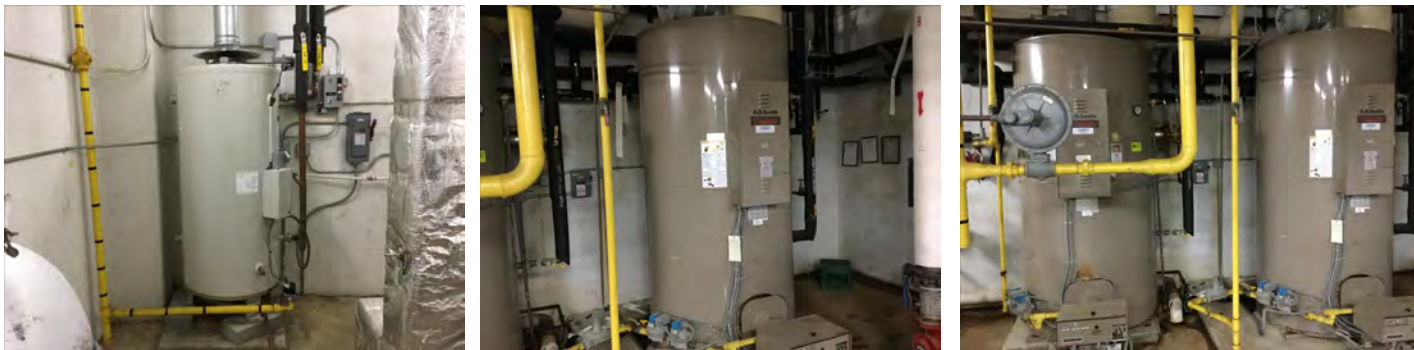
System: D2020 - Domestic Water Distribution

Note: 2 water heaters 300 gal each in boiler room - Original
1 water heater 150 gal in gym - 2015
2 water heater 86 gal in mech room 6 grade - original

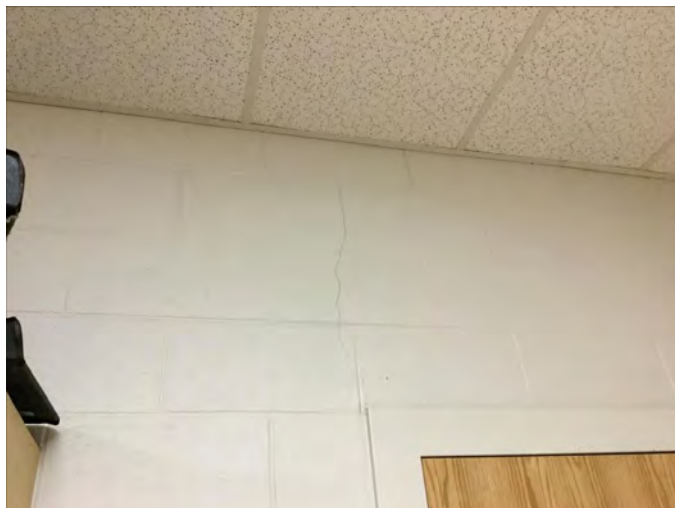
System: C1010 - Partitions

Location: Classroom F111
Distress: Failing
Category: Safety / Building Code Compliance
Priority: 1 - Currently Critical (Immediate)
Correction: Engineering Study
Qty: 1.00
Unit of Measure: Ea.
Estimate: \$13,200.00
Assessor Name: Eduardo Lopez
Date Created: 11/29/2016

Notes: There are visible cracks on the partition wall which should be studied by a professional engineer.

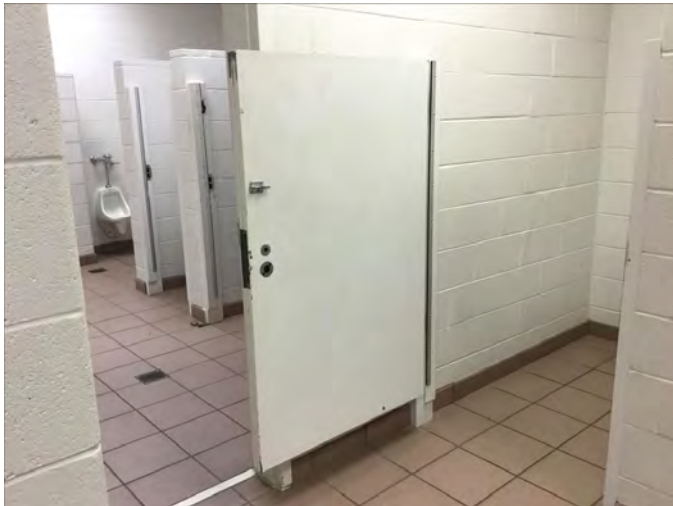
System: C1030 - Fittings

Location: Throughout Building
Distress: Damaged
Category: Deferred Maintenance / Appearance
Priority: 3 - Necessary/Not Yet Critical (Years 2-5)
Correction: Renew System
Qty: 137,779.00
Unit of Measure: S.F.
Estimate: \$639,570.00
Assessor Name: Eduardo Lopez
Date Created: 11/29/2016

Notes: The toilet partitions are damaged and should be replaced.

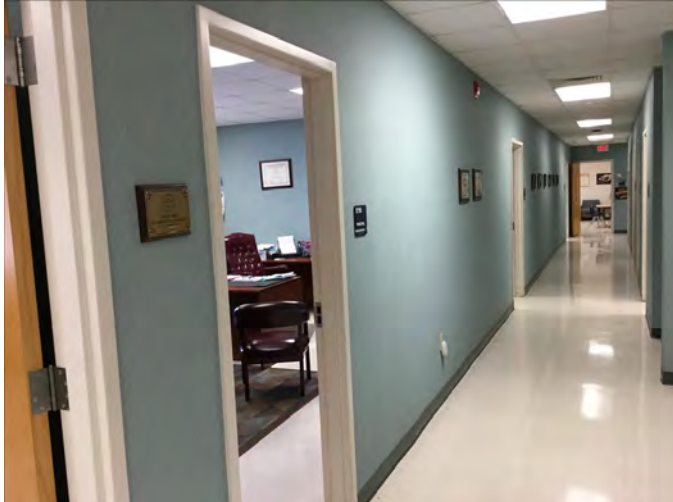
System: C3010 - Wall Finishes

Location: Throughout Building
Distress: Beyond Service Life
Category: Deferred Maintenance / Appearance
Priority: 3 - Necessary/Not Yet Critical (Years 2-5)
Correction: Renew System
Qty: 137,779.00
Unit of Measure: S.F.
Estimate: \$507,716.00
Assessor Name: Eduardo Lopez
Date Created: 11/29/2016

Notes: The wall finish is beyond its service life and should be replaced.

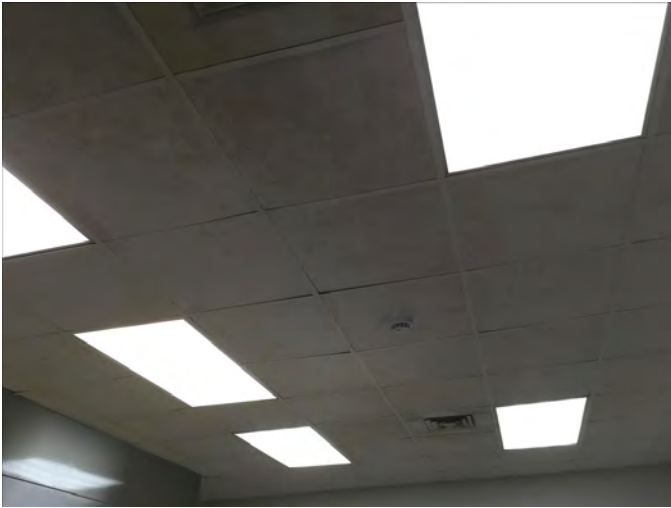
System: C3030 - Ceiling Finishes

Location: Throughout the building
Distress: Failing
Category: Deferred Maintenance / Appearance
Priority: 3 - Necessary/Not Yet Critical (Years 2-5)
Correction: Replace acoustic tile ceiling, non fire-rated
Qty: 688.89
Unit of Measure: C.S.F.
Estimate: \$518,320.85
Assessor Name: Eduardo Lopez
Date Created: 11/29/2016

Notes: The acoustical ceiling tiles are failing due to humidity and should be replaced. (50%)

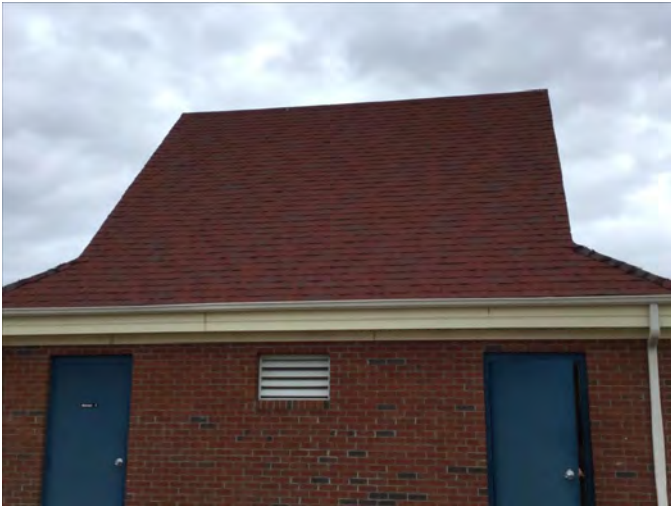
System: B3010140 - Asphalt Shingles

Location: Roof
Distress: Failing
Category: Deferred Maintenance / Building Code Compliance
Priority: 3 - Necessary/Not Yet Critical (Years 2-5)
Correction: Renew System
Qty: 627.00
Unit of Measure: S.F.
Estimate: \$3,955.00
Assessor Name: Eduardo Lopez
Date Created: 11/29/2016

Notes: The asphalt shingles are failing and should be replaced.

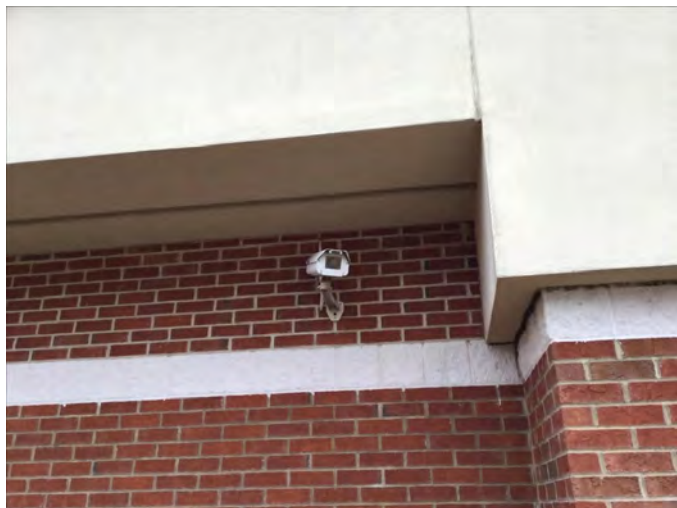
System: G4030 - Site Communications & Security

Location: Exterior Wall
Distress: Beyond Service Life
Category: Deferred Maintenance
Priority: 3 - Necessary/Not Yet Critical (Years 2-5)
Correction: Renew System
Qty: 138,691.00
Unit of Measure: S.F.
Estimate: \$134,253.00
Assessor Name: Eduardo Lopez
Date Created: 11/30/2016
