NC School District/520 Jones County/Elementary School

Comfort Elementary

Campus Assessment Report

March 11, 2017

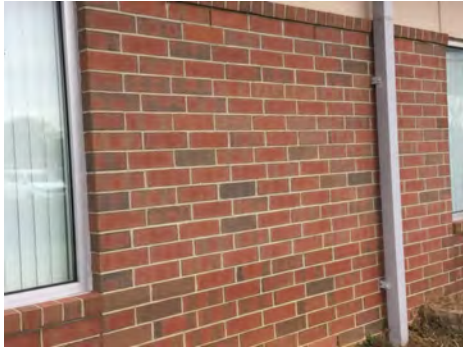
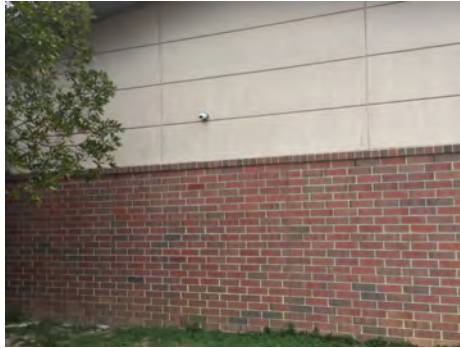
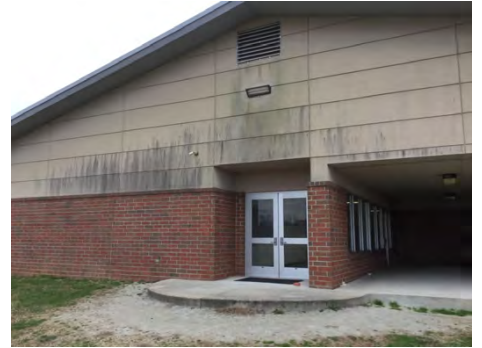
System: B2010 - Exterior Walls

Note: Scheduled for painting 2017.

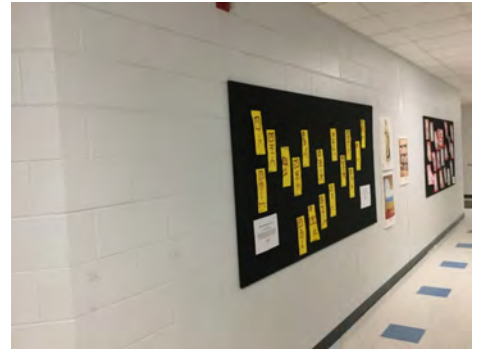
System: C3010 - Wall Finishes

Note: Interior painting is scheduled for 2017.

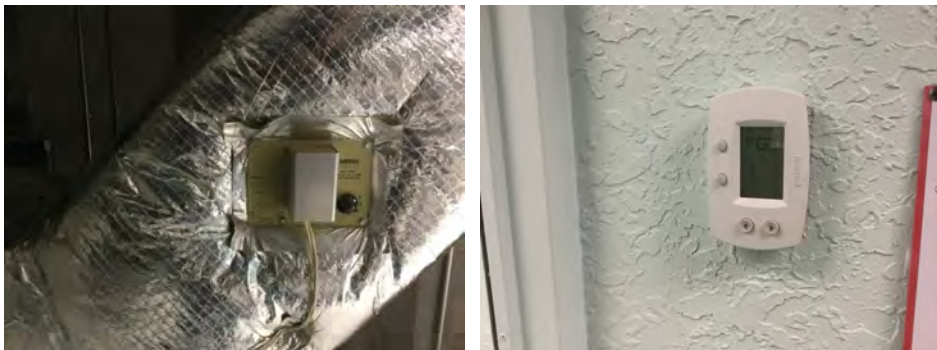
System: D3060 - Controls & Instrumentation

Note: Original proprietary system has been abandoned. Local thermostats are used.

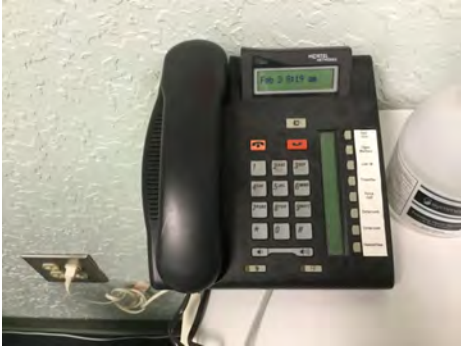
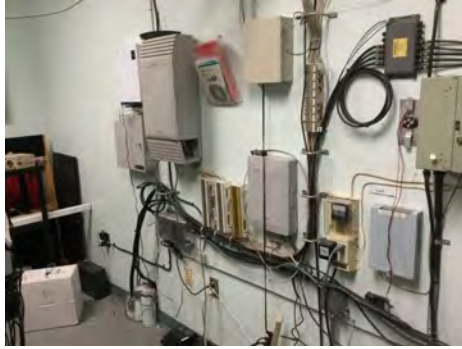
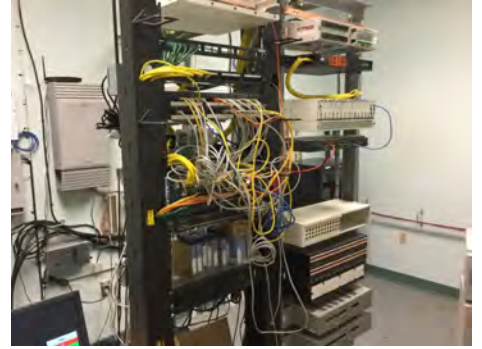
System: D5030920 - Data Communication

Note: PA upgraded 2016. All components not replaced.

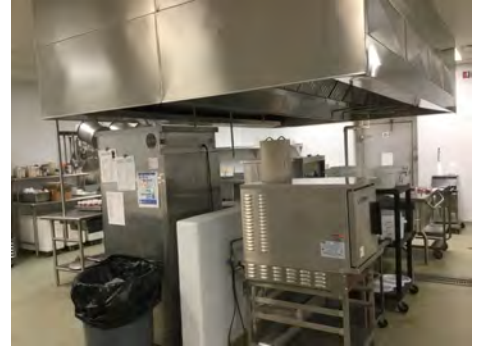
System: E1090 - Other Equipment

Note: Dishwasher abandoned in place.

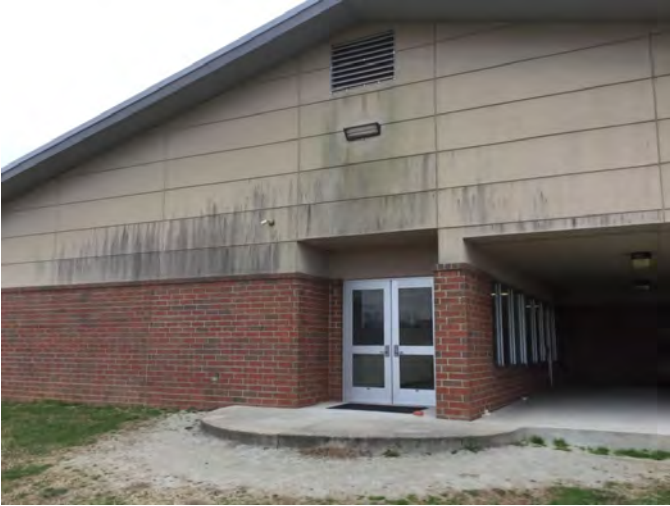
System: B2010 - Exterior Walls

Location: Stucco system
Distress: Damaged
Category: Deferred Maintenance / Appearance
Priority: 3 - Necessary/Not Yet Critical (Years 2-5)
Correction: Spray refinish exterior walls
Qty: 5,000.00
Unit of Measure: S.F.
Estimate: \$9,510.60
Assessor Name: Terence Davis
Date Created: 02/08/2017

Notes: Stucco walls are stained and dirty. Power washing and repainting is recommended.

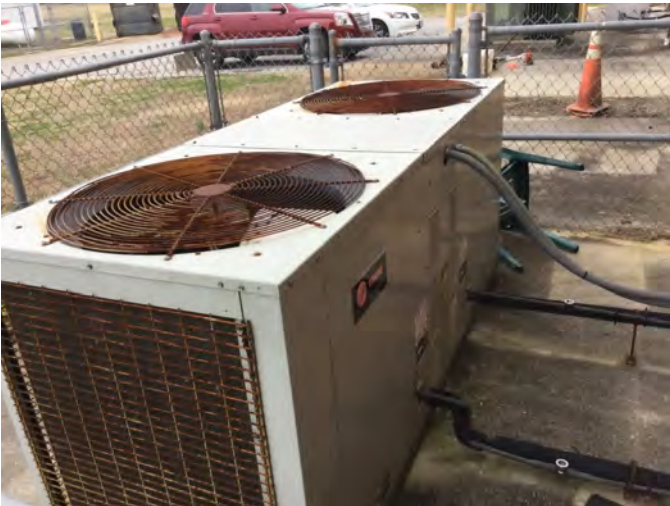
System: D3050 - Terminal & Package Units

Location: Throughout the building
Distress: Beyond Service Life
Category: Deferred Maintenance
Priority: 3 - Necessary/Not Yet Critical (Years 2-5)
Correction: Renew System
Qty: 39,809.00
Unit of Measure: S.F.
Estimate: \$597,732.00
Assessor Name: Terence Davis
Date Created: 02/07/2017

Notes: Heat pumps throughout the building are typically original and have exceeded their expected useful life. Dedicated cooling is not provided at data rooms. System replacement is recommended.

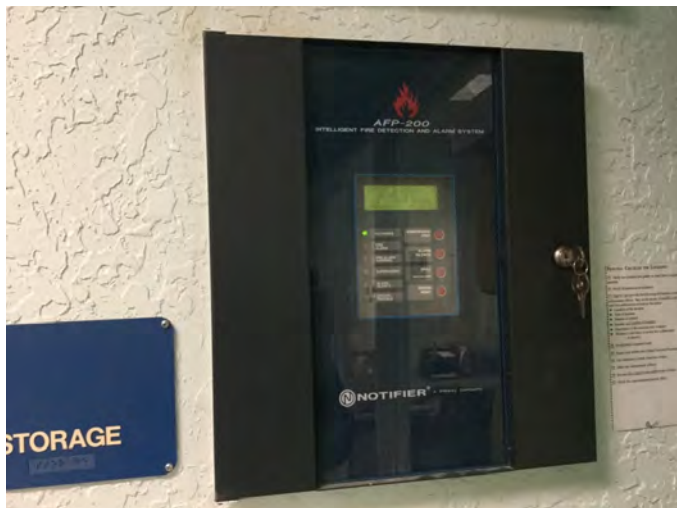
System: D5030910 - Fire Alarm Systems

Location: Throughout the building
Distress: Beyond Service Life
Category: Deferred Maintenance
Priority: 3 - Necessary/Not Yet Critical (Years 2-5)
Correction: Renew System
Qty: 39,809.00
Unit of Measure: S.F.
Estimate: \$148,448.00
Assessor Name: Terence Davis
Date Created: 02/07/2017

Notes: The fire alarm system is original and beyond its expected life. System renewal is recommended to ensure reliability of this life safety system.

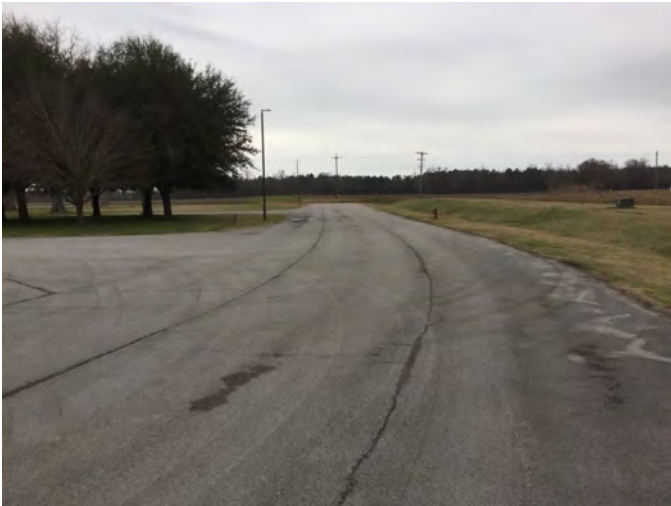
System: G2010 - Roadways

Location: Site roads
Distress: Damaged
Category: Deferred Maintenance
Priority: 3 - Necessary/Not Yet Critical (Years 2-5)
Correction: Resurface the roadway
Qty: 1,000.00
Unit of Measure: L.F.
Estimate: \$48,114.00
Assessor Name: Eduardo Lopez
Date Created: 02/08/2017

Notes: The asphaltic roadway is aged, and should be re-surfaced.

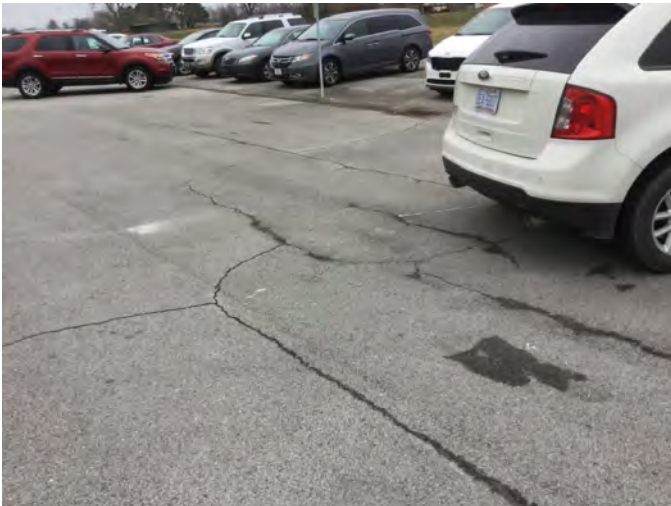
System: G2020 - Parking Lots

Location: Parking lots
Distress: Inadequate
Category: Deferred Maintenance / Accessibility Code Compliance
Priority: 3 - Necessary/Not Yet Critical (Years 2-5)
Correction: Parking lot repair and sealcoating
Qty: 24.00
Unit of Measure: M.S.F.
Estimate: \$21,192.97
Assessor Name: Eduardo Lopez
Date Created: 02/08/2017

Notes: The parking lot is beginning to show age. It should be crack filled and sealed to mitigate premature failure. Re-stripe the lot and provide ADA compliant markings and signage and a fire lane.
