Cornatzer Elementary

Campus Assessment Report

March 10, 2017

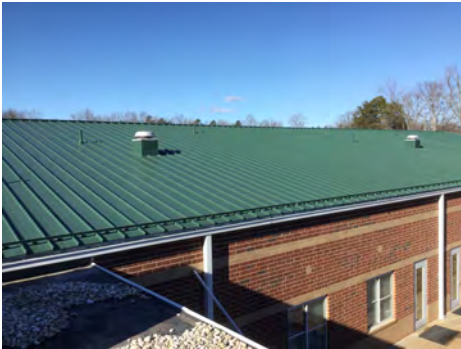
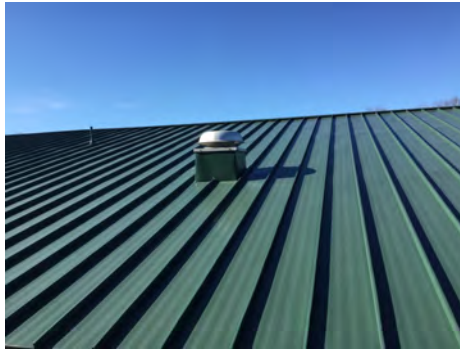
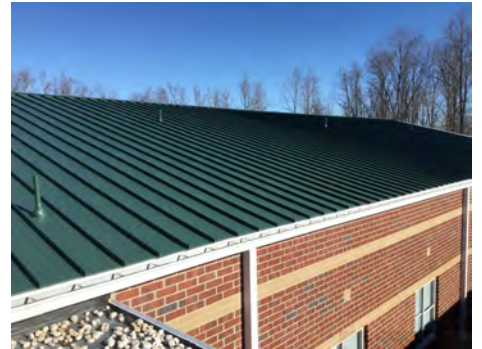
System: B3010130 - Preformed Metal Roofing

Note: Roof repainted in 2015 due to manufacturing defect

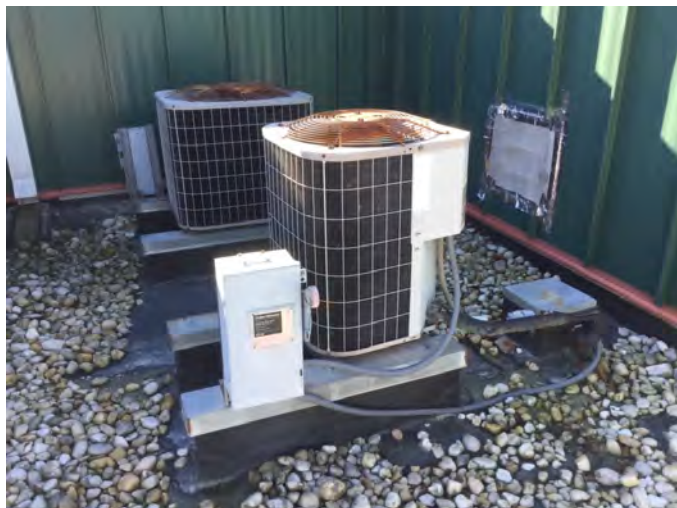
System: D3050 - Terminal & Package Units

Location: 2000 Main
Distress: Beyond Service Life
Category: Deferred Maintenance
Priority: 3 - Necessary/Not Yet Critical (Years 2-5)
Correction: Renew System
Qty: 72,148.00
Unit of Measure: S.F.
Estimate: \$234,914.00
Assessor Name: Somnath Das
Date Created: 12/13/2016

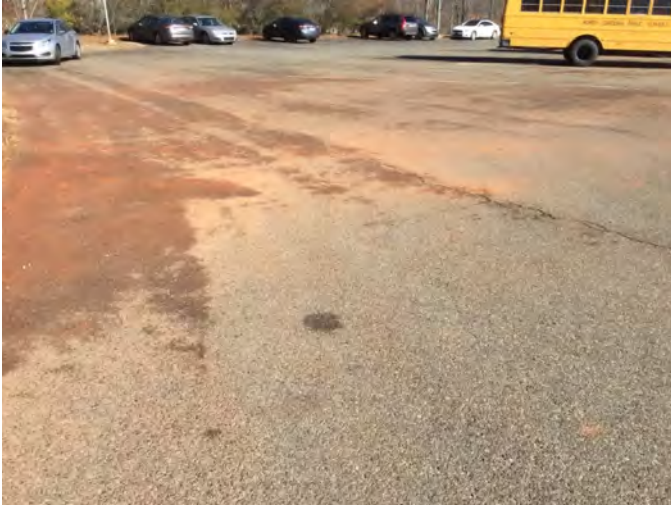
System: G2050 - Landscaping

Location: West end bus parking lot
Distress: Failing
Category: Safety
Priority: 2 - Potentially Critical (Year 1)
Correction: Erosion control; incl. soil preparation, topsoil and sodding
Qty: 5,000.00
Unit of Measure: S.F.
Estimate: \$7,642.80
Assessor Name: Somnath Das
Date Created: 02/11/2017

Notes: Erosion occurring past the west end of the parking lot creates a potential hazard for mud/slippy conditions, and is unsightly.
