NC School District/300 Davie County/Elementary School

# William R. Davie Elementary

## Campus Assessment Report

March 10, 2017

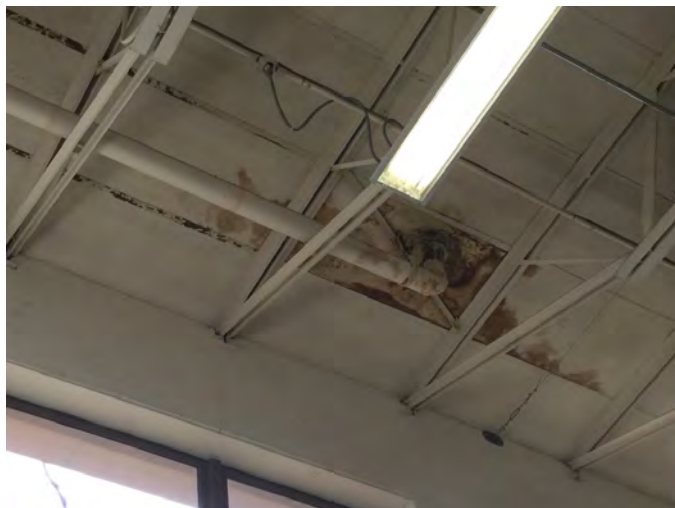
#### System: D2040 - Rain Water Drainage

**Location:** Gymnasium  
**Distress:** Failing  
**Category:** Deferred Maintenance  
**Priority:** 2 - Potentially Critical (Year 1)  
**Correction:** Replace pipe or gutter distribution  
**Qty:** 500.00  
**Unit of Measure:** L.F.  
**Estimate:** \$38,610.00  
**Assessor Name:** Eduardo Lopez  
**Date Created:** 02/15/2017

**Notes:** The rain water drainage system in the gym is aged, in marginal condition, with reported water leaks and should be replaced.

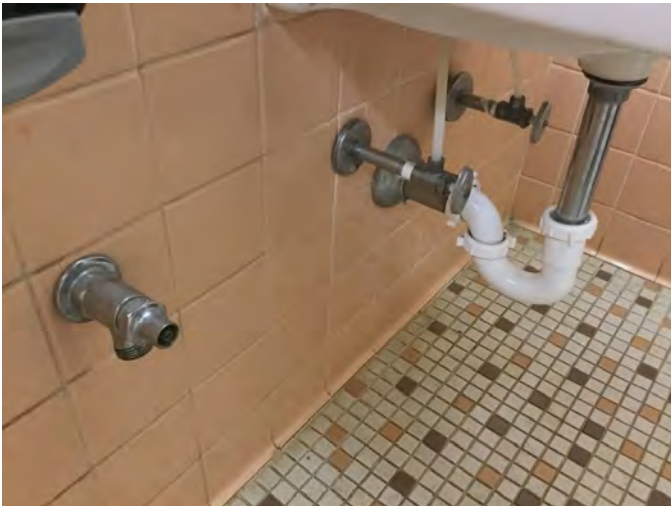
**System: D2020 - Domestic Water Distribution**

**Location:** Throughout the Building  
**Distress:** Beyond Service Life  
**Category:** Deferred Maintenance  
**Priority:** 3 - Necessary/Not Yet Critical (Years 2-5)  
**Correction:** Renew System  
**Qty:** 37,830.00  
**Unit of Measure:** S.F.  
**Estimate:** \$39,948.00  
**Assessor Name:** Eduardo Lopez  
**Date Created:** 02/15/2017

**Notes:** The domestic water distribution system is aged and should be replaced.

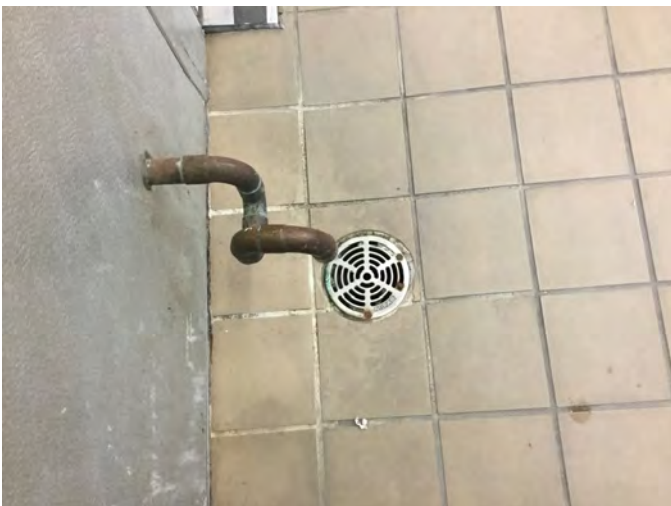
**System: D2030 - Sanitary Waste**

**Location:** Throughout the Building  
**Distress:** Beyond Service Life  
**Category:** Deferred Maintenance  
**Priority:** 3 - Necessary/Not Yet Critical (Years 2-5)  
**Correction:** Renew System  
**Qty:** 37,830.00  
**Unit of Measure:** S.F.  
**Estimate:** \$63,252.00  
**Assessor Name:** Eduardo Lopez  
**Date Created:** 02/15/2017

**Notes:** The sanitary waste system is beyond its expected service life and should be replaced.

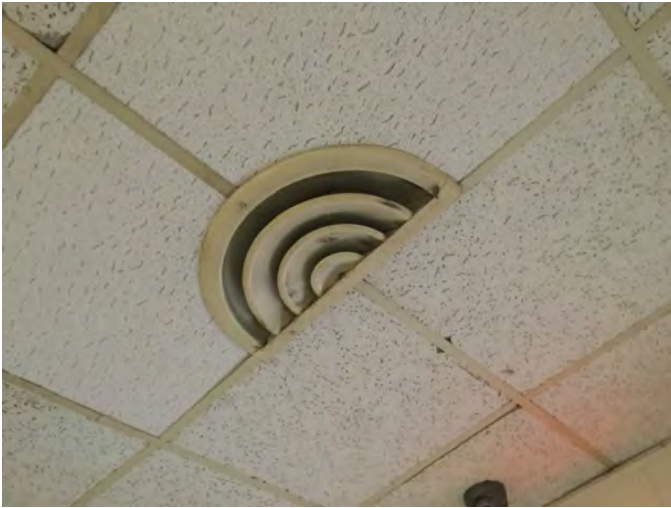
**System: D3040 - Distribution Systems**

**Location:** Throughout the Building  
**Distress:** Beyond Service Life  
**Category:** Deferred Maintenance  
**Priority:** 3 - Necessary/Not Yet Critical (Years 2-5)  
**Correction:** Renew System  
**Qty:** 37,830.00  
**Unit of Measure:** S.F.  
**Estimate:** \$250,510.00  
**Assessor Name:** Eduardo Lopez  
**Date Created:** 02/15/2017

**Notes:** Distribution systems are aged, becoming logistically unsupportable, and should be replaced.

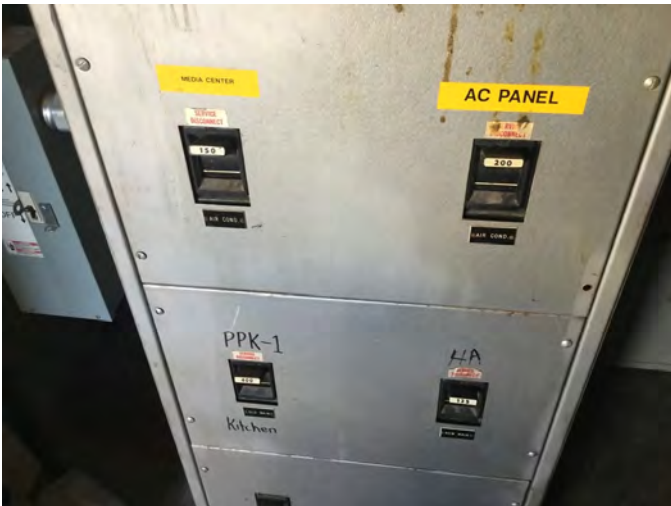
**System: D5010 - Electrical Service/Distribution**

**Location:** Throughout the Building  
**Distress:** Beyond Service Life  
**Category:** Deferred Maintenance  
**Priority:** 3 - Necessary/Not Yet Critical (Years 2-5)  
**Correction:** Renew System  
**Qty:** 37,830.00  
**Unit of Measure:** S.F.  
**Estimate:** \$68,661.00  
**Assessor Name:** Eduardo Lopez  
**Date Created:** 02/15/2017

**Notes:** The original electrical service is operating but is in poor condition and should be replaced.

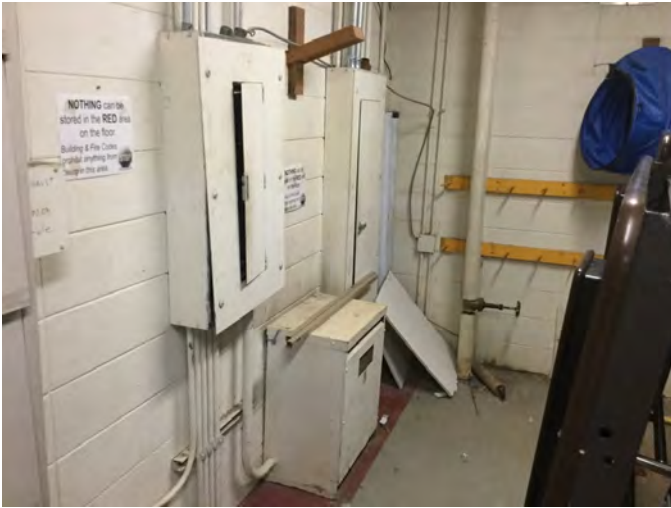
**System: D5020 - Branch Wiring**

**Location:** Throughout the Building  
**Distress:** Beyond Service Life  
**Category:** Deferred Maintenance  
**Priority:** 3 - Necessary/Not Yet Critical (Years 2-5)  
**Correction:** Renew System  
**Qty:** 37,830.00  
**Unit of Measure:** S.F.  
**Estimate:** \$207,649.00  
**Assessor Name:** Eduardo Lopez  
**Date Created:** 02/15/2017

**Notes:** The original branch wiring system is operating but is aged, in marginal condition, and should be replaced.

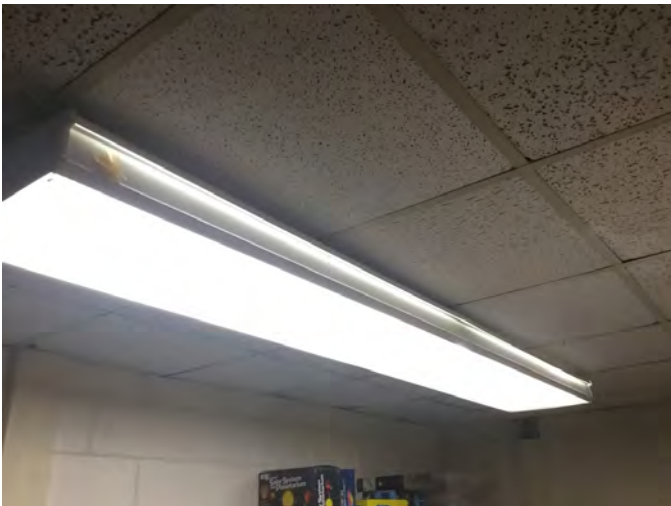
**System: D5020 - Lighting**

**Location:** Throughout the Building  
**Distress:** Beyond Service Life  
**Category:** Deferred Maintenance  
**Priority:** 3 - Necessary/Not Yet Critical (Years 2-5)  
**Correction:** Renew System  
**Qty:** 37,830.00  
**Unit of Measure:** S.F.  
**Estimate:** \$484,375.00  
**Assessor Name:** Eduardo Lopez  
**Date Created:** 02/15/2017

**Notes:** The original lighting system is operating but is aged, in marginal condition, and should be replaced.

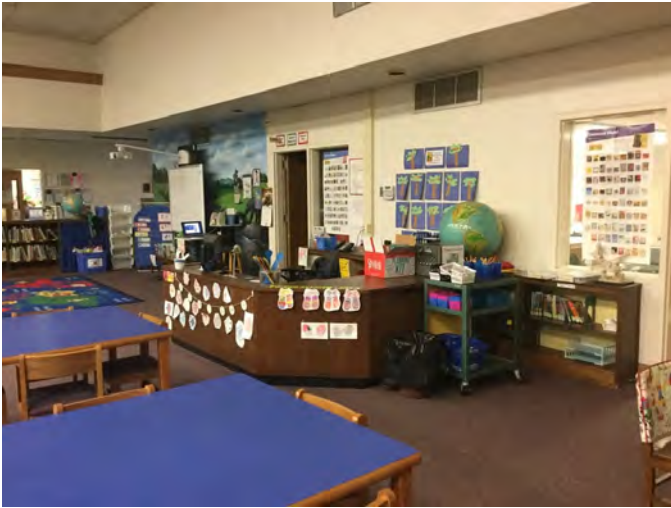
**System: E1020 - Institutional Equipment**

**Location:** Throughout the Building  
**Distress:** Beyond Service Life  
**Category:** Deferred Maintenance  
**Priority:** 3 - Necessary/Not Yet Critical (Years 2-5)  
**Correction:** Renew System  
**Qty:** 37,830.00  
**Unit of Measure:** S.F.  
**Estimate:** \$12,484.00  
**Assessor Name:** Eduardo Lopez  
**Date Created:** 02/15/2017

**Notes:** The institutional equipment is in deteriorating conditions and should be replaced.

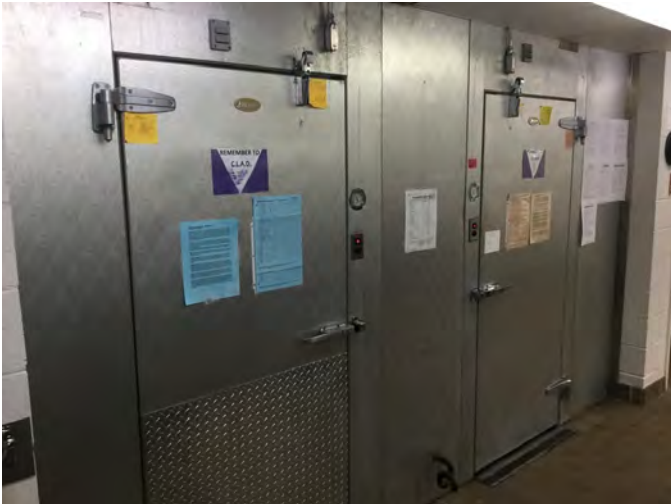
**System: E1090 - Other Equipment**

**Location:** Throughout the Building  
**Distress:** Beyond Service Life  
**Category:** Deferred Maintenance  
**Priority:** 3 - Necessary/Not Yet Critical (Years 2-5)  
**Correction:** Renew System  
**Qty:** 37,830.00  
**Unit of Measure:** S.F.  
**Estimate:** \$77,400.00  
**Assessor Name:** Eduardo Lopez  
**Date Created:** 02/15/2017

**Notes:** The other equipment is in deteriorating conditions and should be replaced.

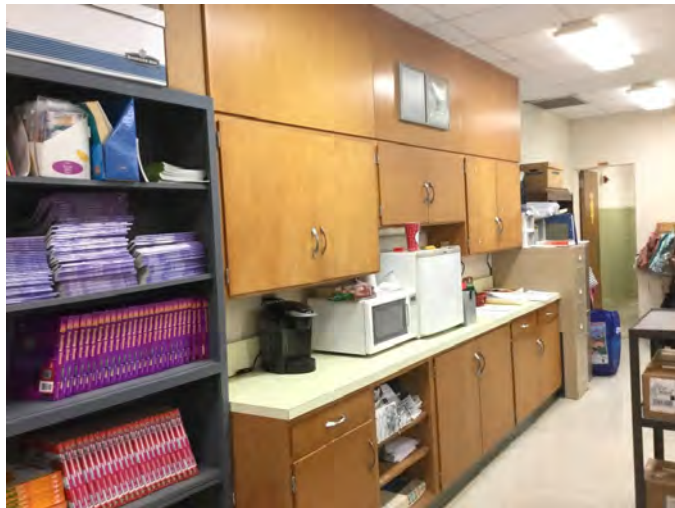
**System: E2010 - Fixed Furnishings**

**Location:** Throughout the Building  
**Distress:** Beyond Service Life  
**Category:** Deferred Maintenance  
**Priority:** 3 - Necessary/Not Yet Critical (Years 2-5)  
**Correction:** Renew System  
**Qty:** 37,830.00  
**Unit of Measure:** S.F.  
**Estimate:** \$238,026.00  
**Assessor Name:** Eduardo Lopez  
**Date Created:** 02/15/2017

**Notes:** The fixed furnishings are aged, in marginal condition, and should be replaced.

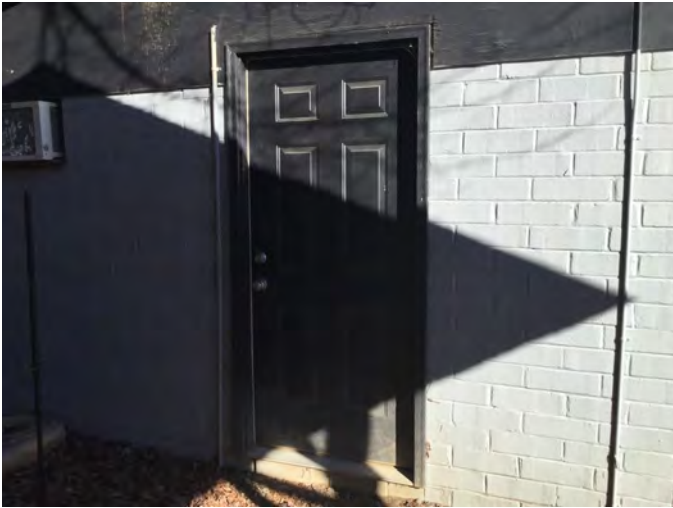
#### **System: B2030 - Exterior Doors**

**Location:** Exterior Walls  
**Distress:** Beyond Service Life  
**Category:** Deferred Maintenance  
**Priority:** 3 - Necessary/Not Yet Critical (Years 2-5)  
**Correction:** Renew System  
**Qty:** 520.00  
**Unit of Measure:** S.F.  
**Estimate:** \$521.00  
**Assessor Name:** Eduardo Lopez  
**Date Created:** 02/12/2017

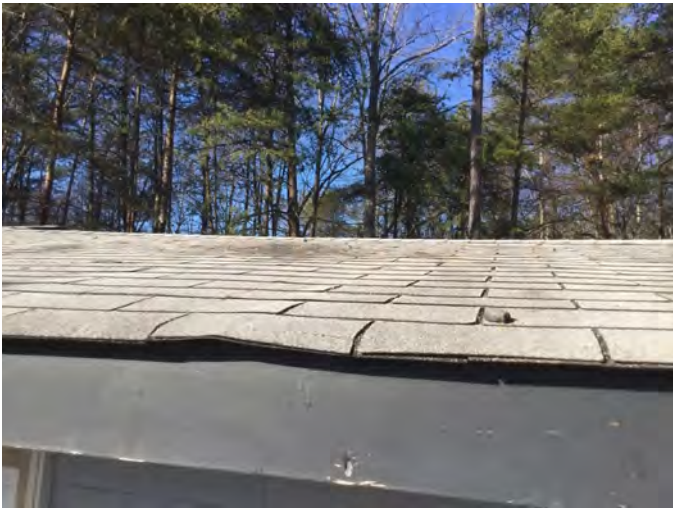
#### **System: B3010140 - Asphalt Shingles**

**Location:** Roof  
**Distress:** Beyond Service Life  
**Category:** Deferred Maintenance  
**Priority:** 3 - Necessary/Not Yet Critical (Years 2-5)  
**Correction:** Renew System  
**Qty:** 520.00  
**Unit of Measure:** S.F.  
**Estimate:** \$3,280.00  
**Assessor Name:** Eduardo Lopez  
**Date Created:** 02/12/2017

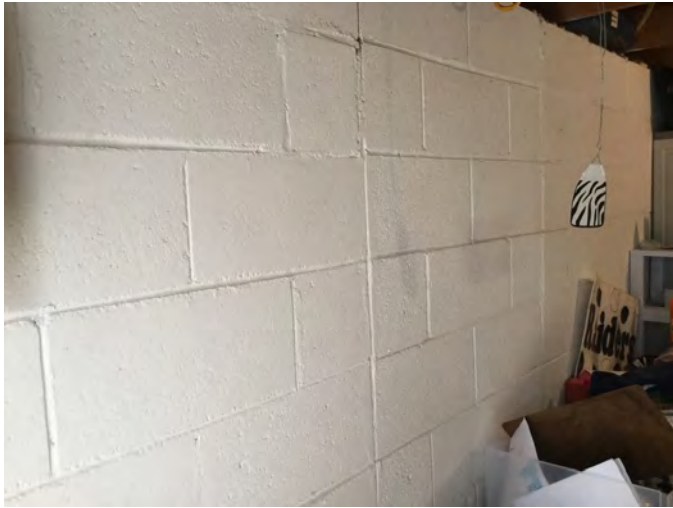
**System: C3010 - Wall Finishes**

**Location:** Throughout the Building  
**Distress:** Beyond Service Life  
**Category:** Deferred Maintenance  
**Priority:** 3 - Necessary/Not Yet Critical (Years 2-5)  
**Correction:** Renew System  
**Qty:** 520.00  
**Unit of Measure:** S.F.  
**Estimate:** \$4,267.00  
**Assessor Name:** Eduardo Lopez  
**Date Created:** 02/12/2017

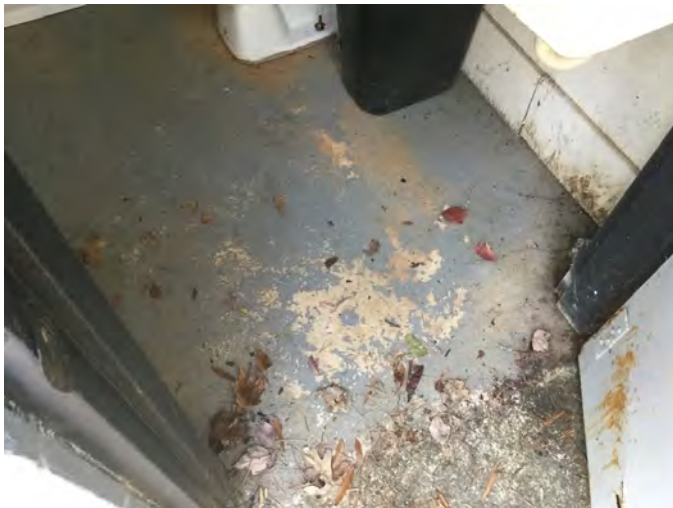
**System: C3020 - Floor Finishes**

**Location:** Throughout the Building  
**Distress:** Beyond Service Life  
**Category:** Deferred Maintenance  
**Priority:** 3 - Necessary/Not Yet Critical (Years 2-5)  
**Correction:** Renew System  
**Qty:** 520.00  
**Unit of Measure:** S.F.  
**Estimate:** \$7,287.00  
**Assessor Name:** Eduardo Lopez  
**Date Created:** 02/12/2017

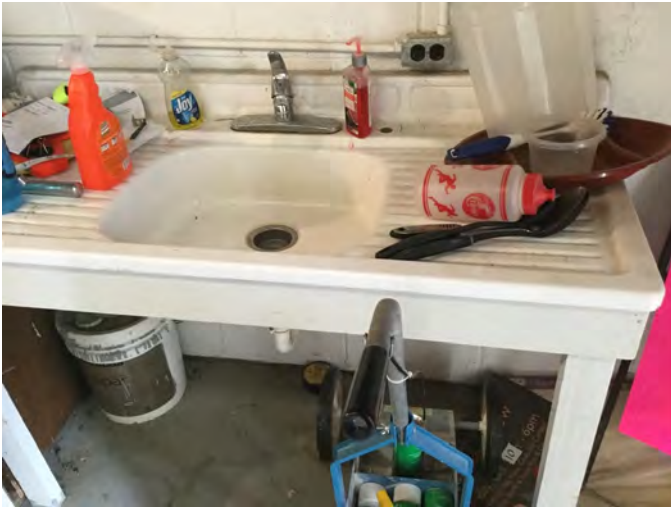
**System: D2010 - Plumbing Fixtures**

**Location:** Throughout the Building  
**Distress:** Beyond Service Life  
**Category:** Deferred Maintenance  
**Priority:** 3 - Necessary/Not Yet Critical (Years 2-5)  
**Correction:** Renew System  
**Qty:** 520.00  
**Unit of Measure:** S.F.  
**Estimate:** \$5,709.00  
**Assessor Name:** Eduardo Lopez  
**Date Created:** 02/12/2017

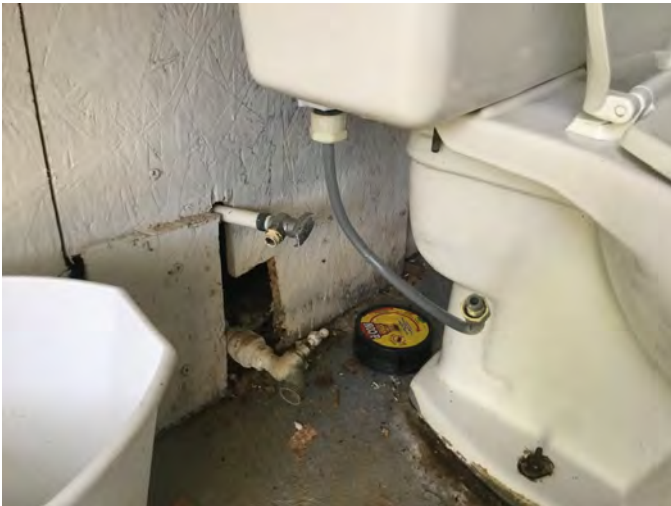
**System: D2020 - Domestic Water Distribution**

**Location:** Throughout the Building  
**Distress:** Beyond Service Life  
**Category:** Deferred Maintenance  
**Priority:** 3 - Necessary/Not Yet Critical (Years 2-5)  
**Correction:** Renew System  
**Qty:** 520.00  
**Unit of Measure:** S.F.  
**Estimate:** \$480.00  
**Assessor Name:** Eduardo Lopez  
**Date Created:** 02/12/2017

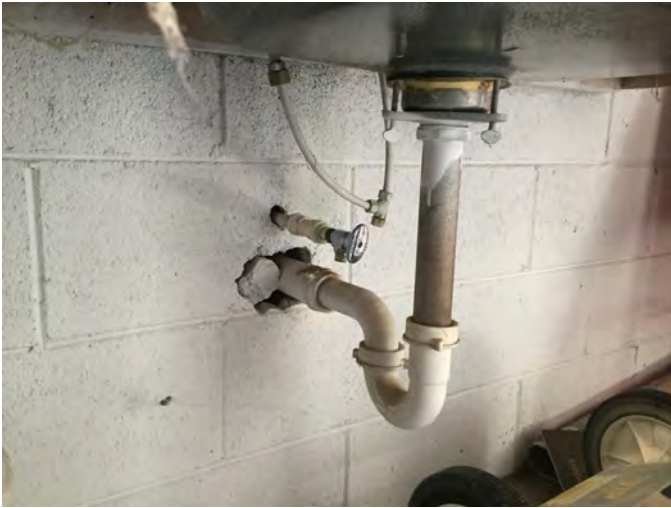
**System: D2030 - Sanitary Waste**

**Location:** Throughout the Building  
**Distress:** Beyond Service Life  
**Category:** Deferred Maintenance  
**Priority:** 3 - Necessary/Not Yet Critical (Years 2-5)  
**Correction:** Renew System  
**Qty:** 520.00  
**Unit of Measure:** S.F.  
**Estimate:** \$3,398.00  
**Assessor Name:** Eduardo Lopez  
**Date Created:** 02/12/2017

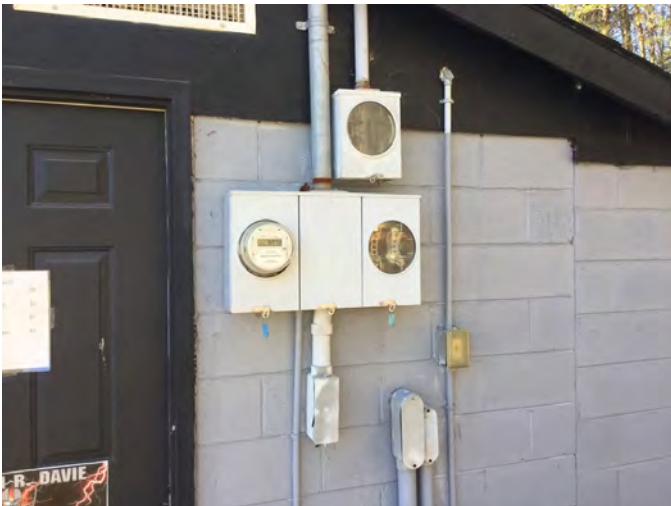
**System: D5010 - Electrical Service/Distribution**

**Location:** Throughout the Building  
**Distress:** Beyond Service Life  
**Category:** Deferred Maintenance  
**Priority:** 3 - Necessary/Not Yet Critical (Years 2-5)  
**Correction:** Renew System  
**Qty:** 520.00  
**Unit of Measure:** S.F.  
**Estimate:** \$841.00  
**Assessor Name:** Eduardo Lopez  
**Date Created:** 02/12/2017

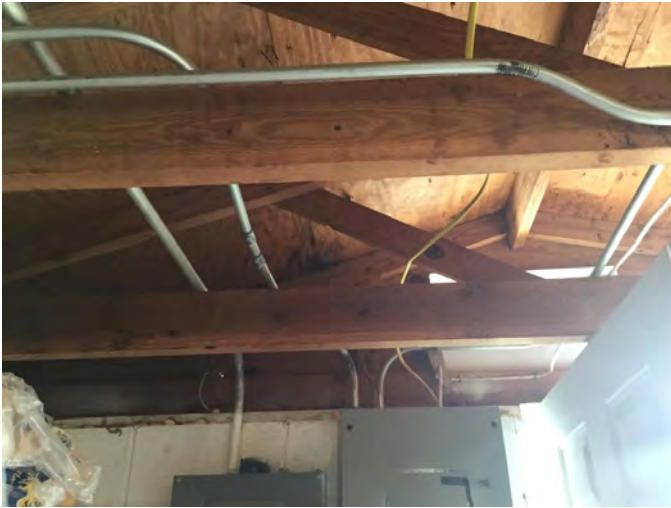
**System: D5020 - Branch Wiring**

**Location:** Throughout the Building  
**Distress:** Beyond Service Life  
**Category:** Deferred Maintenance  
**Priority:** 3 - Necessary/Not Yet Critical (Years 2-5)  
**Correction:** Renew System  
**Qty:** 520.00  
**Unit of Measure:** S.F.  
**Estimate:** \$1,459.00  
**Assessor Name:** Eduardo Lopez  
**Date Created:** 02/12/2017

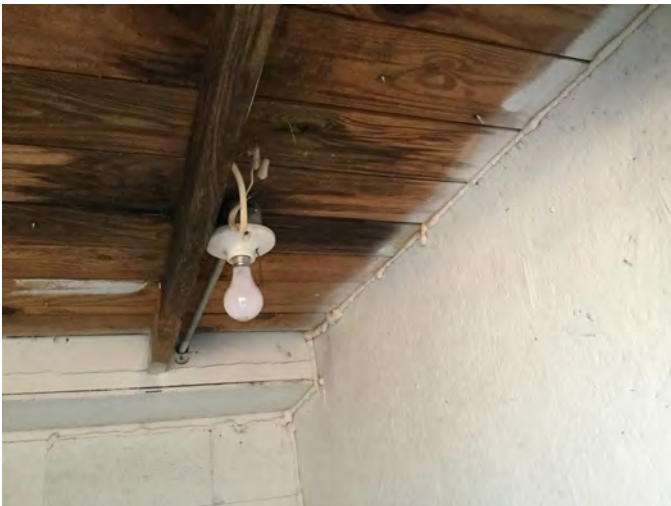
**System: D5020 - Lighting**

**Location:** Throughout the Building  
**Distress:** Beyond Service Life  
**Category:** Deferred Maintenance  
**Priority:** 3 - Necessary/Not Yet Critical (Years 2-5)  
**Correction:** Renew System  
**Qty:** 520.00  
**Unit of Measure:** S.F.  
**Estimate:** \$2,048.00  
**Assessor Name:** Eduardo Lopez  
**Date Created:** 02/12/2017

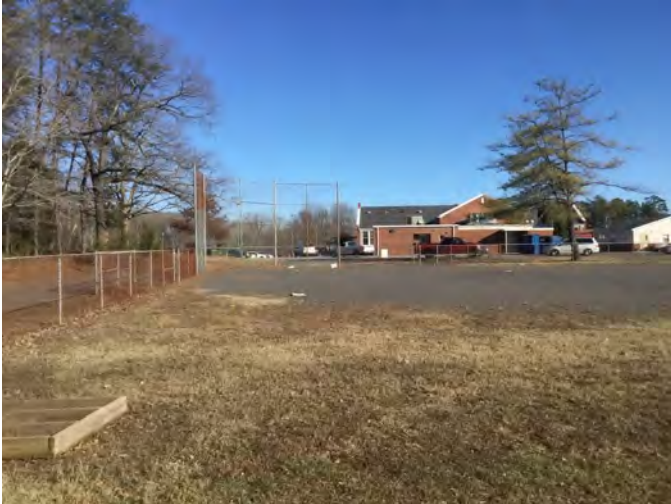
#### System: G2040950 - Playing Field

**Location:** Site  
**Distress:** Beyond Service Life  
**Category:** Deferred Maintenance  
**Priority:** 3 - Necessary/Not Yet Critical (Years 2-5)  
**Correction:** Renew System  
**Qty:** 64,064.00  
**Unit of Measure:** S.F.  
**Estimate:** \$319,936.00  
**Assessor Name:** Eduardo Lopez  
**Date Created:** 02/12/2017

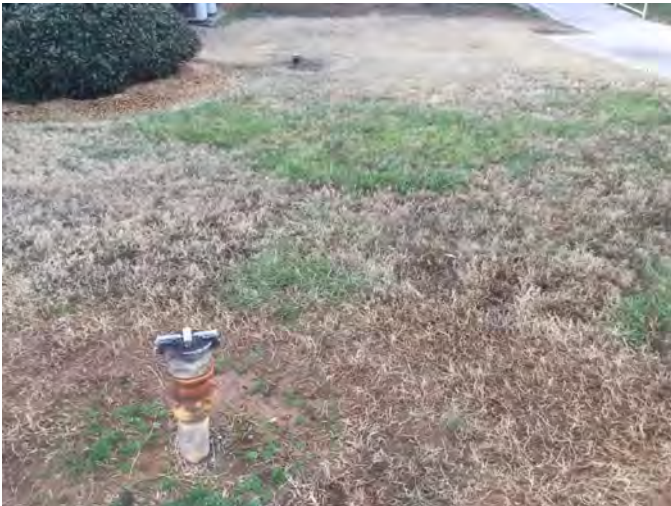
#### System: G3060 - Fuel Distribution

**Location:** Site  
**Distress:** Beyond Service Life  
**Category:** Deferred Maintenance  
**Priority:** 3 - Necessary/Not Yet Critical (Years 2-5)  
**Correction:** Renew System  
**Qty:** 64,064.00  
**Unit of Measure:** S.F.  
**Estimate:** \$69,061.00  
**Assessor Name:** Eduardo Lopez  
**Date Created:** 02/12/2017
