NC School District/430 Harnett County/Elementary School

Harnett Primary

Campus Assessment Report

March 11, 2017

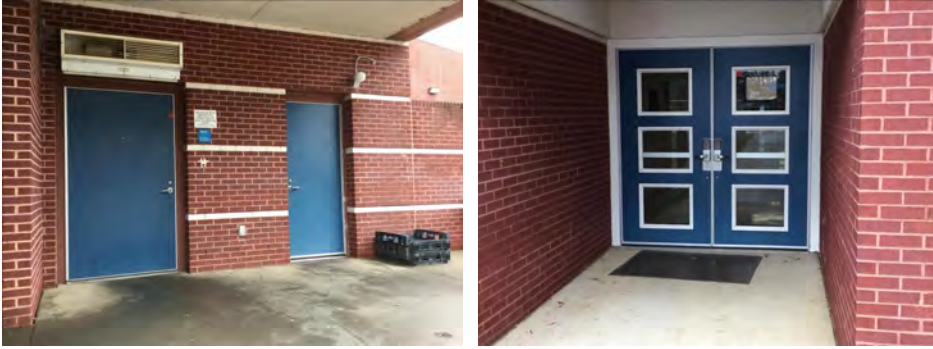
System: B2030 - Exterior Doors

Note: Main entrance need to be replaced. Core need to be replaced.

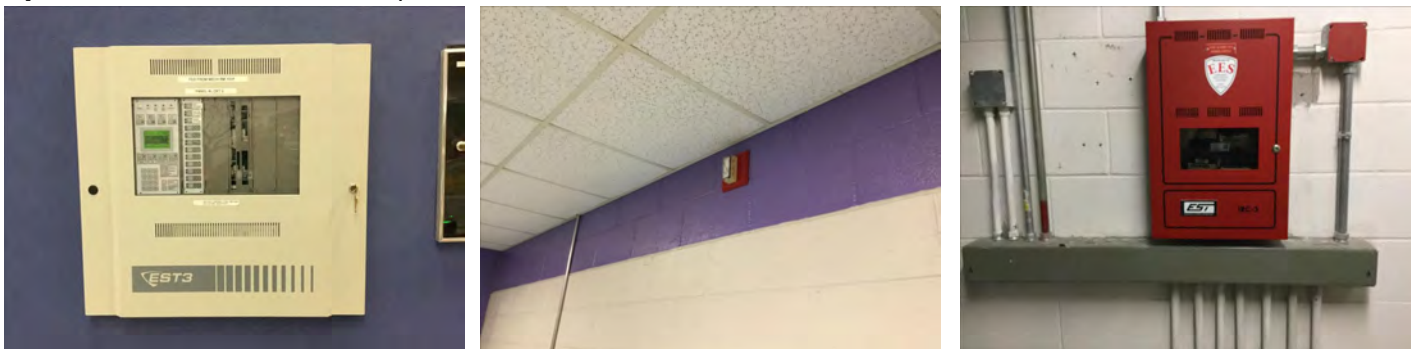
System: D5030910 - Fire Alarm Systems

Note: Main panel replaced.

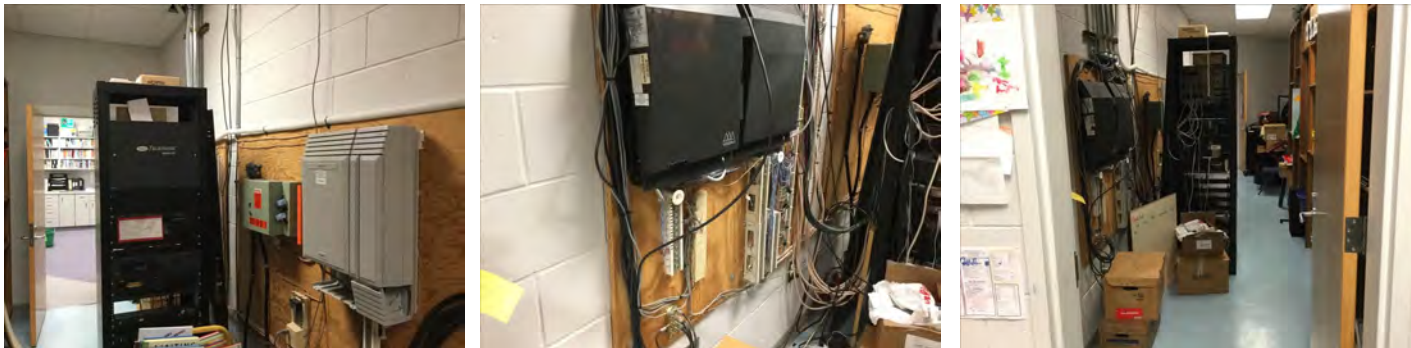
System: D5030920 - Data Communication

Note: Telephone system major issues. Wireless system added 2015.

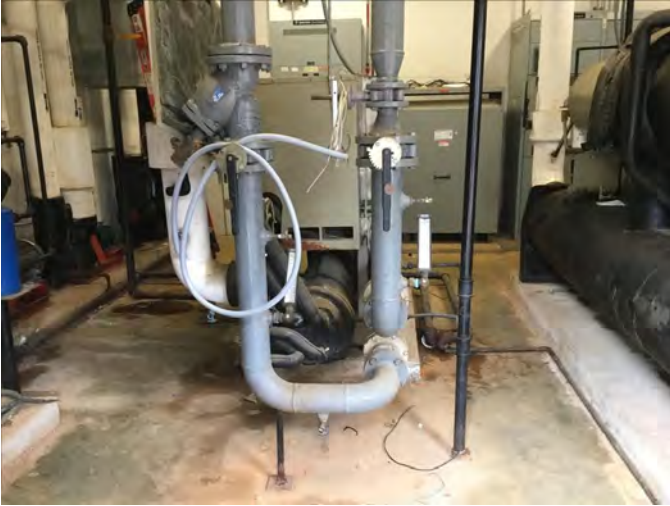
System: D3030 - Cooling Generating Systems

Location: Chiller Room
Distress: Failing
Category: Deferred Maintenance
Priority: 3 - Necessary/Not Yet Critical (Years 2-5)
Correction: Replace chiller, absorption, 100 ton
Qty: 1.00
Unit of Measure: Ea.
Estimate: \$262,020.00
Assessor Name: Eduardo Lopez
Date Created: 12/01/2016

Notes: Chiller is broken.

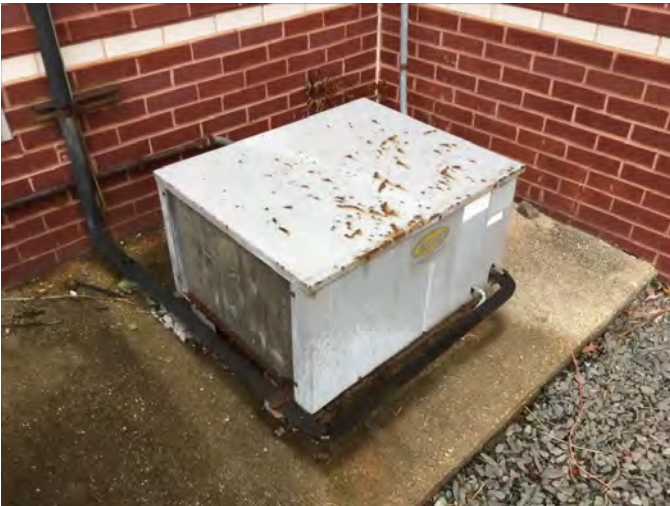
System: D3050 - Terminal & Package Units

Location: Exterior
Distress: Beyond Service Life
Category: Deferred Maintenance
Priority: 3 - Necessary/Not Yet Critical (Years 2-5)
Correction: Renew System
Qty: 94,667.00
Unit of Measure: S.F.
Estimate: \$314,484.00
Assessor Name: Eduardo Lopez
Date Created: 12/07/2016

Notes: The pad mounted DX condensers are aged, rusted, not energy efficient, and should be replaced.

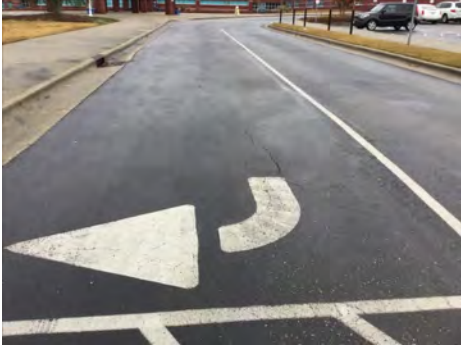
System: G2010 - Roadways

Note: Seal coated 2014
