NC School District/220 Clay County/High School

Hayesville High

Campus Assessment Report

March 13, 2017

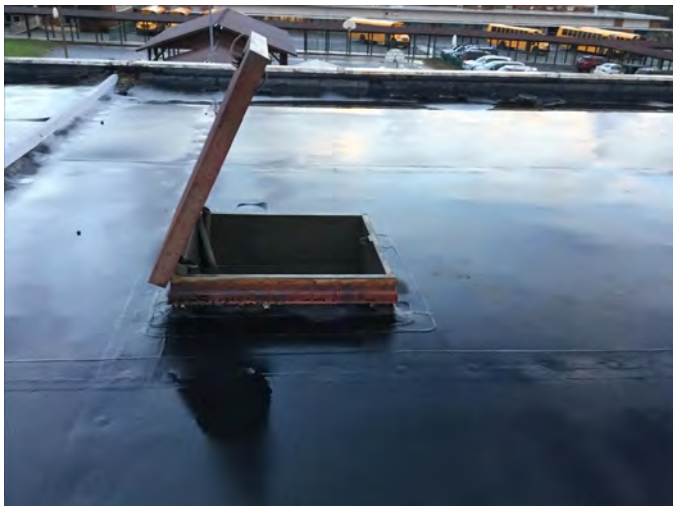
System: B3020 - Roof Openings

Location: Roof
Distress: Beyond Service Life
Category: Deferred Maintenance
Priority: 3 - Necessary/Not Yet Critical (Years 2-5)
Correction: Renew System
Qty: 25,270.00
Unit of Measure: S.F.
Estimate: \$13,343.00
Assessor Name: Eduardo Lopez
Date Created: 02/27/2017

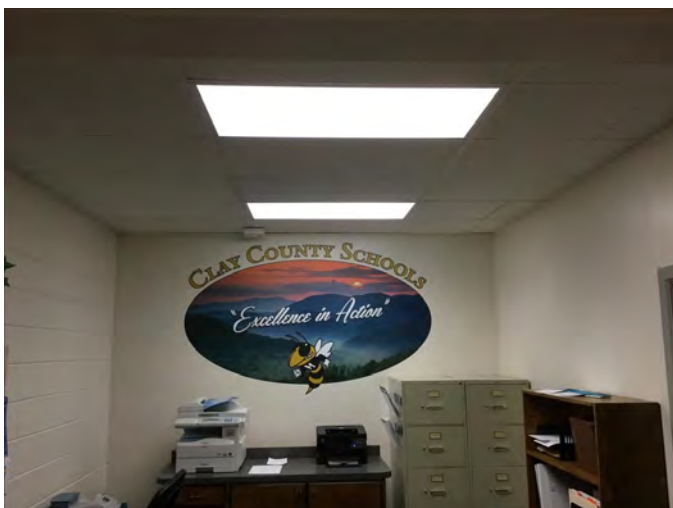
System: C3030 - Ceiling Finishes

Location: Throughout the building
Distress: Damaged
Category: Deferred Maintenance
Priority: 3 - Necessary/Not Yet Critical (Years 2-5)
Correction: Renew System
Qty: 25,270.00
Unit of Measure: S.F.
Estimate: \$314,106.00
Assessor Name: Eduardo Lopez
Date Created: 02/09/2017

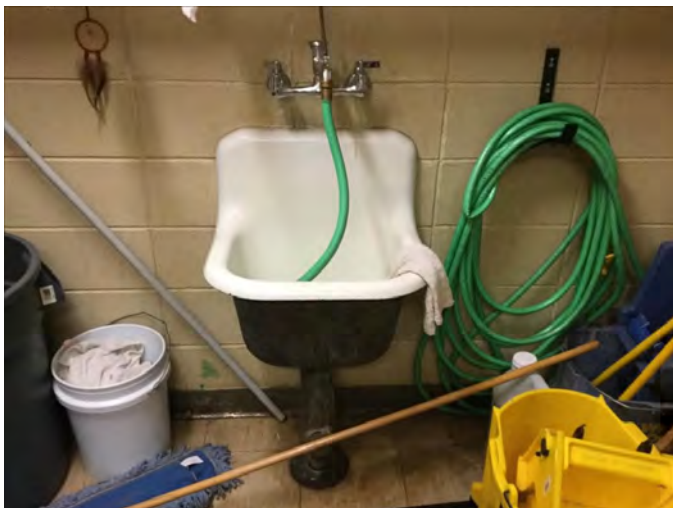
System: D2010 - Plumbing Fixtures

Location: Restrooms
Distress: Inadequate
Category: Building Code Compliance
Priority: 3 - Necessary/Not Yet Critical (Years 2-5)
Correction: Renew System
Qty: 25,270.00
Unit of Measure: S.F.
Estimate: \$262,960.00
Assessor Name: Eduardo Lopez
Date Created: 02/09/2017

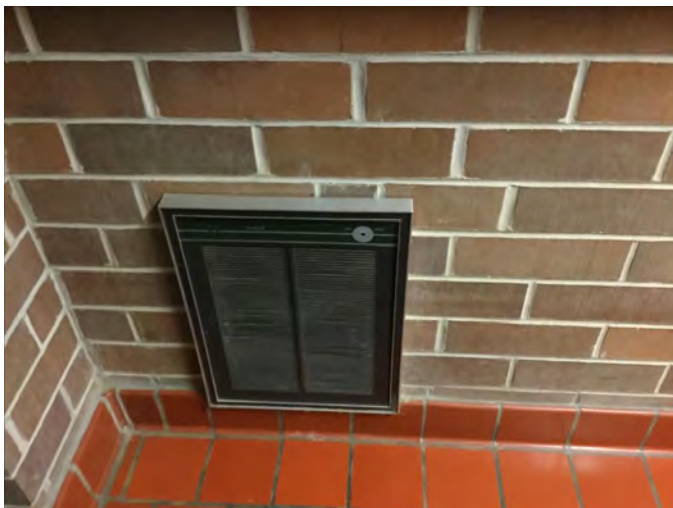
System: D3040 - Distribution Systems

Location: Mechanical Rooms
Distress: Inadequate
Category: Deferred Maintenance
Priority: 3 - Necessary/Not Yet Critical (Years 2-5)
Correction: Renew System
Qty: 25,270.00
Unit of Measure: S.F.
Estimate: \$249,061.00
Assessor Name: Eduardo Lopez
Date Created: 02/09/2017

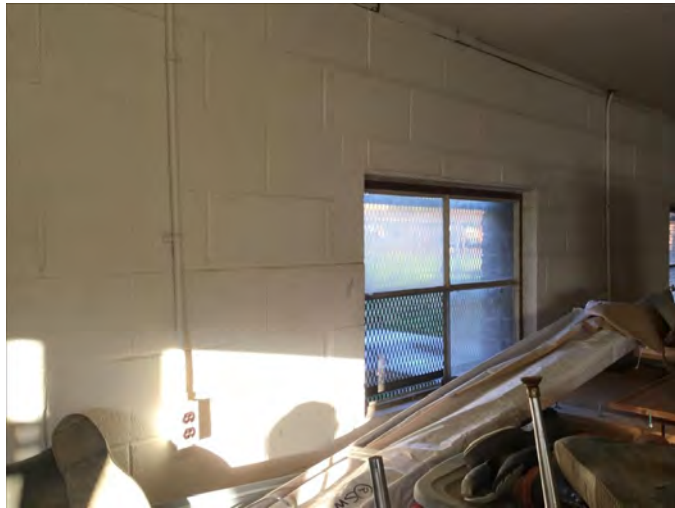
System: C3010 - Wall Finishes

Location: Interior
Distress: Damaged
Category: Deferred Maintenance
Priority: 4 - Recommended (Years 6-10)
Correction: Renew System
Qty: 1,000.00
Unit of Measure: S.F.
Estimate: \$2,871.00
Assessor Name: Terence Davis
Date Created: 02/14/2017

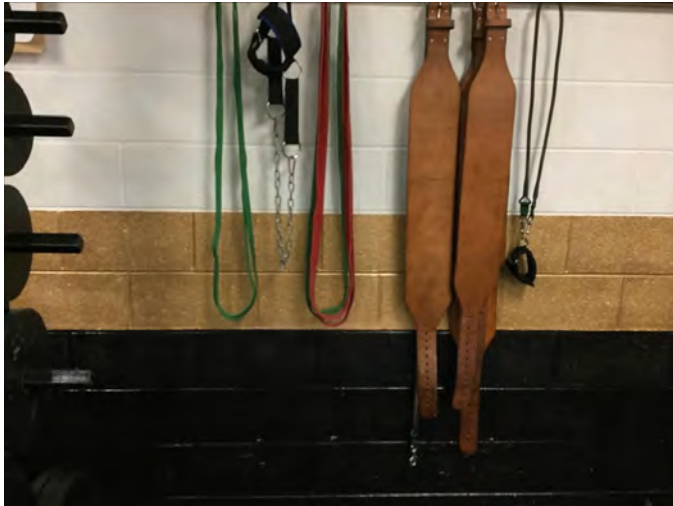
System: C3010 - Wall Finishes

Location: Throughout the building
Distress: Damaged
Category: Deferred Maintenance
Priority: 3 - Necessary/Not Yet Critical (Years 2-5)
Correction: Renew System
Qty: 7,000.00
Unit of Measure: S.F.
Estimate: \$20,097.00
Assessor Name: Eduardo Lopez
Date Created: 02/07/2017

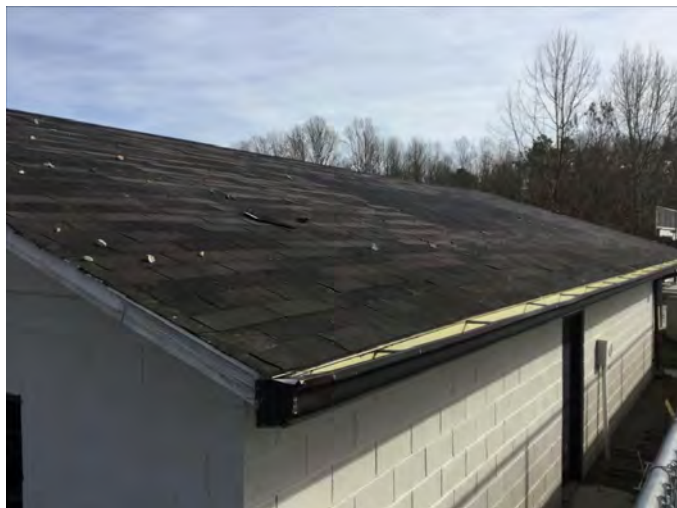
System: B3010140 - Asphalt Shingles

Location: Roof
Distress: Damaged
Category: Deferred Maintenance
Priority: 2 - Potentially Critical (Year 1)
Correction: Renew System
Qty: 1,000.00
Unit of Measure: S.F.
Estimate: \$6,307.00
Assessor Name: Eduardo Lopez
Date Created: 02/28/2017

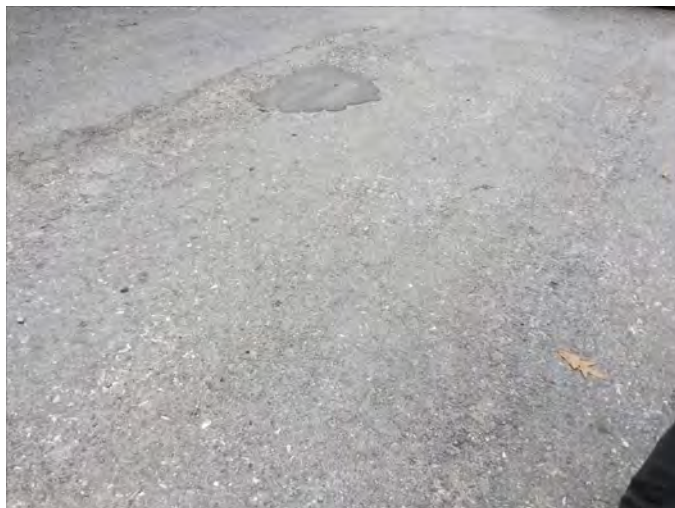
System: G2020 - Parking Lots

Location: Site
Distress: Damaged
Category: Deferred Maintenance
Priority: 2 - Potentially Critical (Year 1)
Correction: Renew System
Qty: 147,030.00
Unit of Measure: S.F.
Estimate: \$215,105.00
Assessor Name: Eduardo Lopez
Date Created: 02/09/2017
