NC School District/220 Clay County/Middle School

Hayesville Middle

Campus Assessment Report

March 13, 2017

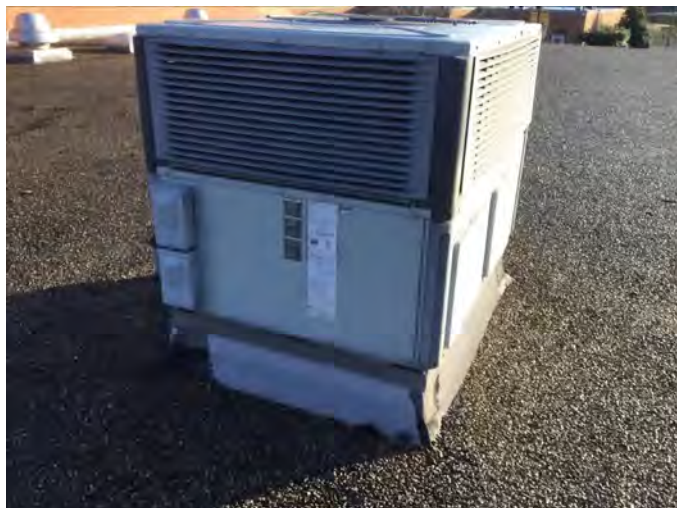
System: D3050 - Terminal & Package Units

Location: Roof
Distress: Beyond Service Life
Category: Deferred Maintenance
Priority: 3 - Necessary/Not Yet Critical (Years 2-5)
Correction: Renew System
Qty: 14,400.00
Unit of Measure: S.F.
Estimate: \$254,074.00
Assessor Name: Eduardo Lopez
Date Created: 02/09/2017

Notes: The roof mounted DX condensing unit is aged and should be scheduled for replacement.
