NC School District/430 Harnett County/Elementary School

Johnsonville Elementary

Campus Assessment Report

March 11, 2017

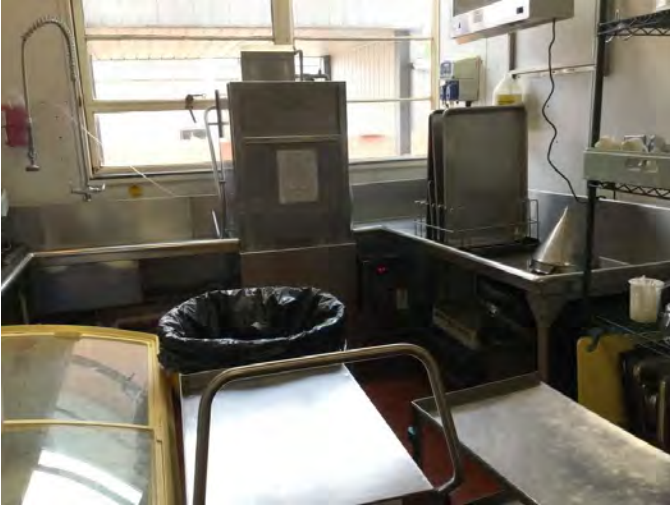
System: B2020 - Exterior Windows

Location: Throughout
Distress: Beyond Service Life
Category: Deferred Maintenance / Energy
Priority: 3 - Necessary/Not Yet Critical (Years 2-5)
Correction: Renew System
Qty: 27,600.00
Unit of Measure: S.F.
Estimate: \$279,312.00
Assessor Name: Terence Davis
Date Created: 12/08/2016

Notes: The aluminum frame, operable, single pane windows are aged, rusted, not energy efficient, and should be replaced.

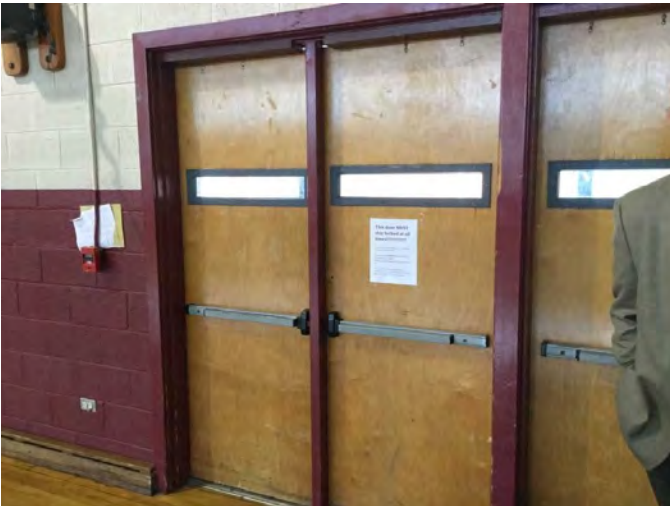
System: B2030 - Exterior Doors

Location: Throughout
Distress: Beyond Service Life
Category: Deferred Maintenance
Priority: 3 - Necessary/Not Yet Critical (Years 2-5)
Correction: Renew System
Qty: 27,600.00
Unit of Measure: S.F.
Estimate: \$30,967.00
Assessor Name: Terence Davis
Date Created: 12/08/2016

Notes: The original exterior doors are aged, warped, and should be replaced.

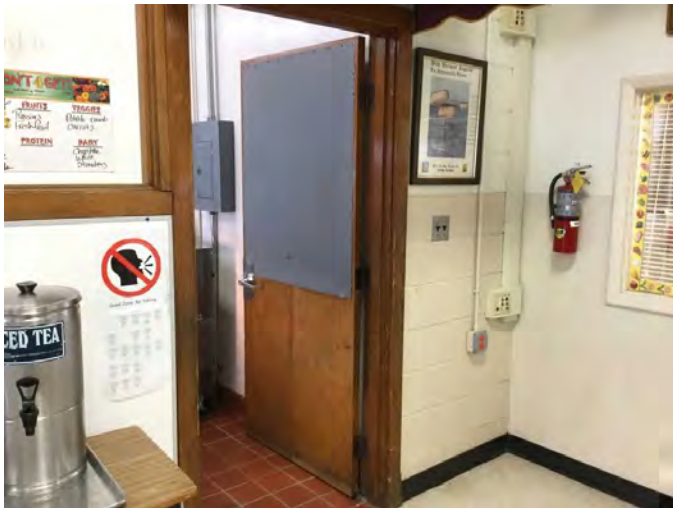
System: C1020 - Interior Doors

Location: Throughout
Distress: Beyond Service Life
Category: Deferred Maintenance / Accessibility Code Compliance
Priority: 3 - Necessary/Not Yet Critical (Years 2-5)
Correction: Renew System
Qty: 27,600.00
Unit of Measure: S.F.
Estimate: \$75,293.00
Assessor Name: Terence Davis
Date Created: 12/08/2016

Notes: The interior doors are aged, failing, hardware is not ADA compliant and should be replaced.

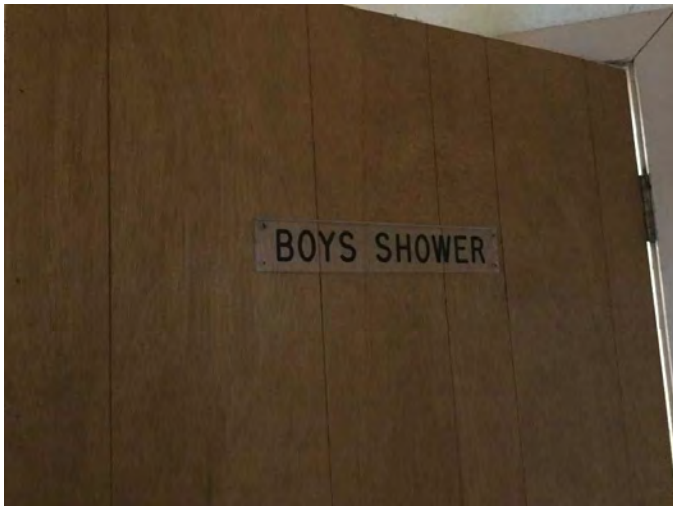
System: C1030 - Fittings

Location: Throughout
Distress: Beyond Service Life
Category: Deferred Maintenance / Accessibility Code Compliance
Priority: 3 - Necessary/Not Yet Critical (Years 2-5)
Correction: Renew System
Qty: 27,600.00
Unit of Measure: S.F.
Estimate: \$289,634.00
Assessor Name: Terence Davis
Date Created: 12/08/2016

Notes: The fittings throughout the building are aged, in marginal condition, handrails and room signage are ADA non-compliance and system should be replaced.

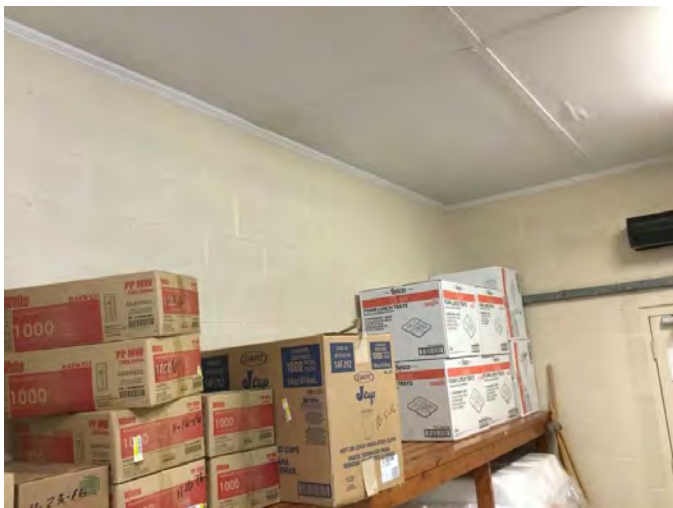
System: C3010 - Wall Finishes

Location: Throughout
Distress: Beyond Service Life
Category: Deferred Maintenance
Priority: 3 - Necessary/Not Yet Critical (Years 2-5)
Correction: Renew System
Qty: 27,600.00
Unit of Measure: S.F.
Estimate: \$82,883.00
Assessor Name: Terence Davis
Date Created: 12/08/2016

Notes: The wall paint is damaged, fading, stained, and should be re-painted.

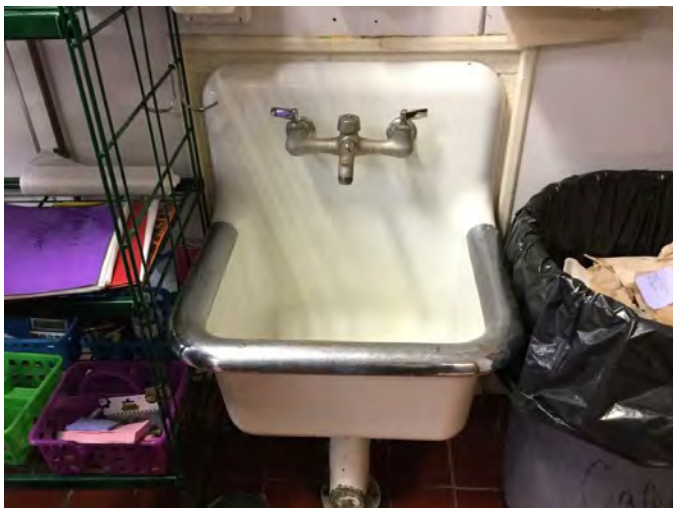
System: D2010 - Plumbing Fixtures

Location: Throughout
Distress: Beyond Service Life
Category: Deferred Maintenance / Energy
Priority: 3 - Necessary/Not Yet Critical (Years 2-5)
Correction: Renew System
Qty: 27,600.00
Unit of Measure: S.F.
Estimate: \$341,854.00
Assessor Name: Terence Davis
Date Created: 12/08/2016

Notes: Plumbing fixtures are in operational conditions. However, they are aged, not ADA compliant and should be replaced with a low-flow water fixtures.

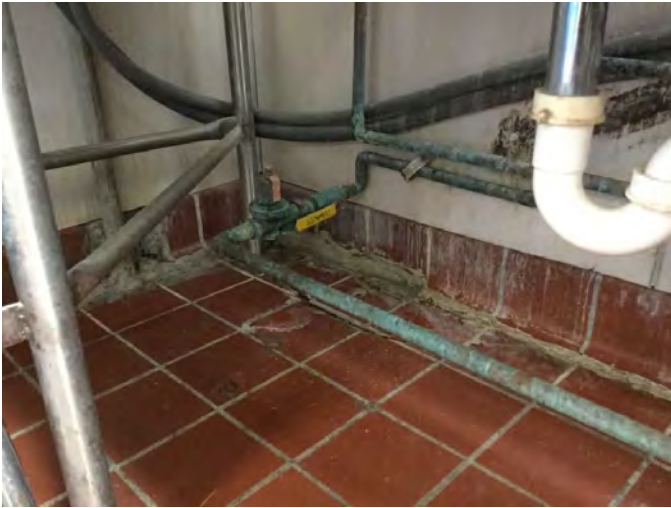
System: D2020 - Domestic Water Distribution

Location: Throughout
Distress: Beyond Service Life
Category: Deferred Maintenance
Priority: 3 - Necessary/Not Yet Critical (Years 2-5)
Correction: Renew System
Qty: 27,600.00
Unit of Measure: S.F.
Estimate: \$29,146.00
Assessor Name: Terence Davis
Date Created: 12/08/2016

Notes: The domestic water distribution system is aged and should be replaced.

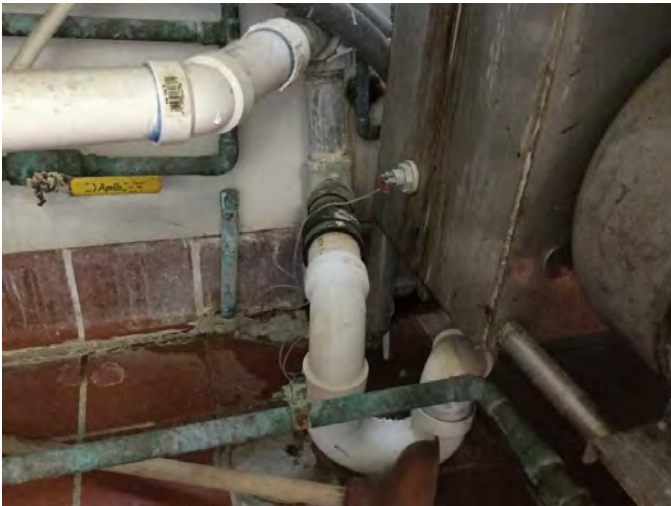
System: D2030 - Sanitary Waste

Location: Throughout
Distress: Beyond Service Life
Category: Deferred Maintenance
Priority: 3 - Necessary/Not Yet Critical (Years 2-5)
Correction: Renew System
Qty: 27,600.00
Unit of Measure: S.F.
Estimate: \$46,147.00
Assessor Name: Terence Davis
Date Created: 12/08/2016

Notes: The sanitary waste system is aged, has reported periodic failures, and should be replaced.

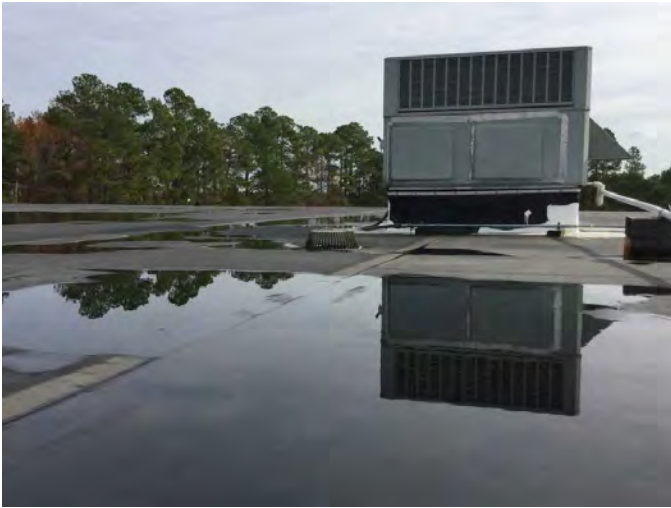
System: D2040 - Rain Water Drainage

Location: Roof
Distress: Beyond Service Life
Category: Deferred Maintenance
Priority: 3 - Necessary/Not Yet Critical (Years 2-5)
Correction: Renew System
Qty: 27,600.00
Unit of Measure: S.F.
Estimate: \$41,290.00
Assessor Name: Terence Davis
Date Created: 12/08/2016

Notes: No roof drains or scuppers on roof causing water ponding in multiple locations. Recommend adding roof drainage.

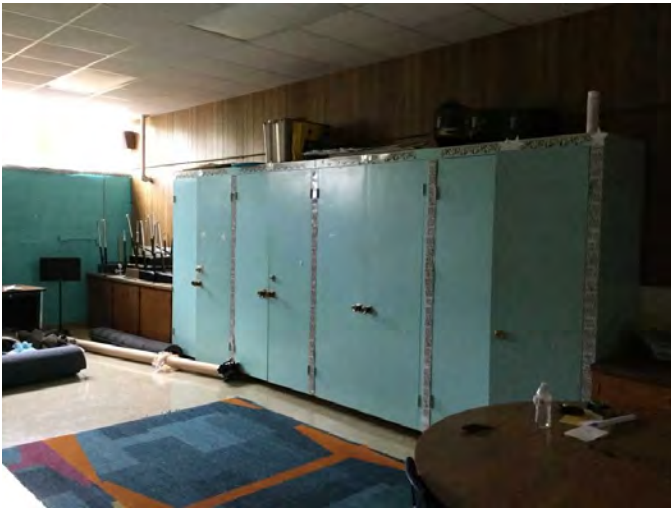
System: E2010 - Fixed Furnishings

Location: Throughout
Distress: Beyond Service Life
Category: Deferred Maintenance
Priority: 3 - Necessary/Not Yet Critical (Years 2-5)
Correction: Renew System
Qty: 27,600.00
Unit of Measure: S.F.
Estimate: \$173,659.00
Assessor Name: Terence Davis
Date Created: 12/08/2016

Notes: The fixed furnishings are aged, in marginal condition, and should be replaced.

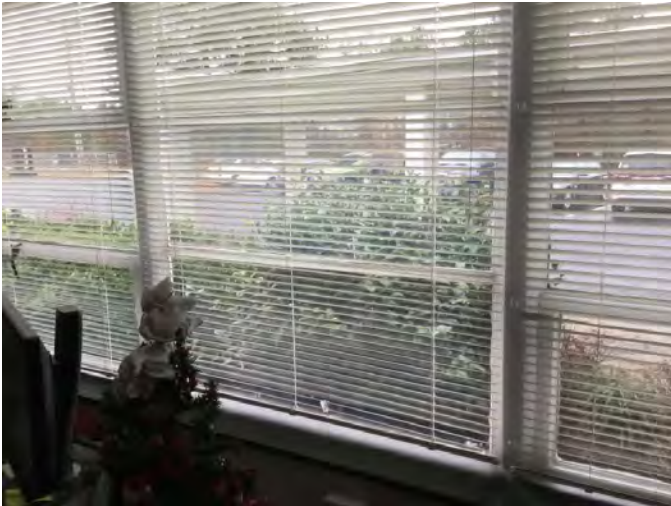
System: B2020 - Exterior Windows

Location: Throughout
Distress: Beyond Service Life
Category: Deferred Maintenance
Priority: 3 - Necessary/Not Yet Critical (Years 2-5)
Correction: Renew System
Qty: 19,653.00
Unit of Measure: S.F.
Estimate: \$198,888.00
Assessor Name: Terence Davis
Date Created: 12/08/2016

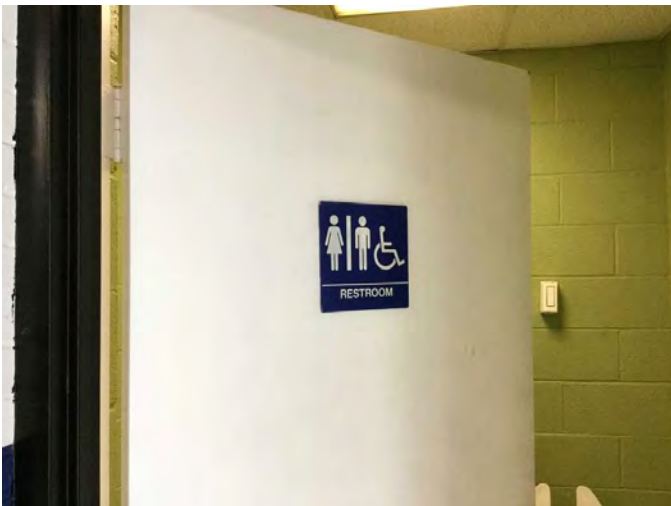
System: C1030 - Fittings

Location: Throughout
Distress: Beyond Service Life
Category: Deferred Maintenance
Priority: 3 - Necessary/Not Yet Critical (Years 2-5)
Correction: Renew System
Qty: 19,653.00
Unit of Measure: S.F.
Estimate: \$206,239.00
Assessor Name: Terence Davis
Date Created: 12/08/2016

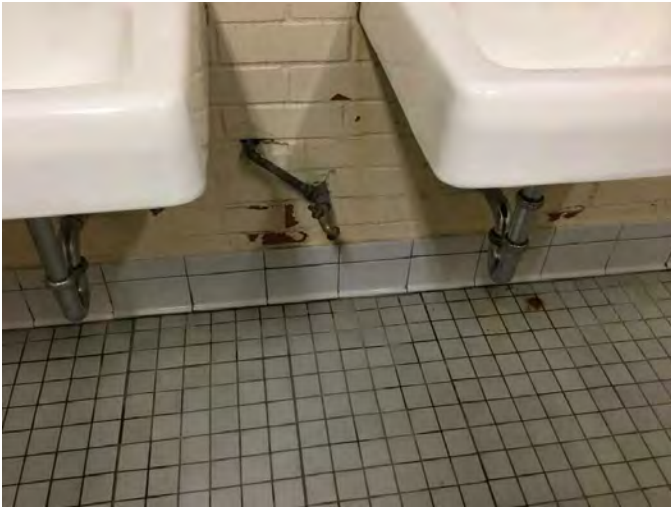
System: D2020 - Domestic Water Distribution

Location: Throughout
Distress: Beyond Service Life
Category: Deferred Maintenance
Priority: 3 - Necessary/Not Yet Critical (Years 2-5)
Correction: Renew System
Qty: 19,653.00
Unit of Measure: S.F.
Estimate: \$20,754.00
Assessor Name: Terence Davis
Date Created: 12/08/2016

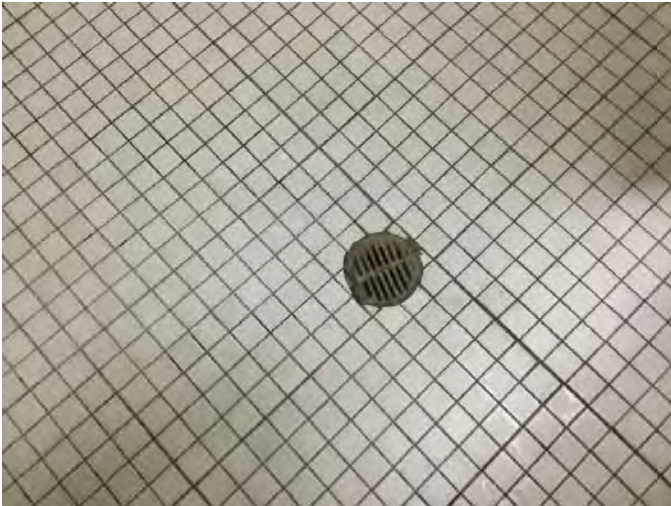
System: D2030 - Sanitary Waste

Location: Throughout
Distress: Beyond Service Life
Category: Deferred Maintenance
Priority: 3 - Necessary/Not Yet Critical (Years 2-5)
Correction: Renew System
Qty: 19,653.00
Unit of Measure: S.F.
Estimate: \$32,860.00
Assessor Name: Terence Davis
Date Created: 12/08/2016

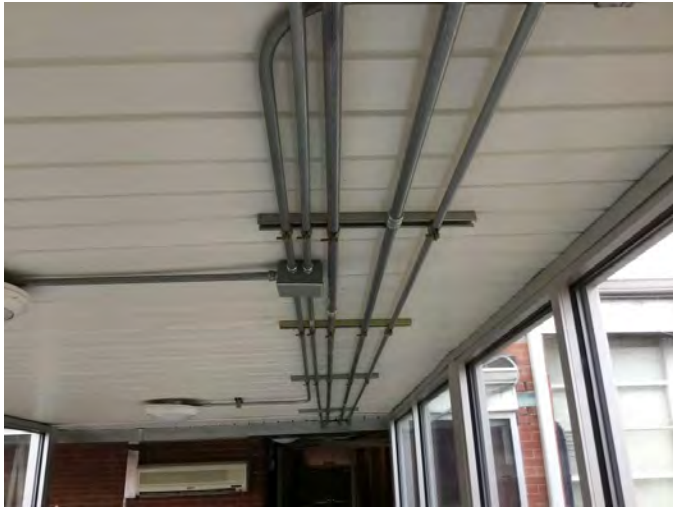
System: D5020 - Branch Wiring

Location: Throughout
Distress: Beyond Service Life
Category: Deferred Maintenance
Priority: 3 - Necessary/Not Yet Critical (Years 2-5)
Correction: Renew System
Qty: 19,653.00
Unit of Measure: S.F.
Estimate: \$107,875.00
Assessor Name: Terence Davis
Date Created: 12/08/2016

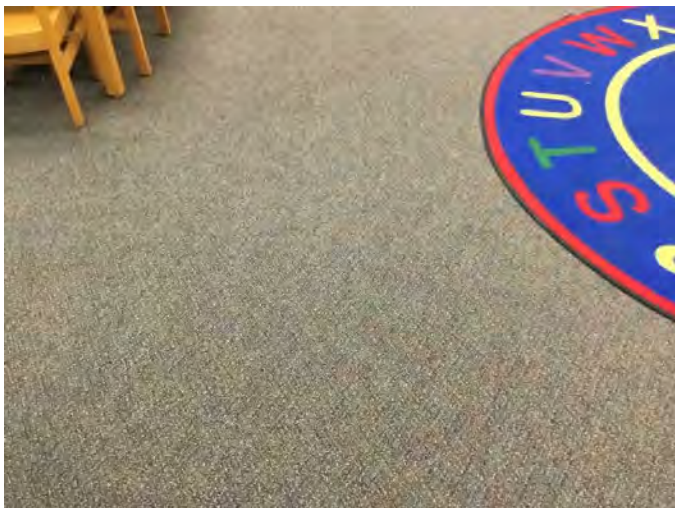
System: C3020 - Floor Finishes

Location: Media
Distress: Beyond Service Life
Category: Appearance
Priority: 3 - Necessary/Not Yet Critical (Years 2-5)
Correction: Replace carpet
Qty: 388.88
Unit of Measure: S.Y.
Estimate: \$33,242.71
Assessor Name: Eduardo Lopez
Date Created: 12/08/2016

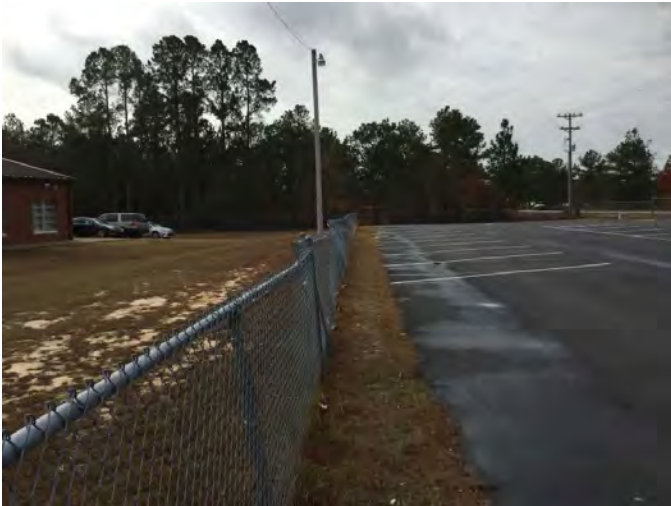
Location: S. parking lot
Distress: Damaged
Category: Safety
Priority: 3 - Necessary/Not Yet Critical (Years 2-5)
Correction: Chain Link Fence Repair
Qty: 250.00
Unit of Measure: L.F.
Estimate: \$8,580.00
Assessor Name: Eduardo Lopez
Date Created: 12/08/2016

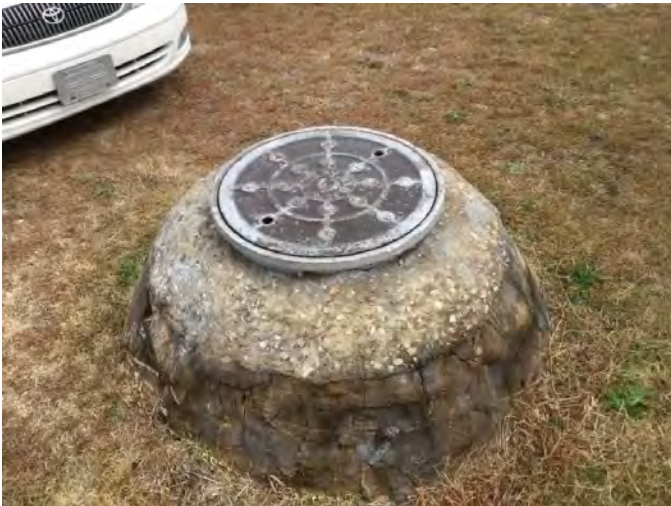
Location: Throughout
Distress: Beyond Service Life
Category: Deferred Maintenance
Priority: 3 - Necessary/Not Yet Critical (Years 2-5)
Correction: Renew System
Qty: 74,194.00
Unit of Measure: S.F.
Estimate: \$118,339.00
Assessor Name: Eduardo Lopez
Date Created: 12/08/2016

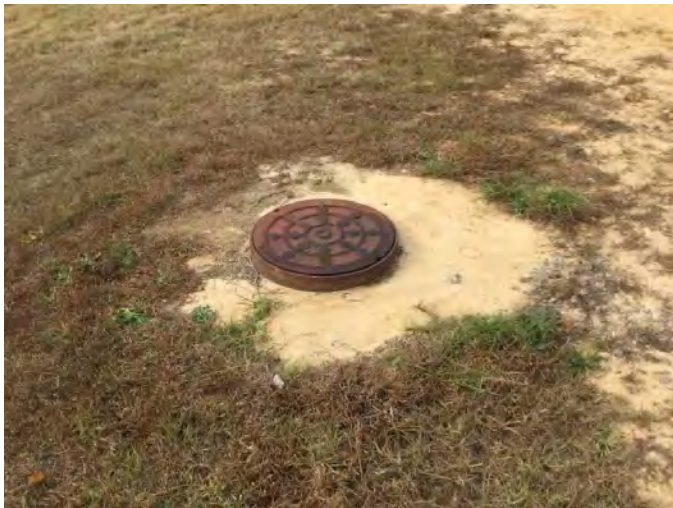
Location: Throughout
Distress: Beyond Service Life
Category: Deferred Maintenance
Priority: 3 - Necessary/Not Yet Critical (Years 2-5)
Correction: Renew System
Qty: 74,194.00
Unit of Measure: S.F.
Estimate: \$370,525.00
Assessor Name: Eduardo Lopez
Date Created: 12/08/2016

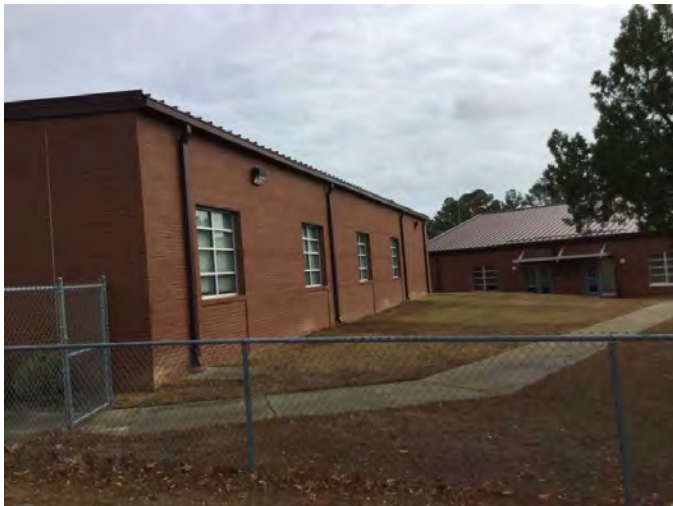
Location: Throughout
Distress: Inadequate
Category: Safety
Priority: 3 - Necessary/Not Yet Critical (Years 2-5)
Correction: Renew System
Qty: 74,194.00
Unit of Measure: S.F.
Estimate: \$119,972.00
Assessor Name: Eduardo Lopez
Date Created: 12/08/2016

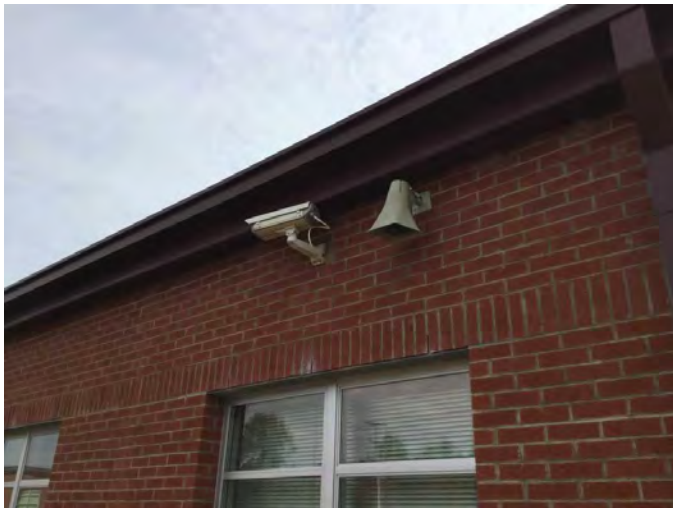
Location: Throughout
Distress: Beyond Service Life
Category: Deferred Maintenance
Priority: 3 - Necessary/Not Yet Critical (Years 2-5)
Correction: Renew System
Qty: 74,194.00
Unit of Measure: S.F.
Estimate: \$68,555.00
Assessor Name: Eduardo Lopez
Date Created: 12/08/2016
