NC School District/430 Harnett County/Elementary School

Lafayette Elementary

Campus Assessment Report

March 11, 2017

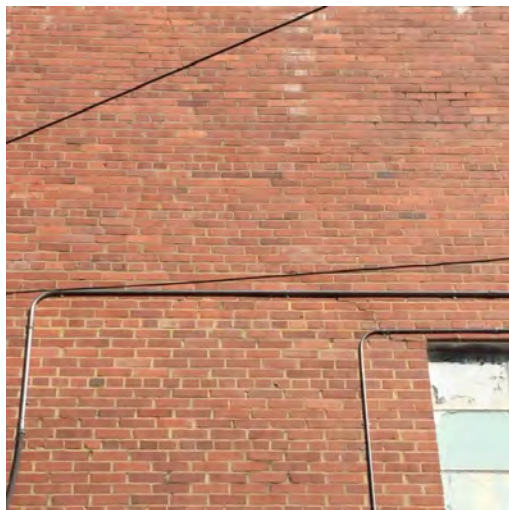
System: B2010 - Exterior Walls

Location: Exterior walls
Distress: Failing
Category: Deferred Maintenance / Safety
Priority: 1 - Currently Critical (Immediate)
Correction: Engineering Study-2016-11-15 17:41:59
Qty: 1.00
Unit of Measure: Ea.
Estimate: \$13,200.00
Assessor Name: Eduardo Lopez
Date Created: 12/07/2016

Notes: Exterior walls show signs of failure throughout the building. An engineering study is recommended to determine the cause. Pricing does not include remediation measures.

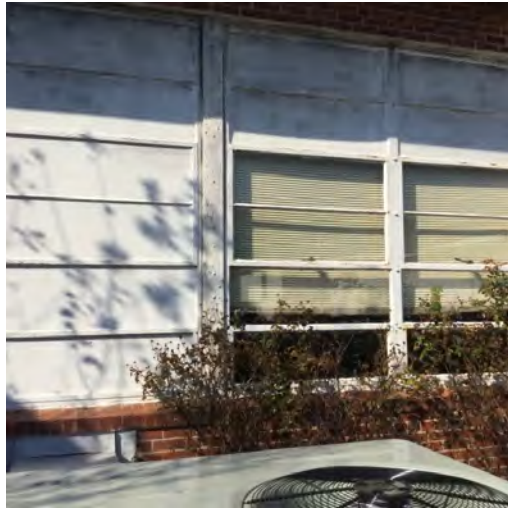
System: B2020 - Exterior Windows

Location: Exterior windows
Distress: Beyond Service Life
Category: Deferred Maintenance
Priority: 3 - Necessary/Not Yet Critical (Years 2-5)
Correction: Renew System
Qty: 19,764.00
Unit of Measure: S.F.
Estimate: \$200,012.00
Assessor Name: Eduardo Lopez
Date Created: 11/15/2016

Notes: The steel frame, operable and fixed, single pane windows are aged, rusted, inoperable, not energy efficient, and should be replaced.

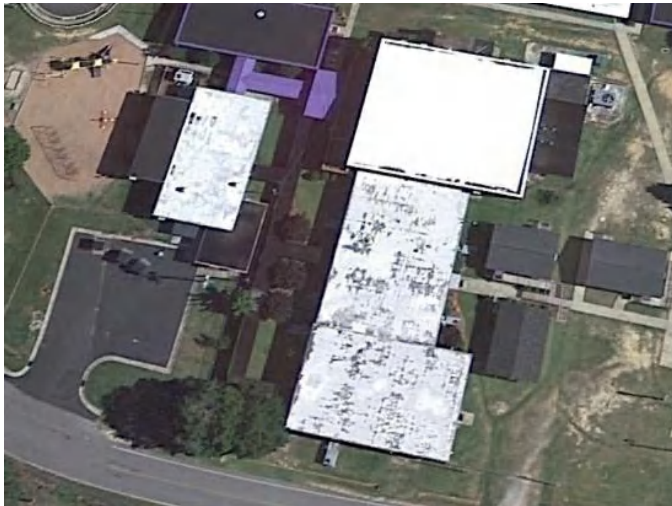
System: B3010120 - Single Ply Membrane

Location: Roof
Distress: Beyond Service Life
Category: Deferred Maintenance
Priority: 3 - Necessary/Not Yet Critical (Years 2-5)
Correction: Renew System
Qty: 19,764.00
Unit of Measure: S.F.
Estimate: \$206,929.00
Assessor Name: Eduardo Lopez
Date Created: 12/07/2016

Notes: Replacement recommended by Rooftop System Engineers, roof consultant. Roof access not obtained during assessment due to safety concerns.

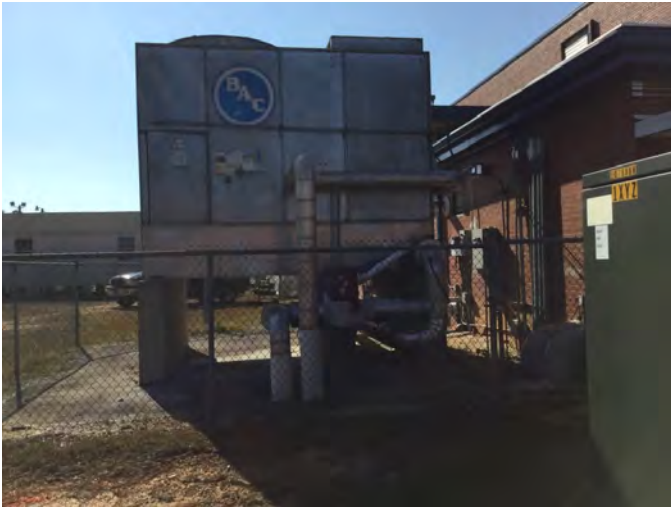
System: D3030 - Cooling Generating Systems

Location: Outside east of building
Distress: Beyond Service Life
Category: Deferred Maintenance
Priority: 3 - Necessary/Not Yet Critical (Years 2-5)
Correction: Renew System
Qty: 19,764.00
Unit of Measure: S.F.
Estimate: \$114,572.00
Assessor Name: Eduardo Lopez
Date Created: 12/07/2016

Notes: The chiller is reaching the end of its expected useful life. System renewal is recommended.

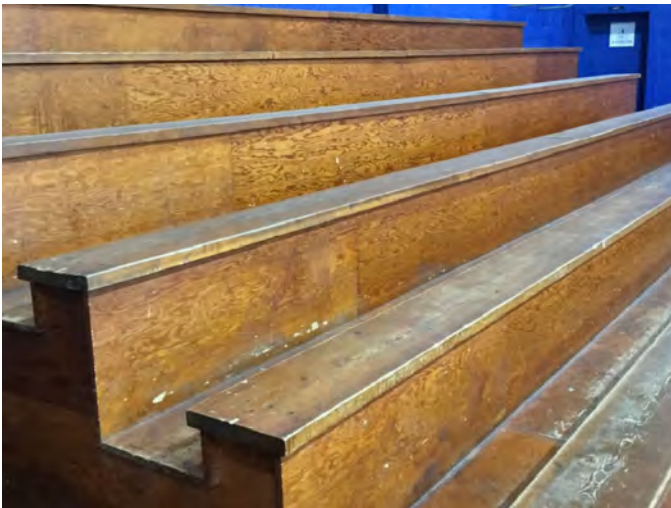
System: E1020 - Institutional Equipment

Location: Gym
Distress: Beyond Service Life
Category: Deferred Maintenance / Safety
Priority: 3 - Necessary/Not Yet Critical (Years 2-5)
Correction: Renew System
Qty: 19,764.00
Unit of Measure: S.F.
Estimate: \$6,522.00
Assessor Name: Eduardo Lopez
Date Created: 11/15/2016

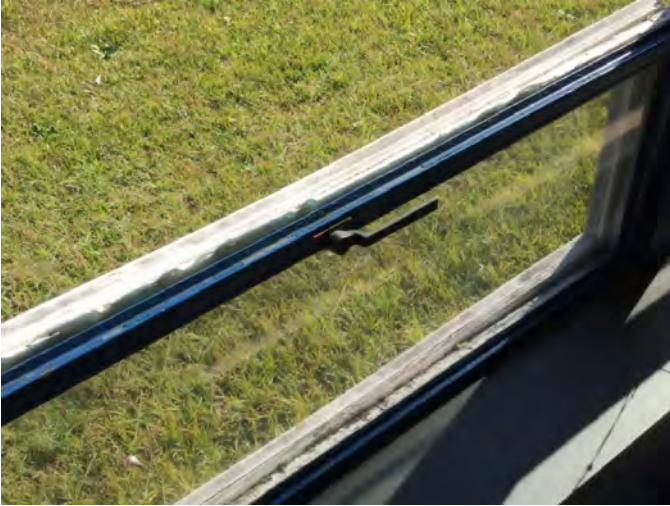
System: B2020 - Exterior Windows

Location: Exterior windows
Distress: Beyond Service Life
Category: Deferred Maintenance
Priority: 3 - Necessary/Not Yet Critical (Years 2-5)
Correction: Renew System
Qty: 4,760.00
Unit of Measure: S.F.
Estimate: \$48,171.00
Assessor Name: Eduardo Lopez
Date Created: 11/15/2016

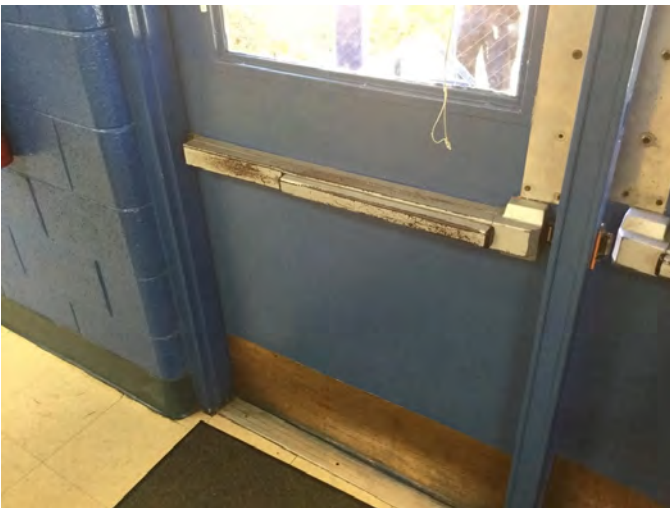
System: B2030 - Exterior Doors

Location: Exterior doors
Distress: Beyond Service Life
Category: Deferred Maintenance
Priority: 3 - Necessary/Not Yet Critical (Years 2-5)
Correction: Renew System
Qty: 4,760.00
Unit of Measure: S.F.
Estimate: \$5,341.00
Assessor Name: Eduardo Lopez
Date Created: 11/15/2016

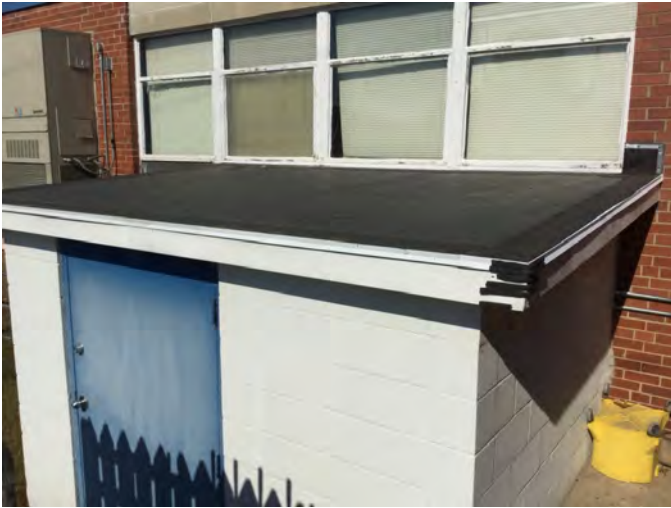
System: B3010120 - Single Ply Membrane

Location: Roofs
Distress: Beyond Service Life
Category: Deferred Maintenance
Priority: 3 - Necessary/Not Yet Critical (Years 2-5)
Correction: Renew System
Qty: 4,760.00
Unit of Measure: S.F.
Estimate: \$49,837.00
Assessor Name: Eduardo Lopez
Date Created: 12/07/2016

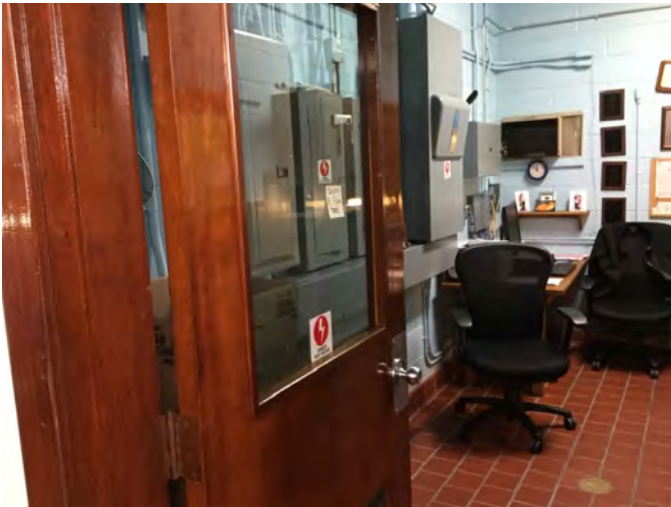
System: C1020 - Interior Doors

Location: Office and storage rooms
Distress: Beyond Service Life
Category: Deferred Maintenance
Priority: 3 - Necessary/Not Yet Critical (Years 2-5)
Correction: Renew System
Qty: 4,760.00
Unit of Measure: S.F.
Estimate: \$12,985.00
Assessor Name: Eduardo Lopez
Date Created: 11/15/2016

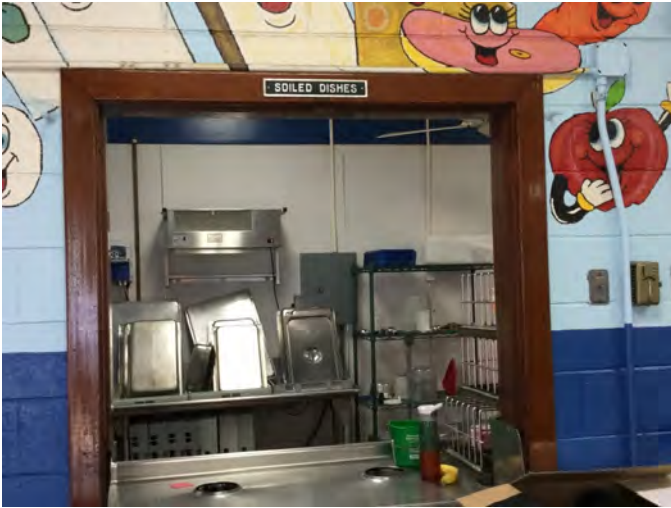
System: C1030 - Fittings

Location: Throughout the building
Distress: Beyond Service Life
Category: Deferred Maintenance
Priority: 3 - Necessary/Not Yet Critical (Years 2-5)
Correction: Renew System
Qty: 4,760.00
Unit of Measure: S.F.
Estimate: \$49,951.00
Assessor Name: Eduardo Lopez
Date Created: 11/15/2016

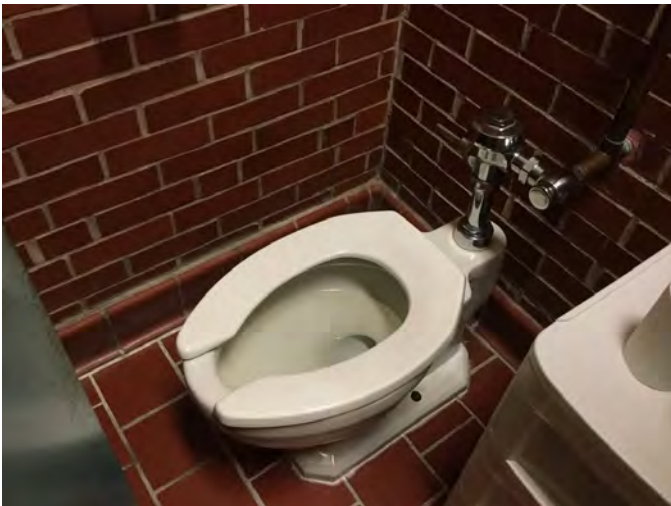
System: D2010 - Plumbing Fixtures

Location: Staff restroom
Distress: Beyond Service Life
Category: Deferred Maintenance
Priority: 3 - Necessary/Not Yet Critical (Years 2-5)
Correction: Renew System
Qty: 4,760.00
Unit of Measure: S.F.
Estimate: \$58,957.00
Assessor Name: Eduardo Lopez
Date Created: 11/15/2016

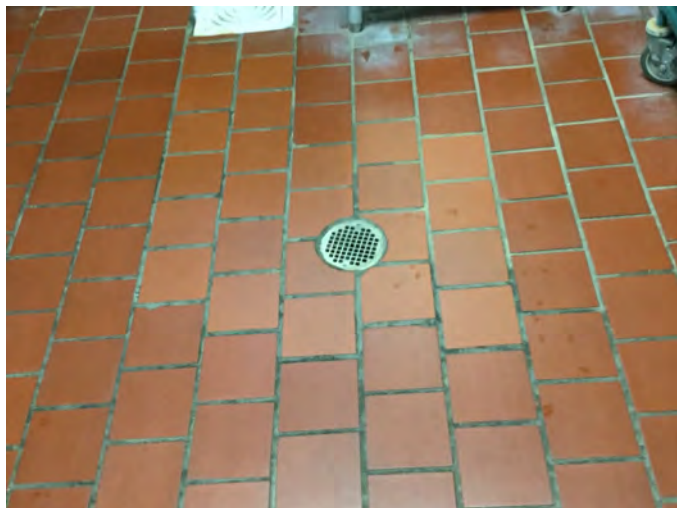
System: D2030 - Sanitary Waste

Location: Kitchen/servery and restroom
Distress: Beyond Service Life
Category: Deferred Maintenance
Priority: 3 - Necessary/Not Yet Critical (Years 2-5)
Correction: Renew System
Qty: 4,760.00
Unit of Measure: S.F.
Estimate: \$7,959.00
Assessor Name: Eduardo Lopez
Date Created: 11/15/2016

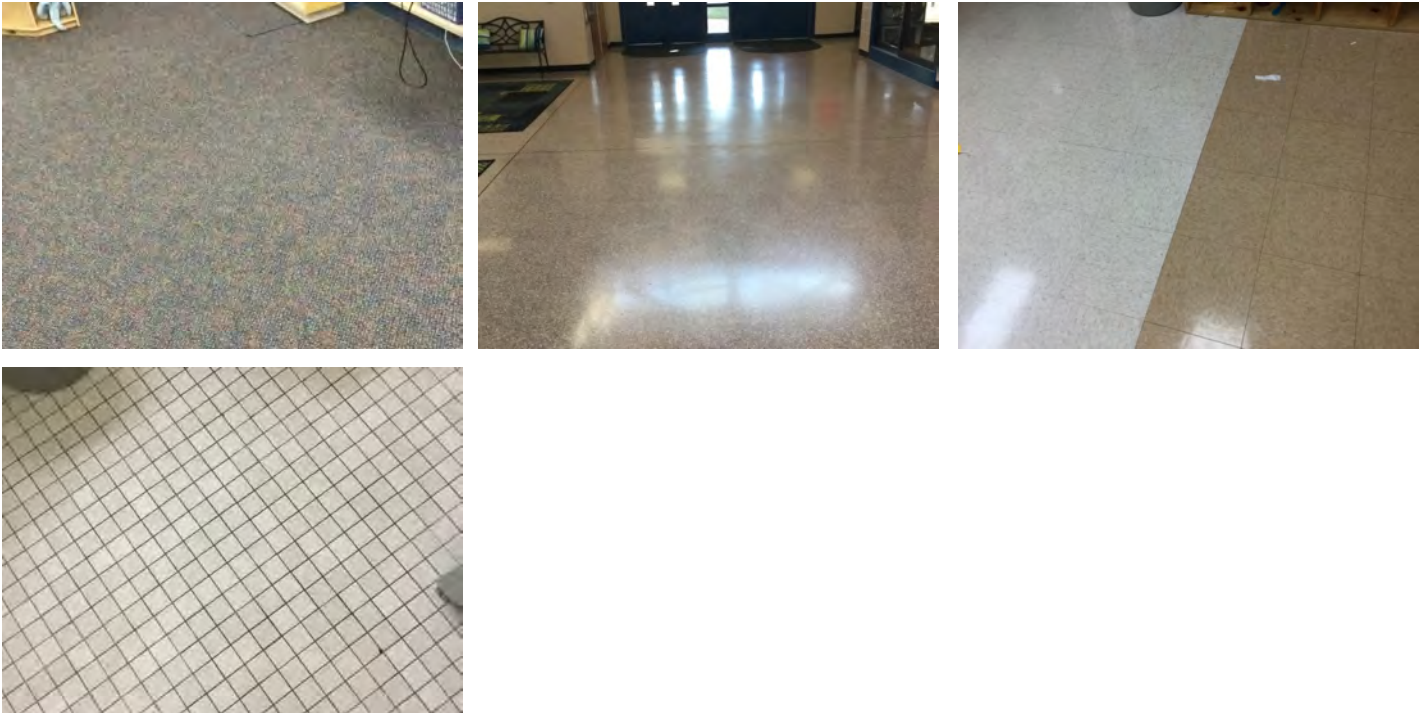
System: C3020 - Floor Finishes

Note: Floor finishes appeared to be in generally well maintained good condition. System renewal not recommended at this time. System life extended to 2022.

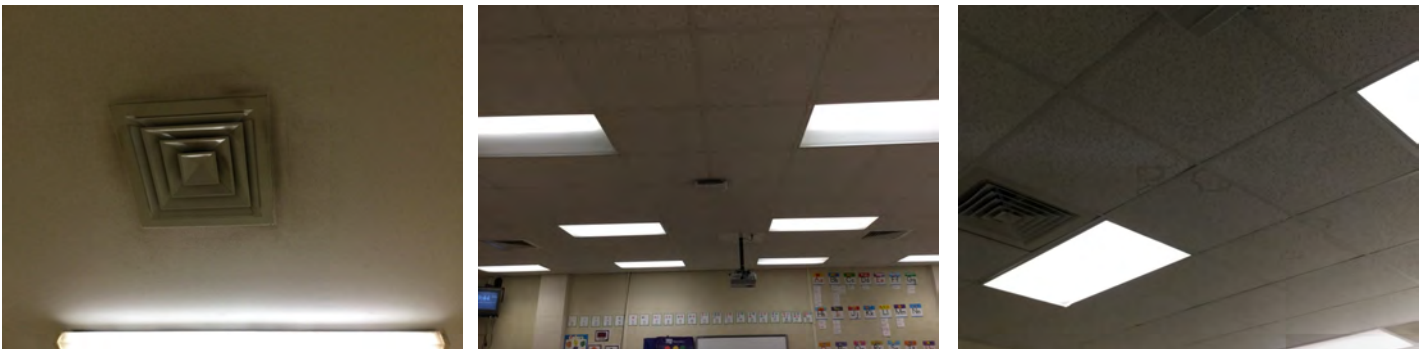
System: C3030 - Ceiling Finishes

Note: Ceiling finishes are in generally well maintained good condition. System renewal re-set to add 5 years of expected service life.

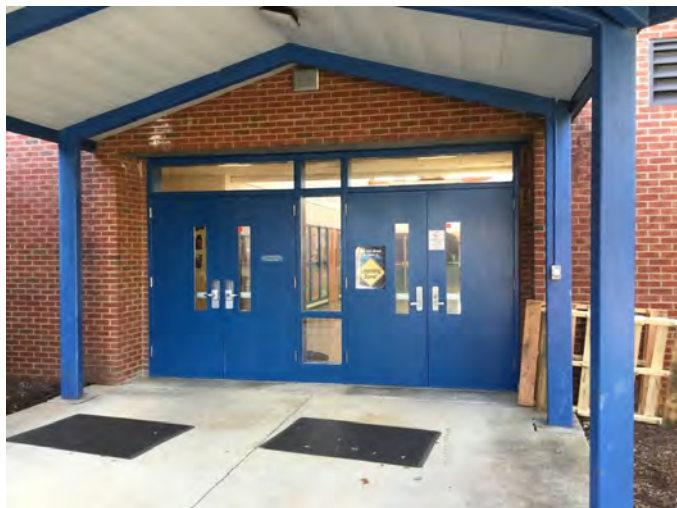
System: D5030810 - Security & Detection Systems

Location: Exterior doors and throughout
Distress: Inadequate
Category: Safety
Priority: 2 - Potentially Critical (Year 1)
Correction: Renew System
Qty: 26,700.00
Unit of Measure: S.F.
Estimate: \$53,747.00
Assessor Name: Eduardo Lopez
Date Created: 12/12/2016

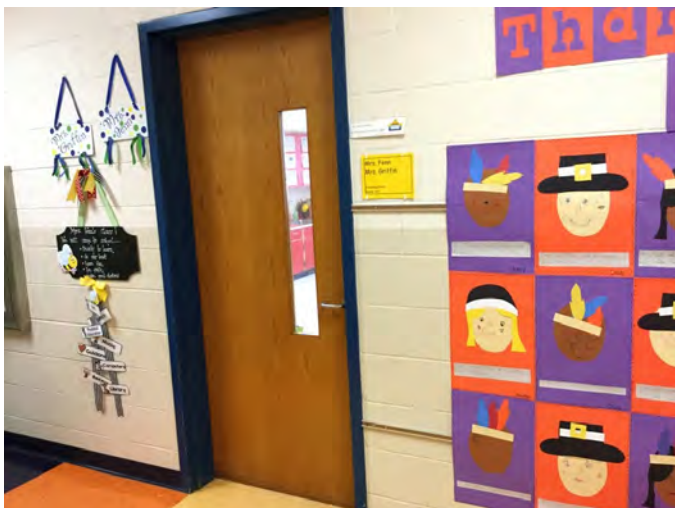
System: C1030 - Fittings

Location: Throughout the building
Distress: Beyond Service Life
Category: Deferred Maintenance
Priority: 3 - Necessary/Not Yet Critical (Years 2-5)
Correction: Renew System
Qty: 26,700.00
Unit of Measure: S.F.
Estimate: \$280,190.00
Assessor Name: Eduardo Lopez
Date Created: 11/15/2016

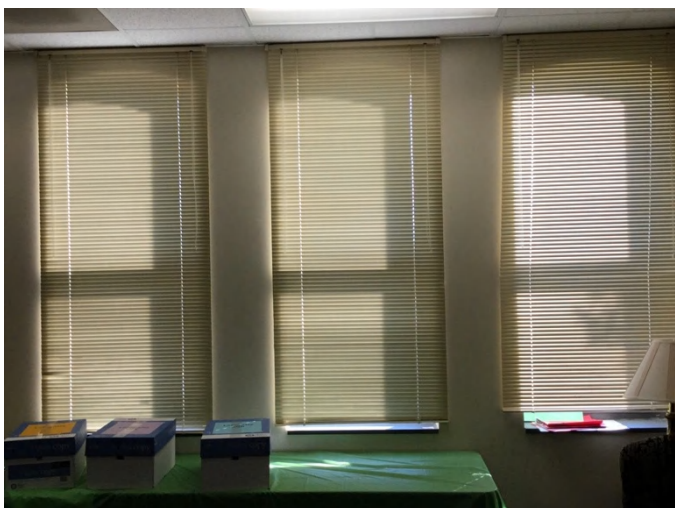
System: E2010 - Fixed Furnishings

Location: Throughout the building
Distress: Beyond Service Life
Category: Deferred Maintenance
Priority: 3 - Necessary/Not Yet Critical (Years 2-5)
Correction: Renew System
Qty: 26,700.00
Unit of Measure: S.F.
Estimate: \$167,996.00
Assessor Name: Eduardo Lopez
Date Created: 11/15/2016

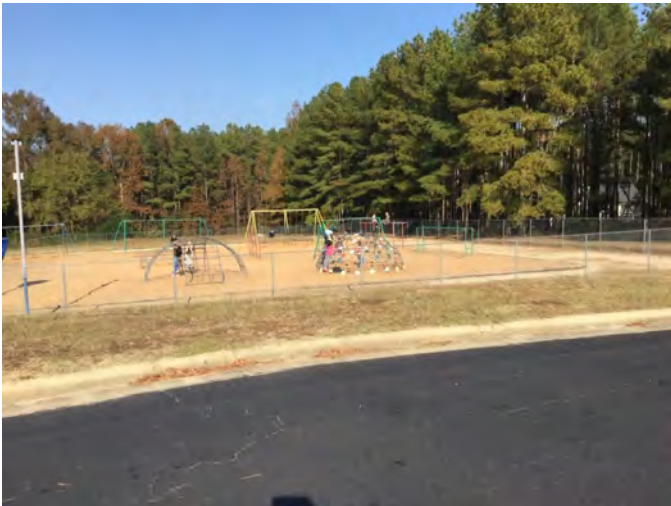
Location: Site
Distress: Beyond Service Life
Category: Deferred Maintenance
Priority: 3 - Necessary/Not Yet Critical (Years 2-5)
Correction: Renew System
Qty: 74,152.00
Unit of Measure: S.F.
Estimate: \$370,315.00
Assessor Name: Eduardo Lopez
Date Created: 11/15/2016
