NC School District/430 Harnett County/Elementary School
Lillington-Shawtown Elementary
Final
Campus Assessment Report

March 11, 2017

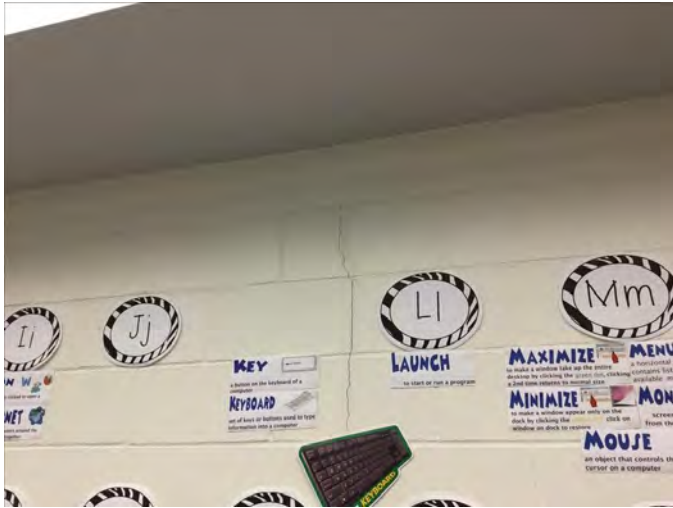
System: C1010 - Partitions

Location: Computer Lab
Distress: Failing
Category: Safety / Building Code Compliance
Priority: 1 - Currently Critical (Immediate)
Correction: Engineering Study
Qty: 1.00
Unit of Measure: Ea.
Estimate: \$13,200.00
Assessor Name: Eduardo Lopez
Date Created: 11/28/2016

Notes: There are visible cracks on the partition wall, which should be studied by a professional engineer.

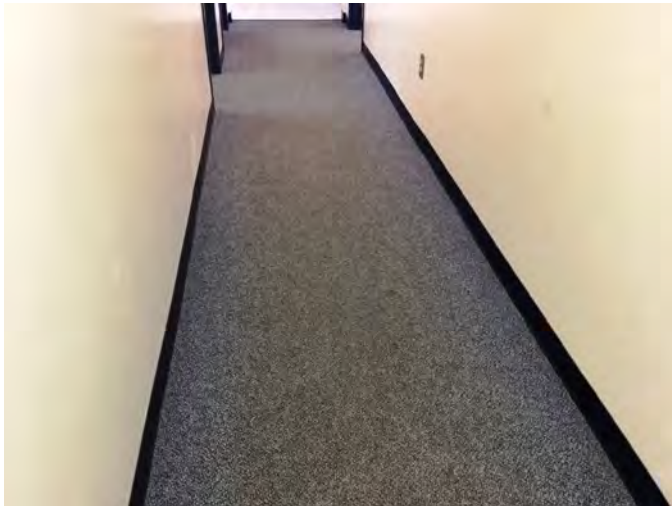
System: C3020 - Floor Finishes

Location: Throughout Building
Distress: Beyond Service Life
Category: Deferred Maintenance / Appearance
Priority: 3 - Necessary/Not Yet Critical (Years 2-5)
Correction: Replace carpet
Qty: 519.55
Unit of Measure: S.Y.
Estimate: \$44,412.80
Assessor Name: Eduardo Lopez
Date Created: 11/29/2016

Notes: The carpet is beyond its service life and should be replaced.

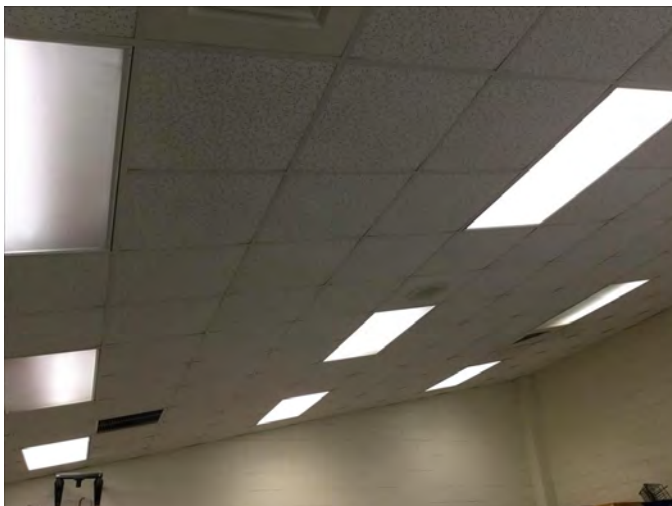
System: C3030 - Ceiling Finishes

Location: Throughout the building
Distress: Damaged
Category: Deferred Maintenance / Appearance
Priority: 3 - Necessary/Not Yet Critical (Years 2-5)
Correction: Replace acoustic tile ceiling, fire-rated
Qty: 16.83
Unit of Measure: C.S.F.
Estimate: \$13,795.90
Assessor Name: Eduardo Lopez
Date Created: 11/28/2016

Notes: The acoustical ceiling tiles are damaged due to water or humidity and should be replaced.
