NC School District/520 Jones County/Elementary School

# Maysville Elementary

## Campus Assessment Report

March 11, 2017

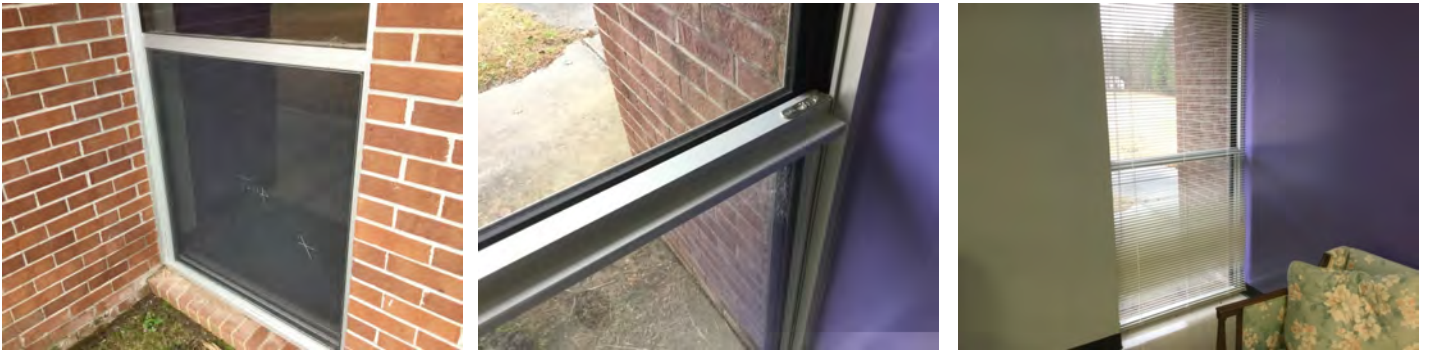
**System:** B2020 - Exterior Windows

**Note:** Exterior windows are believed to have been installed new in 1998. A few are losing seals and should be replaced on a maintenance basis.

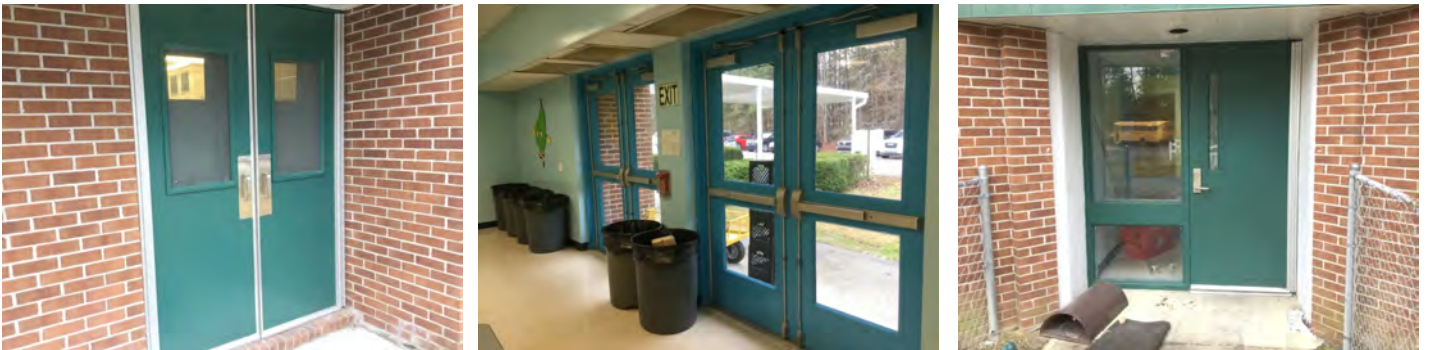
**System:** B2030 - Exterior Doors

**Note:** Exterior doors are believed to have been upgraded in the 1998 renovation. No deficiencies noted.

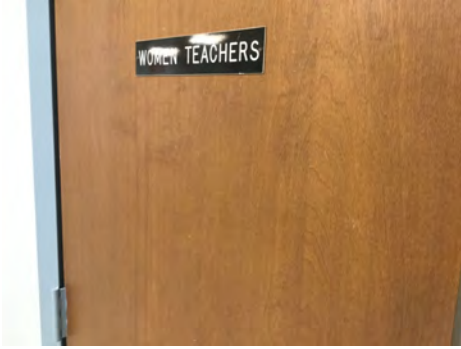
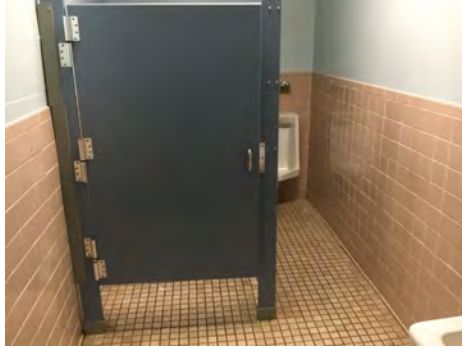
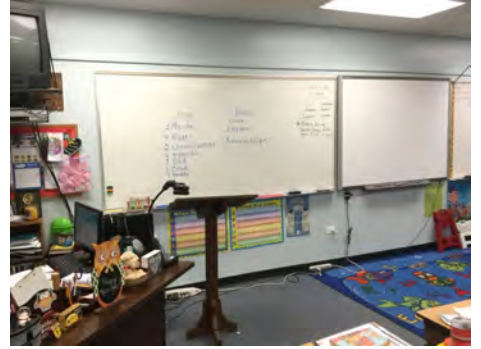
**System:** C1030 - Fittings

**Note:** Signage is not up to code. Toilet partitions and marker boards are in good condition. No manual deficiency entered as system expires in one year.

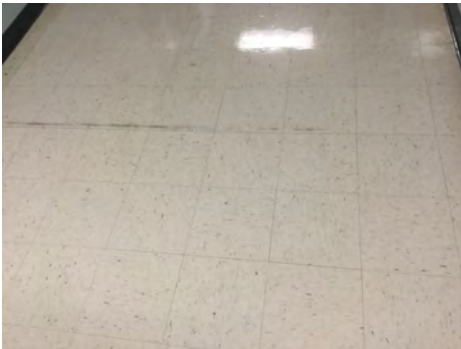
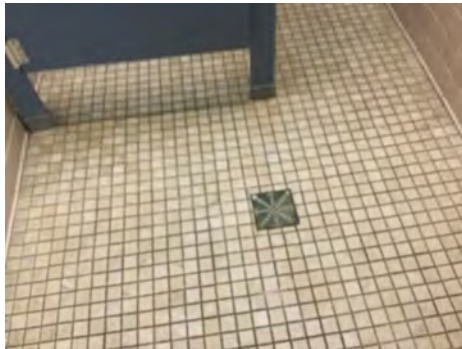
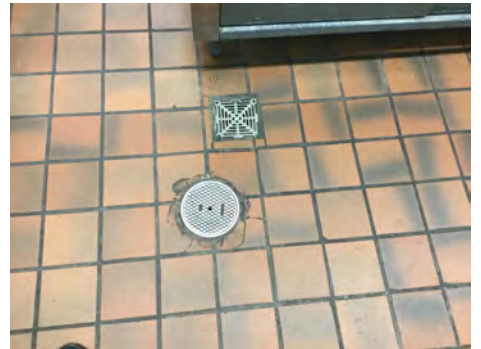
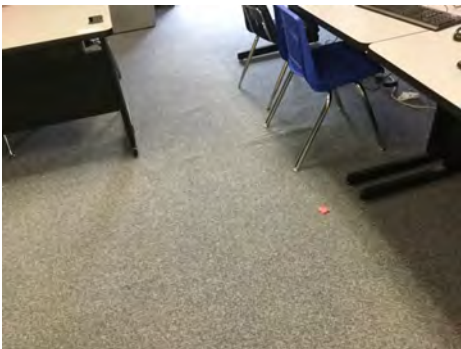
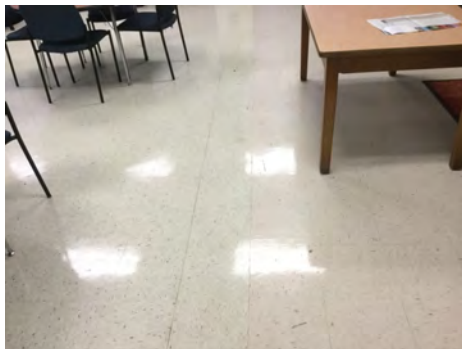
**System:** C3020 - Floor Finishes

**Note:** Carpet and VCT installed over VAT and asbestos mastic to encapsulate it in 1998. System expires in 1 year, so no manual deficiency entered.

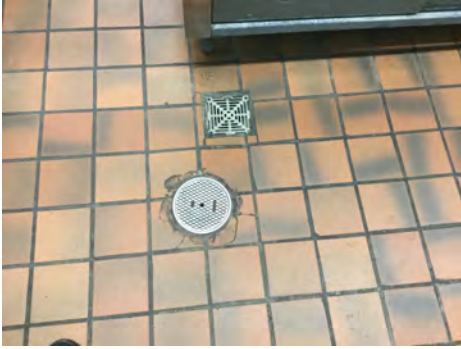
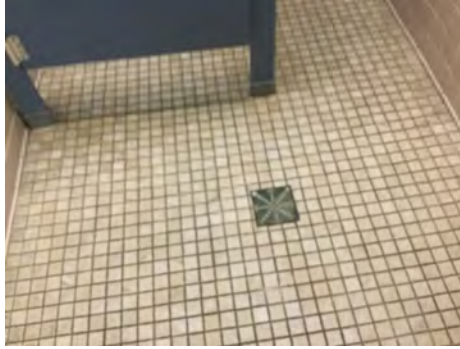
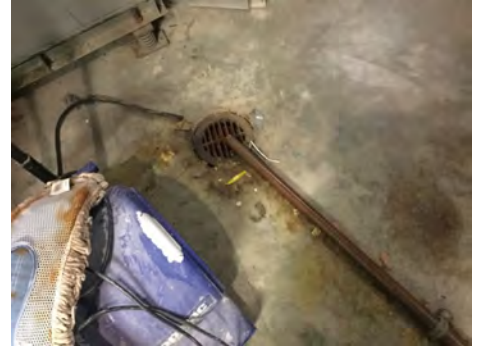
**System:** D2030 - Sanitary Waste

**Note:** No observed or reported problems with the sanitary waste system. System renewal set at 5 years hence.

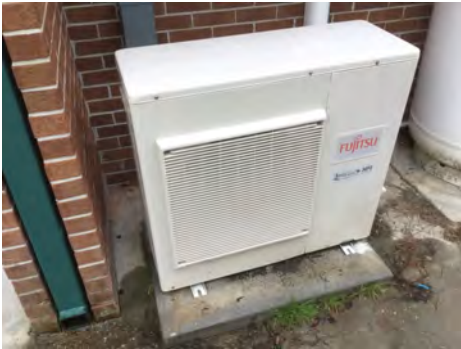
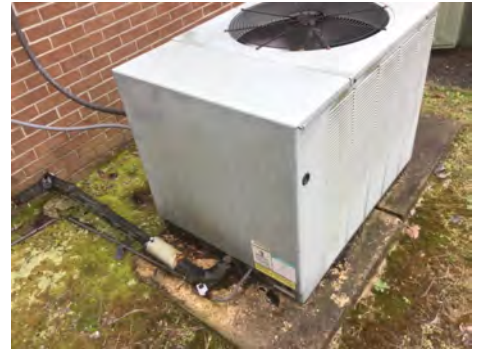
**System:** D3050 - Terminal & Package Units

**Note:** Air conditioning not included in 1998 upgrades. Community paid for retrofit of cooling coils in AHUs and condensing units in 2005.

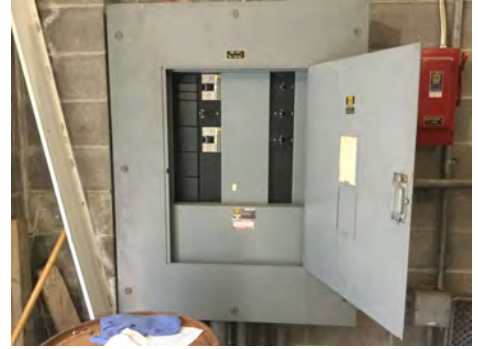
### System: D5020 - Branch Wiring

**Note:** Deficiencies, if any, assumed to have been addressed in 1998 renovations. GFI outlets seen in wet areas. Sufficient power outlets for computer needs. Power strips used for surge protection. No use of extension cords observed.

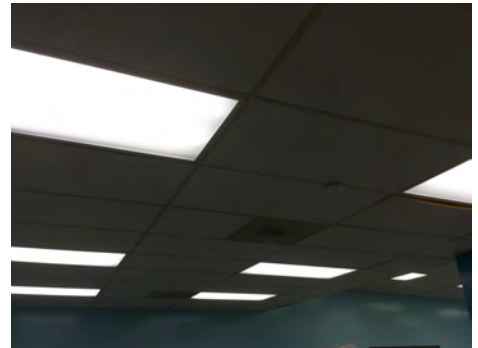
### System: D5020 - Lighting

**Note:** Upgraded existing fixtures with new ballasts and T-8 lamps 2011.

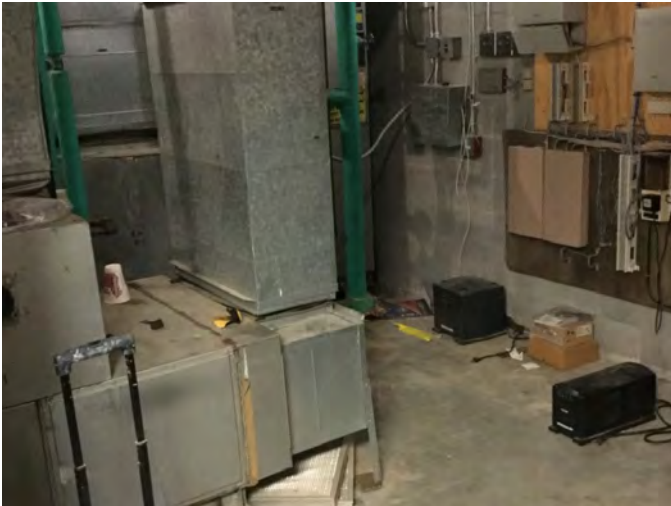
#### System: D3040 - Distribution Systems

**Location:** Throughout the building  
**Distress:** Beyond Service Life  
**Category:** Deferred Maintenance  
**Priority:** 3 - Necessary/Not Yet Critical (Years 2-5)  
**Correction:** Renew System  
**Qty:** 20,392.00  
**Unit of Measure:** S.F.  
**Estimate:** \$140,419.00  
**Assessor Name:** Ann Buerger Linden  
**Date Created:** 02/08/2017

**Notes:** The air distribution system is aged, has internally lined ductwork, and should be replaced. Provide cooling supply to data closets. Toilet room exhaust systems are cruddy.

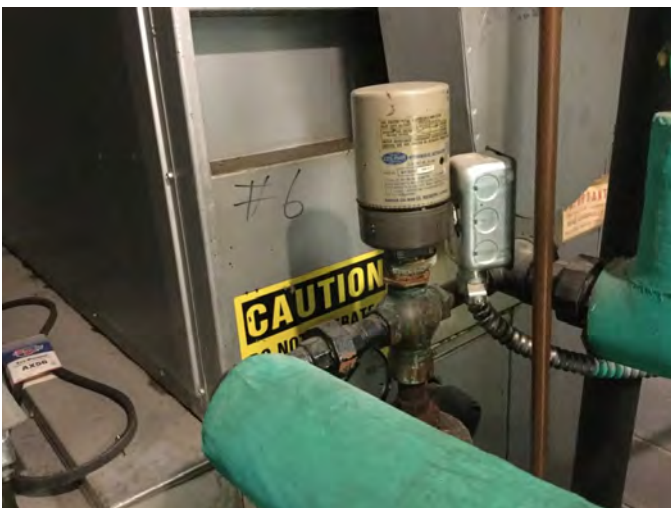
#### System: D3060 - Controls & Instrumentation

**Location:** Throughout the building  
**Distress:** Beyond Service Life  
**Category:** Deferred Maintenance  
**Priority:** 3 - Necessary/Not Yet Critical (Years 2-5)  
**Correction:** Renew System  
**Qty:** 20,392.00  
**Unit of Measure:** S.F.  
**Estimate:** \$44,414.00  
**Assessor Name:** Ann Buerger Linden  
**Date Created:** 02/08/2017

**Notes:** Building controls are locally controlled. Installation of a modern digital system with remote monitoring and control capability for energy conservation is recommended.

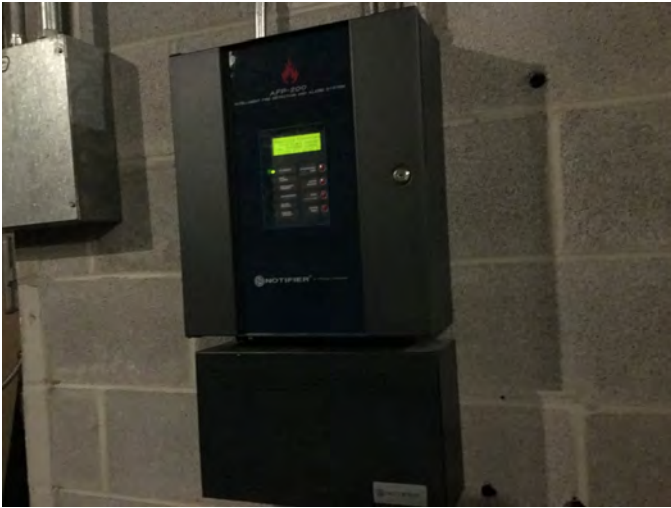
**System: D5030910 - Fire Alarm Systems**

**Location:** Throughout the building.  
**Distress:** Beyond Service Life  
**Category:** Deferred Maintenance  
**Priority:** 3 - Necessary/Not Yet Critical (Years 2-5)  
**Correction:** Renew System  
**Qty:** 20,392.00  
**Unit of Measure:** S.F.  
**Estimate:** \$77,612.00  
**Assessor Name:** Ann Buerger Linden  
**Date Created:** 02/08/2017

**Notes:** The fire alarm system is beyond its expected life. System renewal is recommended to ensure reliability of this life safety system.

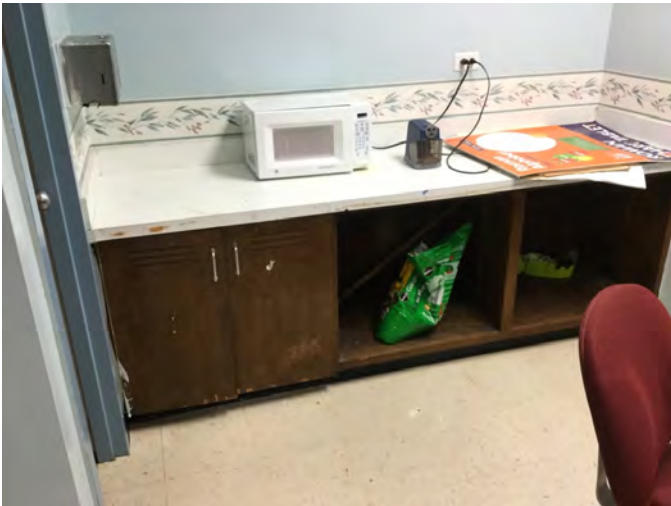
**System: E2010 - Fixed Furnishings**

**Location:** Throughout the building  
**Distress:** Beyond Service Life  
**Category:** Deferred Maintenance  
**Priority:** 3 - Necessary/Not Yet Critical (Years 2-5)  
**Correction:** Renew System  
**Qty:** 20,392.00  
**Unit of Measure:** S.F.  
**Estimate:** \$133,466.00  
**Assessor Name:** Ann Buerger Linden  
**Date Created:** 02/08/2017

**Notes:** Fixed furnishings are typically original, are beyond their expected useful life and are showing wear and tear. System renewal is recommended.

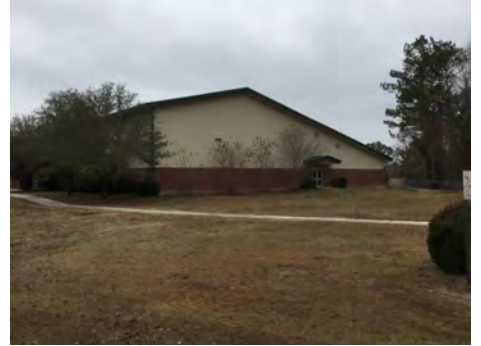
**System:** B2010 - Exterior Walls

**Note:** Walls painted 2016

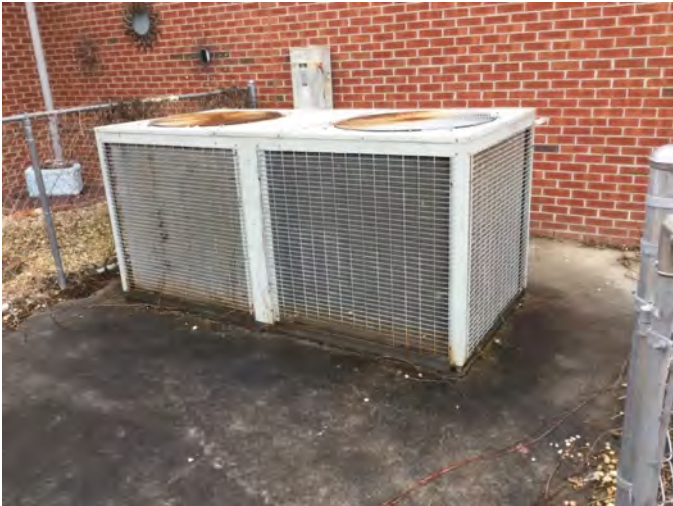
#### System: D3050 - Terminal & Package Units

**Location:** Throughout the building.  
**Distress:** Beyond Service Life  
**Category:** Deferred Maintenance  
**Priority:** 3 - Necessary/Not Yet Critical (Years 2-5)  
**Correction:** Renew System  
**Qty:** 16,581.00  
**Unit of Measure:** S.F.  
**Estimate:** \$555,745.00  
**Assessor Name:** Ann Buerger Linden  
**Date Created:** 02/08/2017

**Notes:** Terminal and package units, mostly ground mounted heat pumps, have exceeded their expected useful life. System renewal is recommended to ensure system performance.

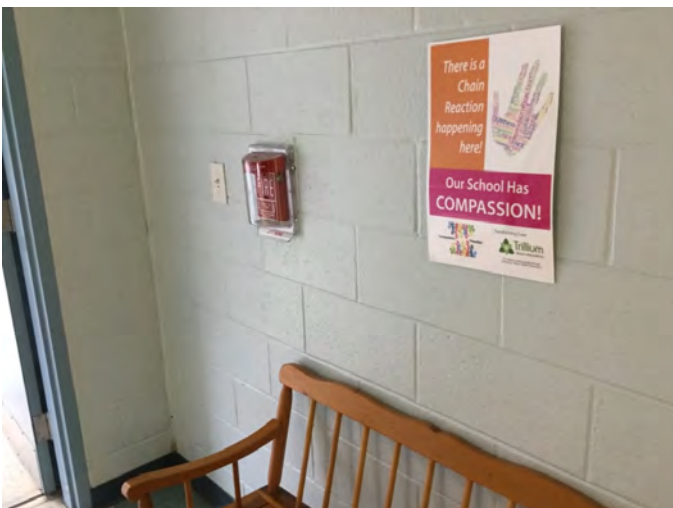
#### System: D5030910 - Fire Alarm Systems

**Location:** Throughout the building  
**Distress:** Beyond Service Life  
**Category:** Deferred Maintenance  
**Priority:** 3 - Necessary/Not Yet Critical (Years 2-5)  
**Correction:** Renew System  
**Qty:** 16,581.00  
**Unit of Measure:** S.F.  
**Estimate:** \$63,107.00  
**Assessor Name:** Ann Buerger Linden  
**Date Created:** 02/08/2017

**Notes:** The fire alarm system is original and beyond its expected life. System renewal is recommended to ensure reliability of this life safety system.

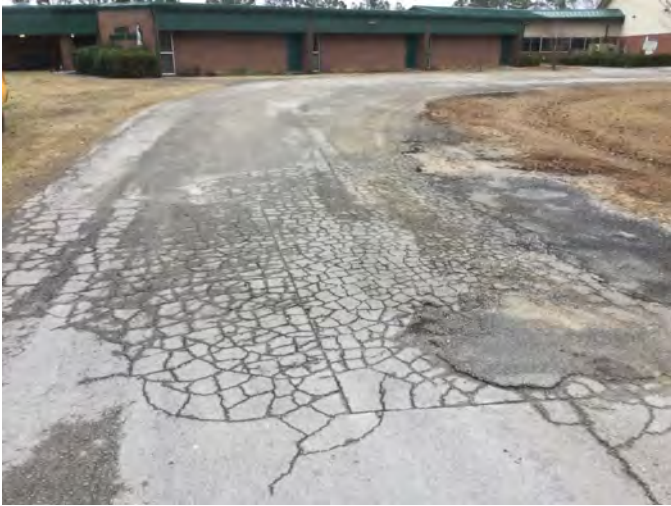
#### **System: G2010 - Roadways**

**Location:** Entrance drive - bus drop-off  
**Distress:** Beyond Service Life  
**Category:** Deferred Maintenance  
**Priority:** 3 - Necessary/Not Yet Critical (Years 2-5)  
**Correction:** Renew System  
**Qty:** 36,973.00  
**Unit of Measure:** S.F.  
**Estimate:** \$154,954.00  
**Assessor Name:** Ann Buerger Linden  
**Date Created:** 02/08/2017

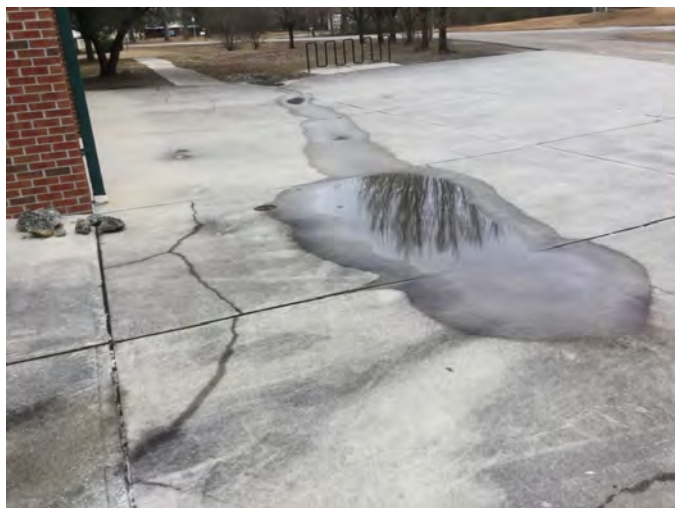
**System: G2030 - Pedestrian Paving**

**Location:** Site  
**Distress:** Beyond Service Life  
**Category:** Deferred Maintenance  
**Priority:** 4 - Recommended (Years 6-10)  
**Correction:** Renew System  
**Qty:** 36,973.00  
**Unit of Measure:** S.F.  
**Estimate:** \$77,680.00  
**Assessor Name:** Ann Buerger Linden  
**Date Created:** 02/08/2017
