NC School District/300 Davie County/Elementary School

Mocksville Elementary

Campus Assessment Report

March 10, 2017

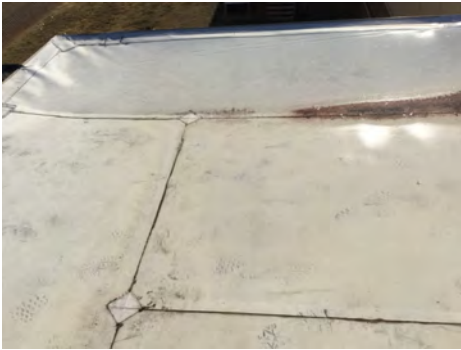
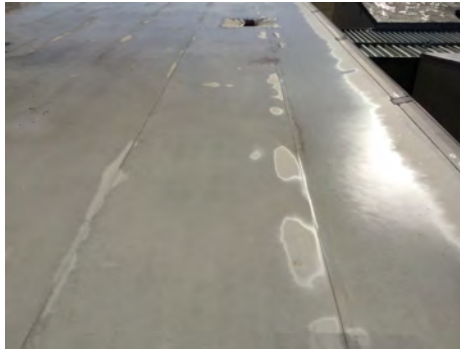
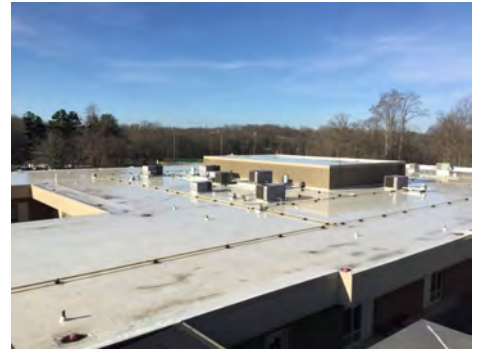
System: B3010120 - Single Ply Membrane

Note: The roof is fairly new with no reported leaks. There was considerable pooling of water due to condensation at the time of assessment. Consider increasing roof slope with tapered insulation at next re-roofing project.

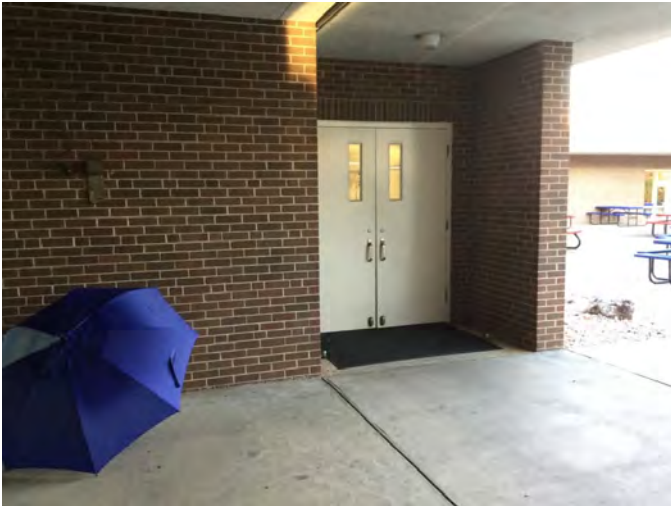
System: B2030 - Exterior Doors

Location: Exterior doors
Distress: Beyond Service Life
Category: Deferred Maintenance
Priority: 3 - Necessary/Not Yet Critical (Years 2-5)
Correction: Renew System
Qty: 50,572.00
Unit of Measure: S.F.
Estimate: \$56,742.00
Assessor Name: Ann Buerger Linden
Date Created: 02/14/2017

Notes: Although the main entry doors have been replaced, and the side breezeway has been enclosed with a door assembly for security reasons, most exterior doors are beyond their expected life and should be replaced.

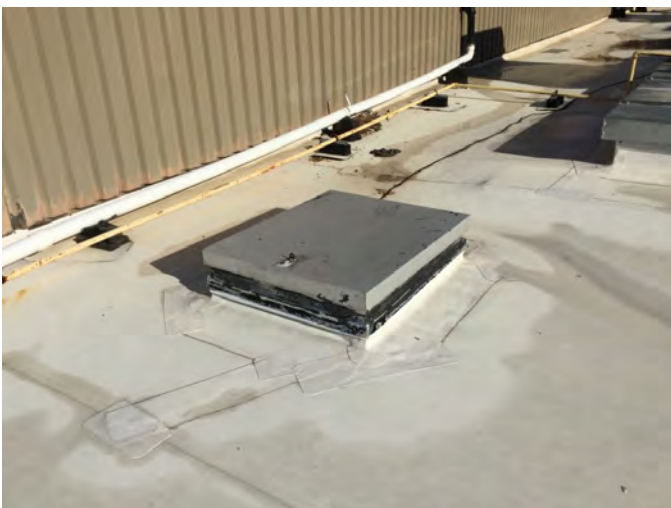
System: B3020 - Roof Openings

Location: Roof
Distress: Beyond Service Life
Category: Deferred Maintenance
Priority: 3 - Necessary/Not Yet Critical (Years 2-5)
Correction: Renew System
Qty: 50,572.00
Unit of Measure: S.F.
Estimate: \$16,132.00
Assessor Name: Ann Buerger Linden
Date Created: 02/14/2017

Notes: The roof hatch is beyond its expected life. Replacement is recommended.

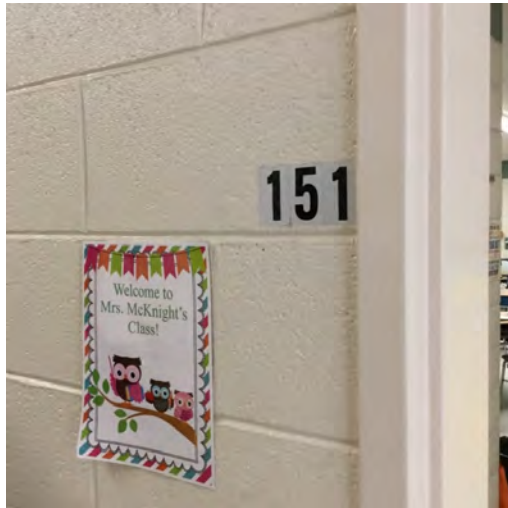
System: C1030 - Fittings

Location: Throughout the building
Distress: Beyond Service Life
Category: Deferred Maintenance
Priority: 3 - Necessary/Not Yet Critical (Years 2-5)
Correction: Renew System
Qty: 50,572.00
Unit of Measure: S.F.
Estimate: \$530,703.00
Assessor Name: Ann Buerger Linden
Date Created: 02/14/2017

Notes: In general, fittings are beyond their expected life. Room signage is not up to code. Lockers in the kitchen are rusted, some blackboards still exist and whiteboards are beginning to be stained. System renewal is recommended.

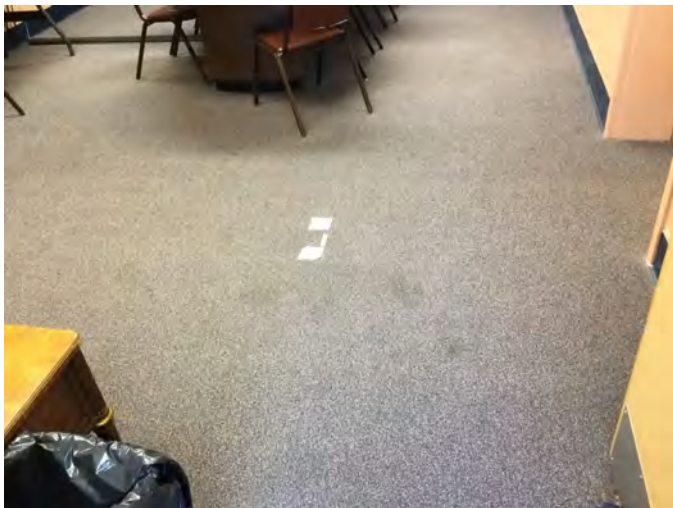
System: C3020 - Floor Finishes

Location: Throughout the building
Distress: Beyond Service Life
Category: Deferred Maintenance
Priority: 3 - Necessary/Not Yet Critical (Years 2-5)
Correction: Renew System
Qty: 50,572.00
Unit of Measure: S.F.
Estimate: \$620,266.00
Assessor Name: Ann Buerger Linden
Date Created: 02/14/2017

Notes: Carpet to VCT changes began in 1988 and is ongoing. Those early replacements, along with original VCT, are beyond their expected useful life. Asbestos containing mastic under VCT is reported to be present in the building. System renewal is recommended.

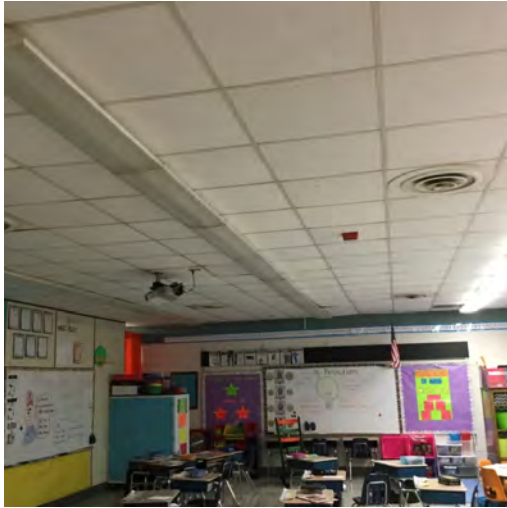
System: C3030 - Ceiling Finishes

Location: Throughout the building
Distress: Beyond Service Life
Category: Deferred Maintenance
Priority: 3 - Necessary/Not Yet Critical (Years 2-5)
Correction: Renew System
Qty: 50,572.00
Unit of Measure: S.F.
Estimate: \$597,458.00
Assessor Name: Ann Buerger Linden
Date Created: 02/14/2017

Notes: The ceiling grid system is believed to be original and is beyond its expected useful life. Although most tile are in fair to good condition, a number of water stained tile were observed. These are believed to precede the roof replacement of several years ago. Grid is generally yellowed. Coordinate ceiling replacement with other system renewals such as HVAC distribution and lighting.

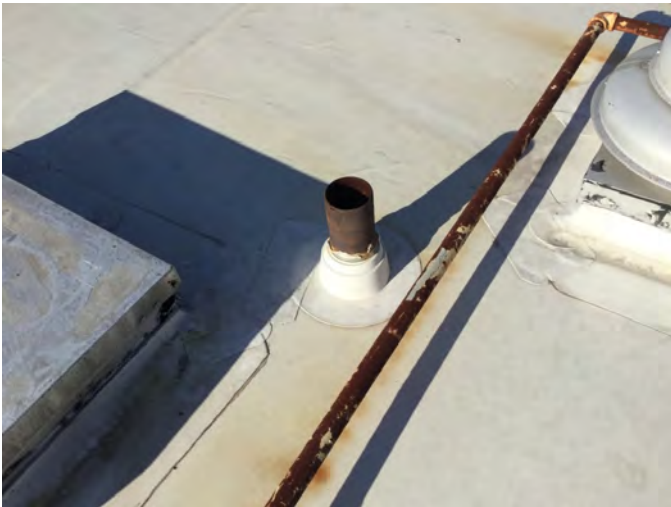
System: D2030 - Sanitary Waste

Location: Throughout the building
Distress: Beyond Service Life
Category: Deferred Maintenance
Priority: 3 - Necessary/Not Yet Critical (Years 2-5)
Correction: Renew System
Qty: 50,572.00
Unit of Measure: S.F.
Estimate: \$84,556.00
Assessor Name: Ann Buerger Linden
Date Created: 02/14/2017

Notes: The sanitary waste system is original and beyond its expected useful life. System renewal is recommended.

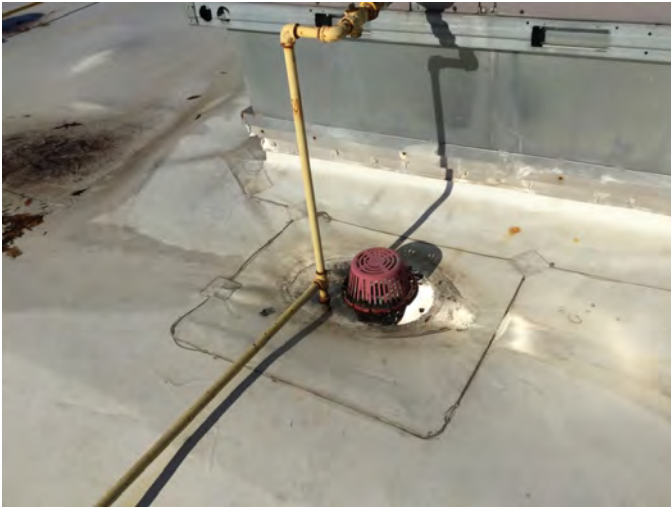
System: D2040 - Rain Water Drainage

Location: Roof and throughout the building
Distress: Beyond Service Life
Category: Deferred Maintenance
Priority: 3 - Necessary/Not Yet Critical (Years 2-5)
Correction: Renew System
Qty: 50,572.00
Unit of Measure: S.F.
Estimate: \$75,656.00
Assessor Name: Ann Buerger Linden
Date Created: 02/14/2017

Notes: The rain water drainage system is believed to be original and is beyond its expected useful life. The facilities management department reports inadequate roof drainage. System renewal is recommended.

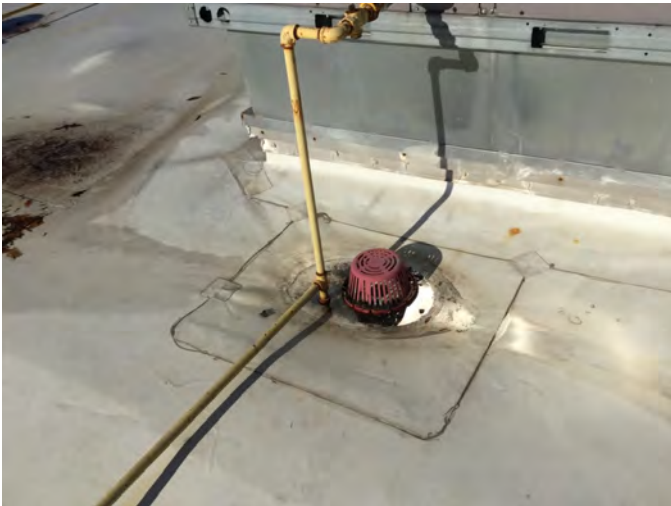
System: D2090 - Other Plumbing Systems -Nat Gas

Location: Roof, kitchen, EQ rooms
Distress: Beyond Service Life
Category: Deferred Maintenance
Priority: 3 - Necessary/Not Yet Critical (Years 2-5)
Correction: Renew System
Qty: 50,572.00
Unit of Measure: S.F.
Estimate: \$9,457.00
Assessor Name: Ann Buerger Linden
Date Created: 02/14/2017

Notes: Natural gas piping is presumed to be original and is there beyond its expected useful life. System renewal is recommended.

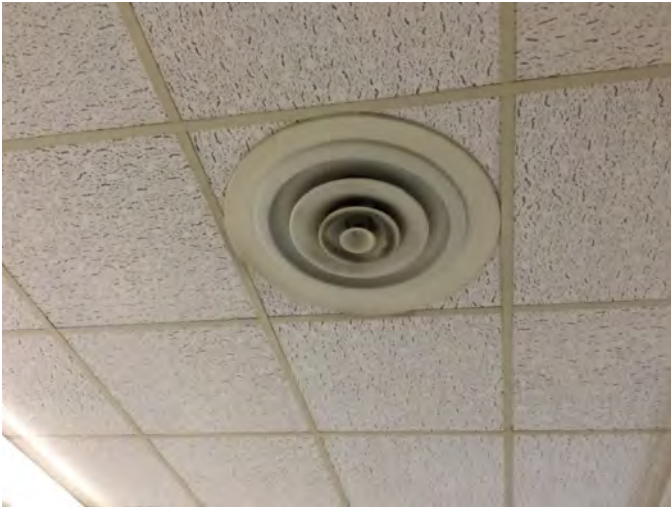
System: D3040 - Distribution Systems

Location: Throughout the building
Distress: Beyond Service Life
Category: Deferred Maintenance
Priority: 3 - Necessary/Not Yet Critical (Years 2-5)
Correction: Renew System
Qty: 50,572.00
Unit of Measure: S.F.
Estimate: \$334,888.00
Assessor Name: Ann Buerger Linden
Date Created: 02/14/2017

Notes: HVAC distribution systems are typically original and beyond expected useful life. Supply ductwork is typically internally insulated and cannot be cleaned. System renewal is recommended.

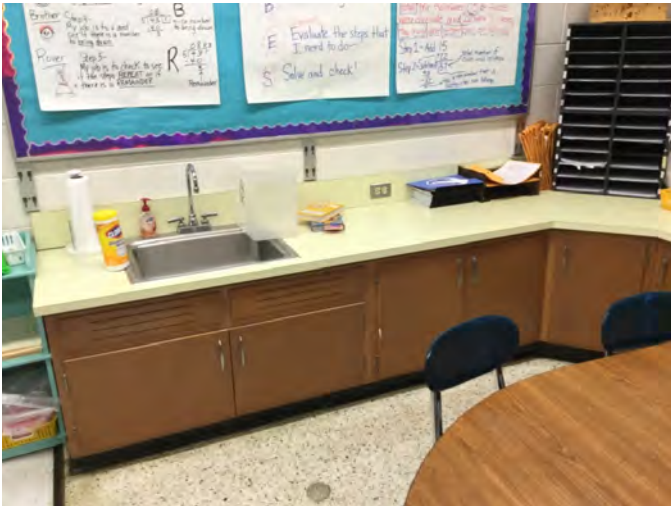
System: D5020 - Branch Wiring

Location: Throughout the building
Distress: Beyond Service Life
Category: Deferred Maintenance
Priority: 3 - Necessary/Not Yet Critical (Years 2-5)
Correction: Renew System
Qty: 50,572.00
Unit of Measure: S.F.
Estimate: \$277,590.00
Assessor Name: Ann Buerger Linden
Date Created: 02/14/2017

Notes: The branch wiring system is mostly original and well beyond its expected useful life. GFI outlets were not seen in all wet areas. System renewal is recommended.

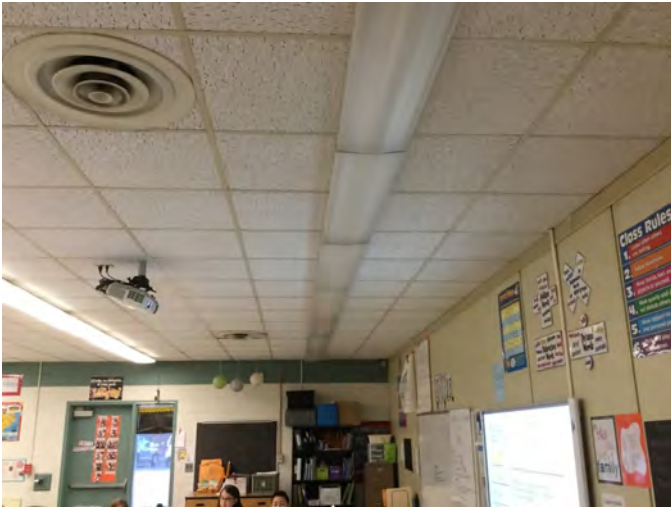
System: D5020 - Lighting

Location: Throughout the building
Distress: Beyond Service Life
Category: Deferred Maintenance
Priority: 3 - Necessary/Not Yet Critical (Years 2-5)
Correction: Renew System
Qty: 50,572.00
Unit of Measure: S.F.
Estimate: \$647,524.00
Assessor Name: Ann Buerger Linden
Date Created: 02/14/2017

Notes: Although lighting has been upgraded to T8 bulbs and ballasts, typically original fixtures have been retrofitted. They system is considered expired. System renewal is recommended.

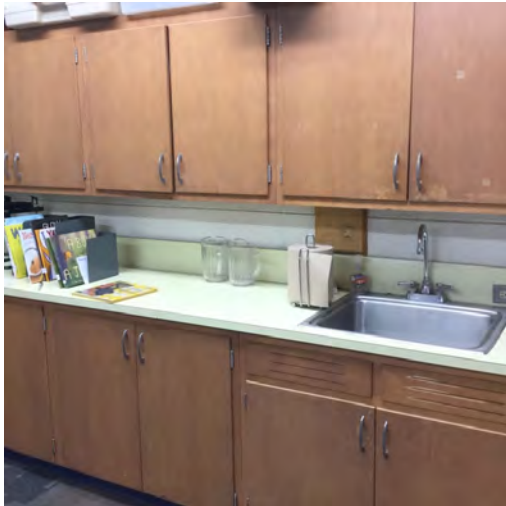
System: E2010 - Fixed Furnishings

Location: Throughout the building
Distress: Beyond Service Life
Category: Deferred Maintenance
Priority: 3 - Necessary/Not Yet Critical (Years 2-5)
Correction: Renew System
Qty: 50,572.00
Unit of Measure: S.F.
Estimate: \$318,199.00
Assessor Name: Ann Buerger Linden
Date Created: 02/14/2017

Notes: Fixed furnishings are typically original and in worn condition with stains, veneer damage etc. System renewal is recommended.

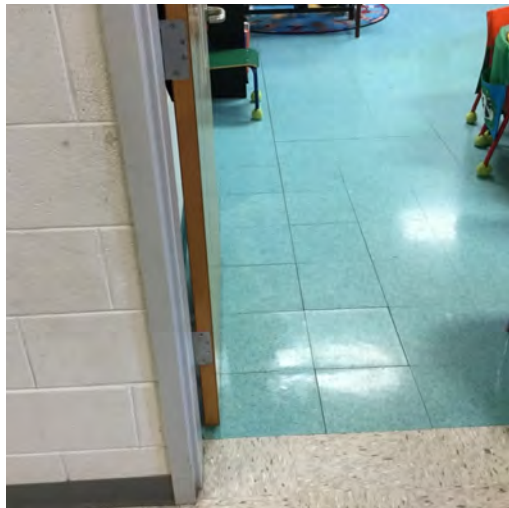
System: C3020 - Floor Finishes

Location: Throughout the building
Distress: Beyond Service Life
Category: Deferred Maintenance
Priority: 3 - Necessary/Not Yet Critical (Years 2-5)
Correction: Renew System
Qty: 10,733.00
Unit of Measure: S.F.
Estimate: \$131,640.00
Assessor Name: Somnath Das
Date Created: 02/14/2017

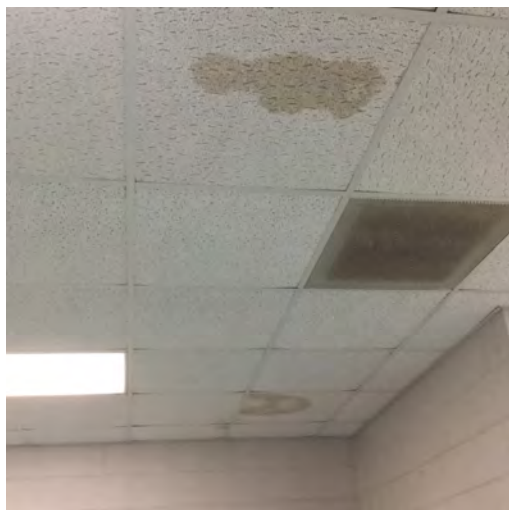
System: C3030 - Ceiling Finishes

Location: Throughout the building
Distress: Beyond Service Life
Category: Deferred Maintenance
Priority: 3 - Necessary/Not Yet Critical (Years 2-5)
Correction: Renew System
Qty: 10,733.00
Unit of Measure: S.F.
Estimate: \$126,800.00
Assessor Name: Somnath Das
Date Created: 02/14/2017

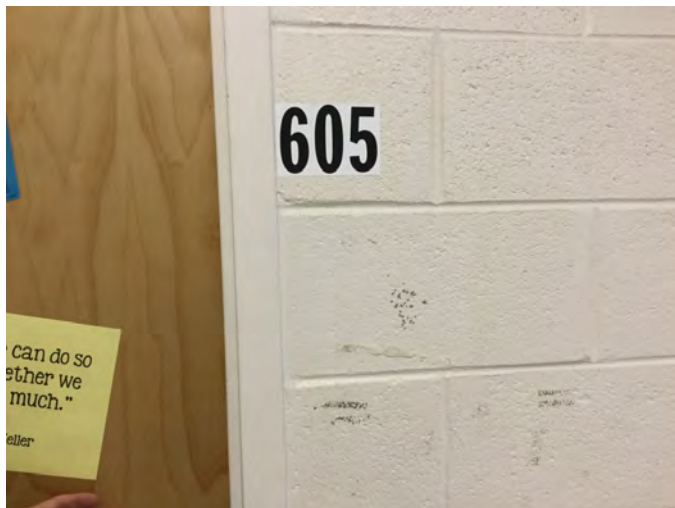
System: C3010 - Wall Finishes

Location: Throughout the building
Distress: Beyond Service Life
Category: Deferred Maintenance
Priority: 3 - Necessary/Not Yet Critical (Years 2-5)
Correction: Renew System
Qty: 17,093.00
Unit of Measure: S.F.
Estimate: \$51,330.00
Assessor Name: Ann Buerger Linden
Date Created: 02/13/2017

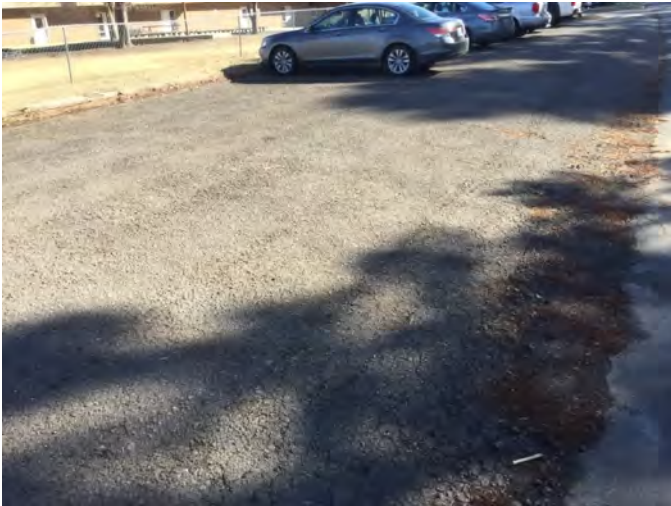
Location: West lot, south side of building
Distress: Beyond Service Life
Category: Deferred Maintenance
Priority: 3 - Necessary/Not Yet Critical (Years 2-5)
Correction: Parking lot repair and resurface
Qty: 4.50
Unit of Measure: M.S.F.
Estimate: \$6,109.96
Assessor Name: Ann Buerger Linden
Date Created: 02/13/2017

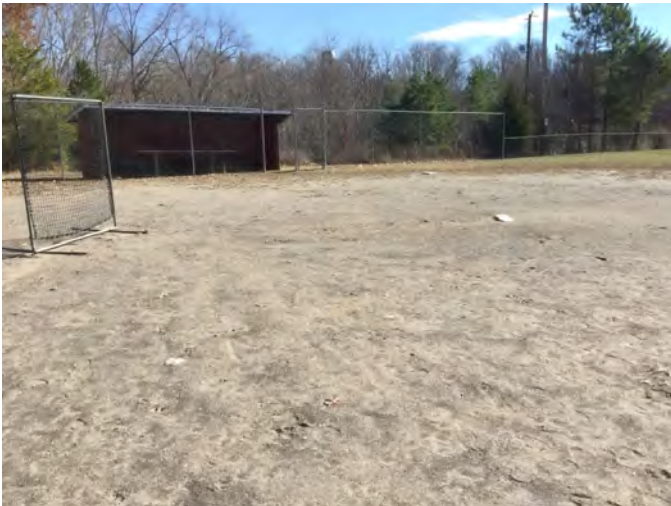
Location: Northeast end of site
Distress: Beyond Service Life
Category: Deferred Maintenance
Priority: 3 - Necessary/Not Yet Critical (Years 2-5)
Correction: Renew System
Qty: 78,398.00
Unit of Measure: S.F.
Estimate: \$391,520.00
Assessor Name: Ann Buerger Linden
Date Created: 12/13/2016

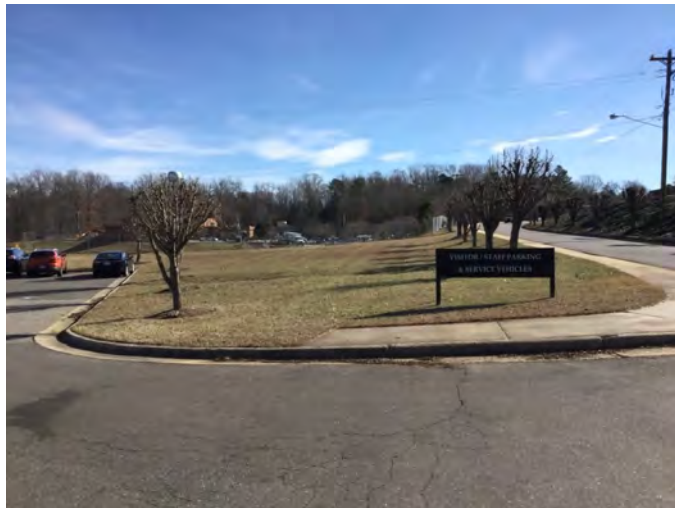
Location: Site
Distress: Inadequate
Category: Deferred Maintenance
Priority: 3 - Necessary/Not Yet Critical (Years 2-5)
Correction: Grading study
Qty: 1.00
Unit of Measure: Ea.
Estimate: \$6,600.00
Assessor Name: Ann Buerger Linden
Date Created: 02/14/2017
