NC School District/300 Davie County/Middle School

# North Davie Middle

## Campus Assessment Report

March 10, 2017

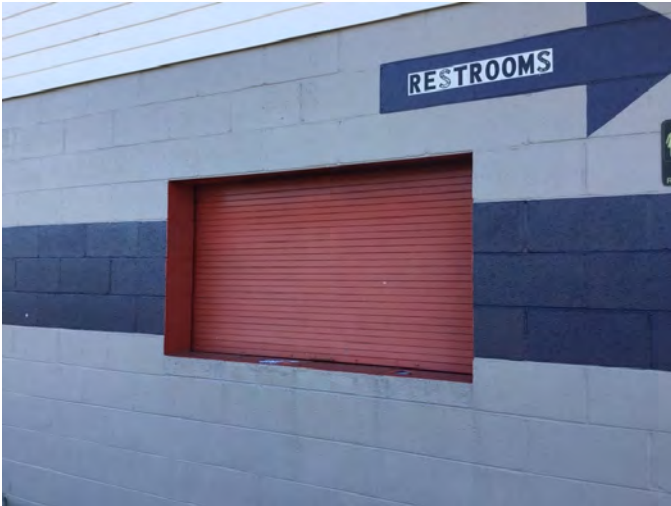
#### System: B2020 - Exterior Windows

**Location:** Exterior Walls  
**Distress:** Beyond Service Life  
**Category:** Deferred Maintenance  
**Priority:** 3 - Necessary/Not Yet Critical (Years 2-5)  
**Correction:** Renew System  
**Qty:** 1,070.00  
**Unit of Measure:** S.F.  
**Estimate:** \$1,071.00  
**Assessor Name:** Eduardo Lopez  
**Date Created:** 01/19/2017

**Notes:** The exterior windows are aged, and should be replaced.

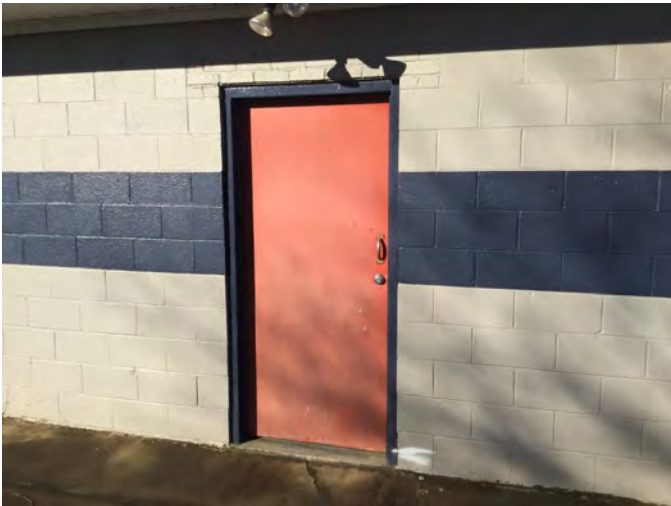
#### System: B2030 - Exterior Doors

**Location:** Exterior Walls  
**Distress:** Beyond Service Life  
**Category:** Deferred Maintenance  
**Priority:** 3 - Necessary/Not Yet Critical (Years 2-5)  
**Correction:** Renew System  
**Qty:** 1,070.00  
**Unit of Measure:** S.F.  
**Estimate:** \$7,615.00  
**Assessor Name:** Eduardo Lopez  
**Date Created:** 01/19/2017

**Notes:** The exterior doors are aged, and should be replaced.

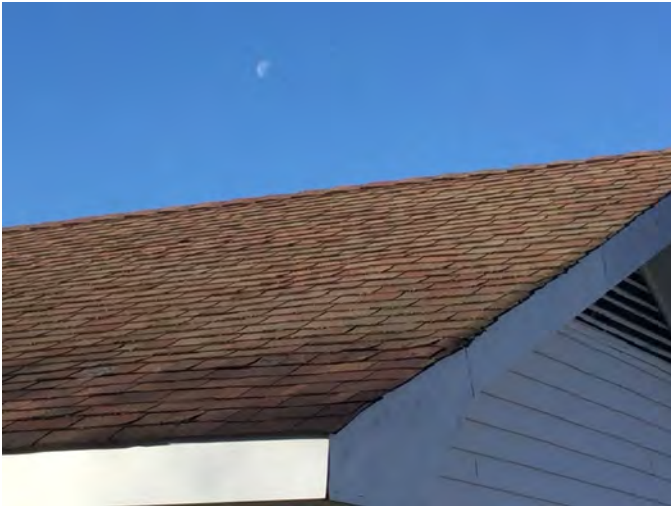
**System: B3010140 - Asphalt Shingles**

**Location:** Roof  
**Distress:** Beyond Service Life  
**Category:** Deferred Maintenance  
**Priority:** 3 - Necessary/Not Yet Critical (Years 2-5)  
**Correction:** Renew System  
**Qty:** 1,070.00  
**Unit of Measure:** S.F.  
**Estimate:** \$6,749.00  
**Assessor Name:** Eduardo Lopez  
**Date Created:** 01/19/2017

**Notes:** The asphalt shingles roof covering is aged, showing signs of failure and should be replaced.

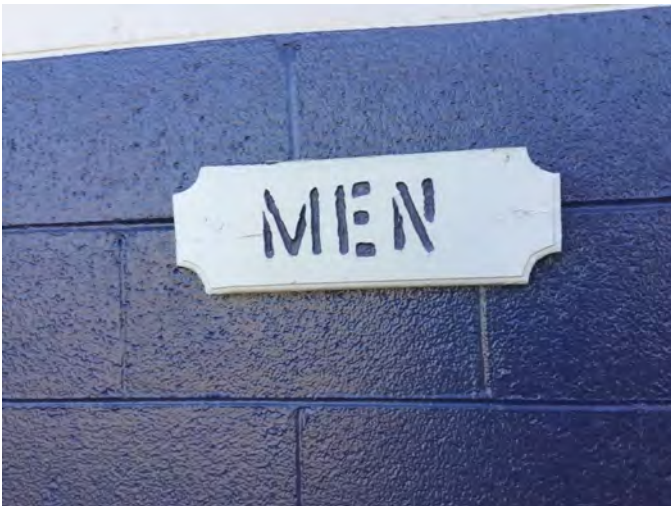
**System: C1030 - Fittings**

**Location:** Throughout the Building  
**Distress:** Beyond Service Life  
**Category:** Deferred Maintenance / Accessibility Code Compliance  
**Priority:** 3 - Necessary/Not Yet Critical (Years 2-5)  
**Correction:** Renew System  
**Qty:** 1,070.00  
**Unit of Measure:** S.F.  
**Estimate:** \$9,969.00  
**Assessor Name:** Eduardo Lopez  
**Date Created:** 01/19/2017

**Notes:** The fittings throughout the building are aged, in marginal condition, partitions and signage are not ADA compliant and should be replaced.

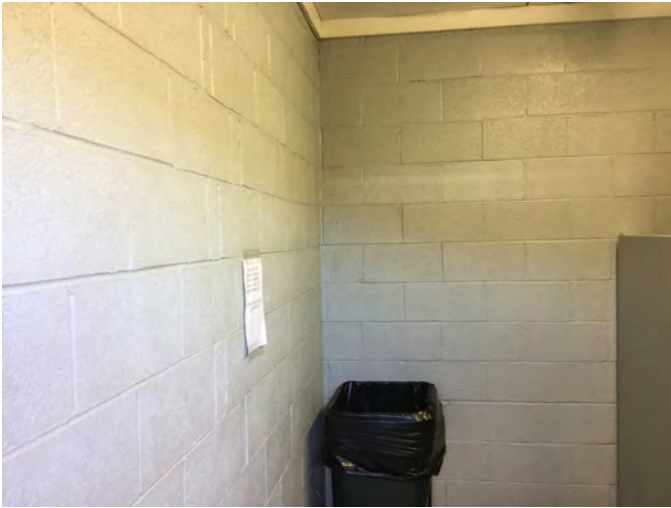
**System: C3010 - Wall Finishes**

**Location:** Throughout the Building  
**Distress:** Beyond Service Life  
**Category:** Deferred Maintenance  
**Priority:** 3 - Necessary/Not Yet Critical (Years 2-5)  
**Correction:** Renew System  
**Qty:** 1,070.00  
**Unit of Measure:** S.F.  
**Estimate:** \$8,780.00  
**Assessor Name:** Eduardo Lopez  
**Date Created:** 01/19/2017

**Notes:** The wall finishes are aged, scuffed, fading, stained and should be replaced.

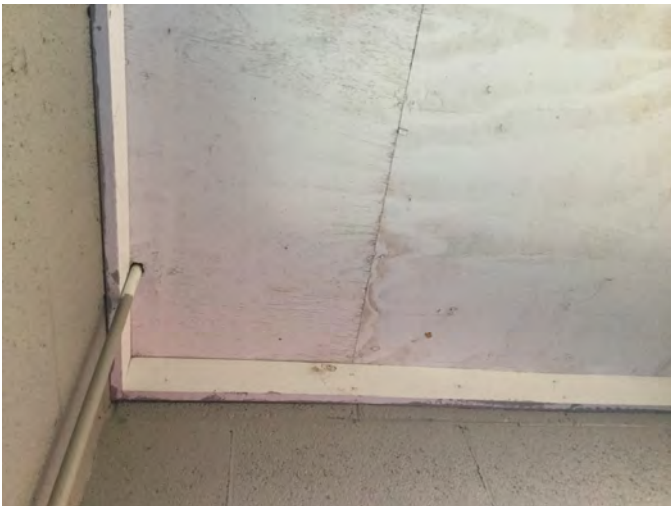
**System: C3030 - Ceiling Finishes**

**Location:** Throughout the Building  
**Distress:** Beyond Service Life  
**Category:** Deferred Maintenance  
**Priority:** 3 - Necessary/Not Yet Critical (Years 2-5)  
**Correction:** Renew System  
**Qty:** 1,070.00  
**Unit of Measure:** S.F.  
**Estimate:** \$11,217.00  
**Assessor Name:** Eduardo Lopez  
**Date Created:** 01/19/2017

**Notes:** The original ceiling finishes are aged, failing and should be replaced.

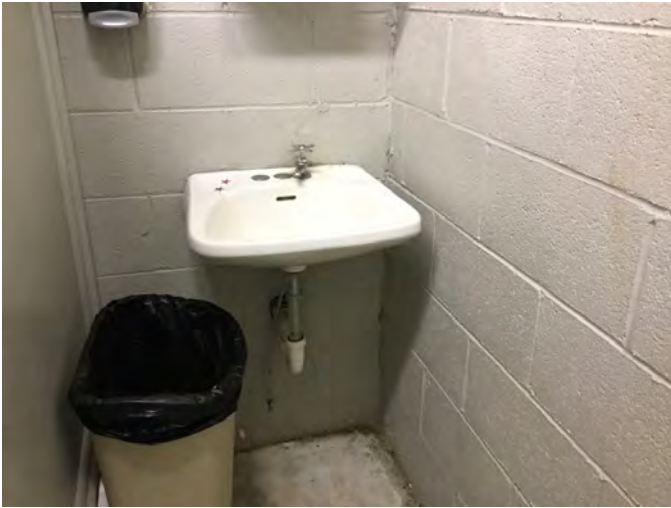
**System: D2010 - Plumbing Fixtures**

**Location:** Throughout the Building  
**Distress:** Beyond Service Life  
**Category:** Deferred Maintenance  
**Priority:** 3 - Necessary/Not Yet Critical (Years 2-5)  
**Correction:** Renew System  
**Qty:** 1,070.00  
**Unit of Measure:** S.F.  
**Estimate:** \$11,746.00  
**Assessor Name:** Eduardo Lopez  
**Date Created:** 01/19/2017

**Notes:** Plumbing fixtures are in operational conditions. However, they are aged, not ADA compliant, and should be scheduled for replacement.

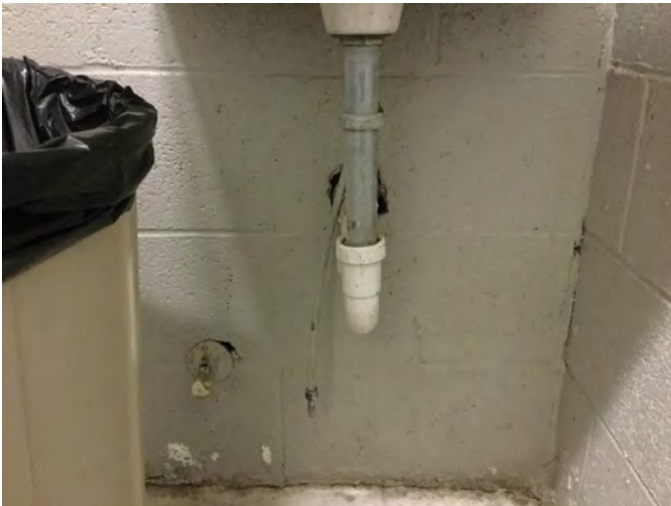
**System: D2020 - Domestic Water Distribution**

**Location:** Throughout the Building  
**Distress:** Beyond Service Life  
**Category:** Deferred Maintenance  
**Priority:** 3 - Necessary/Not Yet Critical (Years 2-5)  
**Correction:** Renew System  
**Qty:** 1,070.00  
**Unit of Measure:** S.F.  
**Estimate:** \$989.00  
**Assessor Name:** Eduardo Lopez  
**Date Created:** 01/19/2017

**Notes:** The domestic water distribution system is aged and should be replaced.

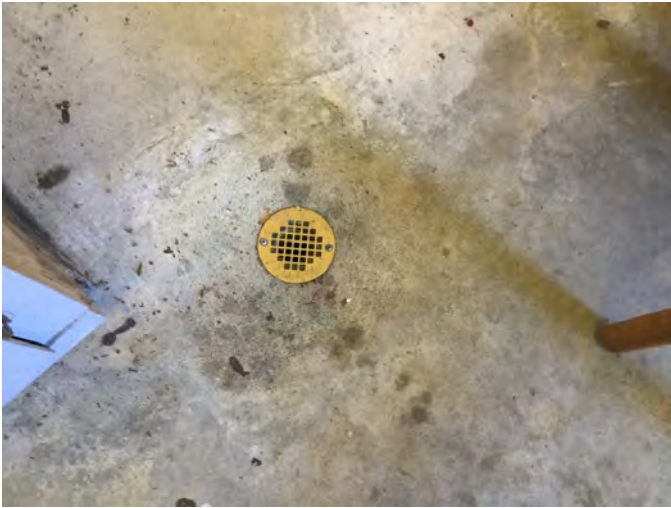
**System: D2030 - Sanitary Waste**

**Location:** Throughout the Building  
**Distress:** Beyond Service Life  
**Category:** Deferred Maintenance  
**Priority:** 3 - Necessary/Not Yet Critical (Years 2-5)  
**Correction:** Renew System  
**Qty:** 1,070.00  
**Unit of Measure:** S.F.  
**Estimate:** \$6,991.00  
**Assessor Name:** Eduardo Lopez  
**Date Created:** 01/19/2017

**Notes:** The sanitary waste system is beyond its expected service life and should be replaced.

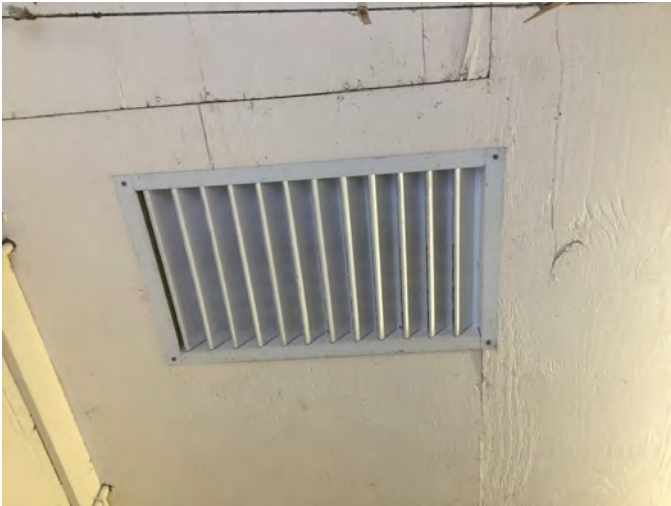
**System: D3040 - Distribution Systems**

**Location:** Throughout the Building  
**Distress:** Beyond Service Life  
**Category:** Deferred Maintenance  
**Priority:** 3 - Necessary/Not Yet Critical (Years 2-5)  
**Correction:** Renew System  
**Qty:** 1,070.00  
**Unit of Measure:** S.F.  
**Estimate:** \$6,297.00  
**Assessor Name:** Eduardo Lopez  
**Date Created:** 01/19/2017

**Notes:** Distribution systems are aged, becoming logistically unsupportable, and should be replaced.

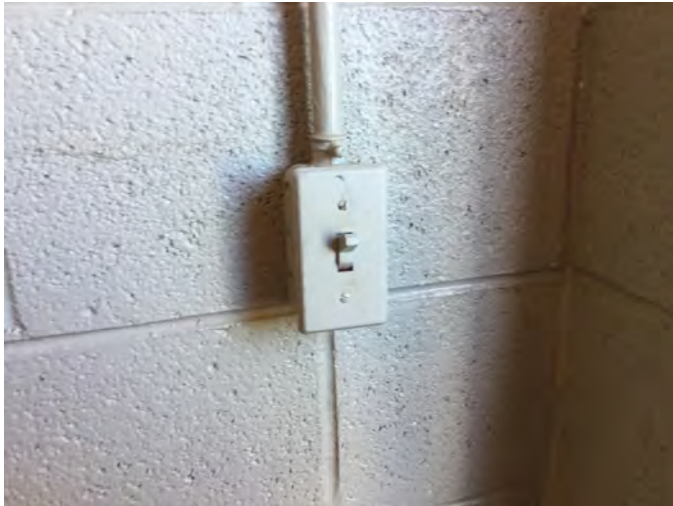
**System: D5020 - Branch Wiring**

**Location:** Throughout the Building  
**Distress:** Beyond Service Life  
**Category:** Deferred Maintenance  
**Priority:** 3 - Necessary/Not Yet Critical (Years 2-5)  
**Correction:** Renew System  
**Qty:** 1,070.00  
**Unit of Measure:** S.F.  
**Estimate:** \$3,001.00  
**Assessor Name:** Eduardo Lopez  
**Date Created:** 01/19/2017

**Notes:** The original branch wiring system is operating but is aged, in marginal condition, and should be replaced.

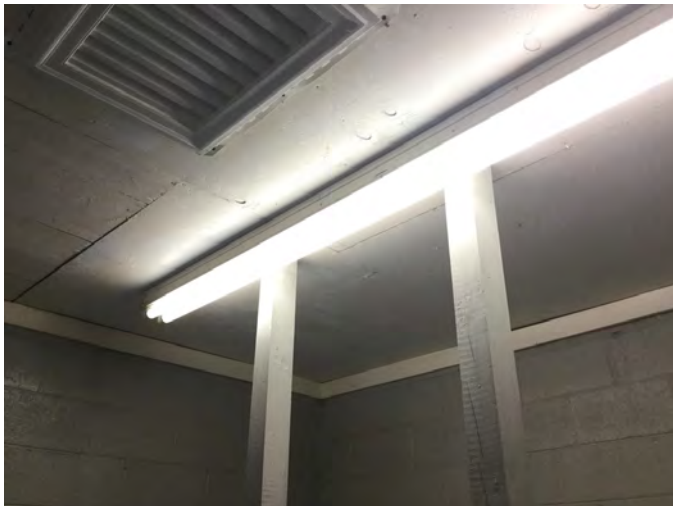
**System: D5020 - Lighting**

**Location:** Throughout the Building  
**Distress:** Beyond Service Life  
**Category:** Deferred Maintenance  
**Priority:** 3 - Necessary/Not Yet Critical (Years 2-5)  
**Correction:** Renew System  
**Qty:** 1,070.00  
**Unit of Measure:** S.F.  
**Estimate:** \$4,214.00  
**Assessor Name:** Eduardo Lopez  
**Date Created:** 01/19/2017

**Notes:** The original lighting system is operating but is aged, in marginal condition, and should be replaced.

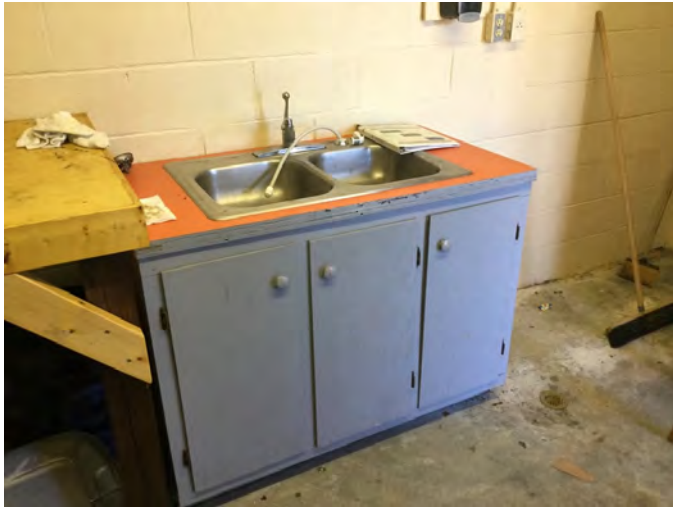
**System: E2010 - Fixed Furnishings**

**Location:** Throughout the Building  
**Distress:** Beyond Service Life  
**Category:** Deferred Maintenance  
**Priority:** 3 - Necessary/Not Yet Critical (Years 2-5)  
**Correction:** Renew System  
**Qty:** 1,070.00  
**Unit of Measure:** S.F.  
**Estimate:** \$5,979.00  
**Assessor Name:** Eduardo Lopez  
**Date Created:** 01/19/2017

**Notes:** The fixed furnishings are aged, in marginal condition, and should be replaced.

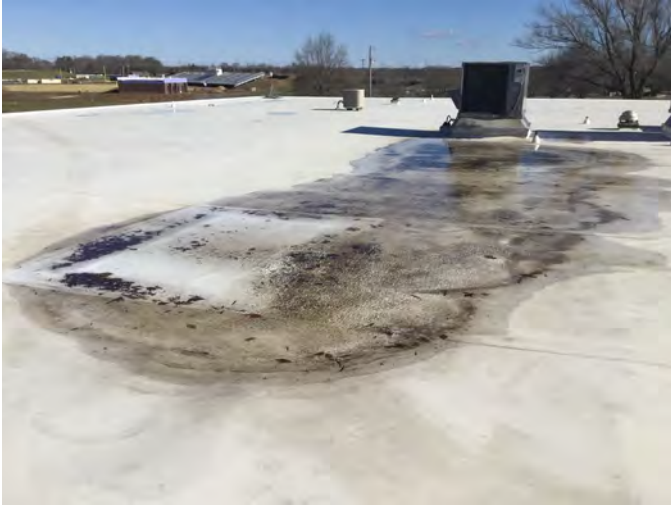
#### **System: D2040 - Rain Water Drainage**

**Location:** Roof  
**Distress:** Beyond Service Life  
**Category:** Deferred Maintenance  
**Priority:** 2 - Potentially Critical (Year 1)  
**Correction:** Renew System  
**Qty:** 72,876.00  
**Unit of Measure:** S.F.  
**Estimate:** \$47,297.00  
**Assessor Name:** Eduardo Lopez  
**Date Created:** 01/19/2017

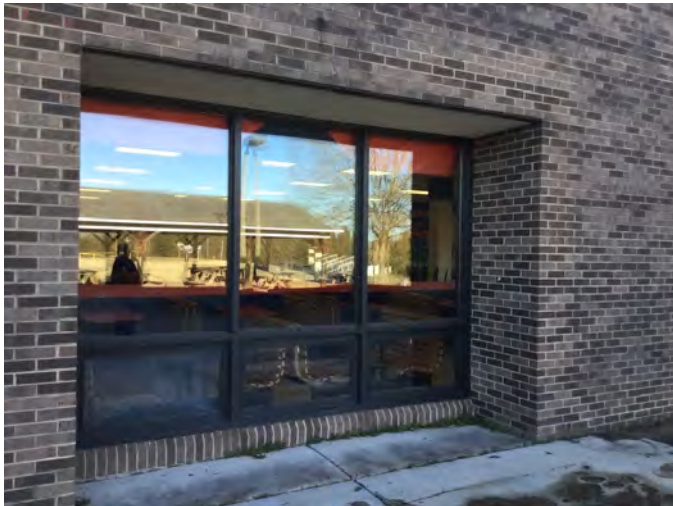
**Location:** Exterior Walls  
**Distress:** Beyond Service Life  
**Category:** Deferred Maintenance  
**Priority:** 3 - Necessary/Not Yet Critical (Years 2-5)  
**Correction:** Renew System  
**Qty:** 72,876.00  
**Unit of Measure:** S.F.  
**Estimate:** \$843,321.00  
**Assessor Name:** Eduardo Lopez  
**Date Created:** 01/19/2017

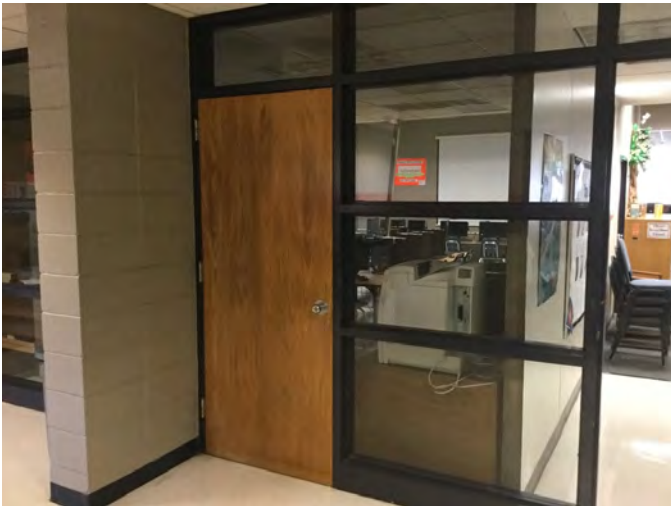
**Location:** Throughout the Building  
**Distress:** Beyond Service Life  
**Category:** Deferred Maintenance / Accessibility Code Compliance  
**Priority:** 3 - Necessary/Not Yet Critical (Years 2-5)  
**Correction:** Renew System  
**Qty:** 72,876.00  
**Unit of Measure:** S.F.  
**Estimate:** \$197,202.00  
**Assessor Name:** Eduardo Lopez  
**Date Created:** 01/19/2017

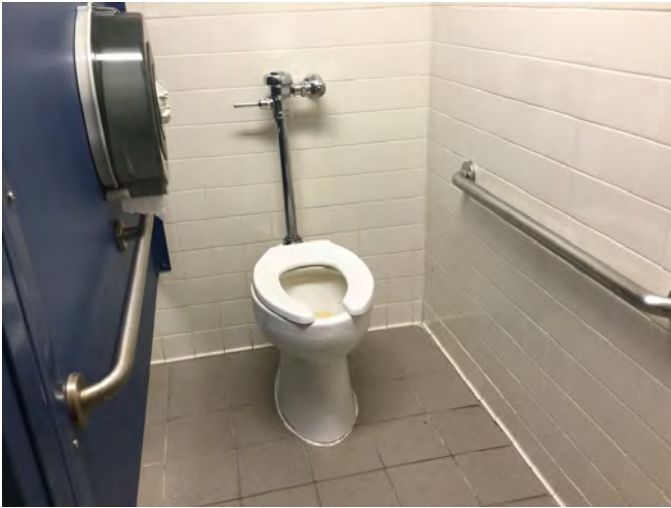
**Location:** Throughout the Building  
**Distress:** Beyond Service Life  
**Category:** Deferred Maintenance / Accessibility Code Compliance  
**Priority:** 3 - Necessary/Not Yet Critical (Years 2-5)  
**Correction:** Renew System  
**Qty:** 72,876.00  
**Unit of Measure:** S.F.  
**Estimate:** \$1,050,945.00  
**Assessor Name:** Eduardo Lopez  
**Date Created:** 01/19/2017

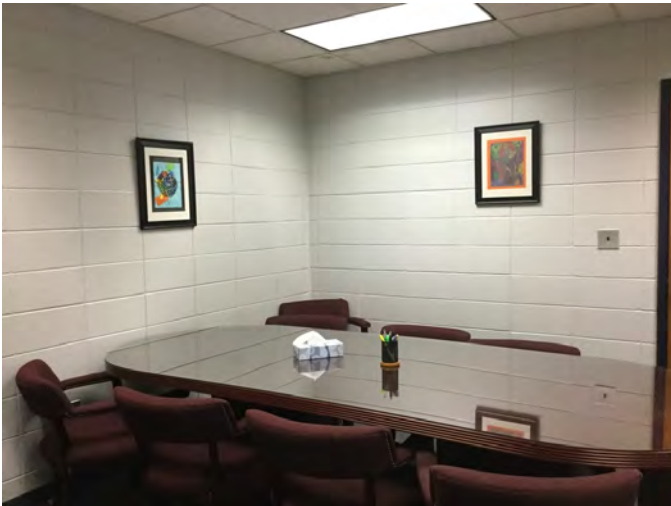
**Location:** Throughout the Building  
**Distress:** Beyond Service Life  
**Category:** Deferred Maintenance  
**Priority:** 3 - Necessary/Not Yet Critical (Years 2-5)  
**Correction:** Renew System  
**Qty:** 72,876.00  
**Unit of Measure:** S.F.  
**Estimate:** \$268,548.00  
**Assessor Name:** Eduardo Lopez  
**Date Created:** 01/19/2017

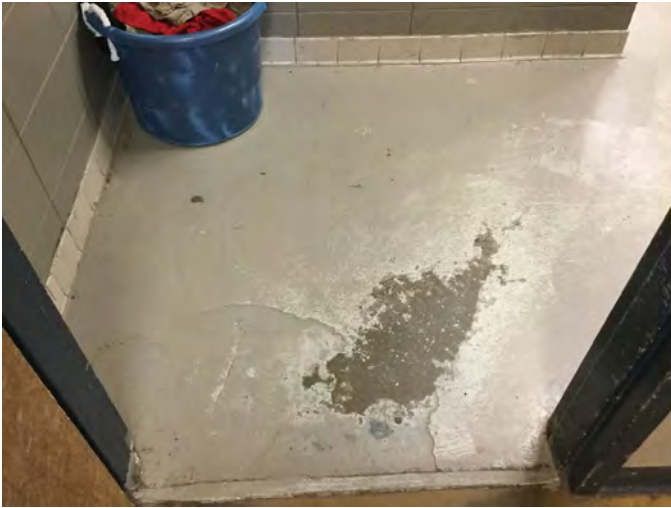
**Location:** Throughout the Building  
**Distress:** Beyond Service Life  
**Category:** Deferred Maintenance  
**Priority:** 3 - Necessary/Not Yet Critical (Years 2-5)  
**Correction:** Renew System  
**Qty:** 72,876.00  
**Unit of Measure:** S.F.  
**Estimate:** \$834,503.00  
**Assessor Name:** Eduardo Lopez  
**Date Created:** 01/19/2017

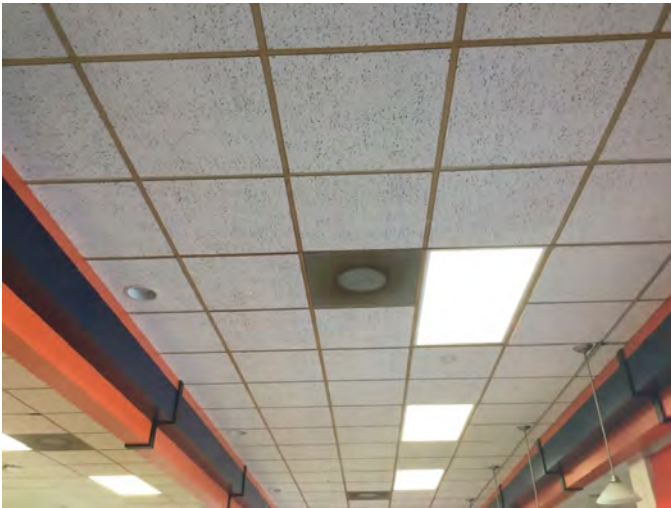
**Location:** Throughout the building  
**Distress:** Beyond Service Life  
**Category:** Deferred Maintenance  
**Priority:** 3 - Necessary/Not Yet Critical (Years 2-5)  
**Correction:** Renew System  
**Qty:** 72,876.00  
**Unit of Measure:** S.F.  
**Estimate:** \$911,460.00  
**Assessor Name:** Eduardo Lopez  
**Date Created:** 02/13/2017

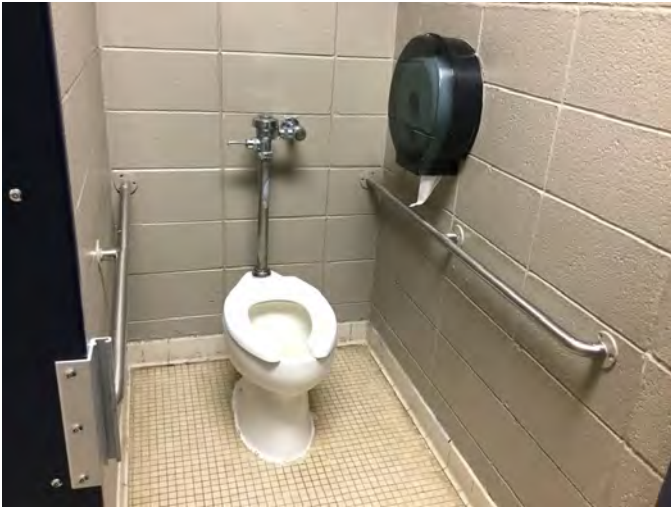
**Location:** Throughout the Building  
**Distress:** Beyond Service Life  
**Category:** Deferred Maintenance / Accessibility Code Compliance  
**Priority:** 3 - Necessary/Not Yet Critical (Years 2-5)  
**Correction:** Renew System  
**Qty:** 72,876.00  
**Unit of Measure:** S.F.  
**Estimate:** \$772,777.00  
**Assessor Name:** Eduardo Lopez  
**Date Created:** 01/19/2017

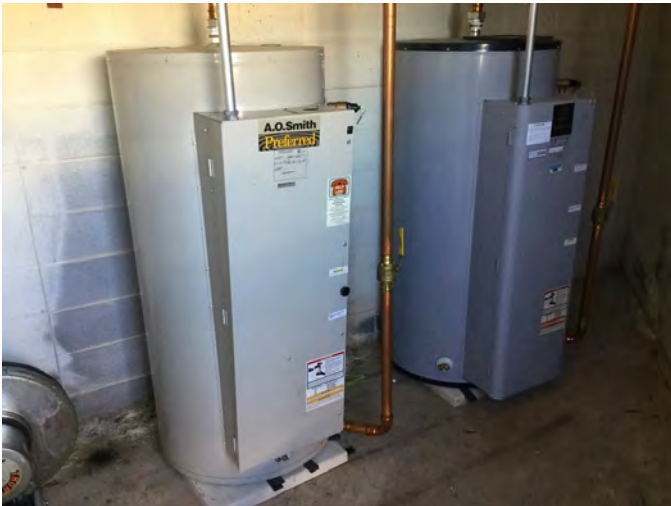
**Location:** Throughout the Building  
**Distress:** Beyond Service Life  
**Category:** Deferred Maintenance  
**Priority:** 3 - Necessary/Not Yet Critical (Years 2-5)  
**Correction:** Renew System  
**Qty:** 72,876.00  
**Unit of Measure:** S.F.  
**Estimate:** \$82,569.00  
**Assessor Name:** Eduardo Lopez  
**Date Created:** 01/19/2017

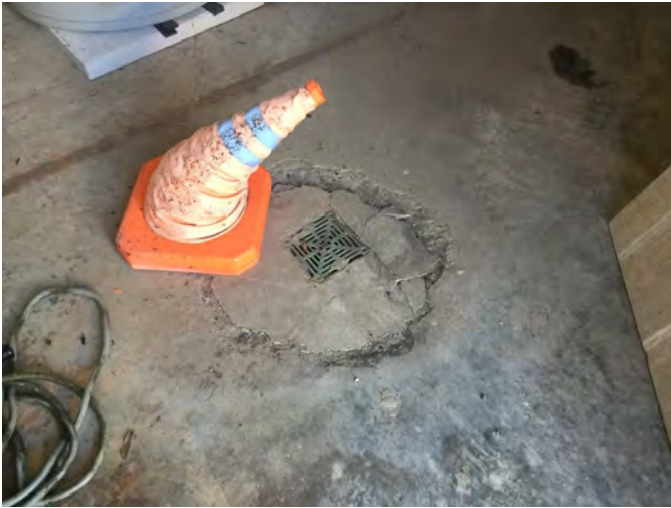
**Location:** Throughout the Building  
**Distress:** Beyond Service Life  
**Category:** Deferred Maintenance  
**Priority:** 3 - Necessary/Not Yet Critical (Years 2-5)  
**Correction:** Renew System  
**Qty:** 72,876.00  
**Unit of Measure:** S.F.  
**Estimate:** \$129,865.00  
**Assessor Name:** Eduardo Lopez  
**Date Created:** 01/19/2017

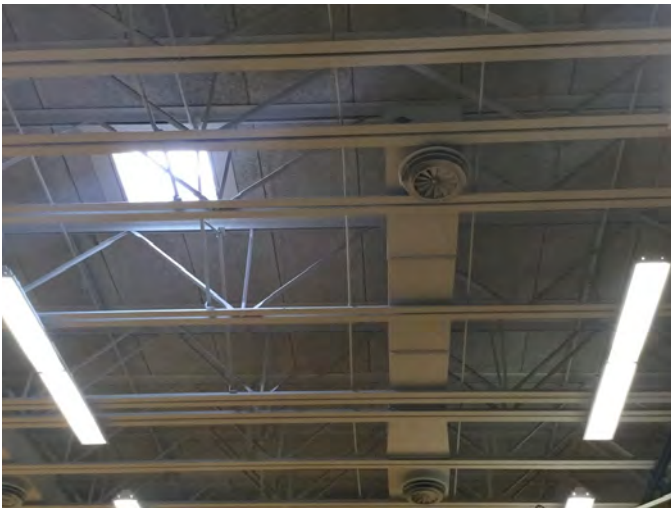
**Location:** Throughout the Building  
**Distress:** Beyond Service Life  
**Category:** Deferred Maintenance  
**Priority:** 3 - Necessary/Not Yet Critical (Years 2-5)  
**Correction:** Renew System  
**Qty:** 72,876.00  
**Unit of Measure:** S.F.  
**Estimate:** \$853,742.00  
**Assessor Name:** Eduardo Lopez  
**Date Created:** 01/19/2017

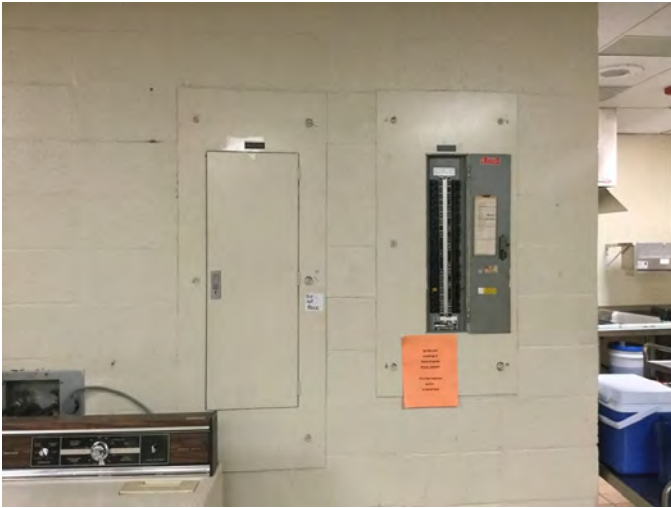
**Location:** Throughout the Building  
**Distress:** Beyond Service Life  
**Category:** Deferred Maintenance  
**Priority:** 3 - Necessary/Not Yet Critical (Years 2-5)  
**Correction:** Renew System  
**Qty:** 72,876.00  
**Unit of Measure:** S.F.  
**Estimate:** \$393,603.00  
**Assessor Name:** Eduardo Lopez  
**Date Created:** 01/19/2017

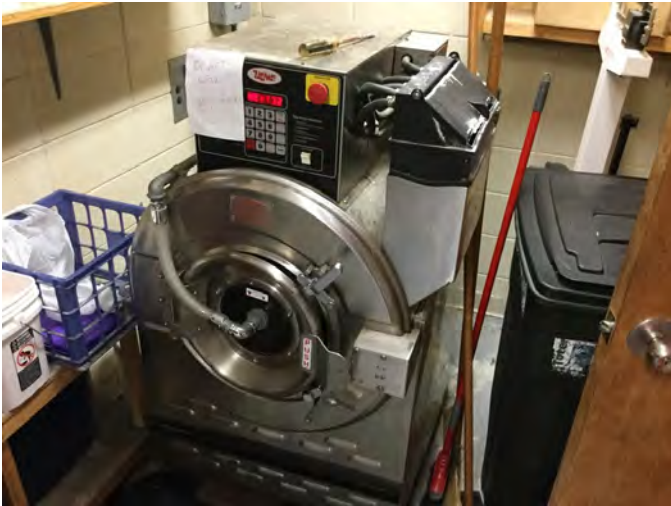
**Location:** Throughout the Building  
**Distress:** Beyond Service Life  
**Category:** Deferred Maintenance  
**Priority:** 3 - Necessary/Not Yet Critical (Years 2-5)  
**Correction:** Renew System  
**Qty:** 72,876.00  
**Unit of Measure:** S.F.  
**Estimate:** \$36,074.00  
**Assessor Name:** Eduardo Lopez  
**Date Created:** 02/12/2017

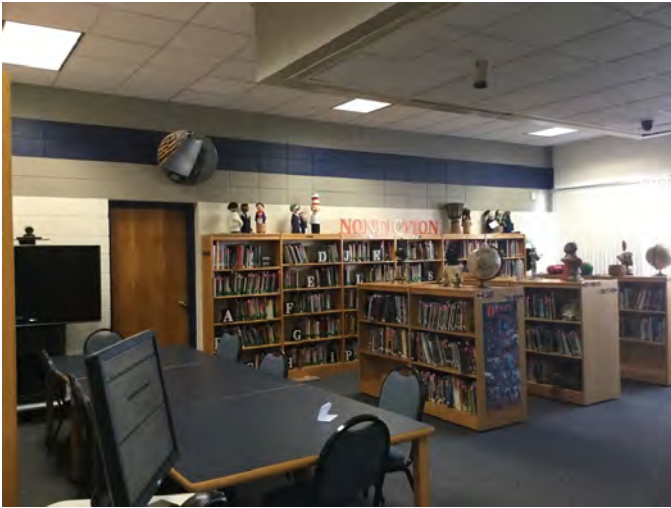
**Location:** Throughout the Building  
**Distress:** Beyond Service Life  
**Category:** Deferred Maintenance  
**Priority:** 3 - Necessary/Not Yet Critical (Years 2-5)  
**Correction:** Renew System  
**Qty:** 72,876.00  
**Unit of Measure:** S.F.  
**Estimate:** \$218,847.00  
**Assessor Name:** Eduardo Lopez  
**Date Created:** 01/19/2017

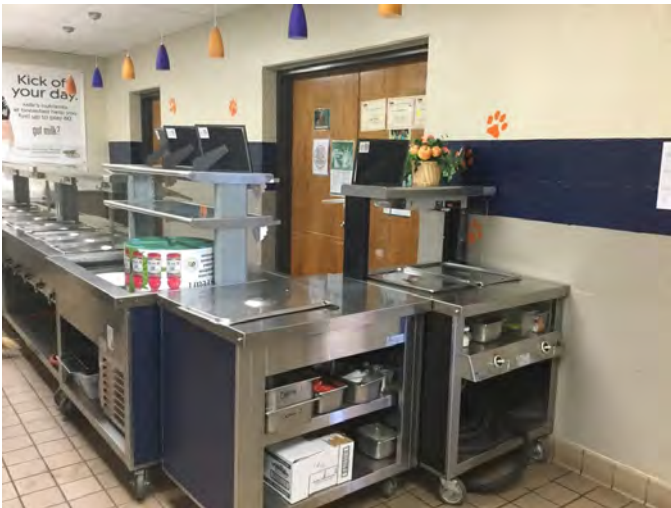
**Location:** Throughout the Building  
**Distress:** Beyond Service Life  
**Category:** Deferred Maintenance  
**Priority:** 3 - Necessary/Not Yet Critical (Years 2-5)  
**Correction:** Renew System  
**Qty:** 72,876.00  
**Unit of Measure:** S.F.  
**Estimate:** \$546,716.00  
**Assessor Name:** Eduardo Lopez  
**Date Created:** 01/19/2017

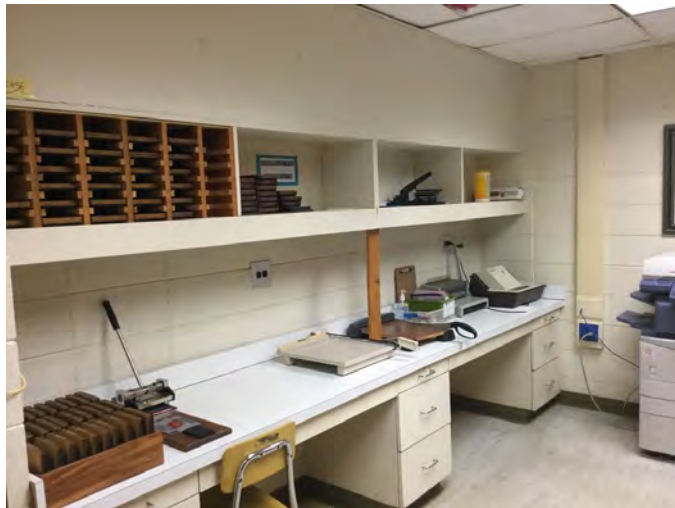
**Location:** Throughout the Building  
**Distress:** Beyond Service Life  
**Category:** Deferred Maintenance  
**Priority:** 3 - Necessary/Not Yet Critical (Years 2-5)  
**Correction:** Renew System  
**Qty:** 72,876.00  
**Unit of Measure:** S.F.  
**Estimate:** \$436,892.00  
**Assessor Name:** Eduardo Lopez  
**Date Created:** 01/19/2017

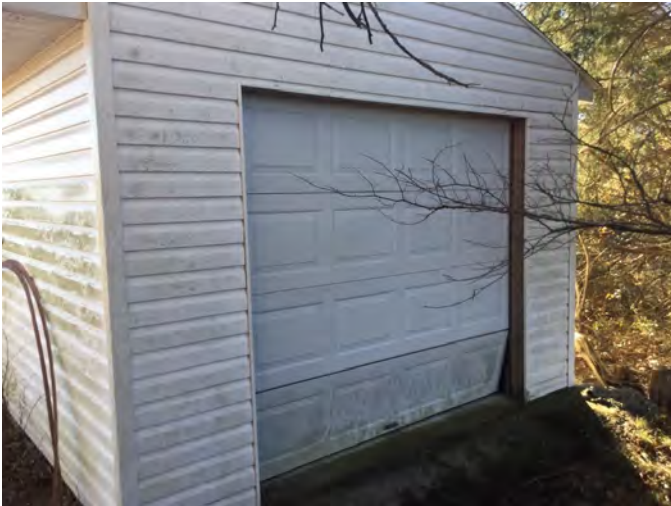
**Location:** Exterior Walls  
**Distress:** Beyond Service Life  
**Category:** Deferred Maintenance  
**Priority:** 3 - Necessary/Not Yet Critical (Years 2-5)  
**Correction:** Renew System  
**Qty:** 210.00  
**Unit of Measure:** S.F.  
**Estimate:** \$2,000.00  
**Assessor Name:** Eduardo Lopez  
**Date Created:** 01/19/2017

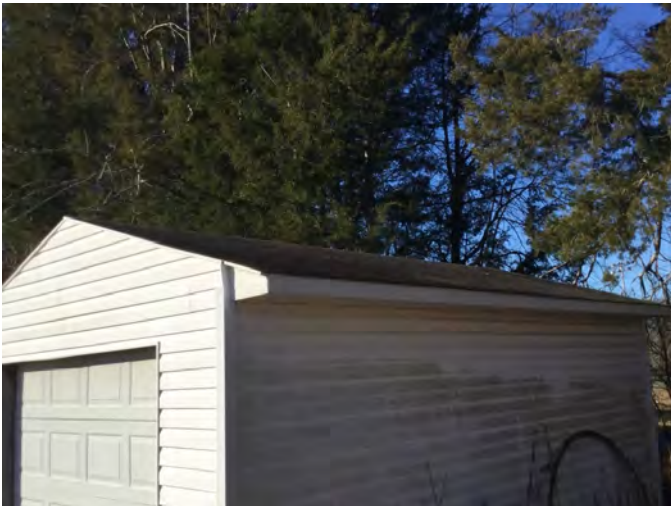
**Location:** Roof  
**Distress:** Beyond Service Life  
**Category:** Deferred Maintenance  
**Priority:** 3 - Necessary/Not Yet Critical (Years 2-5)  
**Correction:** Renew System  
**Qty:** 210.00  
**Unit of Measure:** S.F.  
**Estimate:** \$1,325.00  
**Assessor Name:** Eduardo Lopez  
**Date Created:** 01/19/2017

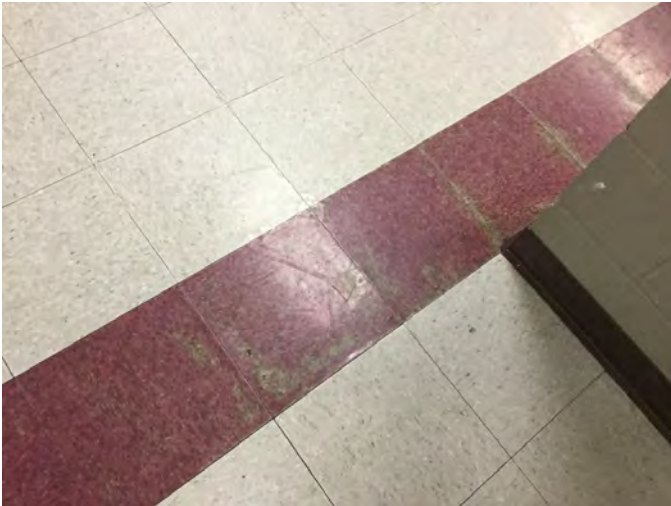
**Location:** Throughout the Building  
**Distress:** Beyond Service Life  
**Category:** Deferred Maintenance  
**Priority:** 3 - Necessary/Not Yet Critical (Years 2-5)  
**Correction:** Renew System  
**Qty:** 7,847.00  
**Unit of Measure:** S.F.  
**Estimate:** \$89,856.00  
**Assessor Name:** Eduardo Lopez  
**Date Created:** 01/19/2017

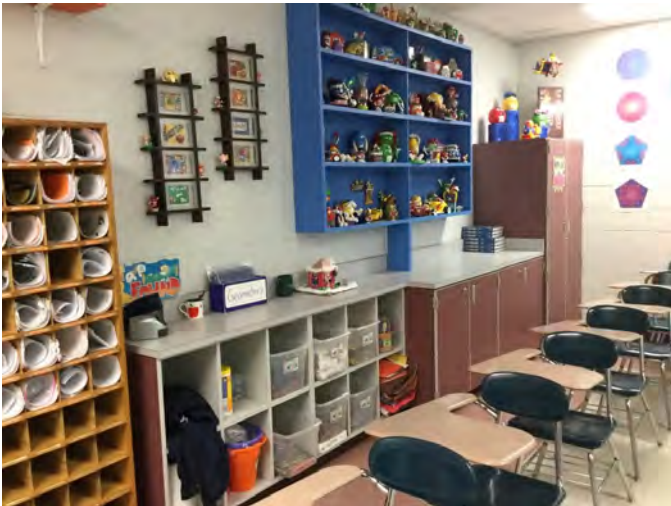
**Location:** Throughout the Building  
**Distress:** Beyond Service Life  
**Category:** Deferred Maintenance  
**Priority:** 3 - Necessary/Not Yet Critical (Years 2-5)  
**Correction:** Renew System  
**Qty:** 7,847.00  
**Unit of Measure:** S.F.  
**Estimate:** \$47,043.00  
**Assessor Name:** Eduardo Lopez  
**Date Created:** 01/19/2017

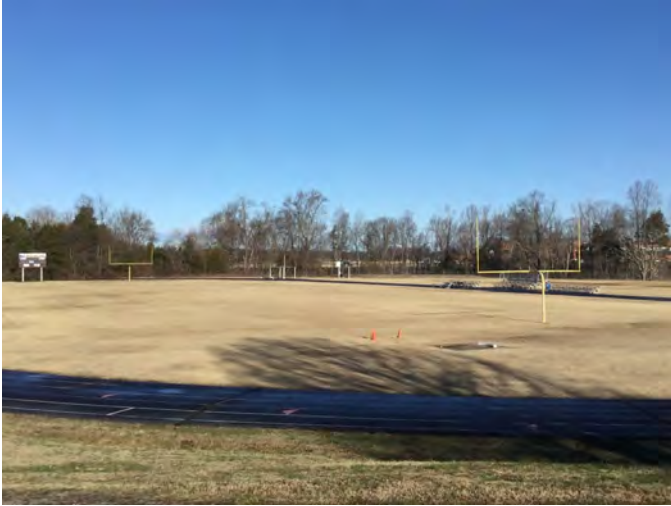
**Location:** Site  
**Distress:** Beyond Service Life  
**Category:** Deferred Maintenance  
**Priority:** 3 - Necessary/Not Yet Critical (Years 2-5)  
**Correction:** Renew System  
**Qty:** 83,653.00  
**Unit of Measure:** S.F.  
**Estimate:** \$435,247.00  
**Assessor Name:** Eduardo Lopez  
**Date Created:** 01/19/2017
