NC School District/520 Jones County/Elementary School

Pollocksville Elementary

Campus Assessment Report

March 11, 2017

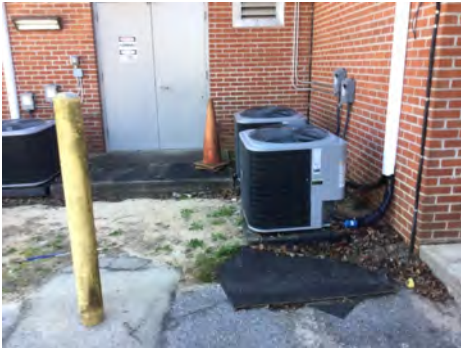
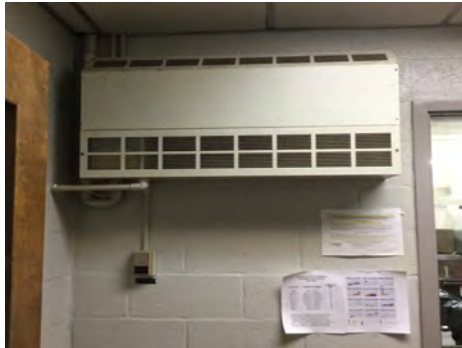
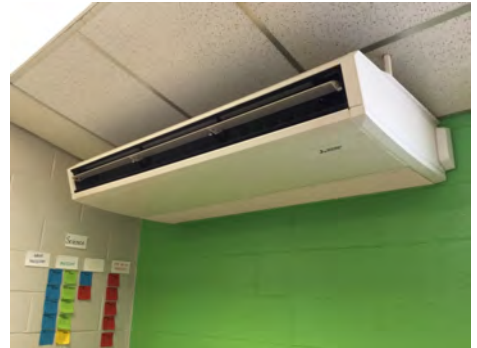
System: D3050 - Terminal & Package Units

Note: Classrooms, media center, cafeteria, and halls replaced 2014.

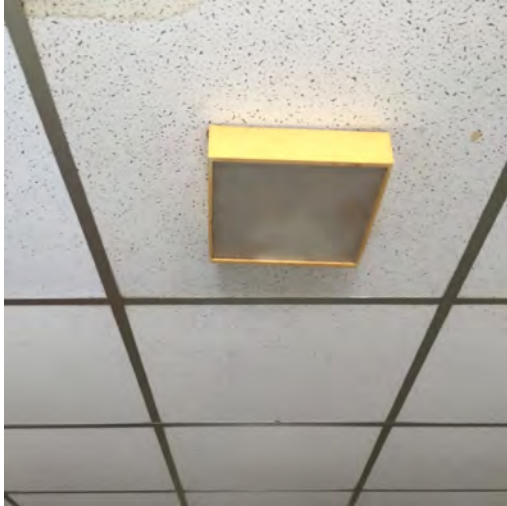
System: D5090 - Other Electrical Systems

Location: Throughout the building
Distress: Beyond Service Life
Category: Deferred Maintenance / Life Safety Code Compliance
Priority: 2 - Potentially Critical (Year 1)
Correction: Renew System
Qty: 34,800.00
Unit of Measure: S.F.
Estimate: \$4,594.00
Assessor Name: Ann Buerger Linden
Date Created: 01/31/2017

Notes: Emergency lighting is typically original, obsolete, and beyond its expected life. Repair parts are difficult to obtain. System renewal is recommended.

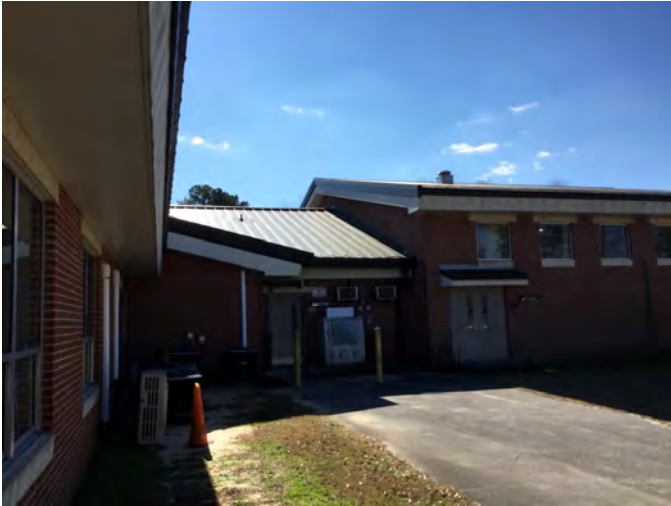
System: B3010130 - Preformed Metal Roofing

Location: Roof
Distress: Missing
Category: Deferred Maintenance
Priority: 3 - Necessary/Not Yet Critical (Years 2-5)
Correction: Install gutters and downspouts
Qty: 1,500.00
Unit of Measure: L.F.
Estimate: \$21,210.75
Assessor Name: Ann Buerger Linden
Date Created: 02/15/2017

Notes: The roof does not typically have gutters and downspouts at the roof edge, creating localized flooding problems and dumping water onto ground mounted HVAC equipment. Addition of gutters and downspouts is recommended.

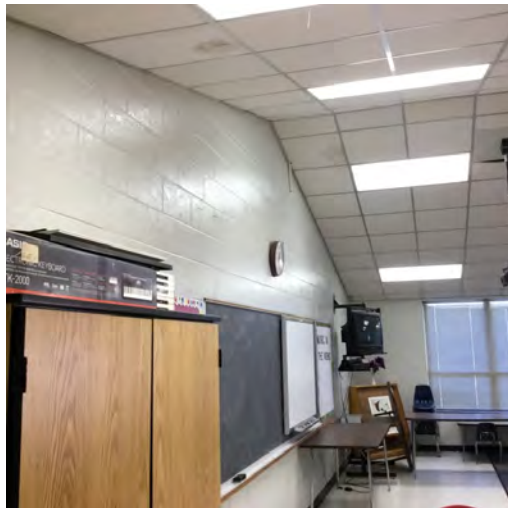
System: C1030 - Fittings

Location: Throughout the bulding
Distress: Beyond Service Life
Category: Deferred Maintenance
Priority: 3 - Necessary/Not Yet Critical (Years 2-5)
Correction: Renew System
Qty: 34,800.00
Unit of Measure: S.F.
Estimate: \$372,847.00
Assessor Name: Ann Buerger Linden
Date Created: 01/31/2017

Notes: Most fittings in the building are original and beyond their expected life. Some blackboards are present. Whiteboards are beginning to be stained. Room signage is not up to code. Toilet partitions do look newer. System renewal is recommended.

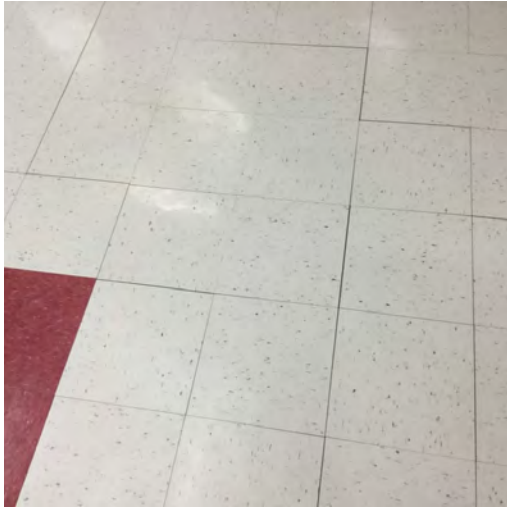
System: C3020 - Floor Finishes

Location: Throughout the building
Distress: Beyond Service Life
Category: Deferred Maintenance
Priority: 3 - Necessary/Not Yet Critical (Years 2-5)
Correction: Renew System
Qty: 34,800.00
Unit of Measure: S.F.
Estimate: \$435,626.00
Assessor Name: Ann Buerger Linden
Date Created: 01/31/2017

Notes: Floor finishes are typically original and are in fair condition. Joints in VCT are separating. Cracks and control joints in concrete are telegraphing through tile. Carpeting is worn. System renewal, with attention to floor prep, is recommended.

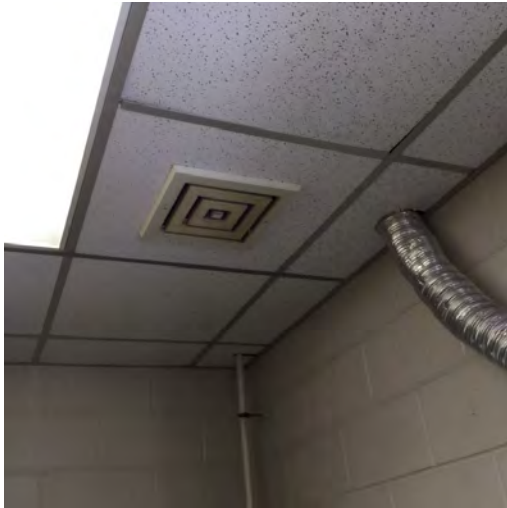
System: D3040 - Distribution Systems

Location: Toilet rooms
Distress: Failing
Category: Deferred Maintenance / Building Code Compliance
Priority: 3 - Necessary/Not Yet Critical (Years 2-5)
Correction: Replace roof mounted exhaust fan, 800 CFM exhaust fan
Qty: 12.00
Unit of Measure: Ea.
Estimate: \$28,321.92
Assessor Name: Ann Buerger Linden
Date Created: 02/15/2017

Notes: Exhaust fans reportedly do not work. Replace fans in toilet rooms.

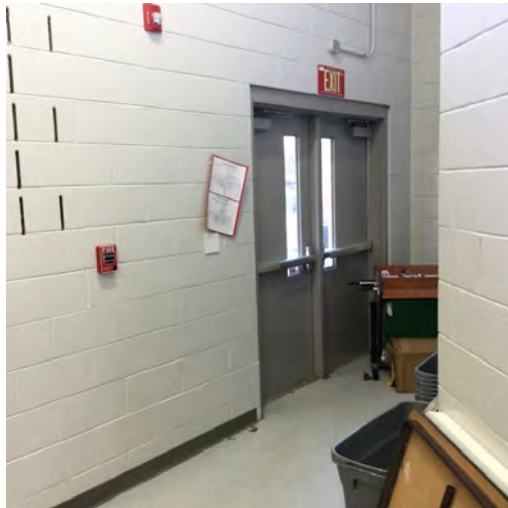
System: D5030810 - Security & Detection Systems

Location: Throughout the building
Distress: Inadequate
Category: Deferred Maintenance / Safety
Priority: 3 - Necessary/Not Yet Critical (Years 2-5)
Correction: Renew System
Qty: 34,800.00
Unit of Measure: S.F.
Estimate: \$71,584.00
Assessor Name: Ann Buerger Linden
Date Created: 01/31/2017

Notes: Security cameras do not cover all areas of the building (gym is not covered) or building exterior. Improvements in camera range are needed. System renewal is recommended.

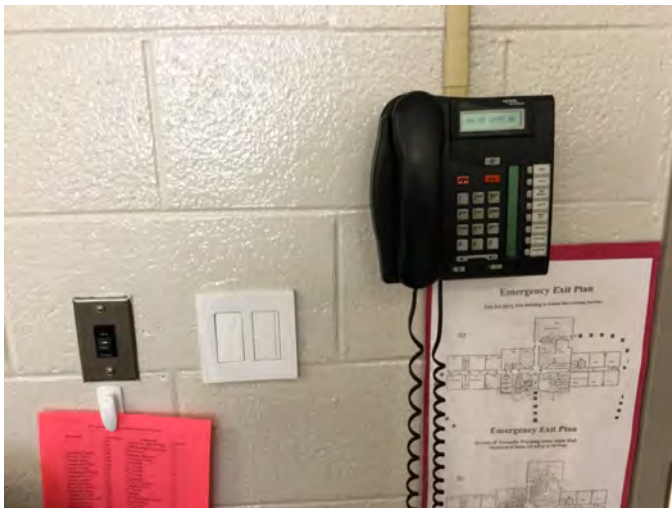
System: D5030920 - Data Communication

Location: Throughout the building
Distress: Beyond Service Life
Category: Deferred Maintenance / Safety
Priority: 3 - Necessary/Not Yet Critical (Years 2-5)
Correction: Renew System
Qty: 34,800.00
Unit of Measure: S.F.
Estimate: \$168,432.00
Assessor Name: Ann Buerger Linden
Date Created: 01/31/2017

Notes: The PA system does not function. Announcements need to be made on a room by room basis via telephone. System renewal is recommended.

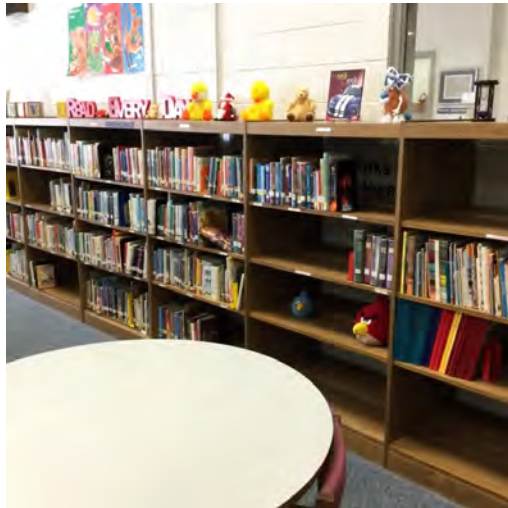
System: E1020 - Institutional Equipment

Location: Throughout the bulding
Distress: Beyond Service Life
Category: Deferred Maintenance
Priority: 3 - Necessary/Not Yet Critical (Years 2-5)
Correction: Renew System
Qty: 34,800.00
Unit of Measure: S.F.
Estimate: \$11,484.00
Assessor Name: Ann Buerger Linden
Date Created: 01/31/2017

Notes: Library equipment and other institutional equipment is typically original and in fair condition. System renewal is recommended.

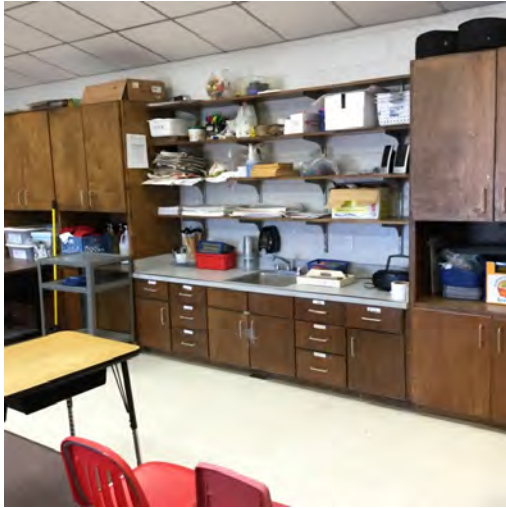
System: E2010 - Fixed Furnishings

Location: Throughout the building
Distress: Beyond Service Life
Category: Deferred Maintenance
Priority: 3 - Necessary/Not Yet Critical (Years 2-5)
Correction: Renew System
Qty: 34,800.00
Unit of Measure: S.F.
Estimate: \$223,172.00
Assessor Name: Ann Buerger Linden
Date Created: 01/31/2017

Notes: Classroom millwork and other fixed furnishing throughout the building is original and in well maintained but worn condition. System renewal is recommended.

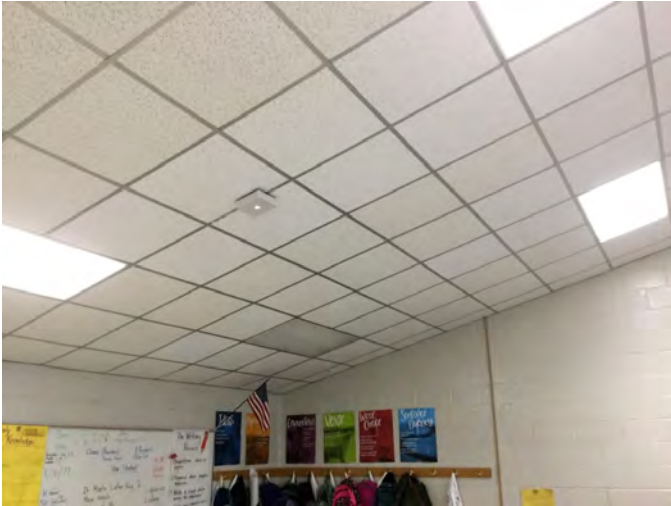
System: C3030 - Ceiling Finishes

Location: Throughout the building
Distress: Beyond Service Life
Category: Deferred Maintenance
Priority: 4 - Recommended (Years 6-10)
Correction: Renew System
Qty: 34,800.00
Unit of Measure: S.F.
Estimate: \$419,932.00
Assessor Name: Ann Buerger Linden
Date Created: 01/31/2017

Notes: Although well maintained in fair to good condition, the ceiling system is beyond its expected useful life and system renewal is recommended.

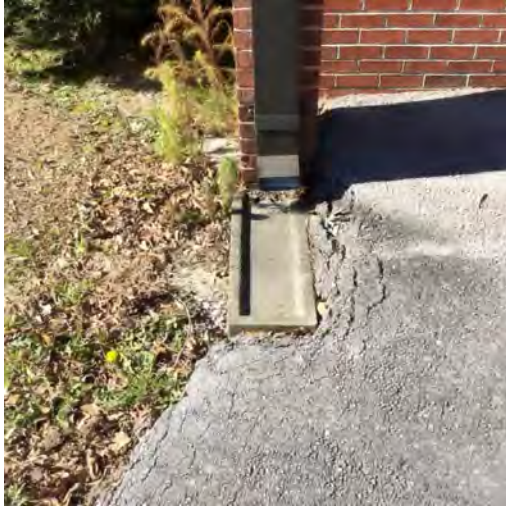
System: G3030 - Storm Sewer

Location: Around the building
Distress: Inadequate
Category: Deferred Maintenance
Priority: 2 - Potentially Critical (Year 1)
Correction: Repair storm sewer system
Qty: 1,500.00
Unit of Measure: L.F.
Estimate: \$17,100.60
Assessor Name: Ann Buerger Linden
Date Created: 02/15/2017

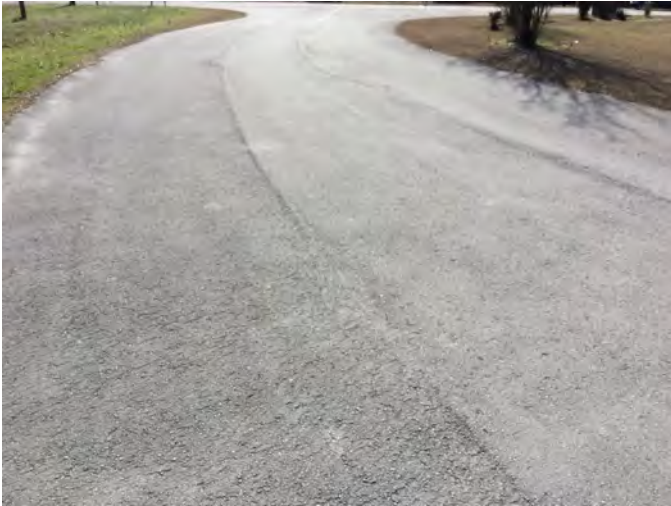
System: G2010 - Roadways

Location: Site roads
Distress: Beyond Service Life
Category: Deferred Maintenance
Priority: 3 - Necessary/Not Yet Critical (Years 2-5)
Correction: Renew System
Qty: 34,800.00
Unit of Measure: S.F.
Estimate: \$145,847.00
Assessor Name: Ann Buerger Linden
Date Created: 01/31/2017

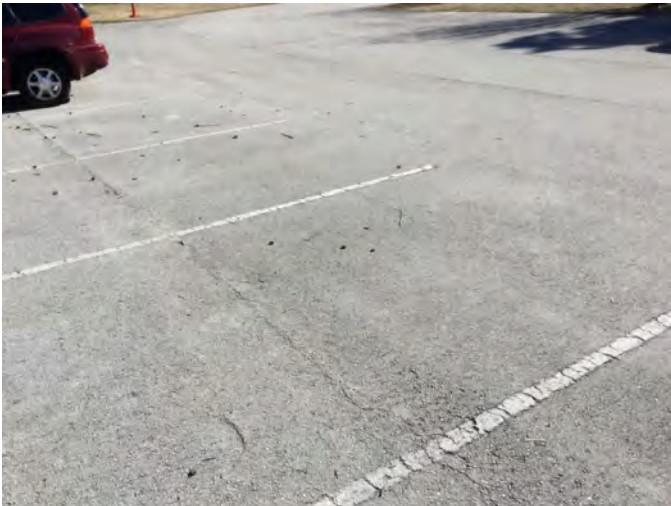
System: G2020 - Parking Lots

Location: Parking lots
Distress: Beyond Service Life
Category: Deferred Maintenance
Priority: 3 - Necessary/Not Yet Critical (Years 2-5)
Correction: Renew System
Qty: 34,800.00
Unit of Measure: S.F.
Estimate: \$50,912.00
Assessor Name: Ann Buerger Linden
Date Created: 01/31/2017

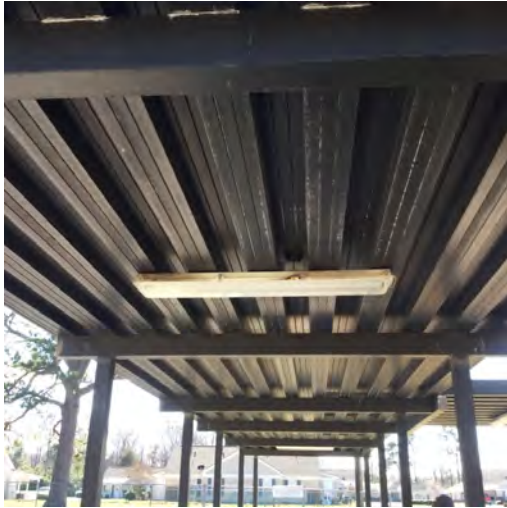
System: G2040950 - Covered Walkways

Location: Site
Distress: Beyond Service Life
Category: Deferred Maintenance
Priority: 3 - Necessary/Not Yet Critical (Years 2-5)
Correction: Renew System
Qty: 34,800.00
Unit of Measure: S.F.
Estimate: \$58,186.00
Assessor Name: Ann Buerger Linden
Date Created: 02/28/2017

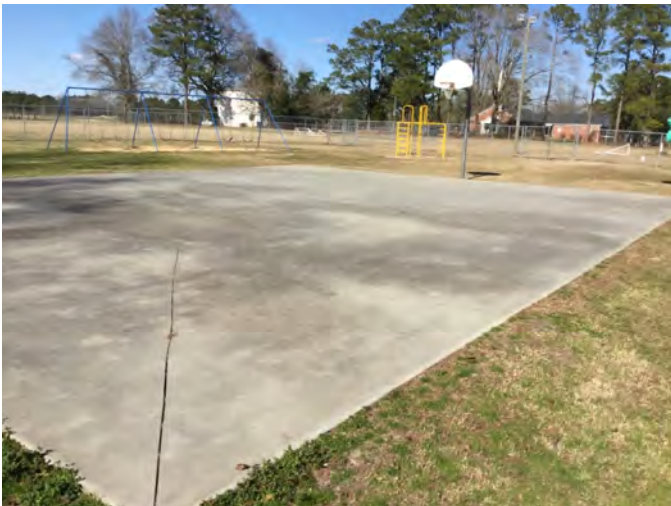
System: G2040950 - Hard Surface Play Area

Location: Playground
Distress: Beyond Service Life
Category: Deferred Maintenance
Priority: 3 - Necessary/Not Yet Critical (Years 2-5)
Correction: Renew System
Qty: 34,800.00
Unit of Measure: S.F.
Estimate: \$28,710.00
Assessor Name: Ann Buerger Linden
Date Created: 01/31/2017

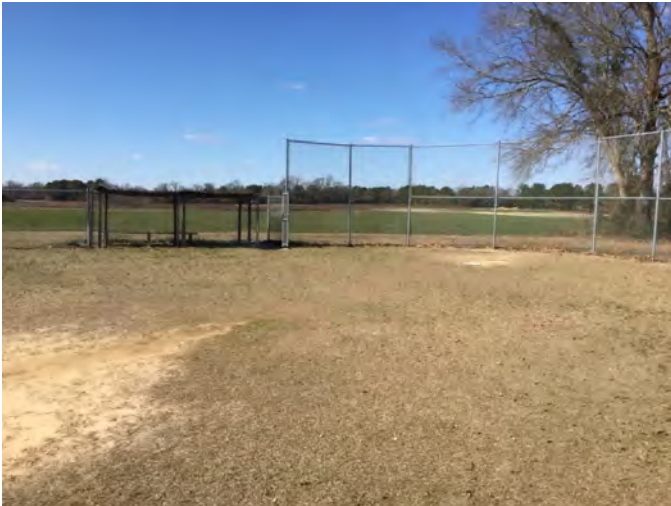
System: G2040950 - Playing Field

Location: Rear of site
Distress: Beyond Service Life
Category: Deferred Maintenance
Priority: 3 - Necessary/Not Yet Critical (Years 2-5)
Correction: Renew System
Qty: 34,800.00
Unit of Measure: S.F.
Estimate: \$173,791.00
Assessor Name: Ann Buerger Linden
Date Created: 01/31/2017

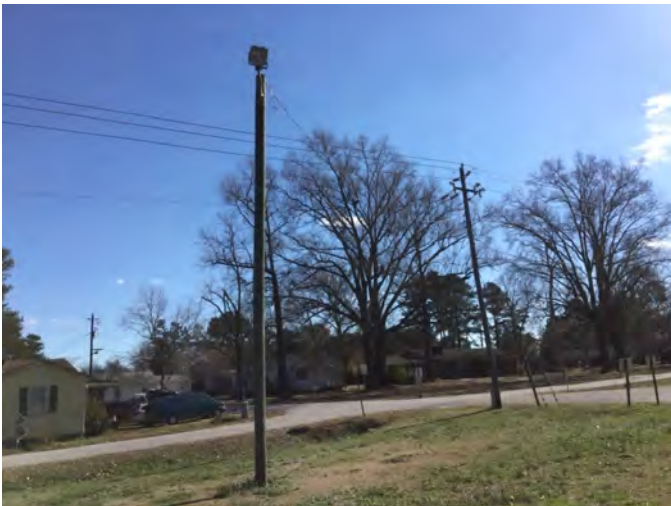
System: G4020 - Site Lighting

Location: Site, parking lots
Distress: Inadequate
Category: Deferred Maintenance / Safety
Priority: 3 - Necessary/Not Yet Critical (Years 2-5)
Correction: Renew System
Qty: 34,800.00
Unit of Measure: S.F.
Estimate: \$56,272.00
Assessor Name: Ann Buerger Linden
Date Created: 02/15/2017
