NC School District/300 Davie County/Elementary School

# Shady Grove Elementary

## Campus Assessment Report

March 10, 2017

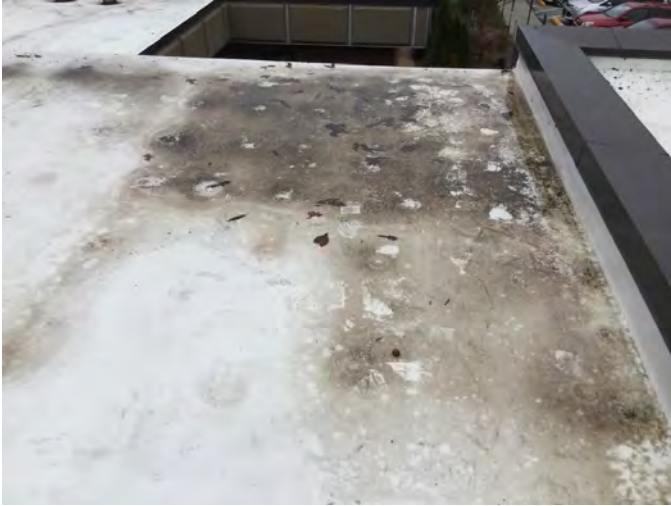
#### **System: B3010120 - Single Ply Membrane**

**Location:** Above Cafeteria and Kitchen  
**Distress:** Inadequate  
**Category:** Deferred Maintenance  
**Priority:** 2 - Potentially Critical (Year 1)  
**Correction:** Minor thermoplastic membrane repairs, 2% of roof area  
**Qty:** 50.00  
**Unit of Measure:** Sq.  
**Estimate:** \$27,449.40  
**Assessor Name:** Eduardo Lopez  
**Date Created:** 01/24/2017

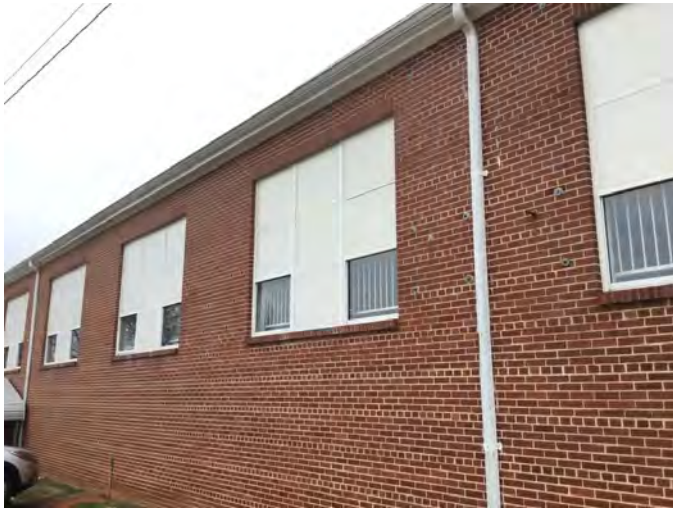
**System: B2020 - Exterior Windows**

**Location:** Exterior Walls  
**Distress:** Beyond Service Life  
**Category:** Deferred Maintenance  
**Priority:** 3 - Necessary/Not Yet Critical (Years 2-5)  
**Correction:** Renew System  
**Qty:** 43,725.00  
**Unit of Measure:** S.F.  
**Estimate:** \$442,497.00  
**Assessor Name:** Eduardo Lopez  
**Date Created:** 01/24/2017

**Notes:** The exterior windows are aged, not energy efficient and should be replaced.

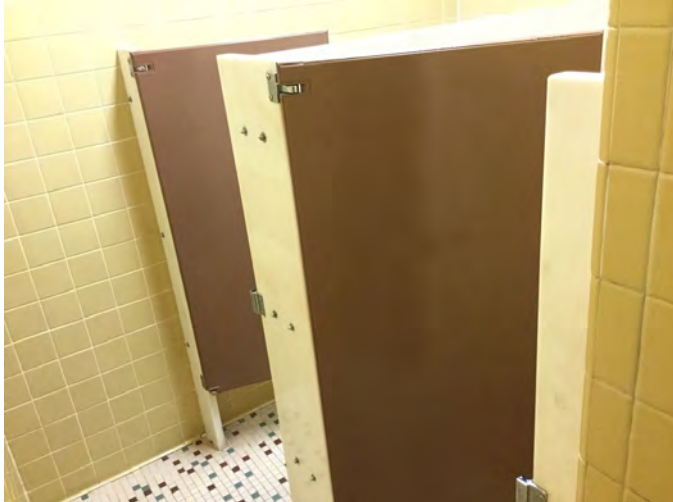
**System: C1030 - Fittings**

**Location:** Throughout the Building  
**Distress:** Beyond Service Life  
**Category:** Deferred Maintenance / Accessibility Code Compliance  
**Priority:** 3 - Necessary/Not Yet Critical (Years 2-5)  
**Correction:** Renew System  
**Qty:** 43,725.00  
**Unit of Measure:** S.F.  
**Estimate:** \$458,850.00  
**Assessor Name:** Eduardo Lopez  
**Date Created:** 01/19/2017

**Notes:** The fittings throughout the building are aged, in marginal condition, room signage are not ADA compliant and should be replaced.

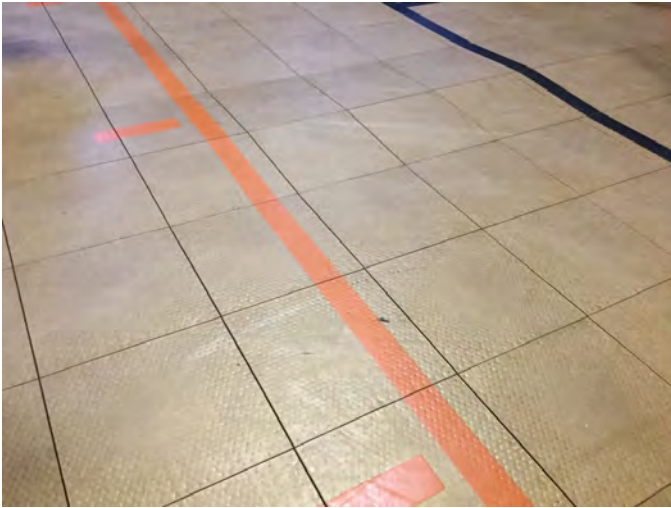
**System: C3020 - Floor Finishes**

**Location:** Gym  
**Distress:** Beyond Service Life  
**Category:** Deferred Maintenance / Safety  
**Priority:** 3 - Necessary/Not Yet Critical (Years 2-5)  
**Correction:** Replace vinyl sheet flooring  
**Qty:** 700.00  
**Unit of Measure:** S.Y.  
**Estimate:** \$119,750.40  
**Assessor Name:** Eduardo Lopez  
**Date Created:** 02/13/2017

**Notes:** Gym flooring has moisture seeping and tiles are uneven causing a trip hazard and should be replaced.

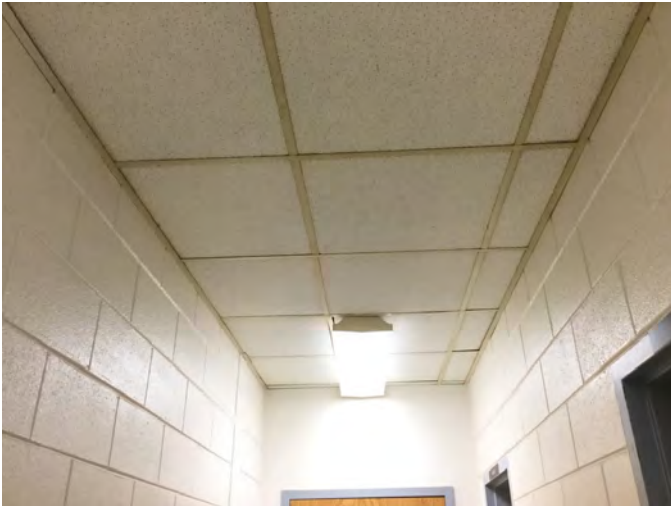
**System: C3030 - Ceiling Finishes**

**Location:** Throughout the Building  
**Distress:** Beyond Service Life  
**Category:** Deferred Maintenance  
**Priority:** 3 - Necessary/Not Yet Critical (Years 2-5)  
**Correction:** Renew System  
**Qty:** 43,725.00  
**Unit of Measure:** S.F.  
**Estimate:** \$516,567.00  
**Assessor Name:** Eduardo Lopez  
**Date Created:** 01/24/2017

**Notes:** The ceiling tiles have been replaced as needed. However the grid shows signs of aging and should be replaced.

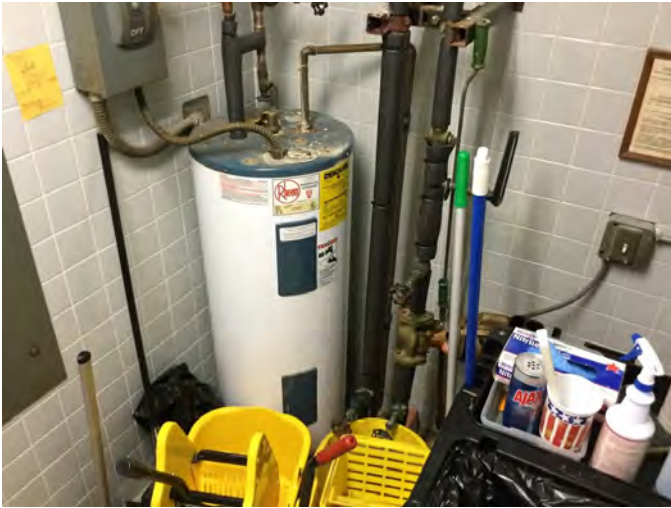
**System: D2020 - Domestic Water Distribution**

**Location:** Throughout the Building  
**Distress:** Beyond Service Life  
**Category:** Deferred Maintenance  
**Priority:** 3 - Necessary/Not Yet Critical (Years 2-5)  
**Correction:** Renew System  
**Qty:** 43,725.00  
**Unit of Measure:** S.F.  
**Estimate:** \$46,174.00  
**Assessor Name:** Eduardo Lopez  
**Date Created:** 01/19/2017

**Notes:** The domestic water distribution system is aged and should be replaced.

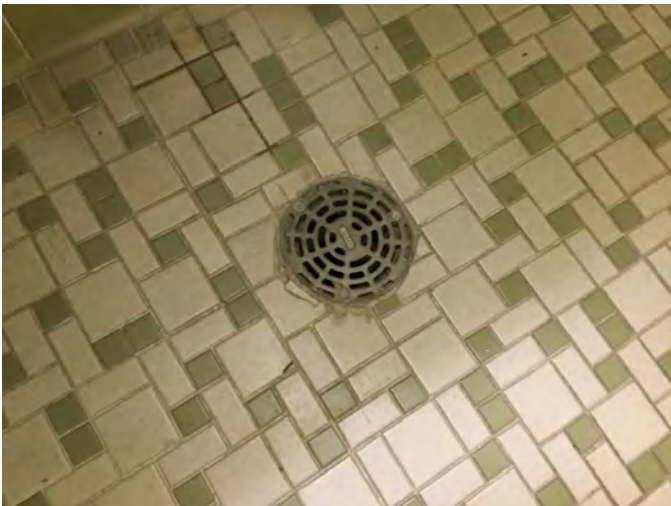
**System: D2030 - Sanitary Waste**

**Location:** Throughout the Building  
**Distress:** Beyond Service Life  
**Category:** Deferred Maintenance  
**Priority:** 3 - Necessary/Not Yet Critical (Years 2-5)  
**Correction:** Renew System  
**Qty:** 43,725.00  
**Unit of Measure:** S.F.  
**Estimate:** \$73,108.00  
**Assessor Name:** Eduardo Lopez  
**Date Created:** 01/19/2017

**Notes:** The sanitary waste system is beyond its expected service life and should be replaced.

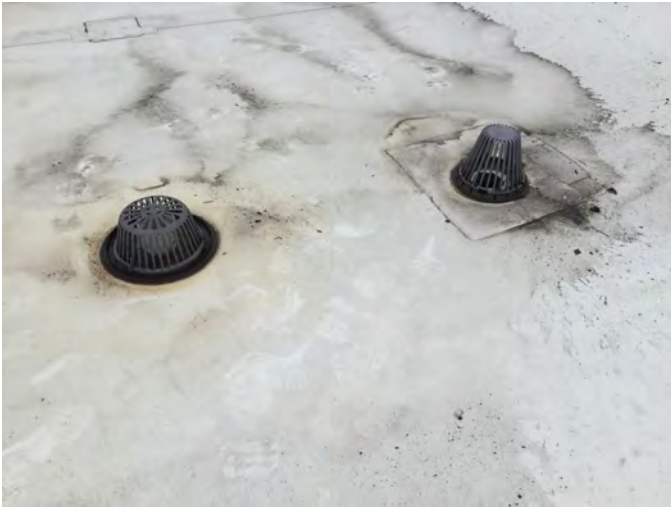
**System: D2040 - Rain Water Drainage**

**Location:** Roof  
**Distress:** Beyond Service Life  
**Category:** Deferred Maintenance  
**Priority:** 3 - Necessary/Not Yet Critical (Years 2-5)  
**Correction:** Renew System  
**Qty:** 43,725.00  
**Unit of Measure:** S.F.  
**Estimate:** \$65,413.00  
**Assessor Name:** Eduardo Lopez  
**Date Created:** 01/19/2017

**Notes:** The rain water drainage system is aged and should be replaced.

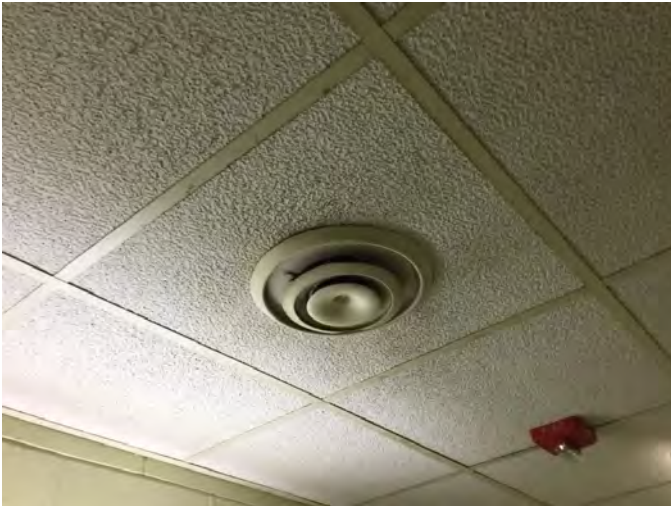
**System: D3040 - Distribution Systems**

**Location:** Throughout the Building  
**Distress:** Beyond Service Life  
**Category:** Deferred Maintenance  
**Priority:** 3 - Necessary/Not Yet Critical (Years 2-5)  
**Correction:** Renew System  
**Qty:** 43,725.00  
**Unit of Measure:** S.F.  
**Estimate:** \$289,547.00  
**Assessor Name:** Eduardo Lopez  
**Date Created:** 01/19/2017

**Notes:** Distribution systems are aged, becoming logistically unsupportable, and should be replaced.

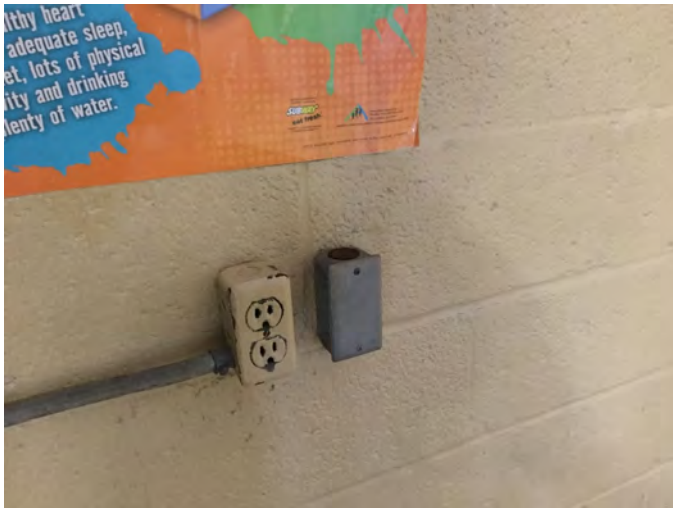
**System: D5020 - Branch Wiring**

**Location:** Throughout the Building  
**Distress:** Beyond Service Life  
**Category:** Deferred Maintenance  
**Priority:** 3 - Necessary/Not Yet Critical (Years 2-5)  
**Correction:** Renew System  
**Qty:** 43,725.00  
**Unit of Measure:** S.F.  
**Estimate:** \$240,007.00  
**Assessor Name:** Eduardo Lopez  
**Date Created:** 01/19/2017

**Notes:** The original branch wiring system is operating but is aged, in marginal condition, and should be replaced.

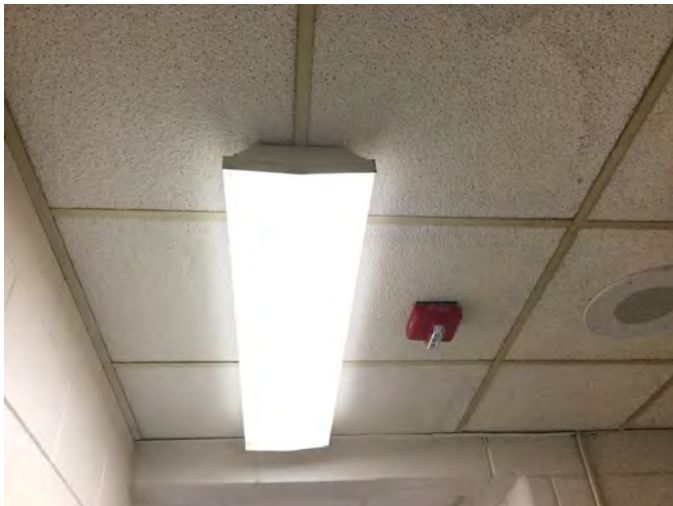
**System: D5020 - Lighting**

**Location:** Throughout the Building  
**Distress:** Beyond Service Life  
**Category:** Deferred Maintenance  
**Priority:** 3 - Necessary/Not Yet Critical (Years 2-5)  
**Correction:** Renew System  
**Qty:** 43,725.00  
**Unit of Measure:** S.F.  
**Estimate:** \$559,855.00  
**Assessor Name:** Eduardo Lopez  
**Date Created:** 01/19/2017

**Notes:** The original lighting system is operating but is aged, in marginal condition, and should be replaced.

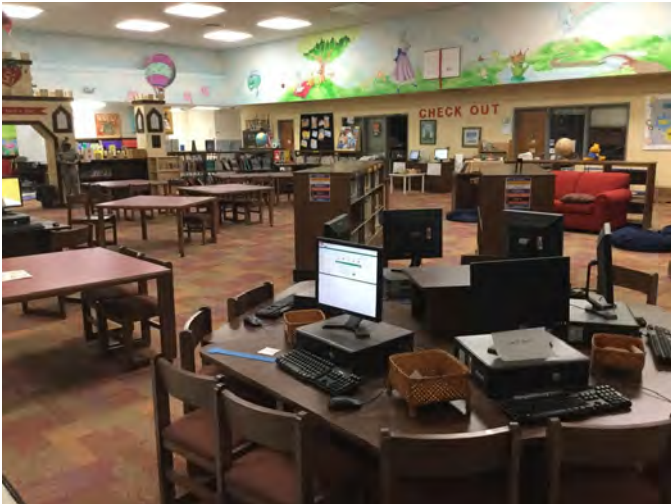
**System: E1020 - Institutional Equipment**

**Location:** Throughout the Building  
**Distress:** Beyond Service Life  
**Category:** Deferred Maintenance  
**Priority:** 3 - Necessary/Not Yet Critical (Years 2-5)  
**Correction:** Renew System  
**Qty:** 43,725.00  
**Unit of Measure:** S.F.  
**Estimate:** \$14,429.00  
**Assessor Name:** Eduardo Lopez  
**Date Created:** 01/19/2017

**Notes:** The institutional equipment is in deteriorating conditions and should be replaced.

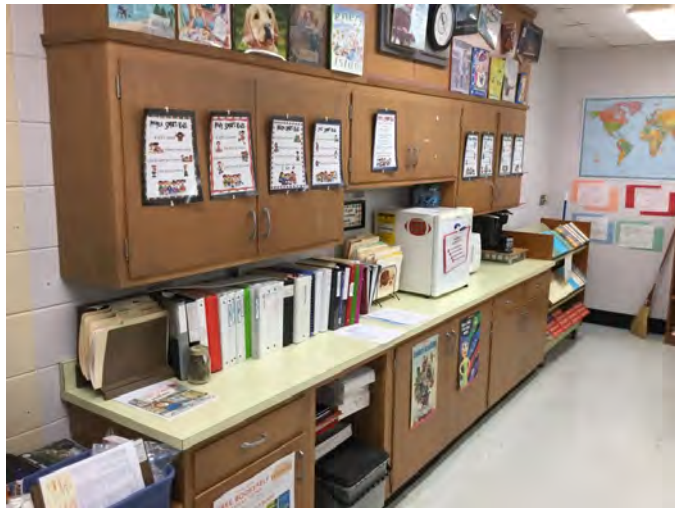
**System: E2010 - Fixed Furnishings**

**Location:** Throughout the Building  
**Distress:** Beyond Service Life  
**Category:** Deferred Maintenance  
**Priority:** 3 - Necessary/Not Yet Critical (Years 2-5)  
**Correction:** Renew System  
**Qty:** 43,725.00  
**Unit of Measure:** S.F.  
**Estimate:** \$275,118.00  
**Assessor Name:** Eduardo Lopez  
**Date Created:** 01/19/2017

**Notes:** The fixed furnishings are aged, in marginal condition, and should be replaced.

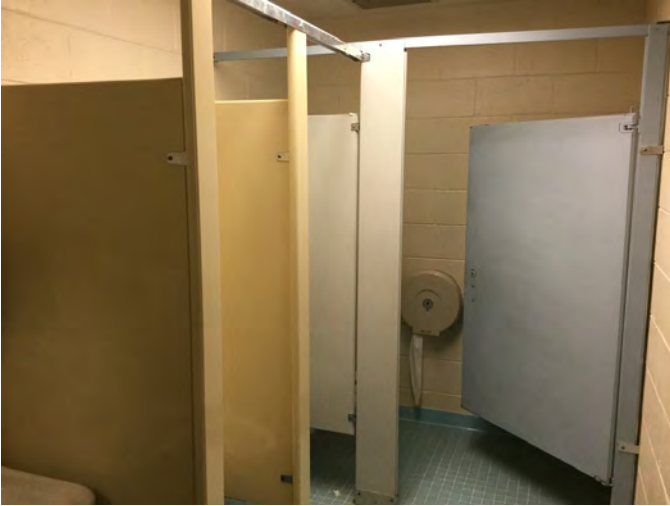
#### System: C1030 - Fittings

**Location:** Throughout the Building  
**Distress:** Beyond Service Life  
**Category:** Deferred Maintenance / Accessibility Code Compliance  
**Priority:** 3 - Necessary/Not Yet Critical (Years 2-5)  
**Correction:** Renew System  
**Qty:** 6,764.00  
**Unit of Measure:** S.F.  
**Estimate:** \$70,981.00  
**Assessor Name:** Eduardo Lopez  
**Date Created:** 01/23/2017

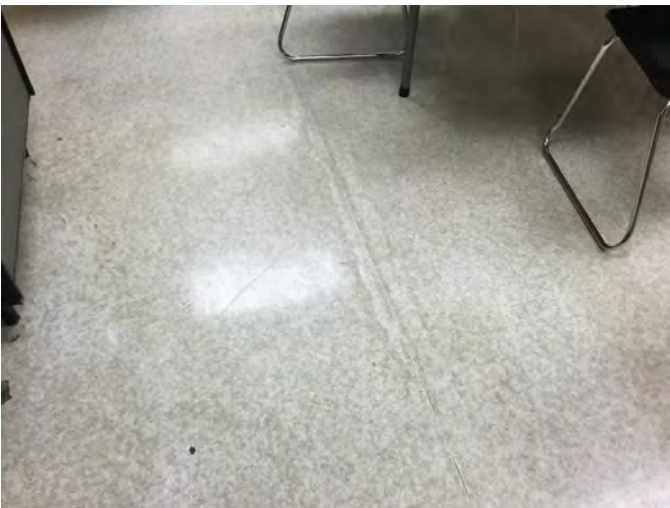
#### System: C3020 - Floor Finishes

**Location:** Throughout the Building  
**Distress:** Beyond Service Life  
**Category:** Deferred Maintenance  
**Priority:** 3 - Necessary/Not Yet Critical (Years 2-5)  
**Correction:** Renew System  
**Qty:** 6,764.00  
**Unit of Measure:** S.F.  
**Estimate:** \$82,960.00  
**Assessor Name:** Eduardo Lopez  
**Date Created:** 01/23/2017

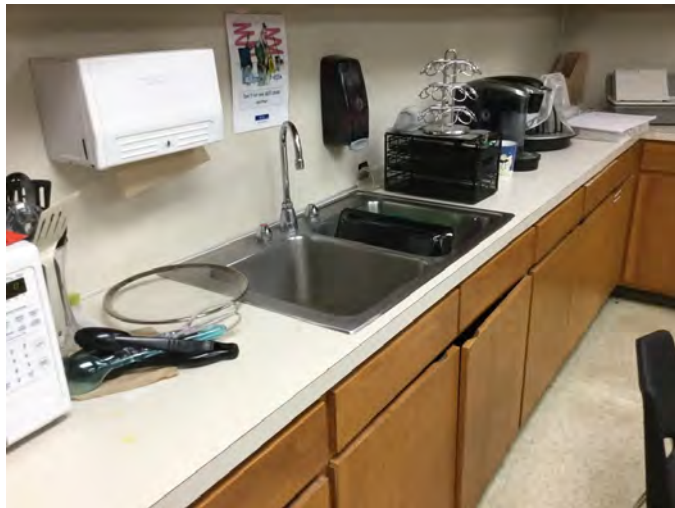
**System: E2010 - Fixed Furnishings**

**Location:** Throughout the Building  
**Distress:** Beyond Service Life  
**Category:** Deferred Maintenance  
**Priority:** 3 - Necessary/Not Yet Critical (Years 2-5)  
**Correction:** Renew System  
**Qty:** 6,764.00  
**Unit of Measure:** S.F.  
**Estimate:** \$42,559.00  
**Assessor Name:** Eduardo Lopez  
**Date Created:** 01/23/2017

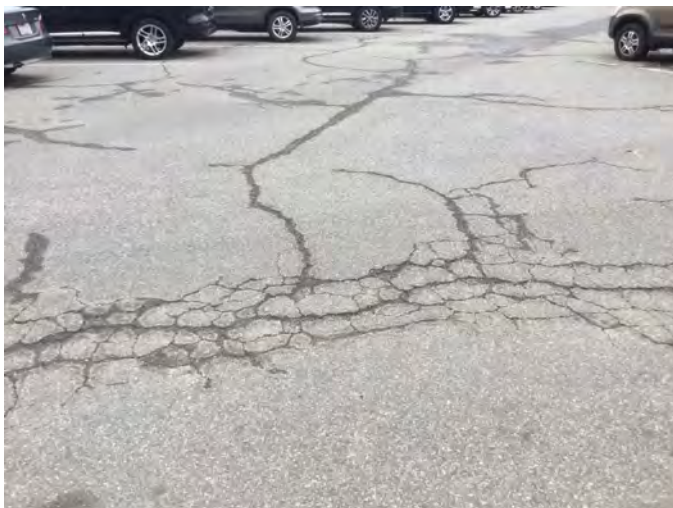
**Location:** Site  
**Distress:** Beyond Service Life  
**Category:** Deferred Maintenance  
**Priority:** 2 - Potentially Critical (Year 1)  
**Correction:** Renew System  
**Qty:** 77,984.00  
**Unit of Measure:** S.F.  
**Estimate:** \$326,831.00  
**Assessor Name:** Eduardo Lopez  
**Date Created:** 01/24/2017
