NC School District/300 Davie County/Middle School

South Davie Middle

Campus Assessment Report

March 10, 2017

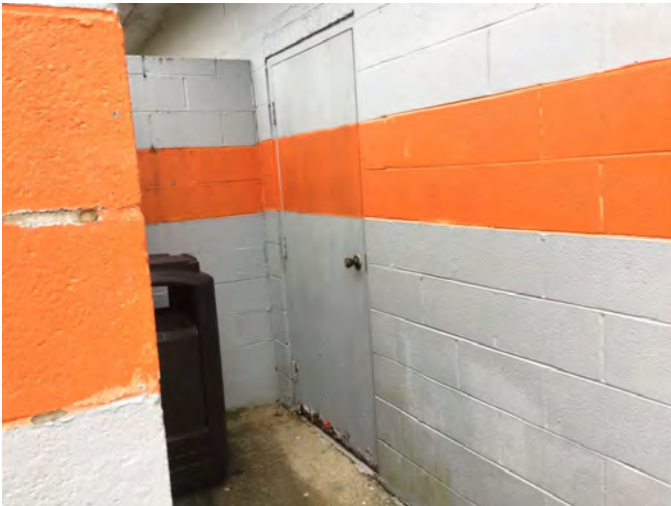
System: B2030 - Exterior Doors

Location: Concessions and restrooms
Distress: Beyond Service Life
Category: Deferred Maintenance
Priority: 3 - Necessary/Not Yet Critical (Years 2-5)
Correction: Renew System
Qty: 1,100.00
Unit of Measure: S.F.
Estimate: \$5,893.00
Assessor Name: Eduardo Lopez
Date Created: 01/23/2017

Notes: Exterior doors to concessions and restrooms are in worn condition with considerable rust. Lever hardware for ADA compliance is not provided. System renewal is recommended.

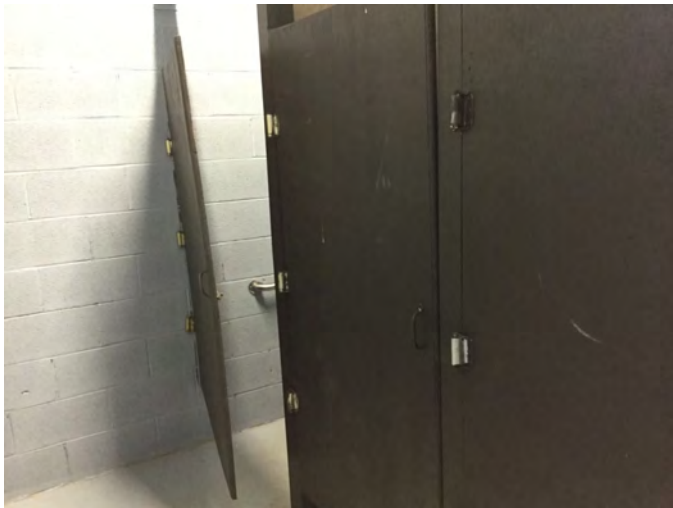
System: C1030 - Fittings

Location: Throughout the building
Distress: Beyond Service Life
Category: Deferred Maintenance
Priority: 3 - Necessary/Not Yet Critical (Years 2-5)
Correction: Renew System
Qty: 1,100.00
Unit of Measure: S.F.
Estimate: \$10,249.00
Assessor Name: Eduardo Lopez
Date Created: 01/23/2017

Notes: Building fittings including toilet partitions and accessories are in marginal condition. Building signage is inadequate. System renewal is recommended.

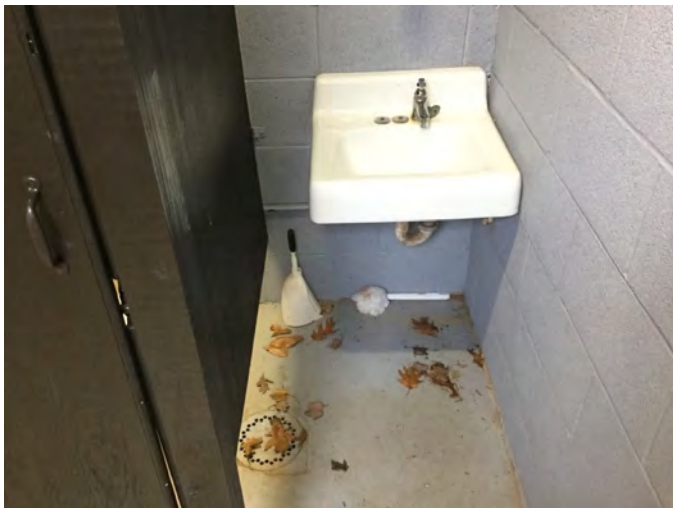
System: D2010 - Plumbing Fixtures

Location: Concessions and Toilet rooms
Distress: Beyond Service Life
Category: Deferred Maintenance
Priority: 3 - Necessary/Not Yet Critical (Years 2-5)
Correction: Renew System
Qty: 1,100.00
Unit of Measure: S.F.
Estimate: \$12,076.00
Assessor Name: Eduardo Lopez
Date Created: 01/23/2017

Notes: Plumbing fixtures are beyond their expected service life. System renewal is recommended.

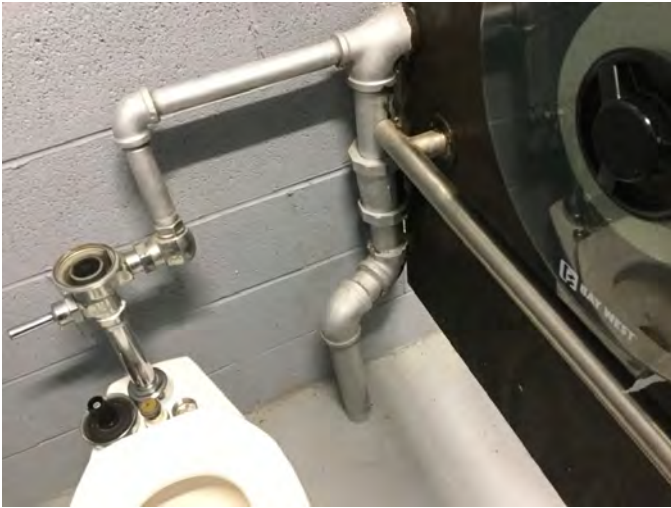
System: D2020 - Domestic Water Distribution

Location: Toilet rooms and concessions
Distress: Beyond Service Life
Category: Deferred Maintenance
Priority: 3 - Necessary/Not Yet Critical (Years 2-5)
Correction: Renew System
Qty: 1,100.00
Unit of Measure: S.F.
Estimate: \$3,993.00
Assessor Name: Eduardo Lopez
Date Created: 01/23/2017

Notes: Domestic water supply systems are beyond their expected life. They are a combination of copper and galvanized piping. Replacement with all copper is recommended.

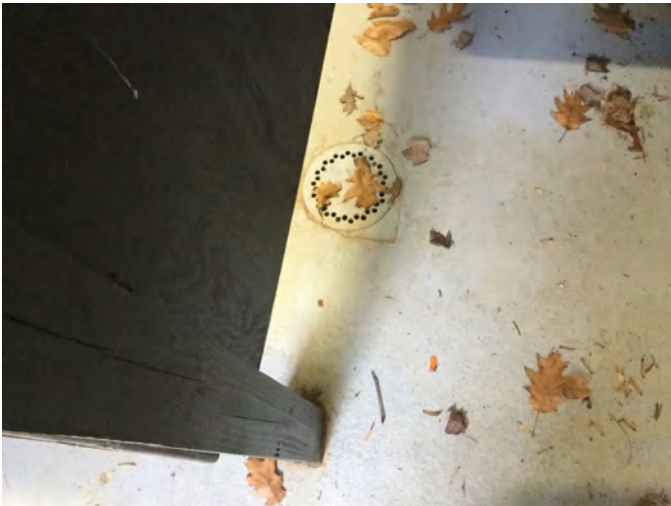
System: D2030 - Sanitary Waste

Location: Toilet rooms and concessions
Distress: Beyond Service Life
Category: Deferred Maintenance
Priority: 3 - Necessary/Not Yet Critical (Years 2-5)
Correction: Renew System
Qty: 1,100.00
Unit of Measure: S.F.
Estimate: \$7,187.00
Assessor Name: Eduardo Lopez
Date Created: 01/23/2017

Notes: The sanitary waste systems has exceeded its expected life. System renewal is recommended.

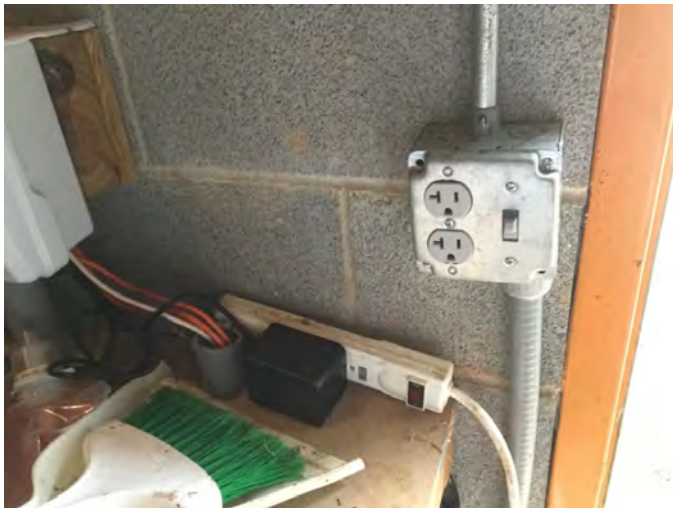
System: D5020 - Branch Wiring

Location: Throughout the building
Distress: Beyond Service Life
Category: Deferred Maintenance
Priority: 3 - Necessary/Not Yet Critical (Years 2-5)
Correction: Renew System
Qty: 1,100.00
Unit of Measure: S.F.
Estimate: \$3,086.00
Assessor Name: Eduardo Lopez
Date Created: 01/24/2017

Notes: The branch wiring system has exceeded its expected useful life. system renewal is recommended with attention to current codes for GFI outlets etc.

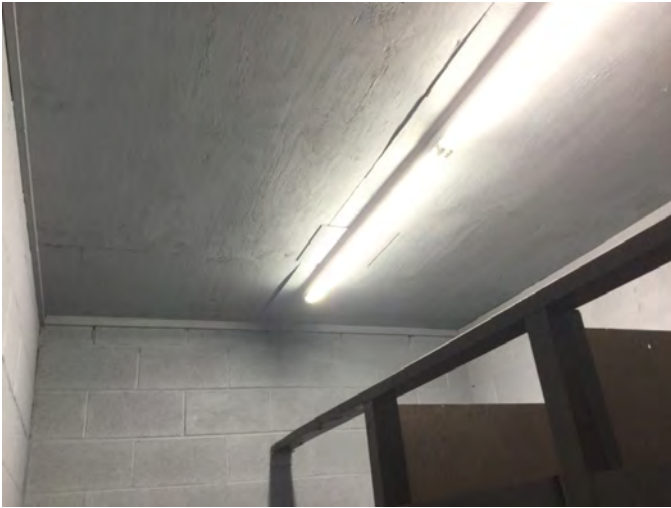
System: D5020 - Lighting

Location: Throughout the building
Distress: Beyond Service Life
Category: Deferred Maintenance
Priority: 3 - Necessary/Not Yet Critical (Years 2-5)
Correction: Renew System
Qty: 1,100.00
Unit of Measure: S.F.
Estimate: \$4,332.00
Assessor Name: Eduardo Lopez
Date Created: 01/23/2017

Notes: Lighting systems are assumed to be original and are beyond their expected life. System renewal is recommended.

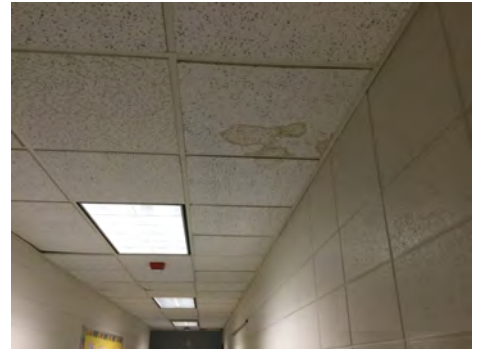
System: C3030 - Ceiling Finishes

Note: Ceiling finishes are generally well maintained in fair to good condition. A few water stained tiles noted should be replaced on a maintenance basis. System renewal put at 5 years hence.

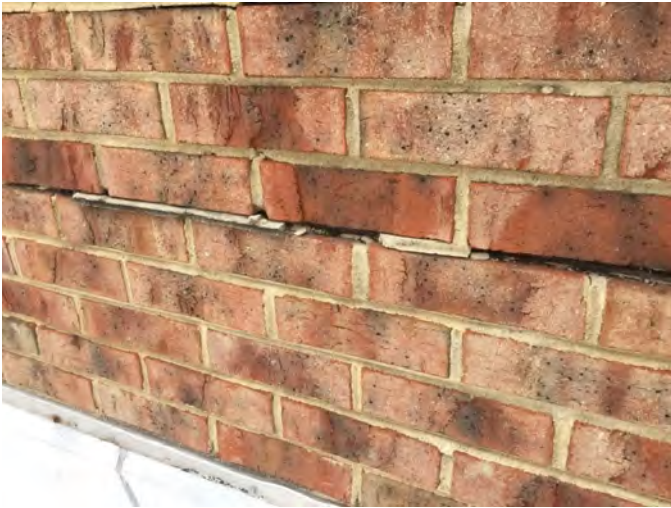
System: B2010 - Exterior Walls

Location: Walls around gym roof, various places around building
Distress: Failing
Category: Deferred Maintenance
Priority: 3 - Necessary/Not Yet Critical (Years 2-5)
Correction: Point clay brick wall, 1st floor
Qty: 10,000.00
Unit of Measure: C.S.F.
Estimate: \$128,293.44
Assessor Name: Somnath Das
Date Created: 01/25/2017

Notes: Brick mortar is deteriorated around gym high walls above roof, particularly at shelf angles. Stairstep cracks in brick mortar noted around openings at front of building, e.g. room 110, and some at rear of building in vicinity of the cafeteria. No significant settlement observed. Brick repairs recommended.

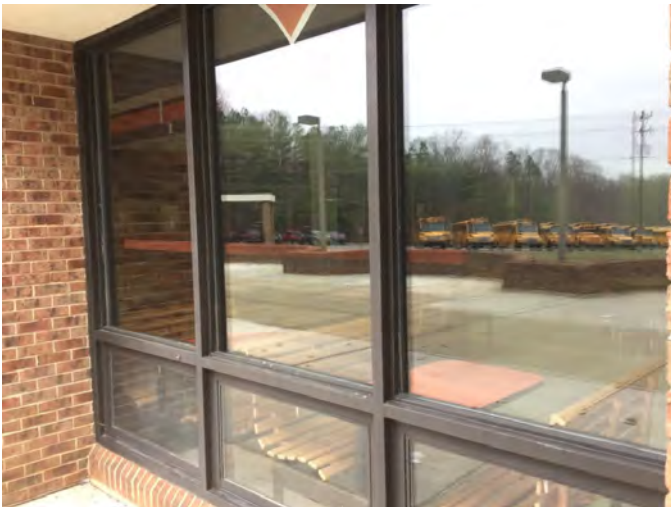
System: B2020 - Exterior Windows

Location: Exterior windows throughout
Distress: Beyond Service Life
Category: Deferred Maintenance
Priority: 3 - Necessary/Not Yet Critical (Years 2-5)
Correction: Renew System
Qty: 72,865.00
Unit of Measure: S.F.
Estimate: \$868,842.00
Assessor Name: Somnath Das
Date Created: 01/24/2017

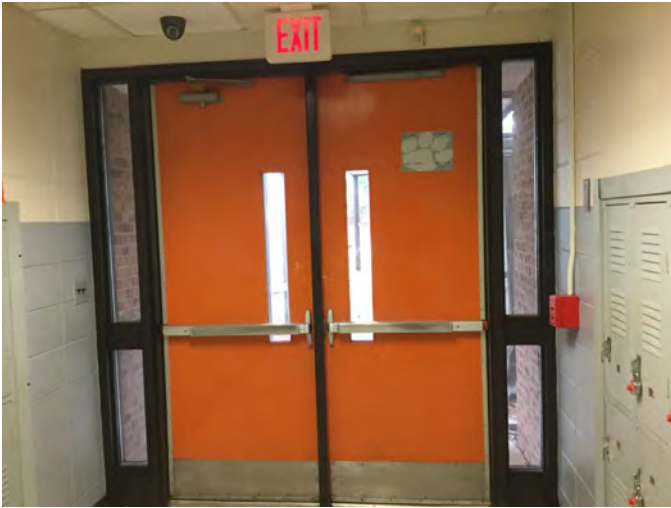
System: B2030 - Exterior Doors

Location: Exterior doors
Distress: Beyond Service Life
Category: Deferred Maintenance
Priority: 3 - Necessary/Not Yet Critical (Years 2-5)
Correction: Renew System
Qty: 72,865.00
Unit of Measure: S.F.
Estimate: \$83,358.00
Assessor Name: Somnath Das
Date Created: 01/24/2017

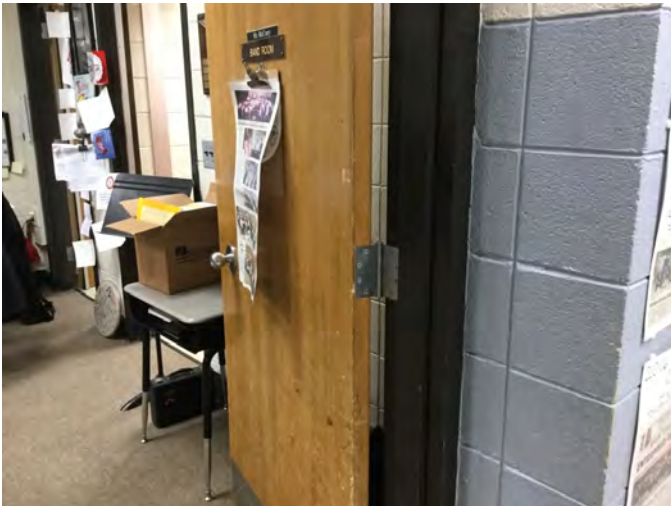
System: C1020 - Interior Doors

Location: Throughout the building
Distress: Beyond Service Life
Category: Deferred Maintenance
Priority: 3 - Necessary/Not Yet Critical (Years 2-5)
Correction: Renew System
Qty: 72,865.00
Unit of Measure: S.F.
Estimate: \$202,783.00
Assessor Name: Somnath Das
Date Created: 01/24/2017

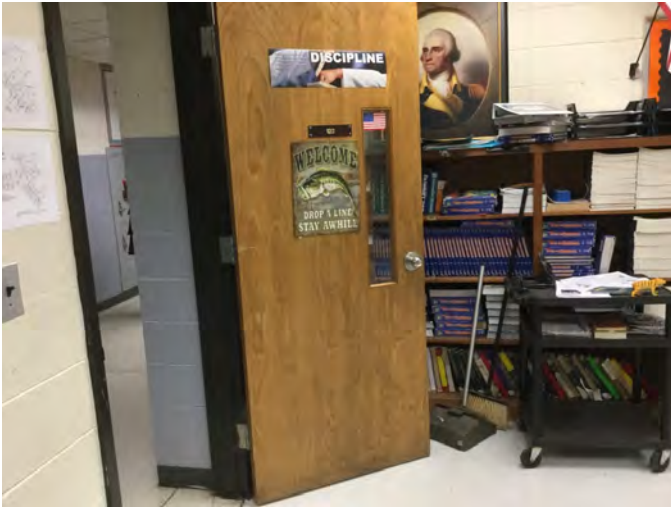
System: C1030 - Fittings

Location: Throughout the building
Distress: Beyond Service Life
Category: Deferred Maintenance
Priority: 3 - Necessary/Not Yet Critical (Years 2-5)
Correction: Renew System
Qty: 72,865.00
Unit of Measure: S.F.
Estimate: \$1,082,045.00
Assessor Name: Somnath Das
Date Created: 01/24/2017

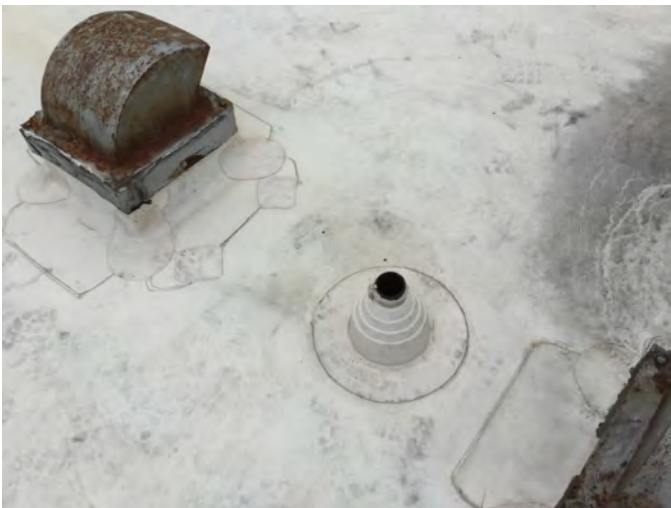
System: D2030 - Sanitary Waste

Location: Throughout the building
Distress: Beyond Service Life
Category: Deferred Maintenance
Priority: 3 - Necessary/Not Yet Critical (Years 2-5)
Correction: Renew System
Qty: 72,865.00
Unit of Measure: S.F.
Estimate: \$134,655.00
Assessor Name: Somnath Das
Date Created: 01/24/2017

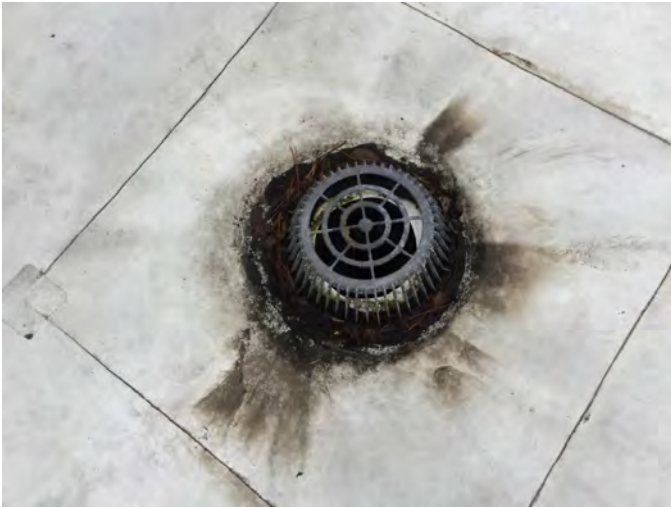
System: D2040 - Rain Water Drainage

Location: Roof and interiors
Distress: Beyond Service Life
Category: Deferred Maintenance
Priority: 3 - Necessary/Not Yet Critical (Years 2-5)
Correction: Renew System
Qty: 72,865.00
Unit of Measure: S.F.
Estimate: \$48,892.00
Assessor Name: Somnath Das
Date Created: 01/24/2017

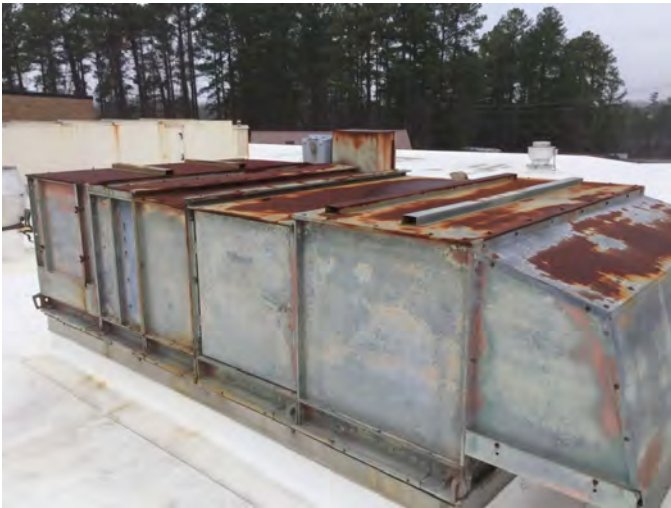
System: D3040 - Distribution Systems

Location: Throughout the building
Distress: Beyond Service Life
Category: Deferred Maintenance
Priority: 3 - Necessary/Not Yet Critical (Years 2-5)
Correction: Renew System
Qty: 72,865.00
Unit of Measure: S.F.
Estimate: \$853,613.00
Assessor Name: Somnath Das
Date Created: 01/24/2017

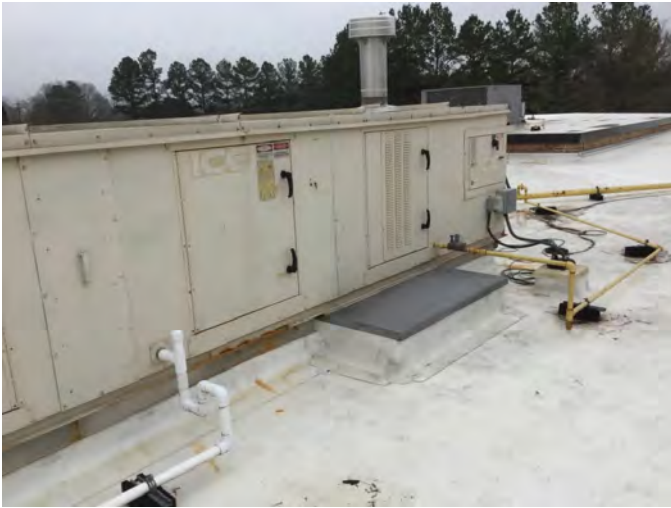
System: D3050 - Terminal & Package Units

Location: Roof
Distress: Beyond Service Life
Category: Deferred Maintenance
Priority: 3 - Necessary/Not Yet Critical (Years 2-5)
Correction: Renew System
Qty: 72,865.00
Unit of Measure: S.F.
Estimate: \$1,094,869.00
Assessor Name: Somnath Das
Date Created: 01/24/2017

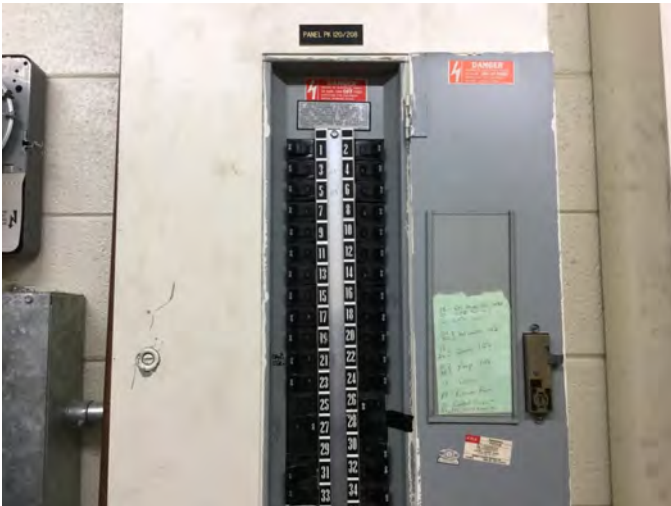
System: D5020 - Branch Wiring

Location: Throughout the building
Distress: Beyond Service Life
Category: Deferred Maintenance
Priority: 3 - Necessary/Not Yet Critical (Years 2-5)
Correction: Renew System
Qty: 72,865.00
Unit of Measure: S.F.
Estimate: \$405,567.00
Assessor Name: Somnath Das
Date Created: 01/24/2017

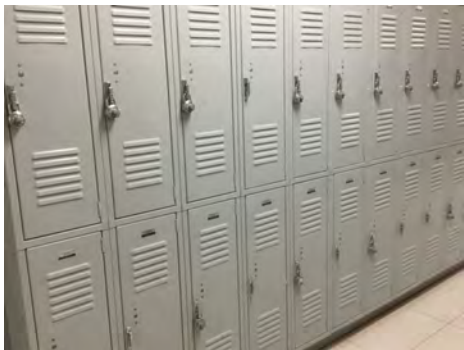
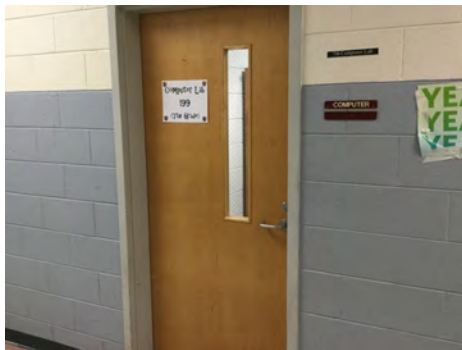
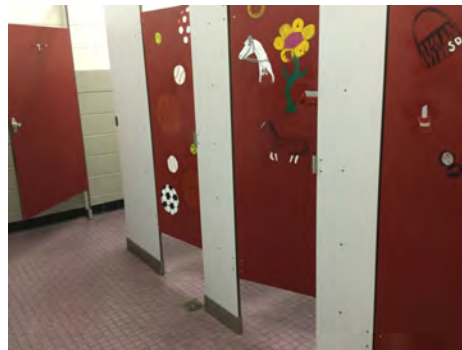
System: C1030 - Fittings

Note: Toilet partitions appear to be newer. Signage is up to code. Lockers are in good condition. System life given 5 more years.

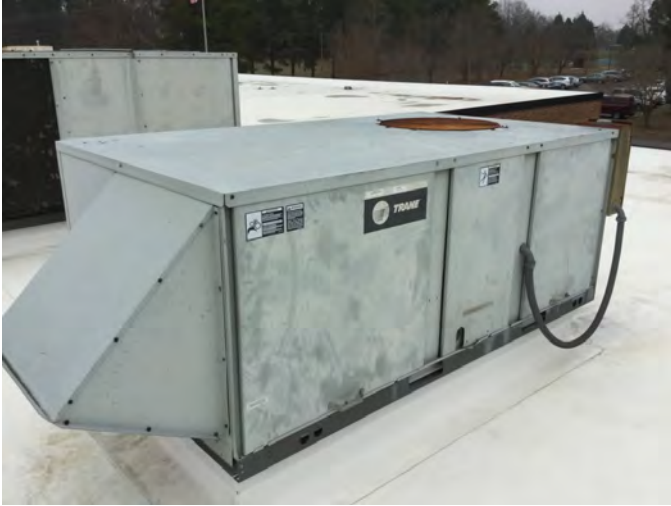
System: D3050 - Terminal & Package Units

Location: Roof
Distress: Beyond Service Life
Category: Deferred Maintenance
Priority: 3 - Necessary/Not Yet Critical (Years 2-5)
Correction: Renew System
Qty: 6,215.00
Unit of Measure: S.F.
Estimate: \$155,941.00
Assessor Name: Somnath Das
Date Created: 01/25/2017

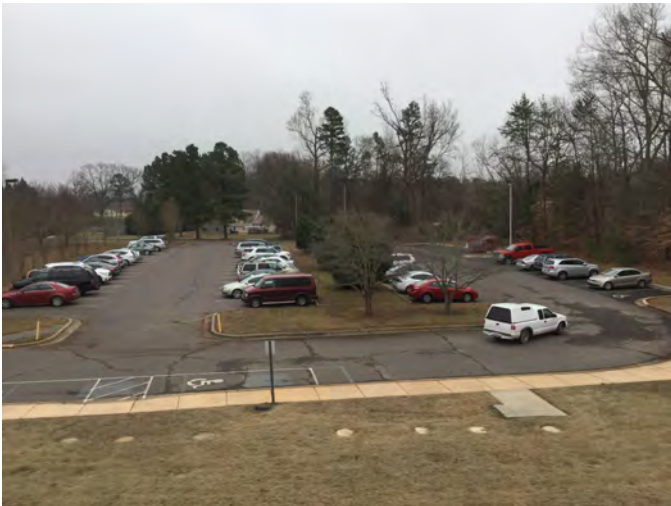
System: G2020 - Parking Lots

Location: Site
Distress: Beyond Service Life
Category: Deferred Maintenance
Priority: 3 - Necessary/Not Yet Critical (Years 2-5)
Correction: Renew System
Qty: 80,770.00
Unit of Measure: S.F.
Estimate: \$123,497.00
Assessor Name: Terence Davis
Date Created: 12/13/2016
