NC School District/430 Harnett County/Elementary School

South Harnett Elementary

Campus Assessment Report

March 11, 2017

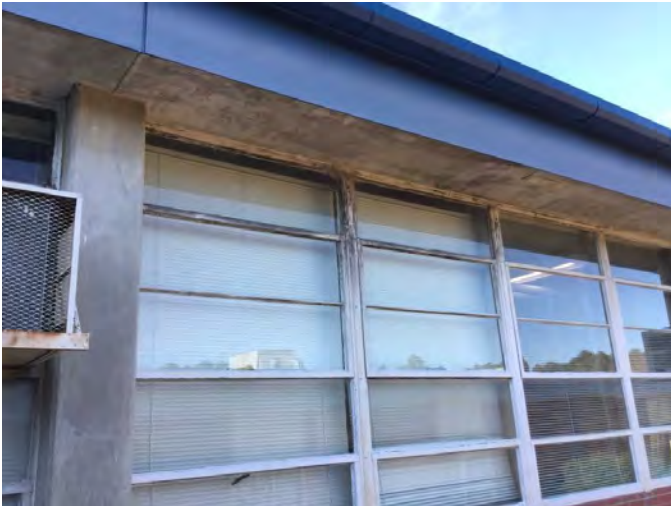
System: B2020 - Exterior Windows

Location: Throughout
Distress: Beyond Service Life
Category: Deferred Maintenance / Energy
Priority: 3 - Necessary/Not Yet Critical (Years 2-5)
Correction: Renew System
Qty: 26,000.00
Unit of Measure: S.F.
Estimate: \$263,120.00
Assessor Name: Matt Mahaffey
Date Created: 12/08/2016

Notes: The steel frame, operable, single pane windows are aged, rusted, not energy efficient, and should be replaced.

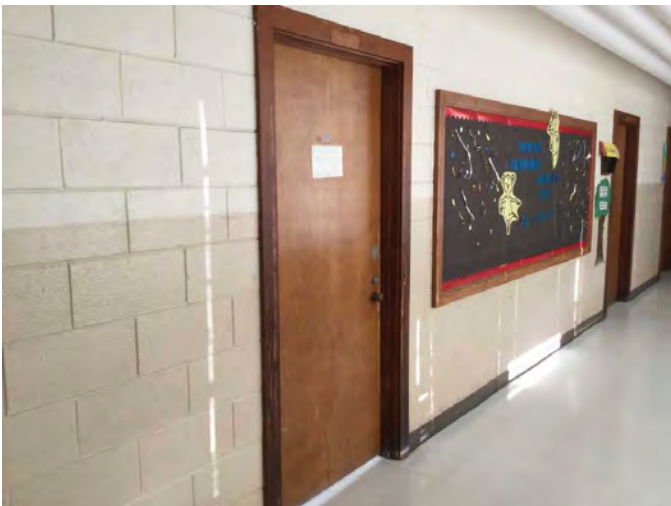
System: C1020 - Interior Doors

Location: Throughout
Distress: Beyond Service Life
Category: Deferred Maintenance / Accessibility Code Compliance
Priority: 3 - Necessary/Not Yet Critical (Years 2-5)
Correction: Renew System
Qty: 26,000.00
Unit of Measure: S.F.
Estimate: \$70,928.00
Assessor Name: Matt Mahaffey
Date Created: 12/08/2016

Notes: The interior doors are aged, failing, hardware is not ADA compliant and should be replaced.

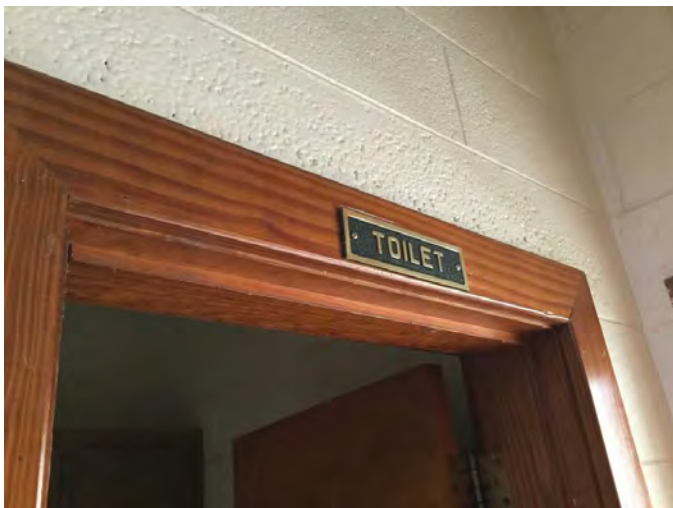
System: C1030 - Fittings

Location: Throughout
Distress: Beyond Service Life
Category: Deferred Maintenance
Priority: 3 - Necessary/Not Yet Critical (Years 2-5)
Correction: Renew System
Qty: 26,000.00
Unit of Measure: S.F.
Estimate: \$272,844.00
Assessor Name: Matt Mahaffey
Date Created: 12/08/2016

Notes: The fittings throughout the building are aged, in marginal condition, handrails and room signage are ADA non-compliance and system should be replaced.

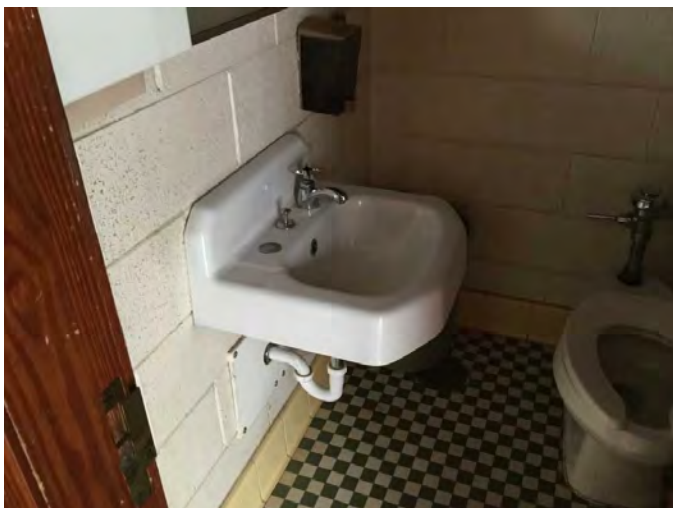
System: D2010 - Plumbing Fixtures

Location: Throughout
Distress: Beyond Service Life
Category: Deferred Maintenance / Accessibility Code Compliance
Priority: 3 - Necessary/Not Yet Critical (Years 2-5)
Correction: Renew System
Qty: 26,000.00
Unit of Measure: S.F.
Estimate: \$322,036.00
Assessor Name: Matt Mahaffey
Date Created: 12/08/2016

Notes: Plumbing fixtures are in operational conditions. However, they are aged, not ADA compliant and should be replaced with a low-flow water fixtures.

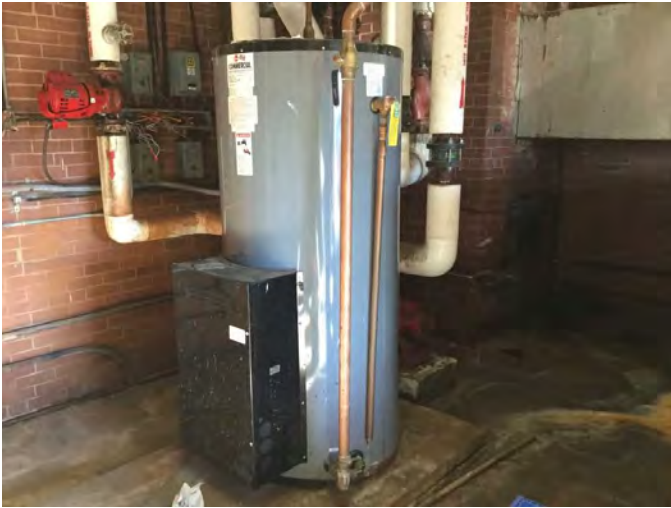
System: D2020 - Domestic Water Distribution

Location: Throughout
Distress: Beyond Service Life
Category: Deferred Maintenance
Priority: 3 - Necessary/Not Yet Critical (Years 2-5)
Correction: Renew System
Qty: 26,000.00
Unit of Measure: S.F.
Estimate: \$27,456.00
Assessor Name: Matt Mahaffey
Date Created: 12/08/2016

Notes: The domestic water distribution system is aged and should be replaced.

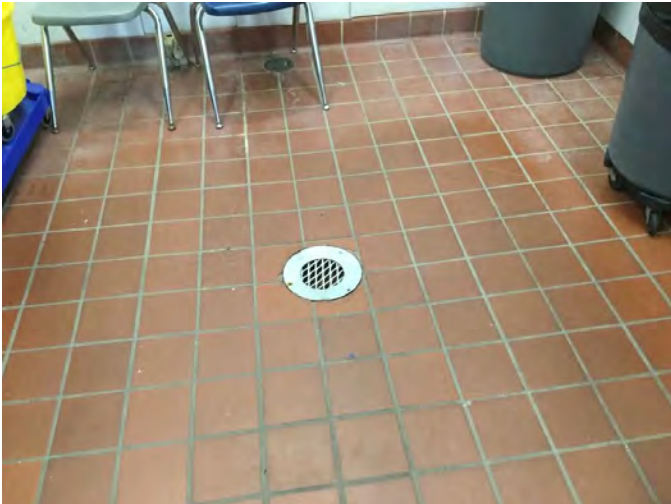
System: D2030 - Sanitary Waste

Location: Throughout
Distress: Beyond Service Life
Category: Deferred Maintenance
Priority: 3 - Necessary/Not Yet Critical (Years 2-5)
Correction: Renew System
Qty: 26,000.00
Unit of Measure: S.F.
Estimate: \$43,472.00
Assessor Name: Matt Mahaffey
Date Created: 12/08/2016

Notes: The sanitary waste system is aged, has reported periodic failures, and should be replaced.

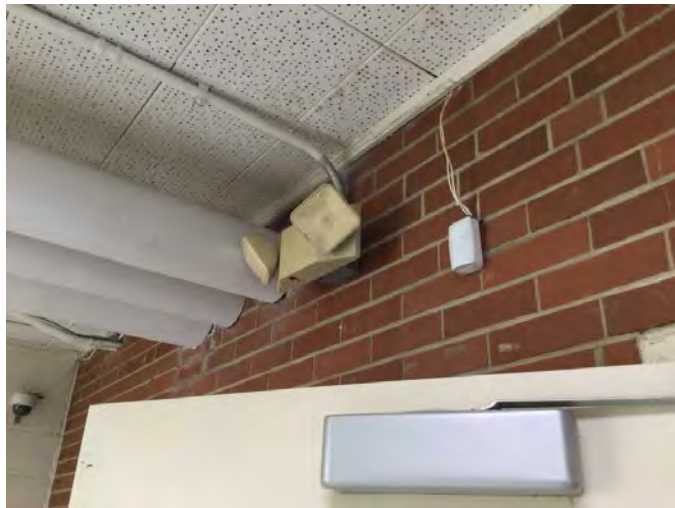
System: D5090 - Other Electrical Systems

Location: Throughout
Distress: Beyond Service Life
Category: Deferred Maintenance
Priority: 3 - Necessary/Not Yet Critical (Years 2-5)
Correction: Renew System
Qty: 26,000.00
Unit of Measure: S.F.
Estimate: \$3,432.00
Assessor Name: Matt Mahaffey
Date Created: 12/08/2016

Notes: Emergency lighting system is aged and should be replaced.

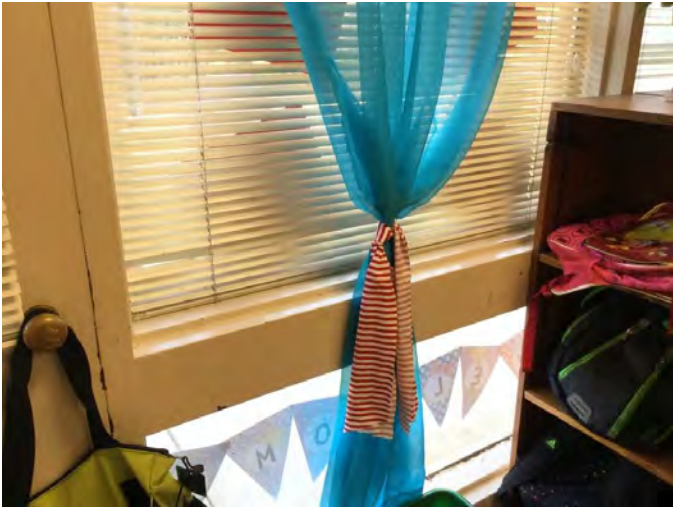
System: B2020 - Exterior Windows

Location: Throughout
Distress: Beyond Service Life
Category: Deferred Maintenance
Priority: 3 - Necessary/Not Yet Critical (Years 2-5)
Correction: Renew System
Qty: 15,250.00
Unit of Measure: S.F.
Estimate: \$154,330.00
Assessor Name: Eduardo Lopez
Date Created: 12/09/2016

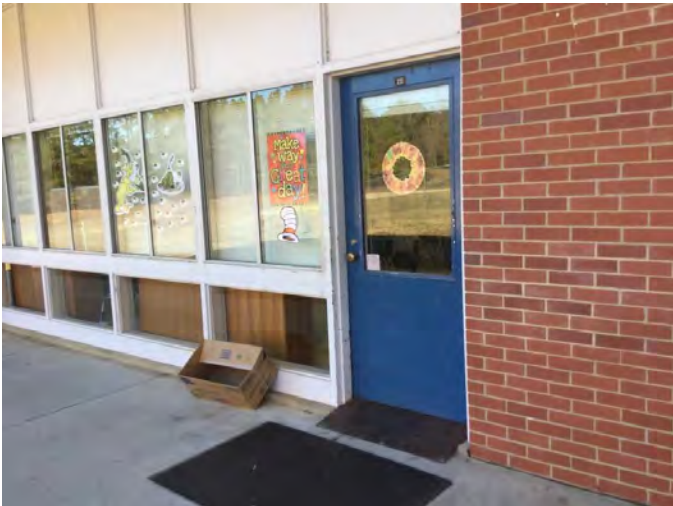
System: B2030 - Exterior Doors

Location: Throughout
Distress: Beyond Service Life
Category: Deferred Maintenance / Building Code Compliance
Priority: 3 - Necessary/Not Yet Critical (Years 2-5)
Correction: Renew System
Qty: 15,250.00
Unit of Measure: S.F.
Estimate: \$17,111.00
Assessor Name: Eduardo Lopez
Date Created: 12/09/2016

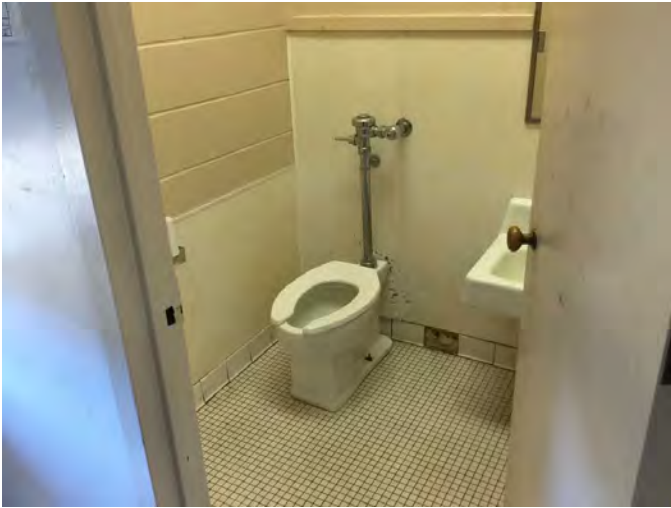
System: C1020 - Interior Doors

Location: Throughout
Distress: Beyond Service Life
Category: Deferred Maintenance / Accessibility Code Compliance
Priority: 3 - Necessary/Not Yet Critical (Years 2-5)
Correction: Renew System
Qty: 15,250.00
Unit of Measure: S.F.
Estimate: \$41,602.00
Assessor Name: Eduardo Lopez
Date Created: 12/09/2016

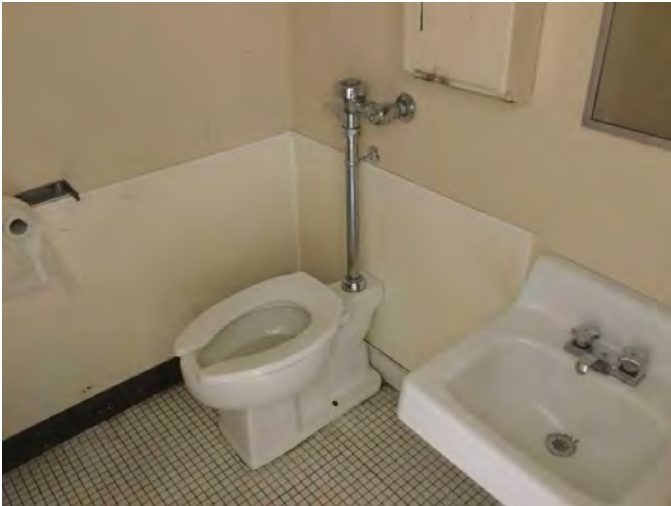
System: C1030 - Fittings

Location: Throughout
Distress: Beyond Service Life
Category: Deferred Maintenance / Accessibility Code Compliance
Priority: 3 - Necessary/Not Yet Critical (Years 2-5)
Correction: Renew System
Qty: 15,250.00
Unit of Measure: S.F.
Estimate: \$160,034.00
Assessor Name: Eduardo Lopez
Date Created: 12/09/2016

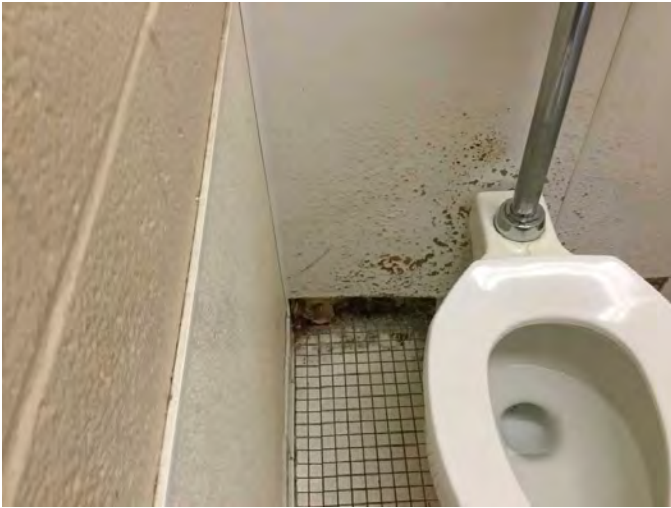
System: C3010 - Wall Finishes

Location: Throughout
Distress: Beyond Service Life
Category: Deferred Maintenance
Priority: 3 - Necessary/Not Yet Critical (Years 2-5)
Correction: Renew System
Qty: 15,250.00
Unit of Measure: S.F.
Estimate: \$45,796.00
Assessor Name: Eduardo Lopez
Date Created: 12/09/2016

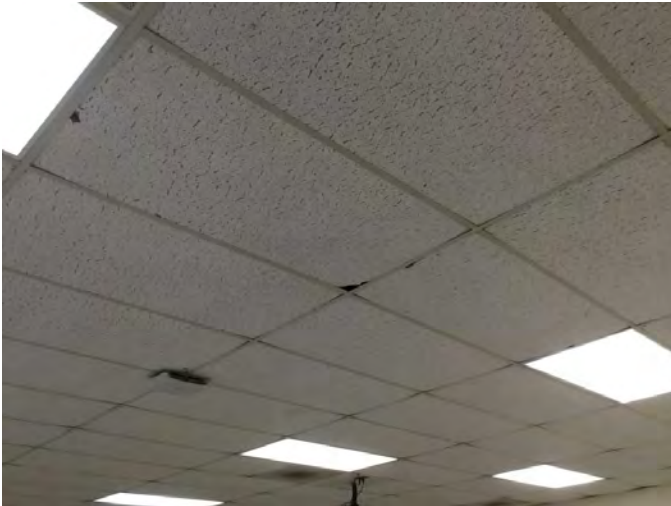
System: C3030 - Ceiling Finishes

Location: Throughout
Distress: Beyond Service Life
Category: Deferred Maintenance
Priority: 3 - Necessary/Not Yet Critical (Years 2-5)
Correction: Renew System
Qty: 15,250.00
Unit of Measure: S.F.
Estimate: \$180,164.00
Assessor Name: Eduardo Lopez
Date Created: 12/09/2016

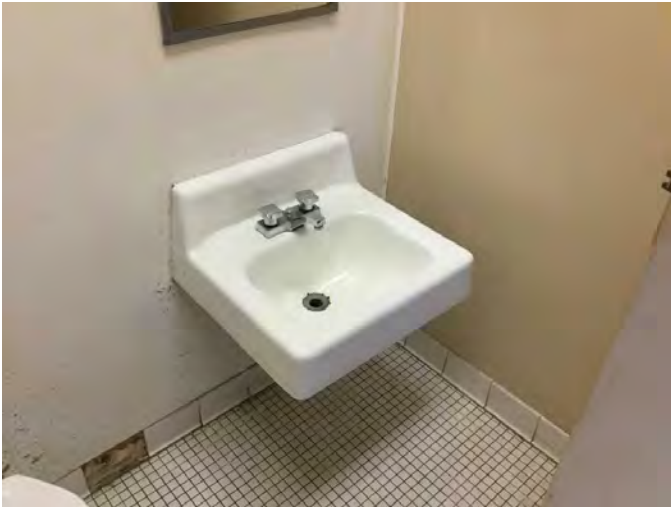
System: D2010 - Plumbing Fixtures

Location: Throughout
Distress: Beyond Service Life
Category: Deferred Maintenance / Accessibility Code Compliance
Priority: 3 - Necessary/Not Yet Critical (Years 2-5)
Correction: Renew System
Qty: 15,250.00
Unit of Measure: S.F.
Estimate: \$188,887.00
Assessor Name: Eduardo Lopez
Date Created: 12/09/2016

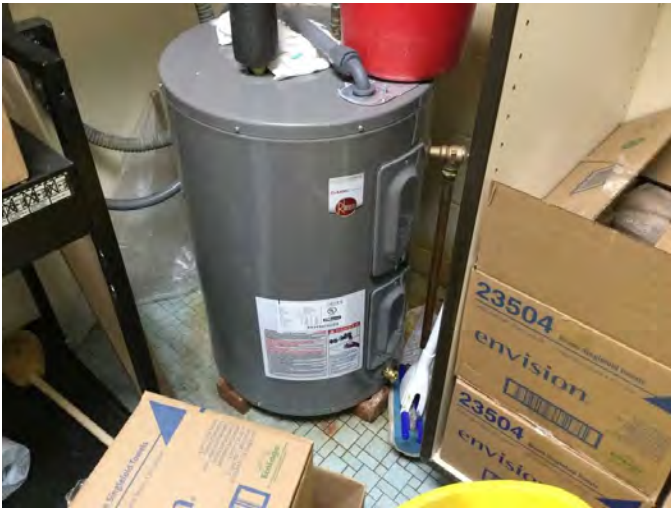
System: D2020 - Domestic Water Distribution

Location: Throughout
Distress: Beyond Service Life
Category: Deferred Maintenance
Priority: 3 - Necessary/Not Yet Critical (Years 2-5)
Correction: Renew System
Qty: 15,250.00
Unit of Measure: S.F.
Estimate: \$16,104.00
Assessor Name: Eduardo Lopez
Date Created: 12/09/2016

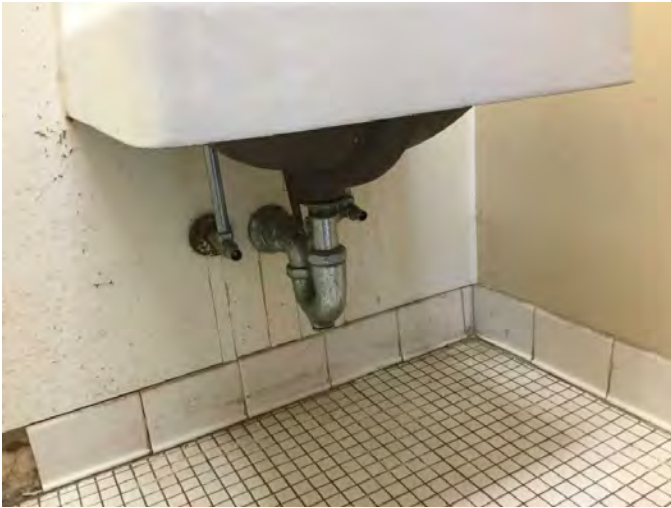
System: D2030 - Sanitary Waste

Location: Throughout
Distress: Beyond Service Life
Category: Deferred Maintenance
Priority: 3 - Necessary/Not Yet Critical (Years 2-5)
Correction: Renew System
Qty: 15,250.00
Unit of Measure: S.F.
Estimate: \$25,498.00
Assessor Name: Eduardo Lopez
Date Created: 12/09/2016

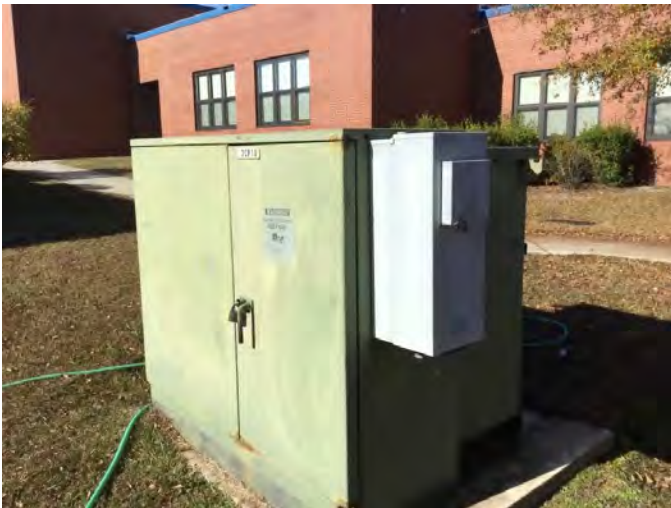
System: D5010 - Electrical Service/Distribution

Location: Throughout
Distress: Beyond Service Life
Category: Deferred Maintenance
Priority: 3 - Necessary/Not Yet Critical (Years 2-5)
Correction: Renew System
Qty: 15,250.00
Unit of Measure: S.F.
Estimate: \$27,679.00
Assessor Name: Eduardo Lopez
Date Created: 12/09/2016

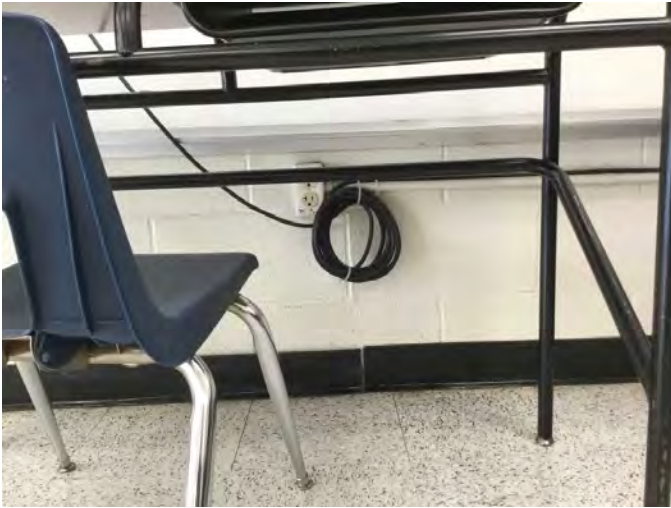
System: D5020 - Branch Wiring

Location: Throughout
Distress: Beyond Service Life
Category: Deferred Maintenance
Priority: 3 - Necessary/Not Yet Critical (Years 2-5)
Correction: Renew System
Qty: 15,250.00
Unit of Measure: S.F.
Estimate: \$83,707.00
Assessor Name: Eduardo Lopez
Date Created: 12/09/2016

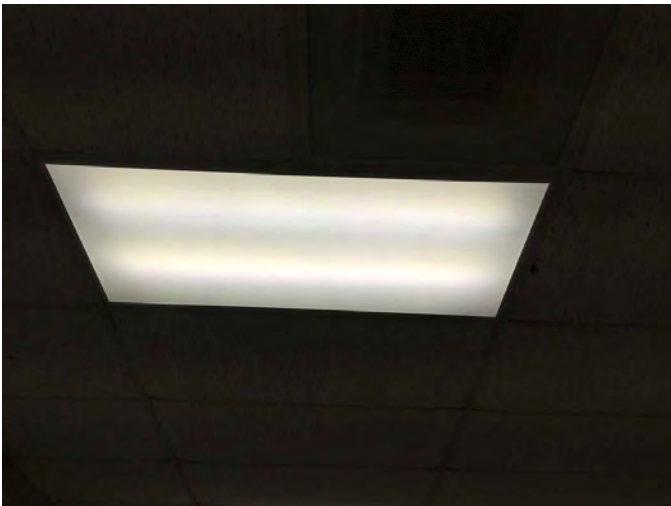
System: D5020 - Lighting

Location: Throughout
Distress: Beyond Service Life
Category: Deferred Maintenance / Energy
Priority: 3 - Necessary/Not Yet Critical (Years 2-5)
Correction: Renew System
Qty: 15,250.00
Unit of Measure: S.F.
Estimate: \$195,261.00
Assessor Name: Eduardo Lopez
Date Created: 12/09/2016

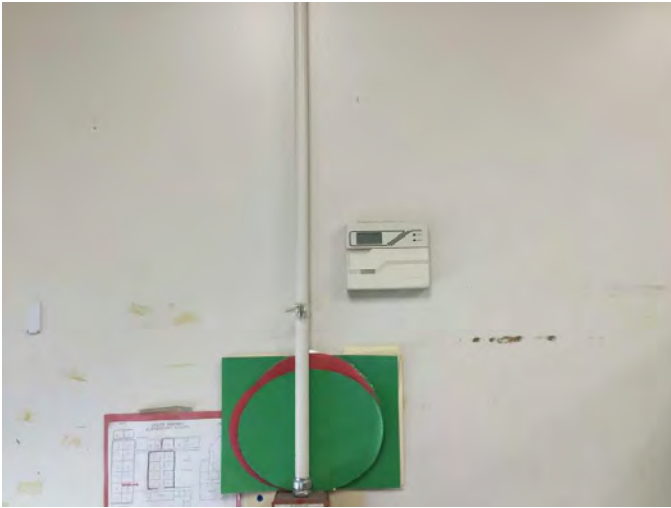
System: D5030810 - Security & Detection Systems

Location: Throughout
Distress: Inadequate
Category: Safety / Code Compliance
Priority: 3 - Necessary/Not Yet Critical (Years 2-5)
Correction: Renew System
Qty: 15,250.00
Unit of Measure: S.F.
Estimate: \$30,698.00
Assessor Name: Eduardo Lopez
Date Created: 12/09/2016

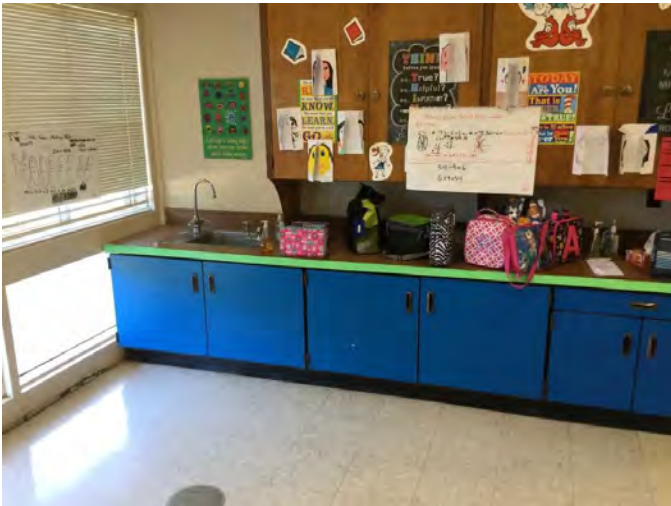
System: E2010 - Fixed Furnishings

Location: Classrooms
Distress: Beyond Service Life
Category: Deferred Maintenance
Priority: 3 - Necessary/Not Yet Critical (Years 2-5)
Correction: Renew System
Qty: 15,250.00
Unit of Measure: S.F.
Estimate: \$95,953.00
Assessor Name: Eduardo Lopez
Date Created: 12/09/2016

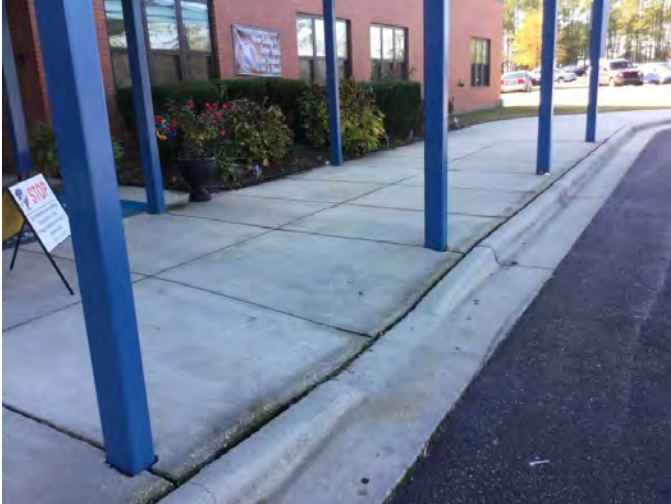
System: G2010 - Roadways

Location: Front drive
Distress: Missing
Category: Building Code Compliance
Priority: 2 - Potentially Critical (Year 1)
Correction: Fire lane marking; incl. curb painting and with the words "No Parking, Fire Lane" painted in black
Qty: 500.00
Unit of Measure: L.F.
Estimate: \$1,479.59
Assessor Name: Matt Mahaffey
Date Created: 12/09/2016

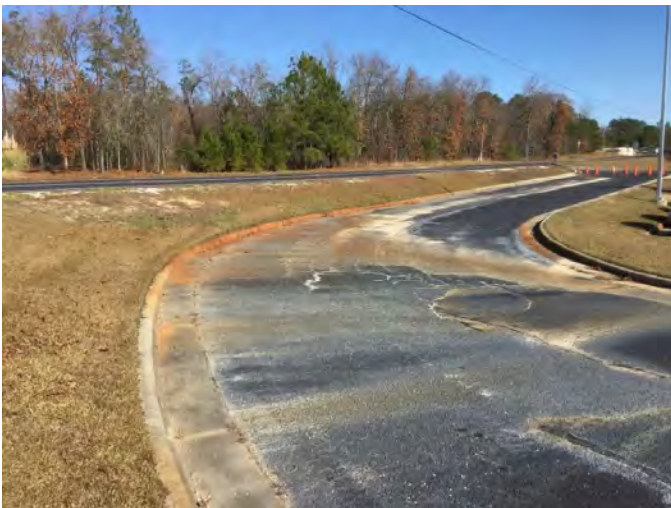
System: G2050 - Landscaping

Location: Front entry drive
Distress: Damaged
Category: Safety
Priority: 2 - Potentially Critical (Year 1)
Correction: Erosion control; incl. soil preparation, topsoil and sodding
Qty: 4,200.00
Unit of Measure: S.F.
Estimate: \$113,609.31
Assessor Name: Matt Mahaffey
Date Created: 12/09/2016

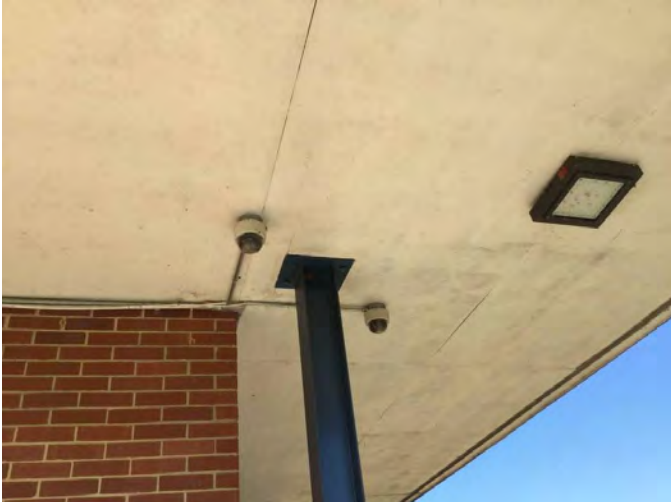
Location: Site
Distress: Inadequate
Category: Safety
Priority: 3 - Necessary/Not Yet Critical (Years 2-5)
Correction: Renew System
Qty: 75,757.00
Unit of Measure: S.F.
Estimate: \$69,999.00
Assessor Name: Matt Mahaffey
Date Created: 12/09/2016
