NC School District/430 Harnett County/High School

Star Academy

Campus Assessment Report

March 11, 2017

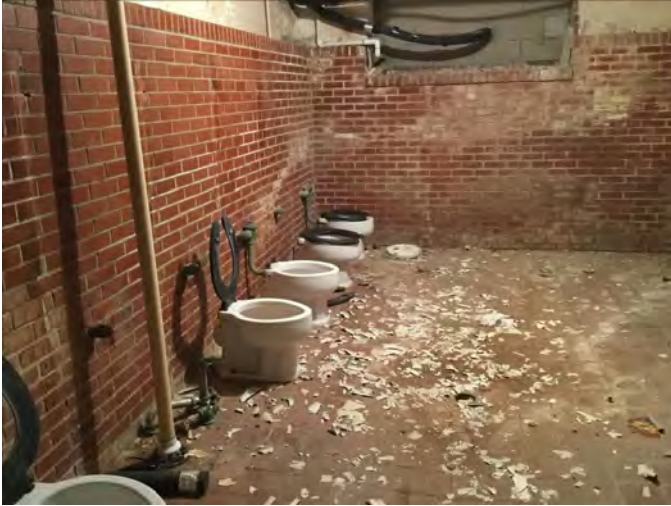
System: D2010 - Plumbing Fixtures

Location: Throughout
Distress: Beyond Service Life
Category: Deferred Maintenance / Accessibility Code Compliance
Priority: 2 - Potentially Critical (Year 1)
Correction: Renew System
Qty: 17,649.00
Unit of Measure: S.F.
Estimate: \$183,655.00
Assessor Name: Terence Davis
Date Created: 11/22/2016

Notes: Plumbing fixtures are in operational conditions. However, they are aged, not ADA compliant and should be replaced with a low-flow water fixtures.

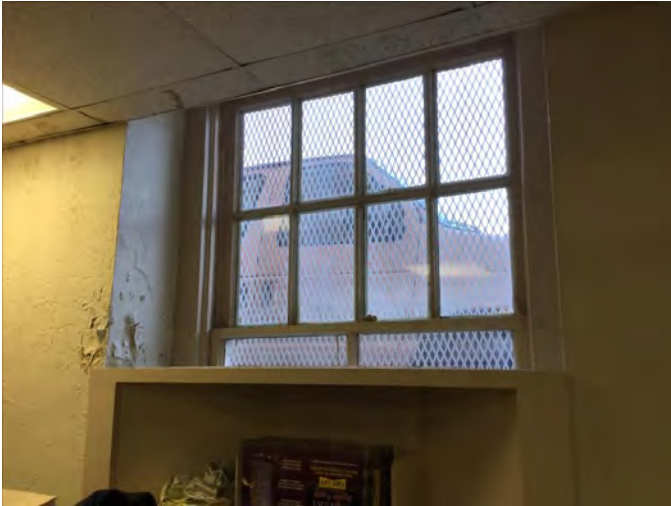
System: B2020 - Exterior Windows

Location: Throughout
Distress: Beyond Service Life
Category: Deferred Maintenance / Energy
Priority: 3 - Necessary/Not Yet Critical (Years 2-5)
Correction: Renew System
Qty: 17,649.00
Unit of Measure: S.F.
Estimate: \$265,776.00
Assessor Name: Terence Davis
Date Created: 11/22/2016

Notes: The wood frame, operable, single pane windows are aged, damaged, not energy efficient, and should be replaced.

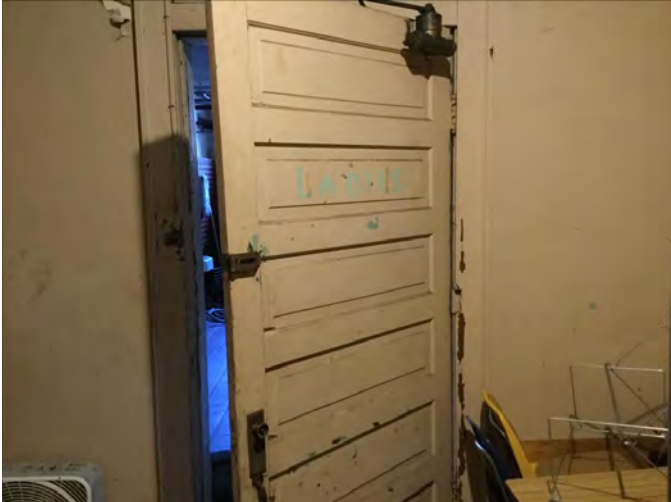
System: C1020 - Interior Doors

Location: Throughout
Distress: Beyond Service Life
Category: Deferred Maintenance / Accessibility Code Compliance
Priority: 3 - Necessary/Not Yet Critical (Years 2-5)
Correction: Renew System
Qty: 17,649.00
Unit of Measure: S.F.
Estimate: \$50,670.00
Assessor Name: Terence Davis
Date Created: 11/22/2016

Notes: The interior doors are aged, failing, hardware is not ADA compliant and should be replaced.

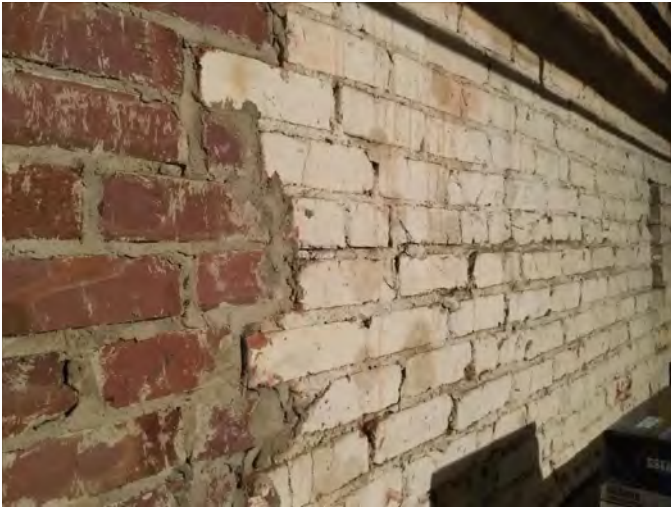
System: C3010 - Wall Finishes

Location: Basement, restrooms
Distress: Beyond Service Life
Category: Deferred Maintenance
Priority: 3 - Necessary/Not Yet Critical (Years 2-5)
Correction: Renew System
Qty: 17,649.00
Unit of Measure: S.F.
Estimate: \$53,388.00
Assessor Name: Terence Davis
Date Created: 11/22/2016

Notes: The wall finishes are aged, scuffed, fading, stained, and should be replaced.

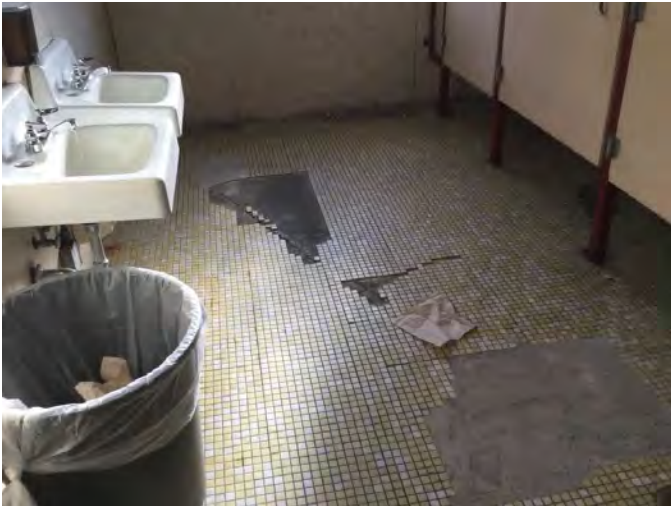
System: C3020 - Floor Finishes

Location: Toilets
Distress: Failing
Category: Deferred Maintenance / Safety
Priority: 3 - Necessary/Not Yet Critical (Years 2-5)
Correction: Replace ceramic tiles
Qty: 800.00
Unit of Measure: S.F.
Estimate: \$12,672.00
Assessor Name: Terence Davis
Date Created: 11/22/2016

Notes: Ceramic tile in toilets are failing and should be replaced.

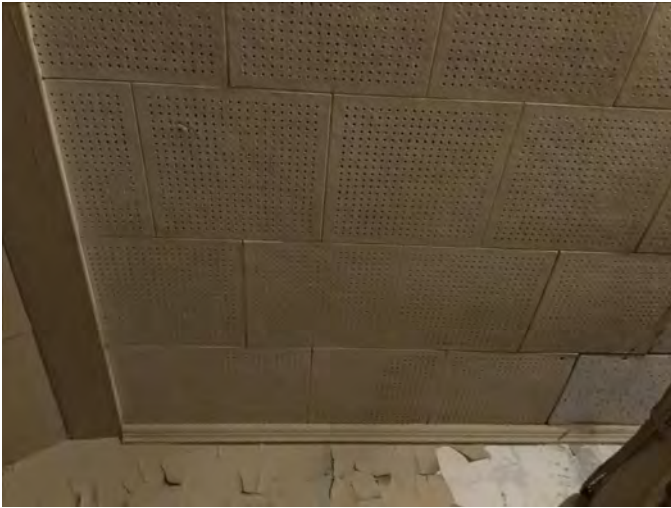
System: C3030 - Ceiling Finishes

Location: Throughout
Distress: Beyond Service Life
Category: Deferred Maintenance / Appearance
Priority: 3 - Necessary/Not Yet Critical (Years 2-5)
Correction: Renew System
Qty: 17,649.00
Unit of Measure: S.F.
Estimate: \$219,377.00
Assessor Name: Terence Davis
Date Created: 11/22/2016

Notes: The acoustic ceiling tiles are aged, failing and should be replaced.

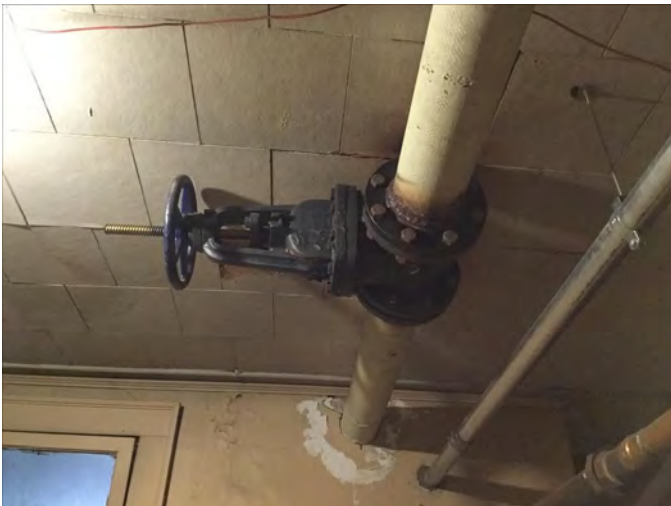
System: D2020 - Domestic Water Distribution

Location: Throughout
Distress: Beyond Service Life
Category: Deferred Maintenance
Priority: 3 - Necessary/Not Yet Critical (Years 2-5)
Correction: Renew System
Qty: 17,649.00
Unit of Measure: S.F.
Estimate: \$34,168.00
Assessor Name: Terence Davis
Date Created: 11/22/2016

Notes: The domestic water distribution system is aged, does not include back flow preventer and should be replaced.
Hot water heaters are aged and failing.

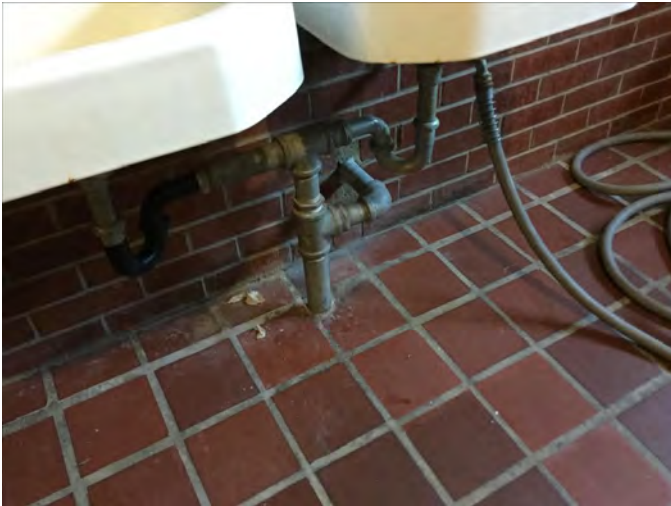
System: D2030 - Sanitary Waste

Location: Throughout
Distress: Beyond Service Life
Category: Deferred Maintenance
Priority: 3 - Necessary/Not Yet Critical (Years 2-5)
Correction: Renew System
Qty: 17,649.00
Unit of Measure: S.F.
Estimate: \$53,777.00
Assessor Name: Terence Davis
Date Created: 11/22/2016

Notes: The sanitary waste system is aged, has reported periodic failures, and should be replaced.

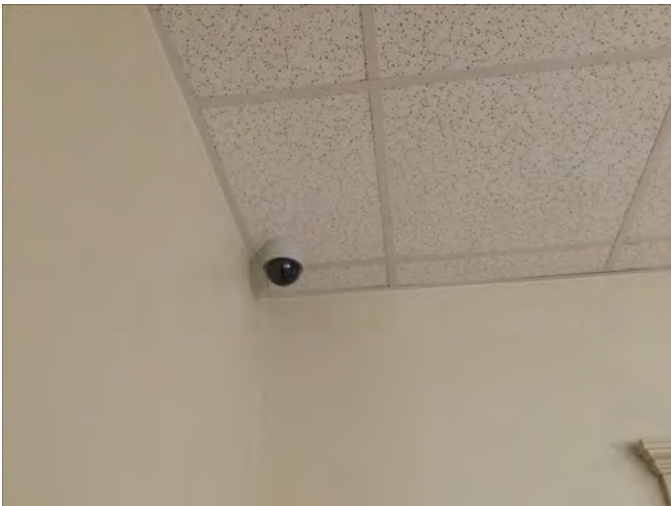
System: D5030810 - Security & Detection Systems

Location: Throughout
Distress: Beyond Service Life
Category: Deferred Maintenance
Priority: 3 - Necessary/Not Yet Critical (Years 2-5)
Correction: Renew System
Qty: 17,649.00
Unit of Measure: S.F.
Estimate: \$40,769.00
Assessor Name: Terence Davis
Date Created: 11/22/2016

Notes: Security system is analog and aging and should be replaced. Security cameras are beginning to fail.

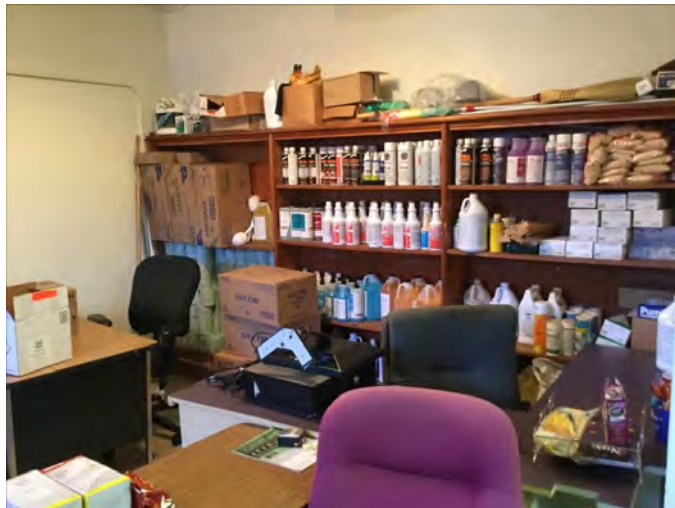
System: E2010 - Fixed Furnishings

Location: Classrooms
Distress: Beyond Service Life
Category: Deferred Maintenance
Priority: 3 - Necessary/Not Yet Critical (Years 2-5)
Correction: Renew System
Qty: 17,649.00
Unit of Measure: S.F.
Estimate: \$103,476.00
Assessor Name: Terence Davis
Date Created: 11/22/2016

Notes: Fixed casework is aged and beginning to fail and should be replaced.

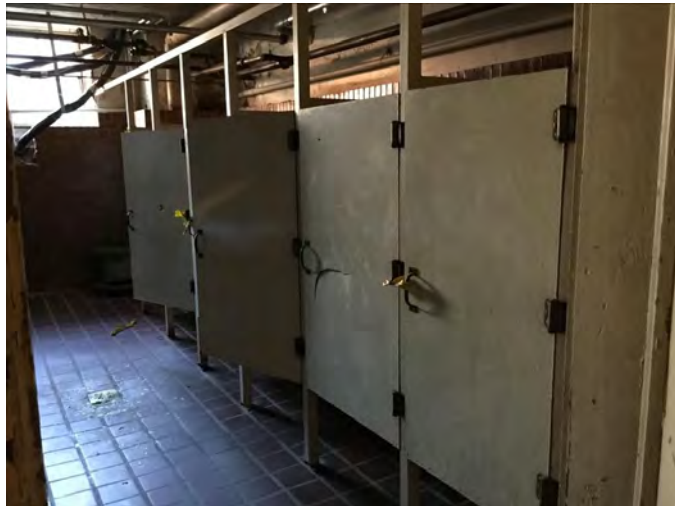
System: C1030 - Fittings

Location: Throughout
Distress: Beyond Service Life
Category: Deferred Maintenance
Priority: 5 - Codes or Standards Compliance
Correction: Renew System
Qty: 17,649.00
Unit of Measure: S.F.
Estimate: \$30,674.00
Assessor Name: Terence Davis
Date Created: 11/22/2016

Notes: The fittings throughout the building are aged, in marginal condition, not ADA compliant and should be replaced.

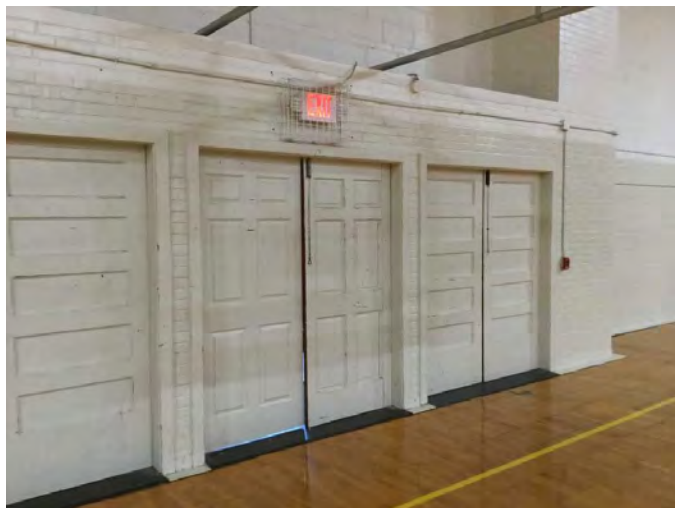
System: D5030810 - Security & Detection Systems

Location: Gym
Distress: Missing
Category: Safety
Priority: 1 - Currently Critical (Immediate)
Correction: Renew System
Qty: 15,055.00
Unit of Measure: S.F.
Estimate: \$34,777.00
Assessor Name: Matt Mahaffey
Date Created: 11/22/2016

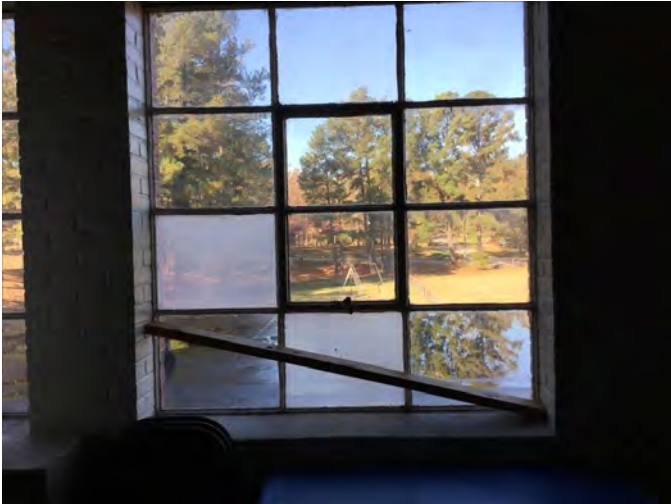
System: B2020 - Exterior Windows

Location: Throughout
Distress: Beyond Service Life
Category: Deferred Maintenance / Energy
Priority: 3 - Necessary/Not Yet Critical (Years 2-5)
Correction: Renew System
Qty: 15,055.00
Unit of Measure: S.F.
Estimate: \$226,713.00
Assessor Name: Matt Mahaffey
Date Created: 11/22/2016

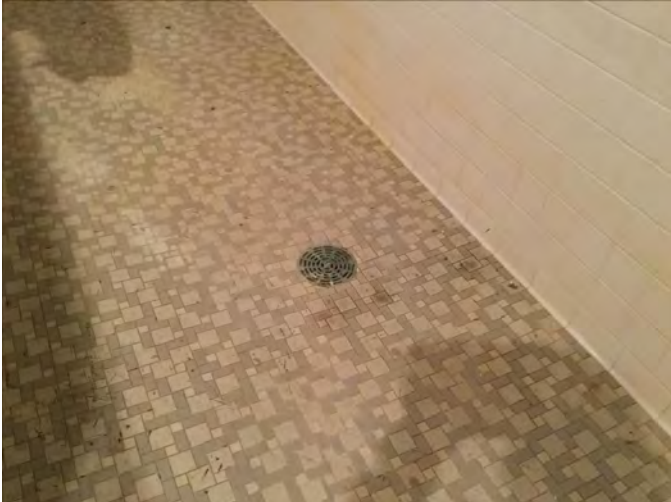
System: D2030 - Sanitary Waste

Location: Throughout
Distress: Beyond Service Life
Category: Deferred Maintenance
Priority: 3 - Necessary/Not Yet Critical (Years 2-5)
Correction: Renew System
Qty: 15,055.00
Unit of Measure: S.F.
Estimate: \$45,873.00
Assessor Name: Matt Mahaffey
Date Created: 11/22/2016

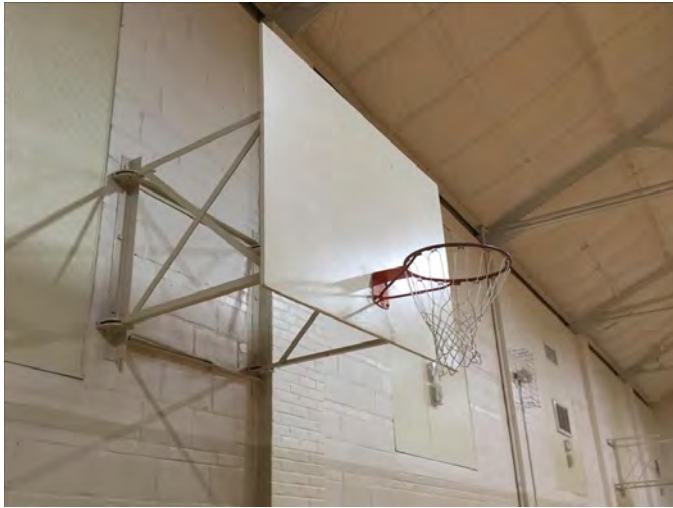
Location: Gym
Distress: Beyond Service Life
Category: Deferred Maintenance
Priority: 3 - Necessary/Not Yet Critical (Years 2-5)
Correction: Renew System
Qty: 15,055.00
Unit of Measure: S.F.
Estimate: \$94,892.00
Assessor Name: Matt Mahaffey
Date Created: 11/22/2016

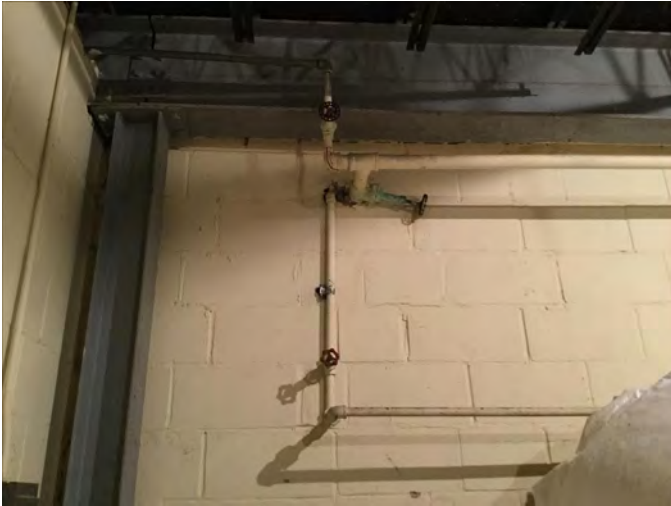
Location: Throughout
Distress: Beyond Service Life
Category: Deferred Maintenance
Priority: 4 - Recommended (Years 6-10)
Correction: Renew System
Qty: 15,055.00
Unit of Measure: S.F.
Estimate: \$29,146.00
Assessor Name: Matt Mahaffey
Date Created: 11/22/2016

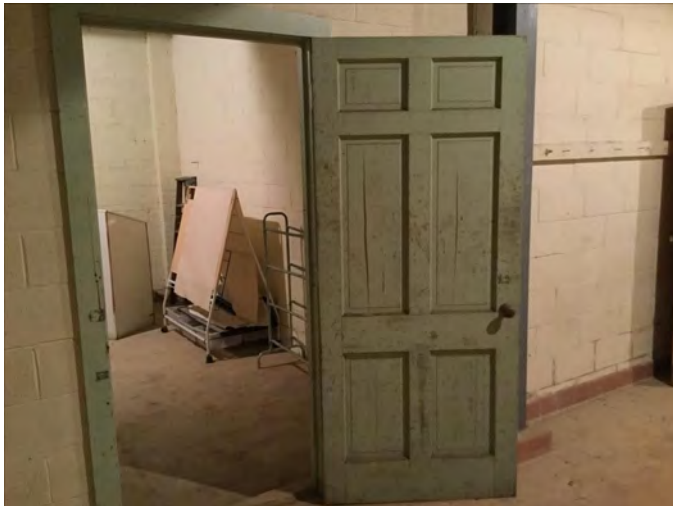
Location: Throughout
Distress: Beyond Service Life
Category: Deferred Maintenance / Accessibility Code Compliance
Priority: 5 - Codes or Standards Compliance
Correction: Renew System
Qty: 15,055.00
Unit of Measure: S.F.
Estimate: \$43,223.00
Assessor Name: Matt Mahaffey
Date Created: 11/22/2016

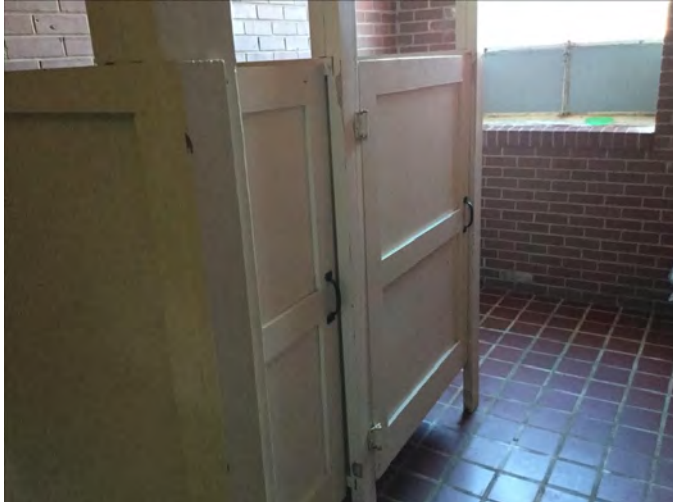
Location: Throughout
Distress: Beyond Service Life
Category: Deferred Maintenance / Accessibility Code Compliance
Priority: 5 - Codes or Standards Compliance
Correction: Renew System
Qty: 15,055.00
Unit of Measure: S.F.
Estimate: \$26,166.00
Assessor Name: Matt Mahaffey
Date Created: 11/22/2016

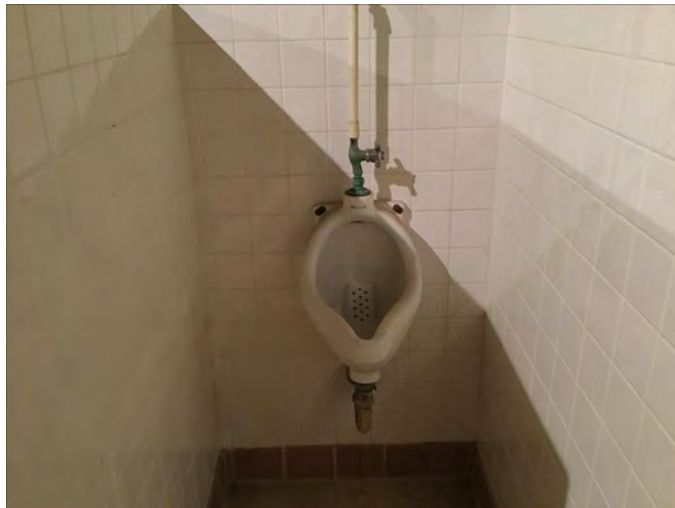
Location: Throughout
Distress: Beyond Service Life
Category: Deferred Maintenance / Accessibility Code Compliance
Priority: 5 - Codes or Standards Compliance
Correction: Renew System
Qty: 15,055.00
Unit of Measure: S.F.
Estimate: \$156,662.00
Assessor Name: Matt Mahaffey
Date Created: 11/22/2016

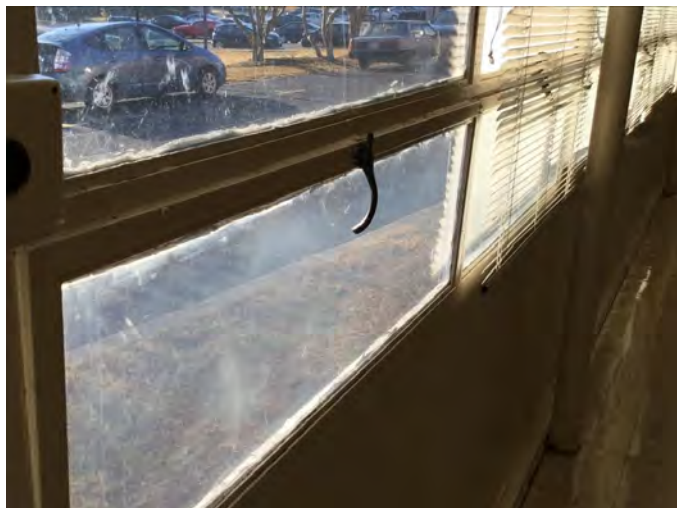
Location: Throughout
Distress: Beyond Service Life
Category: Deferred Maintenance / Energy
Priority: 2 - Potentially Critical (Year 1)
Correction: Renew System
Qty: 4,605.00
Unit of Measure: S.F.
Estimate: \$69,347.00
Assessor Name: Matt Mahaffey
Date Created: 11/22/2016

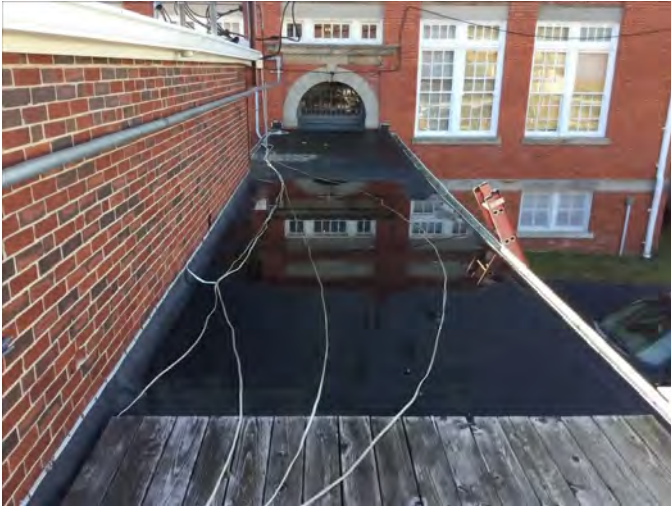
Location: Roof
Distress: Beyond Service Life
Category: Deferred Maintenance
Priority: 3 - Necessary/Not Yet Critical (Years 2-5)
Correction: Renew System
Qty: 4,605.00
Unit of Measure: S.F.
Estimate: \$48,214.00
Assessor Name: Matt Mahaffey
Date Created: 11/22/2016

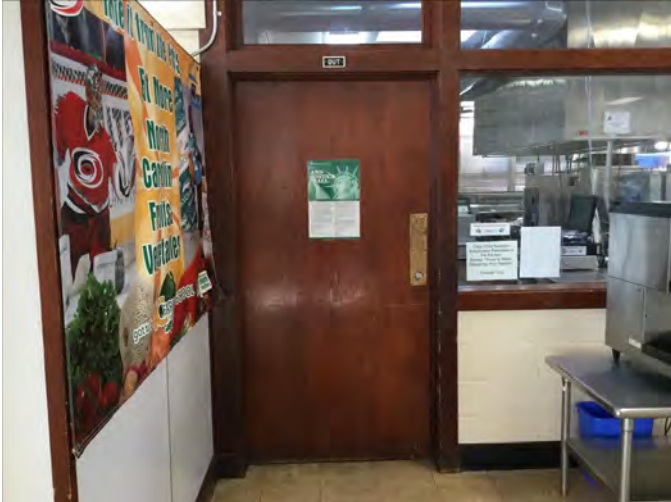
Location: Throughout
Distress: Beyond Service Life
Category: Deferred Maintenance / Accessibility Code Compliance
Priority: 3 - Necessary/Not Yet Critical (Years 2-5)
Correction: Renew System
Qty: 4,605.00
Unit of Measure: S.F.
Estimate: \$13,221.00
Assessor Name: Matt Mahaffey
Date Created: 11/22/2016

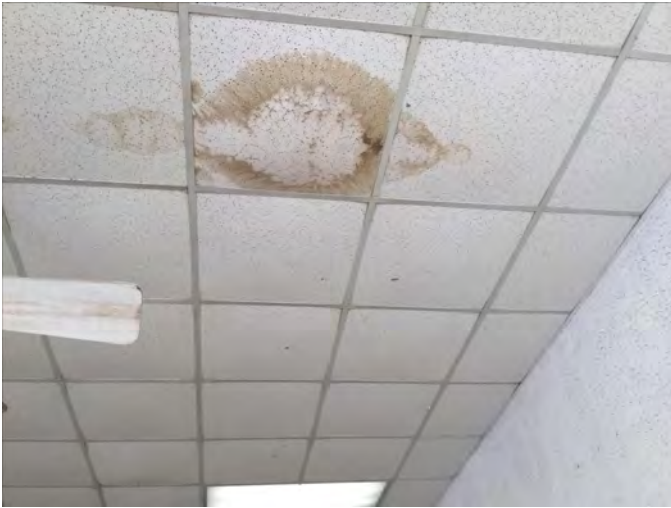
Location: Throughout
Distress: Beyond Service Life
Category: Deferred Maintenance / Appearance
Priority: 3 - Necessary/Not Yet Critical (Years 2-5)
Correction: Renew System
Qty: 4,605.00
Unit of Measure: S.F.
Estimate: \$57,240.00
Assessor Name: Matt Mahaffey
Date Created: 11/22/2016

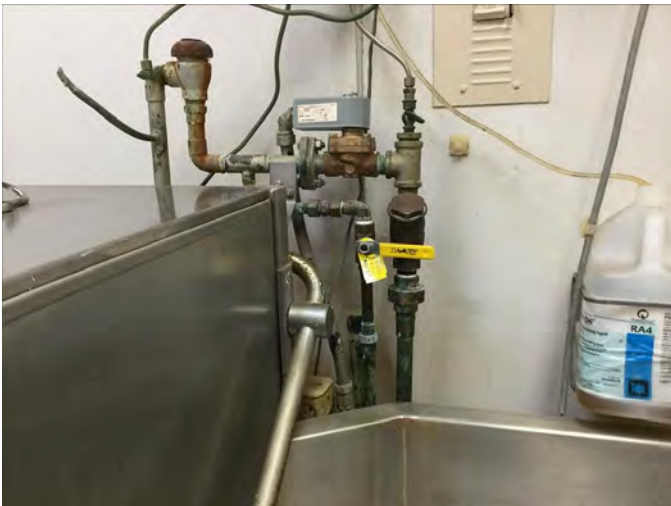
Location: Throughout
Distress: Beyond Service Life
Category: Deferred Maintenance
Priority: 3 - Necessary/Not Yet Critical (Years 2-5)
Correction: Renew System
Qty: 4,605.00
Unit of Measure: S.F.
Estimate: \$8,915.00
Assessor Name: Matt Mahaffey
Date Created: 11/22/2016

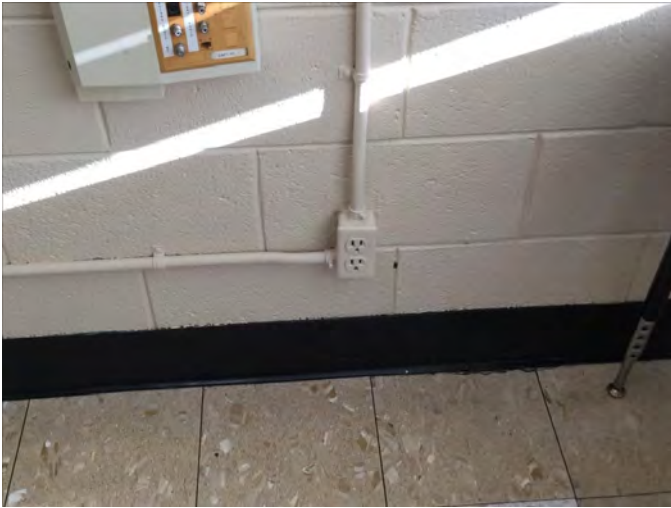
Location: Throughout
Distress: Beyond Service Life
Category: Deferred Maintenance
Priority: 3 - Necessary/Not Yet Critical (Years 2-5)
Correction: Renew System
Qty: 4,605.00
Unit of Measure: S.F.
Estimate: \$24,669.00
Assessor Name: Matt Mahaffey
Date Created: 11/22/2016

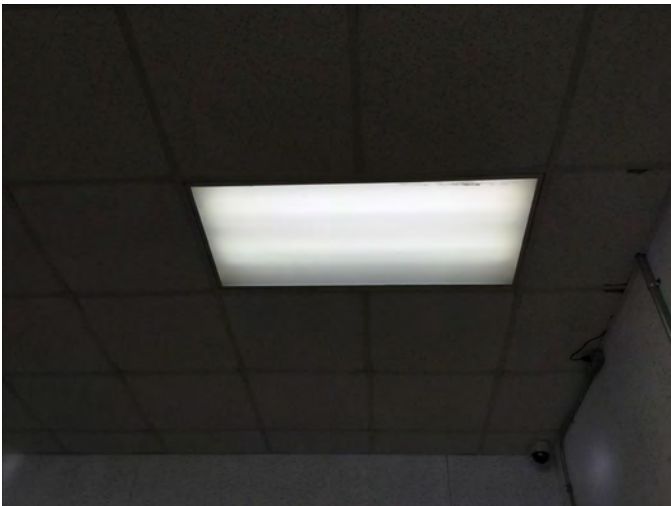
Location: Throughout
Distress: Beyond Service Life
Category: Deferred Maintenance
Priority: 3 - Necessary/Not Yet Critical (Years 2-5)
Correction: Renew System
Qty: 4,605.00
Unit of Measure: S.F.
Estimate: \$57,645.00
Assessor Name: Matt Mahaffey
Date Created: 11/22/2016

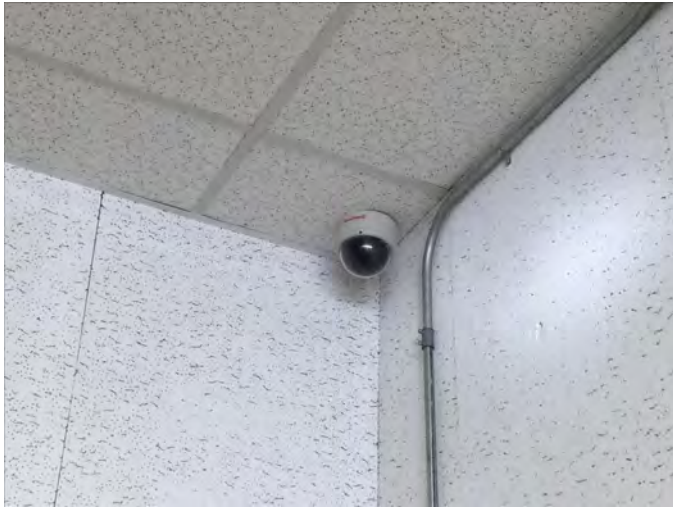
Location: Throughout
Distress: Beyond Service Life
Category: Deferred Maintenance
Priority: 3 - Necessary/Not Yet Critical (Years 2-5)
Correction: Renew System
Qty: 4,605.00
Unit of Measure: S.F.
Estimate: \$10,638.00
Assessor Name: Matt Mahaffey
Date Created: 11/22/2016

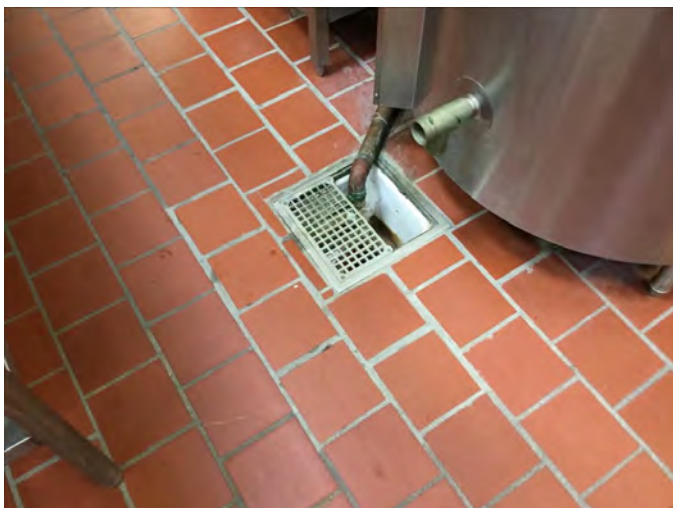
Location: Kitchen
Distress: Beyond Service Life
Category: Deferred Maintenance
Priority: 4 - Recommended (Years 6-10)
Correction: Renew System
Qty: 4,605.00
Unit of Measure: S.F.
Estimate: \$14,031.00
Assessor Name: Matt Mahaffey
Date Created: 11/22/2016

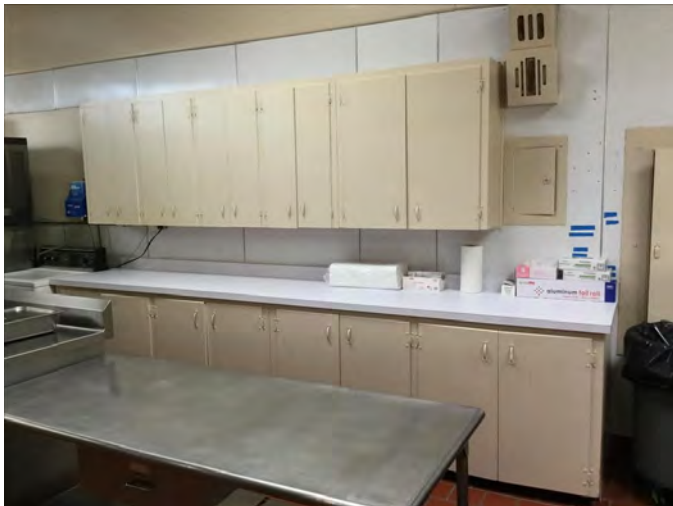
Location: Kitchen
Distress: Beyond Service Life
Category: Deferred Maintenance
Priority: 4 - Recommended (Years 6-10)
Correction: Renew System
Qty: 4,605.00
Unit of Measure: S.F.
Estimate: \$8,003.00
Assessor Name: Matt Mahaffey
Date Created: 11/22/2016

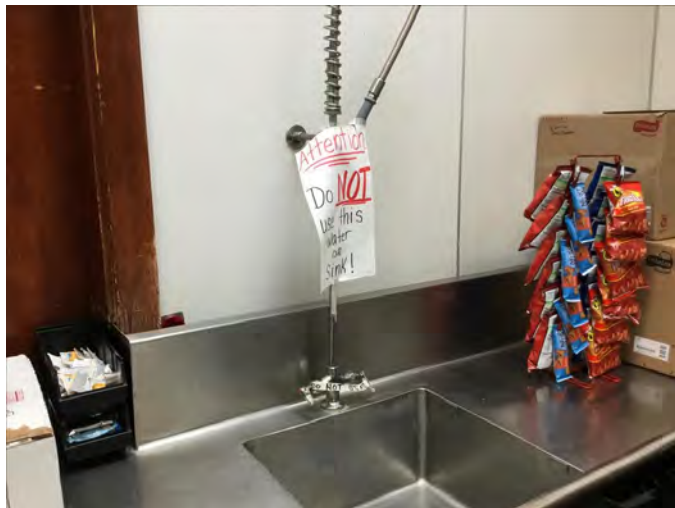
Location: Throughout
Distress: Beyond Service Life
Category: Deferred Maintenance / Accessibility Code Compliance
Priority: 5 - Codes or Standards Compliance
Correction: Renew System
Qty: 4,605.00
Unit of Measure: S.F.
Estimate: \$47,920.00
Assessor Name: Matt Mahaffey
Date Created: 11/22/2016

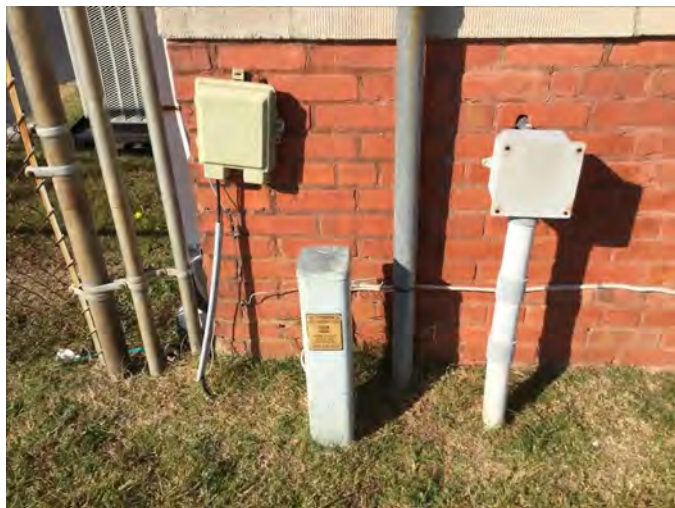
Location: Site
Distress: Inadequate
Category: Safety
Priority: 1 - Currently Critical (Immediate)
Correction: Renew System
Qty: 37,309.00
Unit of Measure: S.F.
Estimate: \$36,115.00
Assessor Name: Matt Mahaffey
Date Created: 11/22/2016

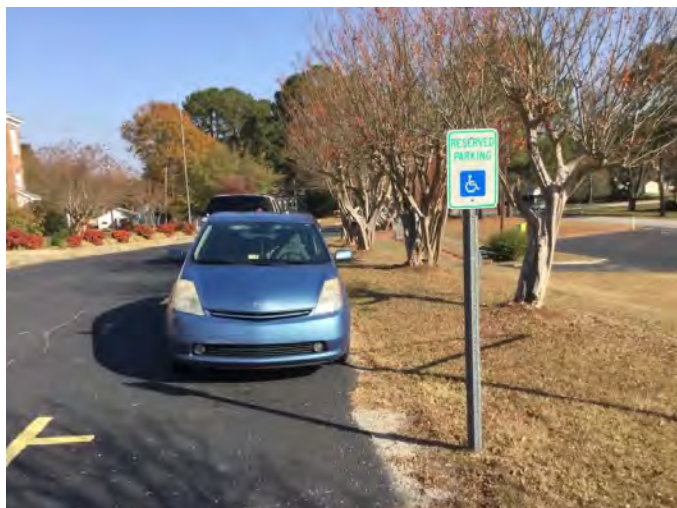
Location: Parking
Distress: Inadequate
Category: Accessibility Code Compliance
Priority: 2 - Potentially Critical (Year 1)
Correction: Add handicap parking space, incl. pavement markings, sign and post
Qty: 5.00
Unit of Measure: Ea.
Estimate: \$2,450.91
Assessor Name: Matt Mahaffey
Date Created: 11/23/2016

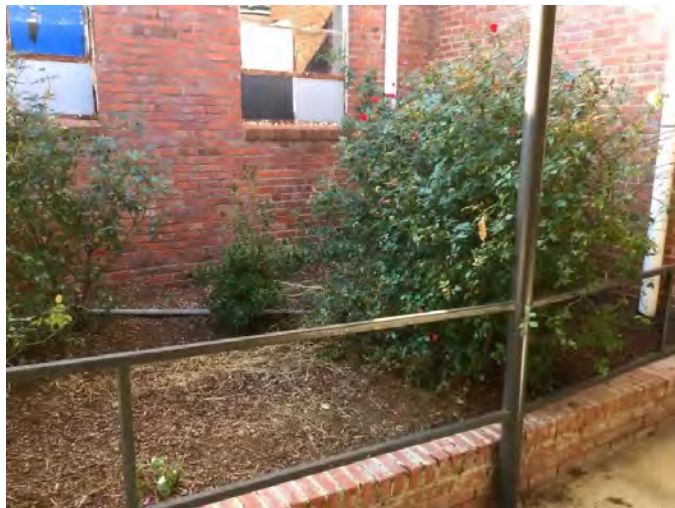
Location: Site
Distress: Beyond Service Life
Category: Deferred Maintenance / Accessibility Code Compliance
Priority: 3 - Necessary/Not Yet Critical (Years 2-5)
Correction: Remove and replace sidewalk and ramp railing.
Qty: 110.00
Unit of Measure: L.F.
Estimate: \$20,222.73
Assessor Name: Matt Mahaffey
Date Created: 11/23/2016

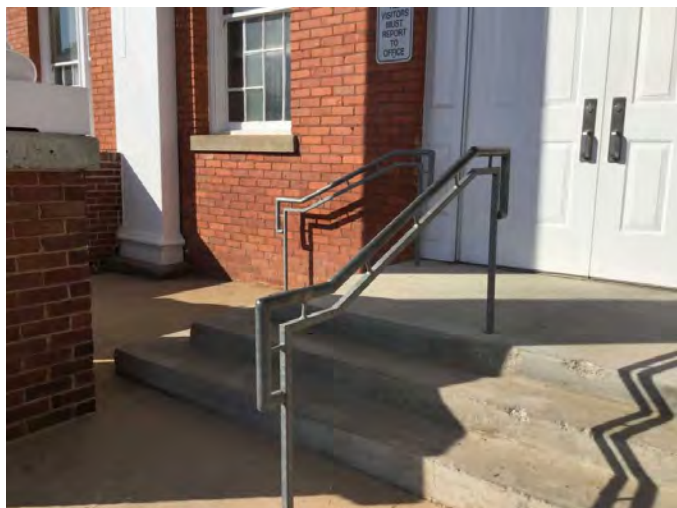
Location: Entrance
Distress: Missing
Category: Accessibility Code Compliance
Priority: 5 - Codes or Standards Compliance
Correction: Add handicap ramp with railings
Qty: 30.00
Unit of Measure: L.F.
Estimate: \$14,802.48
Assessor Name: Matt Mahaffey
Date Created: 11/23/2016
