NC School District/520 Jones County/Elementary School

Trenton Elementary

Campus Assessment Report

March 11, 2017

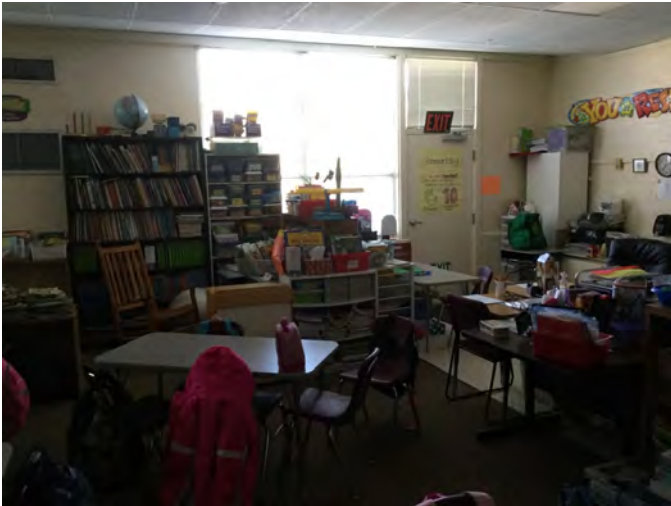
System: B2030 - Exterior Doors

Location: Throughout the building
Distress: Beyond Service Life
Category: Deferred Maintenance
Priority: 3 - Necessary/Not Yet Critical (Years 2-5)
Correction: Renew System
Qty: 35,500.00
Unit of Measure: S.F.
Estimate: \$40,612.00
Assessor Name: Terence Davis
Date Created: 02/15/2017

Notes: Exterior doors are generally in fair condition and beyond their expected useful life. Direct exit doors at classrooms have reverse swing. System renewal is recommended.

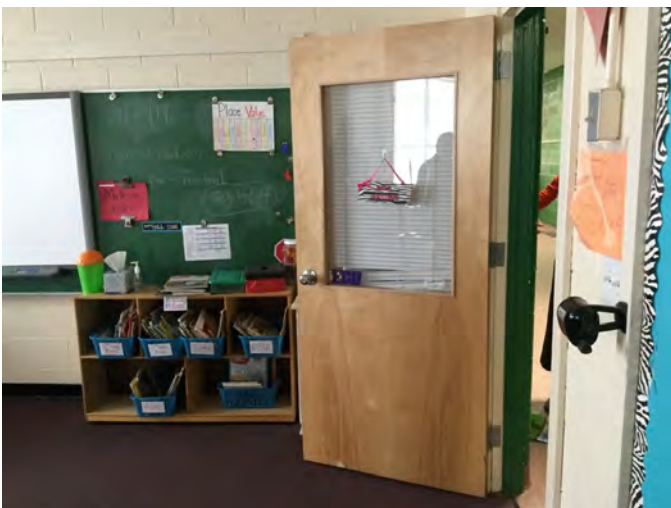
System: C1020 - Interior Doors

Location: Throughout the building
Distress: Beyond Service Life
Category: Deferred Maintenance
Priority: 3 - Necessary/Not Yet Critical (Years 2-5)
Correction: Renew System
Qty: 35,500.00
Unit of Measure: S.F.
Estimate: \$98,797.00
Assessor Name: Terence Davis
Date Created: 02/15/2017

Notes: Interior doors are in aged condition and do not have ADA compliant hardware. System renewal is recommended.

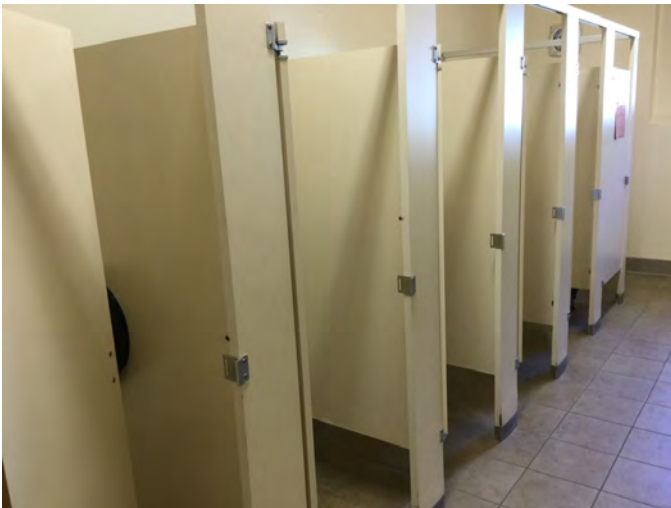
System: C1030 - Fittings

Location: Throughout the building
Distress: Beyond Service Life
Category: Deferred Maintenance
Priority: 3 - Necessary/Not Yet Critical (Years 2-5)
Correction: Renew System
Qty: 35,500.00
Unit of Measure: S.F.
Estimate: \$380,347.00
Assessor Name: Terence Davis
Date Created: 02/15/2017

Notes: Fittings are generally beyond their expected useful life. Signage is not up to current codes. Toilet partitions are deteriorating.

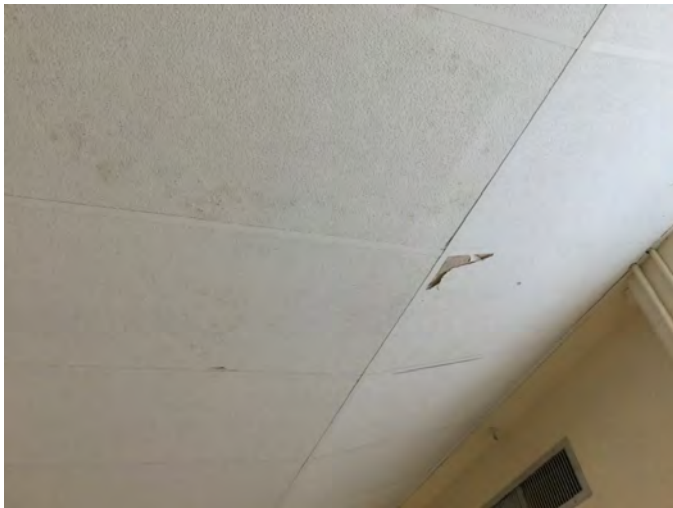
System: C3030 - Ceiling Finishes

Location: Throughout the building
Distress: Beyond Service Life
Category: Deferred Maintenance
Priority: 3 - Necessary/Not Yet Critical (Years 2-5)
Correction: Renew System
Qty: 35,500.00
Unit of Measure: S.F.
Estimate: \$428,379.00
Assessor Name: Terence Davis
Date Created: 02/15/2017

Notes: Ceilings are beyond their expected life. It appears that some acoustical tile ceilings have been spray painted. Painting acoustical tiles reduces their acoustical properties. System replacement is recommended.

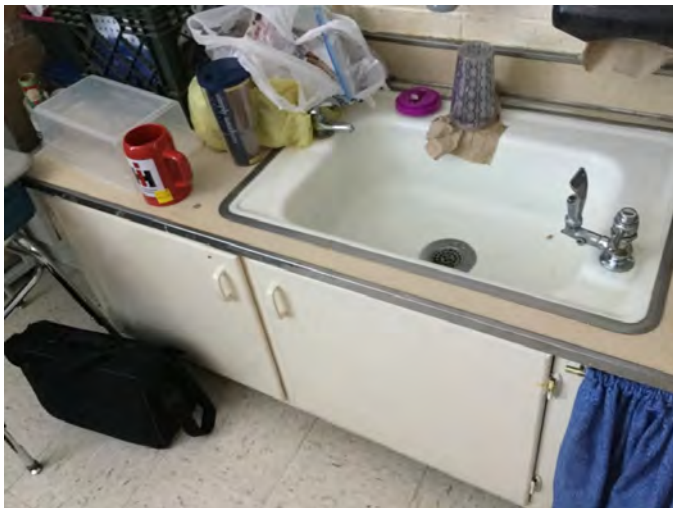
System: D2010 - Plumbing Fixtures

Location: Throughout the building
Distress: Beyond Service Life
Category: Deferred Maintenance
Priority: 3 - Necessary/Not Yet Critical (Years 2-5)
Correction: Renew System
Qty: 35,500.00
Unit of Measure: S.F.
Estimate: \$448,294.00
Assessor Name: Terence Davis
Date Created: 02/15/2017

Notes: Though some fixtures have been updated, there are many obsolete fixtures throughout the building. There are no ADA compliant restrooms in the building. System renewal is recommended.

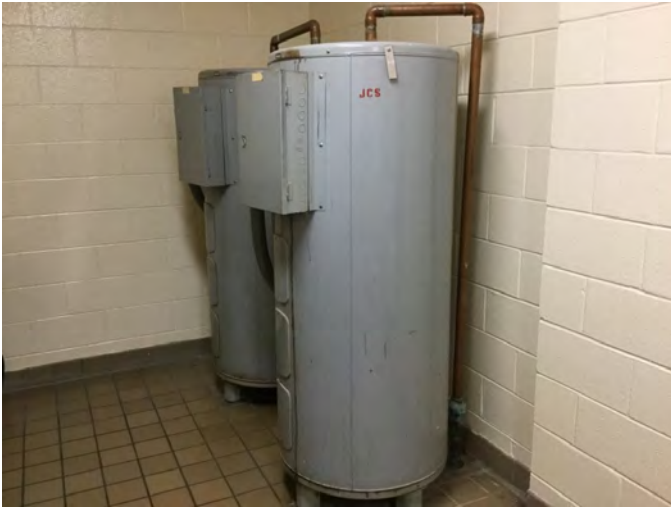
System: D2020 - Domestic Water Distribution

Location: Throughout the building
Distress: Beyond Service Life
Category: Deferred Maintenance
Priority: 3 - Necessary/Not Yet Critical (Years 2-5)
Correction: Renew System
Qty: 35,500.00
Unit of Measure: S.F.
Estimate: \$38,269.00
Assessor Name: Terence Davis
Date Created: 02/15/2017

Notes: The domestic water distribution system is well beyond its expected life. System renewal is recommended.

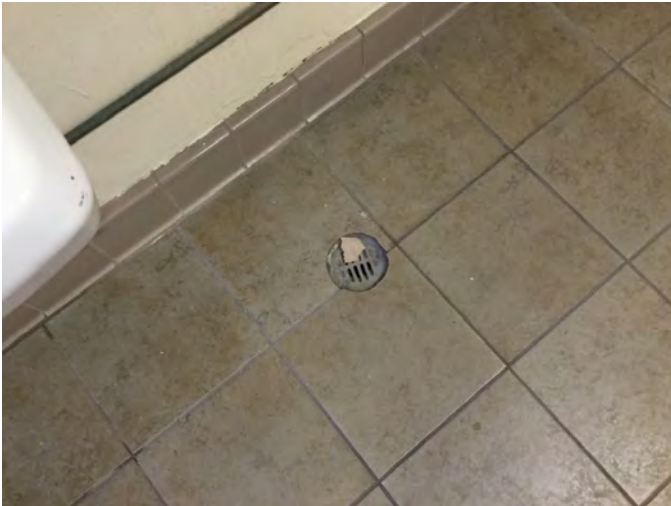
System: D2030 - Sanitary Waste

Location: Throughout the building
Distress: Beyond Service Life
Category: Deferred Maintenance
Priority: 3 - Necessary/Not Yet Critical (Years 2-5)
Correction: Renew System
Qty: 35,500.00
Unit of Measure: S.F.
Estimate: \$60,137.00
Assessor Name: Terence Davis
Date Created: 02/15/2017

Notes: The sanitary waste system has not been replaced since original construction, and is therefore beyond its expected useful life. System renewal is recommended.

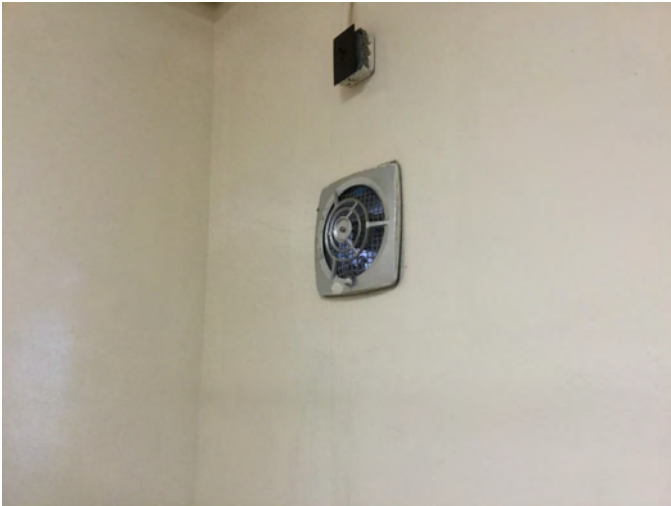
System: D3040 - Distribution Systems

Location: Throughout the building
Distress: Beyond Service Life
Category: Deferred Maintenance
Priority: 3 - Necessary/Not Yet Critical (Years 2-5)
Correction: Renew System
Qty: 35,500.00
Unit of Measure: S.F.
Estimate: \$239,767.00
Assessor Name: Terence Davis
Date Created: 02/15/2017

Notes: Toilet exhaust systems are obsolete. Other distribution systems are expired. No air conditioning is provided in corridors. System renewal is recommended.

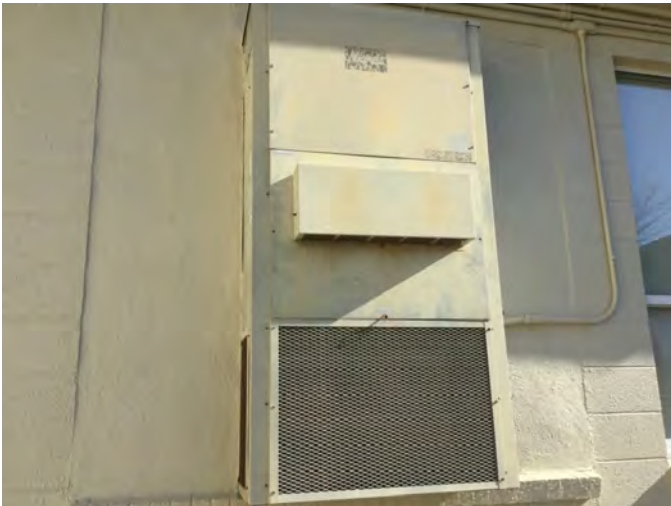
System: D3050 - Terminal & Package Units

Location: Throughout the building
Distress: Beyond Service Life
Category: Deferred Maintenance / Energy
Priority: 3 - Necessary/Not Yet Critical (Years 2-5)
Correction: Renew System
Qty: 35,500.00
Unit of Measure: S.F.
Estimate: \$522,099.00
Assessor Name: Terence Davis
Date Created: 02/15/2017

Notes: Window mounted package units are beyond their expected life. There is no independent cooling for the MDF. Corridors are not conditioned. System renewal is recommended.

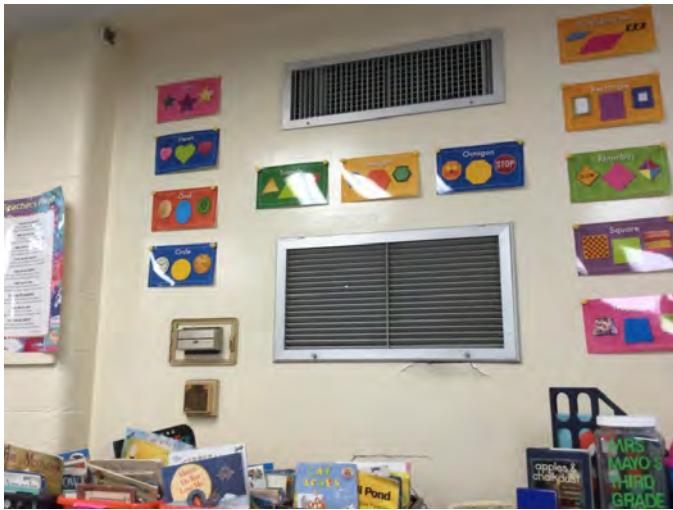
System: D3060 - Controls & Instrumentation

Location: Throughout the building
Distress: Beyond Service Life
Category: Deferred Maintenance
Priority: 3 - Necessary/Not Yet Critical (Years 2-5)
Correction: Renew System
Qty: 35,500.00
Unit of Measure: S.F.
Estimate: \$75,757.00
Assessor Name: Terence Davis
Date Created: 02/15/2017

Notes: Building HVAC controls are beyond their expected life. They are locally controlled. Installation of a modern digital system with remote monitoring and control capability for energy conservation is recommended.

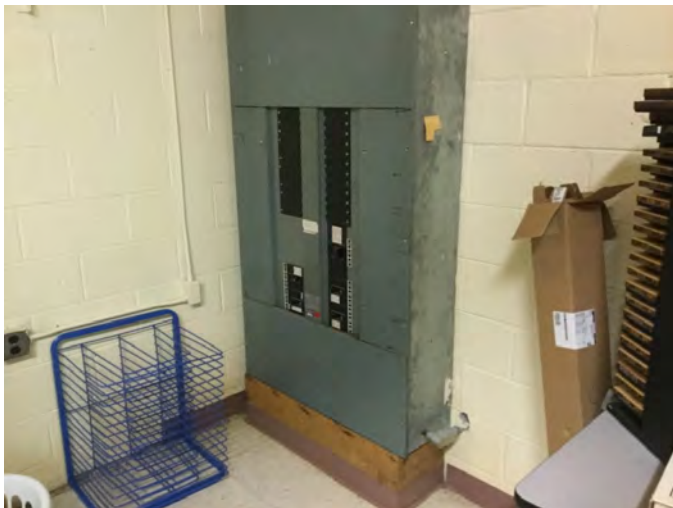
System: D5010 - Electrical Service/Distribution

Location: Main electric services
Distress: Beyond Service Life
Category: Deferred Maintenance
Priority: 3 - Necessary/Not Yet Critical (Years 2-5)
Correction: Renew System
Qty: 35,500.00
Unit of Measure: S.F.
Estimate: \$65,995.00
Assessor Name: Terence Davis
Date Created: 02/15/2017

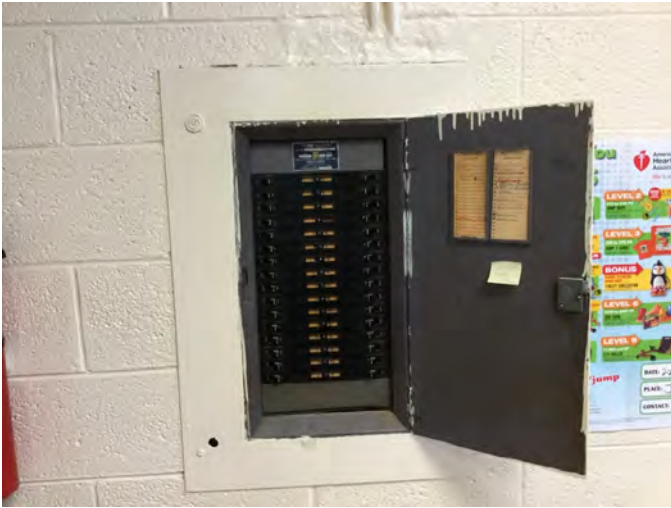
System: D5020 - Branch Wiring

Location: Throughout the building
Distress: Beyond Service Life
Category: Deferred Maintenance
Priority: 3 - Necessary/Not Yet Critical (Years 2-5)
Correction: Renew System
Qty: 35,500.00
Unit of Measure: S.F.
Estimate: \$197,593.00
Assessor Name: Terence Davis
Date Created: 02/15/2017

Notes: Branch wiring is expired. There are insufficient outlets throughout the building. System renewal is recommended.

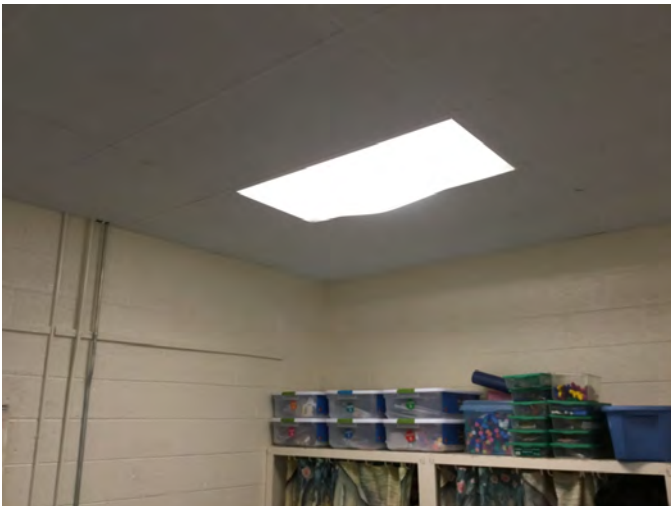
System: D5020 - Lighting

Location: Throughout the building
Distress: Beyond Service Life
Category: Deferred Maintenance
Priority: 3 - Necessary/Not Yet Critical (Years 2-5)
Correction: Renew System
Qty: 35,500.00
Unit of Measure: S.F.
Estimate: \$465,476.00
Assessor Name: Terence Davis
Date Created: 02/15/2017

Notes: A lighting upgrade in 2011 replaced ballasts and lamps, but did not typically replace fixtures and the system is now considered expired with renewal recommended.

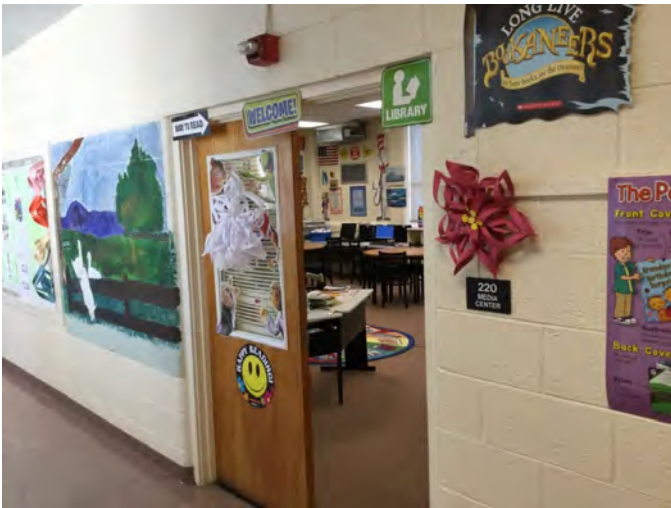
System: D5030910 - Fire Alarm Systems

Location: Throughout the building
Distress: Beyond Service Life
Category: Deferred Maintenance
Priority: 3 - Necessary/Not Yet Critical (Years 2-5)
Correction: Renew System
Qty: 35,500.00
Unit of Measure: S.F.
Estimate: \$132,380.00
Assessor Name: Terence Davis
Date Created: 02/15/2017

Notes: The fire alarm system is of an unknown date, however is assumed to be beyond its expected life. Strobes and annunciators not seen in restrooms. System renewal is recommended.

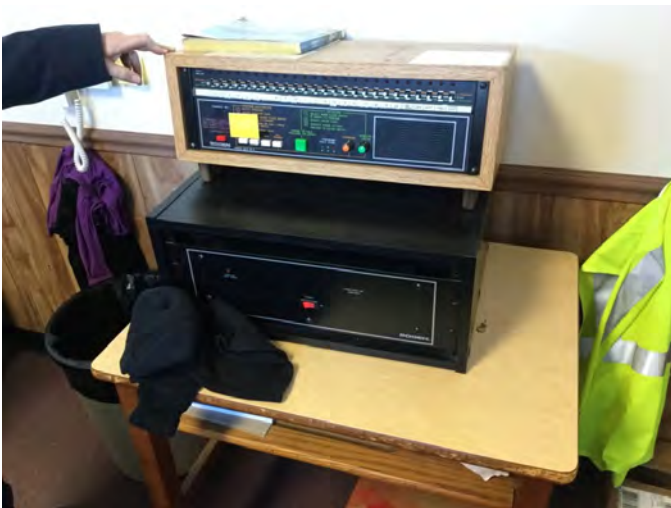
System: D5030920 - Data Communication

Location: Throughout the building
Distress: Beyond Service Life
Category: Deferred Maintenance
Priority: 3 - Necessary/Not Yet Critical (Years 2-5)
Correction: Renew System
Qty: 35,500.00
Unit of Measure: S.F.
Estimate: \$171,820.00
Assessor Name: Terence Davis
Date Created: 02/15/2017

Notes: The PA system does not function. Announcements need to be made on a room by room basis via telephone. System renewal is recommended.

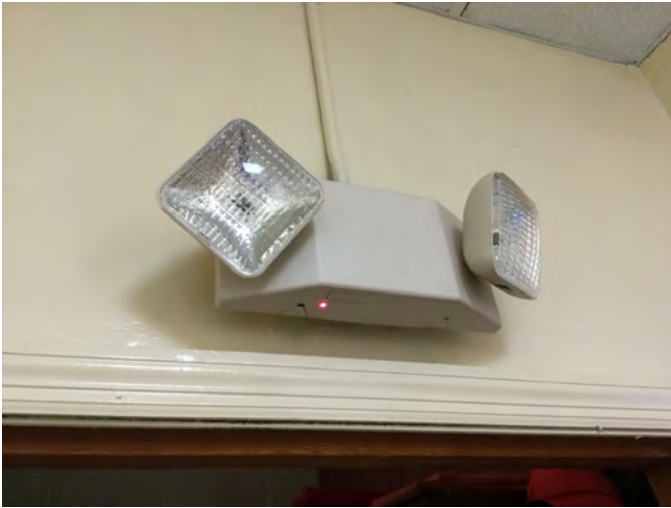
System: D5090 - Other Electrical Systems

Location: Throughout the building
Distress: Beyond Service Life
Category: Deferred Maintenance
Priority: 3 - Necessary/Not Yet Critical (Years 2-5)
Correction: Renew System
Qty: 35,500.00
Unit of Measure: S.F.
Estimate: \$4,686.00
Assessor Name: Terence Davis
Date Created: 02/15/2017

Notes: Emergency and egress lighting is beyond its expected useful life. System coverage should be reviewed as some exit signage does not appear to be illuminated. System renewal is recommended.

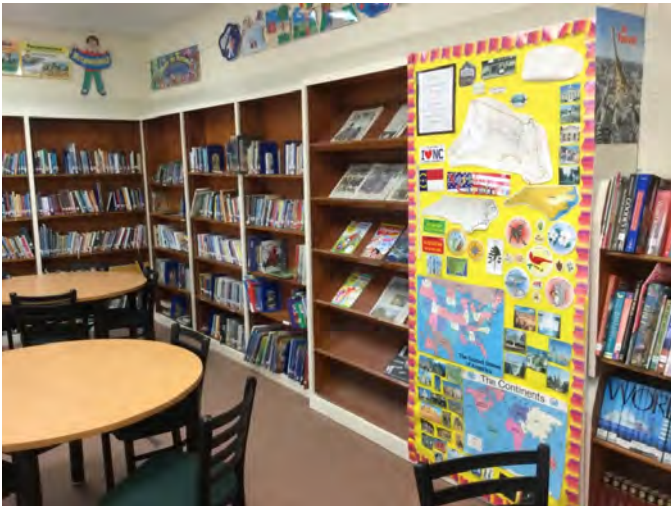
System: F1020 - Institutional Equipment

Location: Library and classrooms
Distress: Beyond Service Life
Category: Deferred Maintenance
Priority: 3 - Necessary/Not Yet Critical (Years 2-5)
Correction: Renew System
Qty: 35,500.00
Unit of Measure: S.F.
Estimate: \$11,715.00
Assessor Name: Terence Davis
Date Created: 02/15/2017

Notes: Institutional equipment is generally beyond its expected life. System renewal is recommended.

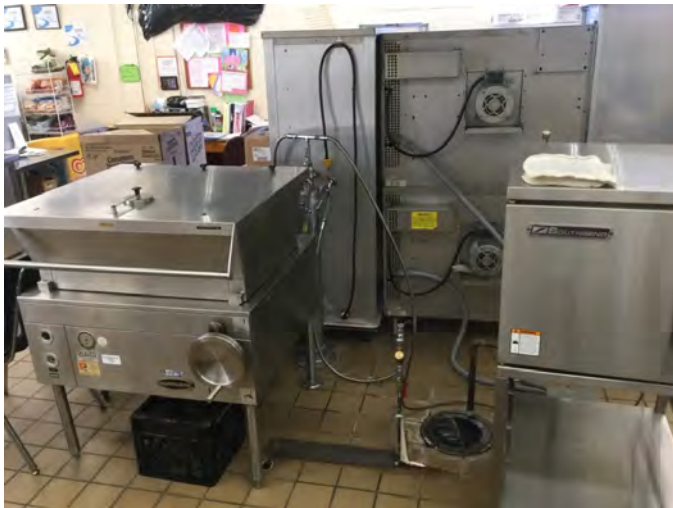
System: E1090 - Other Equipment

Location: Kitchen
Distress: Beyond Service Life
Category: Deferred Maintenance
Priority: 3 - Necessary/Not Yet Critical (Years 2-5)
Correction: Renew System
Qty: 35,500.00
Unit of Measure: S.F.
Estimate: \$74,195.00
Assessor Name: Terence Davis
Date Created: 02/15/2017

Notes: Kitchen equipment is generally well beyond its expected service life and should be replaced.

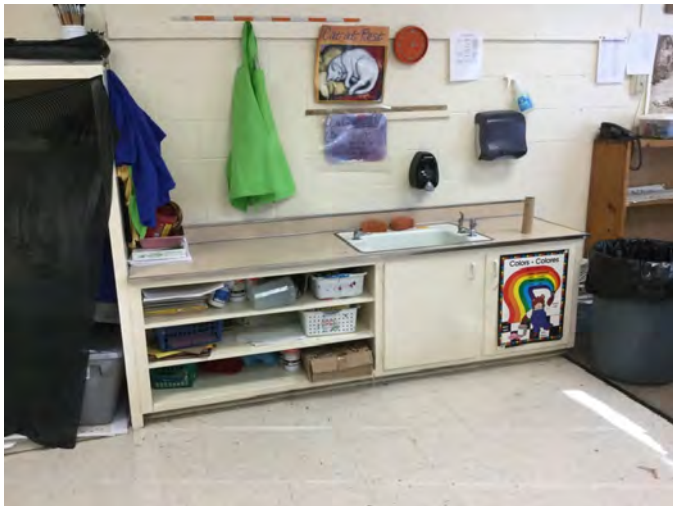
System: E2010 - Fixed Furnishings

Location: Throughout the building
Distress: Beyond Service Life
Category: Deferred Maintenance
Priority: 3 - Necessary/Not Yet Critical (Years 2-5)
Correction: Renew System
Qty: 35,500.00
Unit of Measure: S.F.
Estimate: \$227,662.00
Assessor Name: Terence Davis
Date Created: 02/15/2017

Notes: Fixed furnishings are beyond their expected life and are in poor condition. System renewal is recommended.

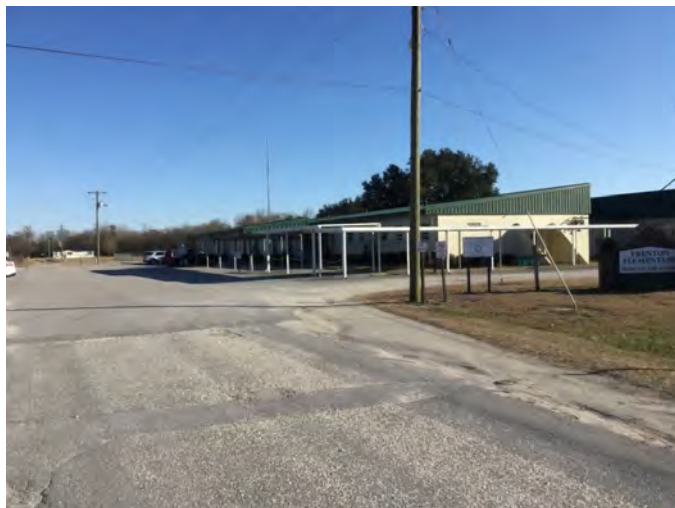
System: G4020 - Site Lighting

Location: Site
Distress: Inadequate
Category: Deferred Maintenance / Safety
Priority: 2 - Potentially Critical (Year 1)
Correction: Renew System
Qty: 35,500.00
Unit of Measure: S.F.
Estimate: \$57,404.00
Assessor Name: Ann Buerger Linden
Date Created: 02/15/2017

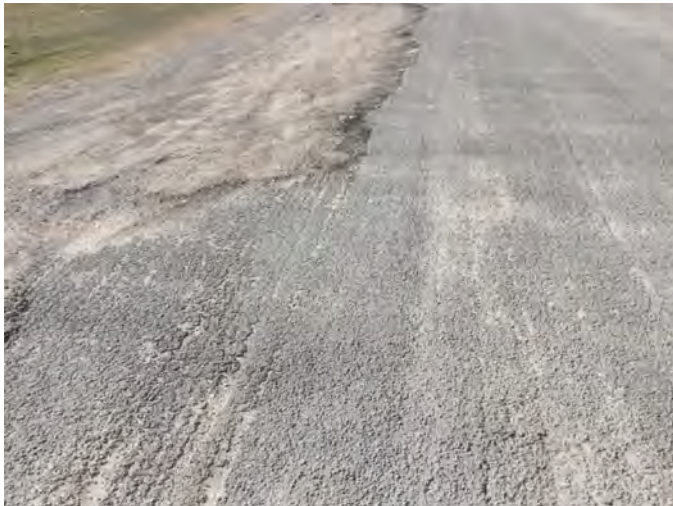
System: G2010 - Roadways

Location: Roadways
Distress: Beyond Service Life
Category: Deferred Maintenance
Priority: 3 - Necessary/Not Yet Critical (Years 2-5)
Correction: Renew System
Qty: 35,500.00
Unit of Measure: S.F.
Estimate: \$148,781.00
Assessor Name: Ann Buerger Linden
Date Created: 02/15/2017

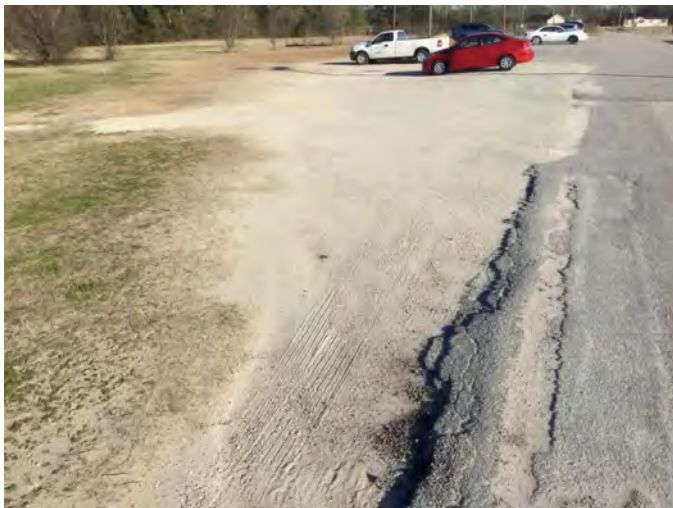
System: G2020 - Parking Lots

Location: Parking lots
Distress: Beyond Service Life
Category: Deferred Maintenance
Priority: 3 - Necessary/Not Yet Critical (Years 2-5)
Correction: Renew System
Qty: 35,500.00
Unit of Measure: S.F.
Estimate: \$51,937.00
Assessor Name: Ann Buerger Linden
Date Created: 02/15/2017

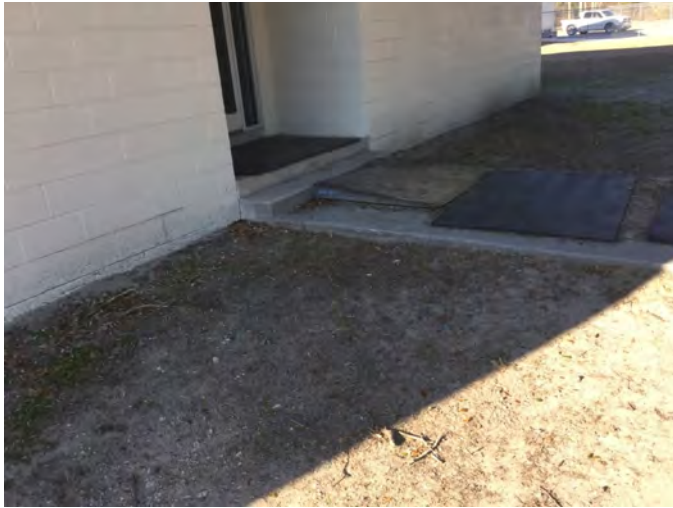
System: G2030 - Pedestrian Paving

Location: Site sidewalks
Distress: Beyond Service Life
Category: Deferred Maintenance
Priority: 3 - Necessary/Not Yet Critical (Years 2-5)
Correction: Renew System
Qty: 35,500.00
Unit of Measure: S.F.
Estimate: \$74,586.00
Assessor Name: Ann Buerger Linden
Date Created: 02/15/2017

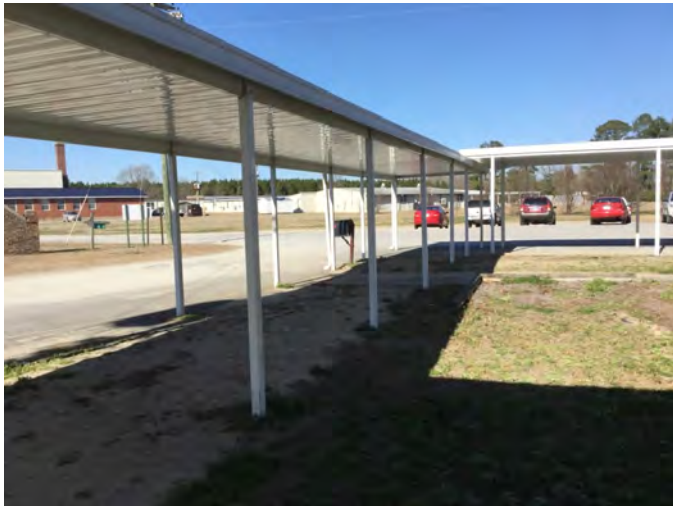
System: G2040950 - Covered Walkways

Location: Site
Distress: Inadequate
Category: Deferred Maintenance
Priority: 3 - Necessary/Not Yet Critical (Years 2-5)
Correction: Renew System
Qty: 35,500.00
Unit of Measure: S.F.
Estimate: \$59,356.00
Assessor Name: Ann Buerger Linden
Date Created: 02/15/2017

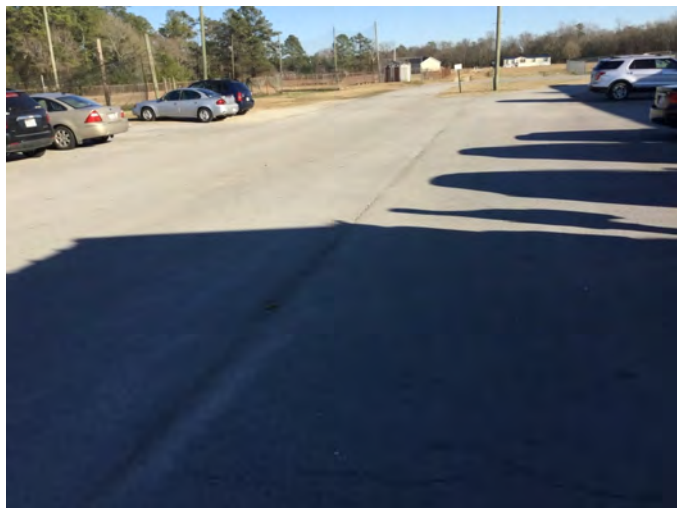
System: G3030 - Storm Sewer

Location: Site
Distress: Missing
Category: Deferred Maintenance
Priority: 3 - Necessary/Not Yet Critical (Years 2-5)
Correction: Renew System
Qty: 35,500.00
Unit of Measure: S.F.
Estimate: \$177,287.00
Assessor Name: Ann Buerger Linden
Date Created: 02/15/2017
