NC School District/430 Harnett County/High School

Triton High

Campus Assessment Report

March 11, 2017

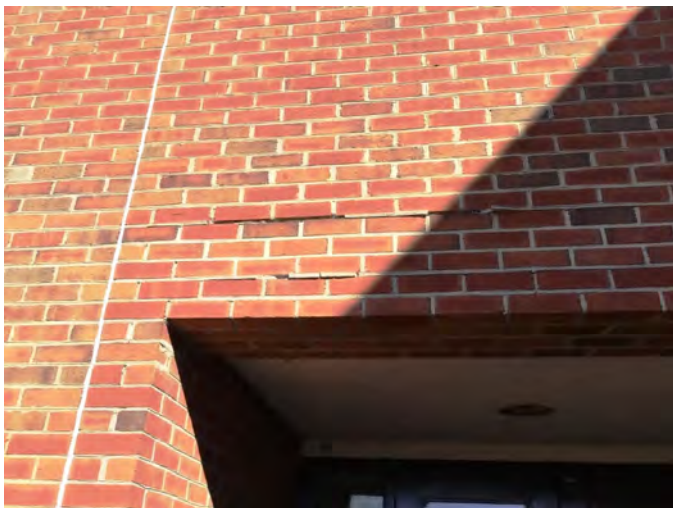
System: B2010 - Exterior Walls

Location: Exterior of the building
Distress: Failing
Category: Safety / Building Code Compliance
Priority: 1 - Currently Critical (Immediate)
Correction: Engineering Study-2016-11-15 17:41:59
Qty: 1.00
Unit of Measure: Ea.
Estimate: \$13,200.00
Assessor Name: Eduardo Lopez
Date Created: 12/06/2016

Notes: There are various places where visible cracks are showing, and then there are other areas where the bricks and mortar are missing.

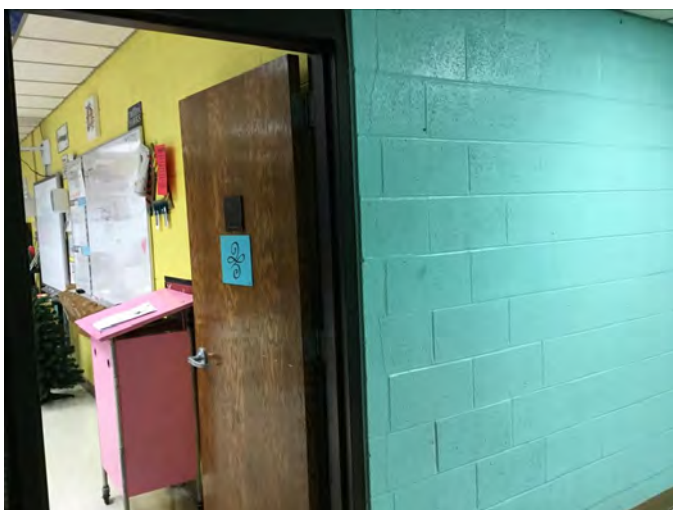
System: C1010 - Partitions

Location: Library 2nd Floor and 1st floor classroom 318
Distress: Failing
Category: Safety / Building Code Compliance
Priority: 1 - Currently Critical (Immediate)
Correction: Engineering Study
Qty: 1.00
Unit of Measure: Ea.
Estimate: \$13,200.00
Assessor Name: Eduardo Lopez
Date Created: 11/30/2016

Notes: There are visible cracks on the partition wall which should be studied by a professional engineer.

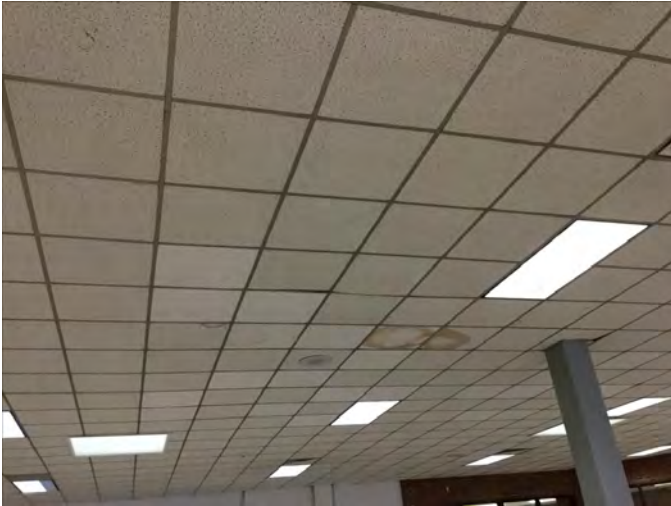
System: C3030 - Ceiling Finishes

Location: Throughout Building
Distress: Failing
Category: Deferred Maintenance / Building Code Compliance
Priority: 2 - Potentially Critical (Year 1)
Correction: Renew System
Qty: 246,550.00
Unit of Measure: S.F.
Estimate: \$2,863,925.00
Assessor Name: Eduardo Lopez
Date Created: 11/30/2016

Notes: The ceiling finishes are in poor condition, most of the areas near the gymnasium, auditorium, and cafeteria are showing signs of high humidity. Some of the ceiling tiles has mold, some of them are broken and the rest of them are sagging. The ceiling tiles need to be replaced.

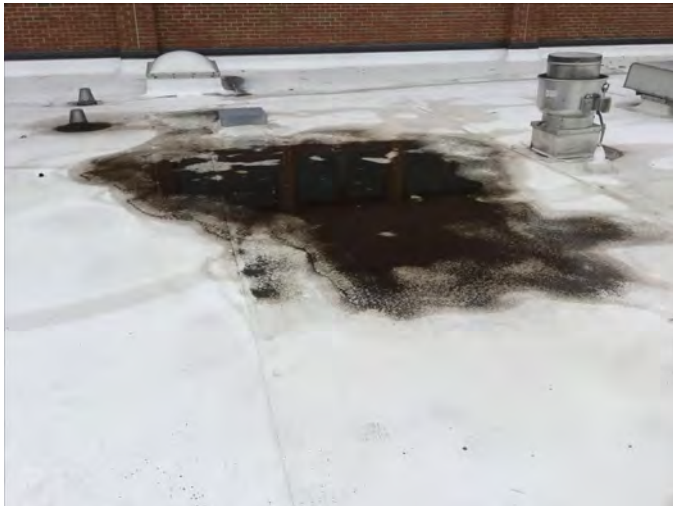
System: B3010120 - Single Ply Membrane

Location: Roof
Distress: Failing
Category: Building Code Compliance
Priority: 3 - Necessary/Not Yet Critical (Years 2-5)
Correction: Minor replacement, 25% of roof area, thermoset
Qty: 2,105.00
Unit of Measure: Sq.
Estimate: \$1,401,109.05
Assessor Name: Eduardo Lopez
Date Created: 11/30/2016

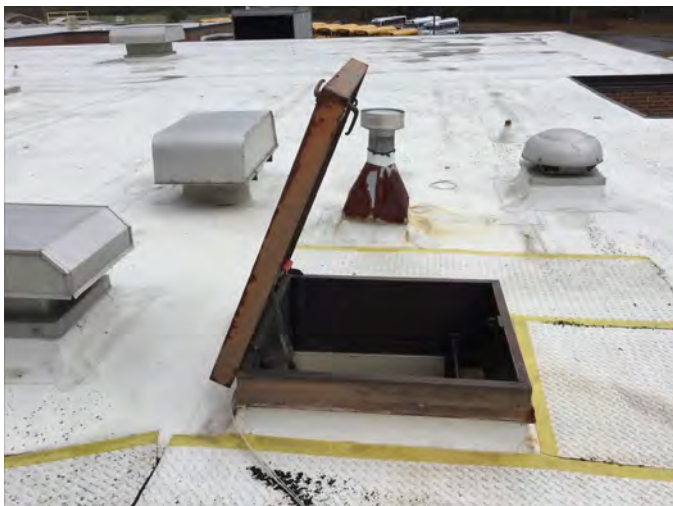
System: B3020 - Roof Openings

Location: Roof
Distress: Beyond Service Life
Category: Deferred Maintenance / Building Code Compliance
Priority: 3 - Necessary/Not Yet Critical (Years 2-5)
Correction: Replace roof hatch and structure single unit
Qty: 3.00
Unit of Measure: Ea.
Estimate: \$6,127.31
Assessor Name: Eduardo Lopez
Date Created: 11/30/2016

Notes: The roof hatches are rusted and beyond their service life and need to be replaced with OSHA compliant access hatches.

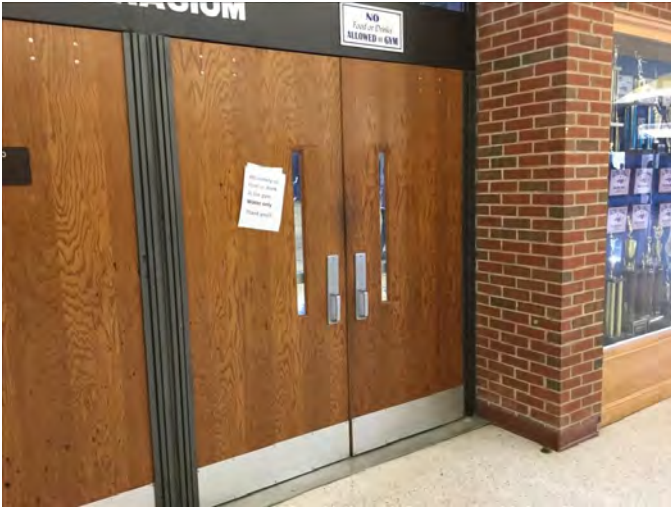
System: C1020 - Interior Doors

Location: Throughout Building
Distress: Beyond Service Life
Category: Deferred Maintenance
Priority: 3 - Necessary/Not Yet Critical (Years 2-5)
Correction: Renew System
Qty: 246,550.00
Unit of Measure: S.F.
Estimate: \$661,740.00
Assessor Name: Eduardo Lopez
Date Created: 11/30/2016

Notes: The interior doors are beyond their service life and should be replaced.

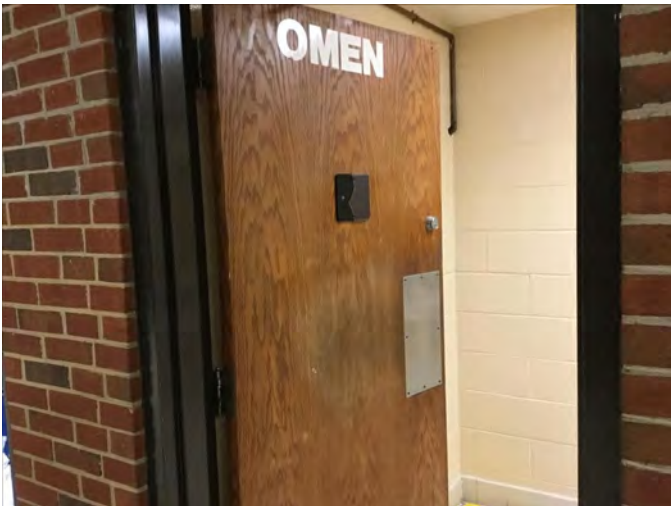
System: C1030 - Fittings

Location: Throughout the building
Distress: Inadequate
Category: Deferred Maintenance / Accessibility Code Compliance
Priority: 3 - Necessary/Not Yet Critical (Years 2-5)
Correction: Replace signage and toilet partitions
Qty: 325.00
Unit of Measure: Ea.
Estimate: \$34,446.56
Assessor Name: Eduardo Lopez
Date Created: 11/30/2016

Notes: The signages are not ADA code compliant and they should be replaced.

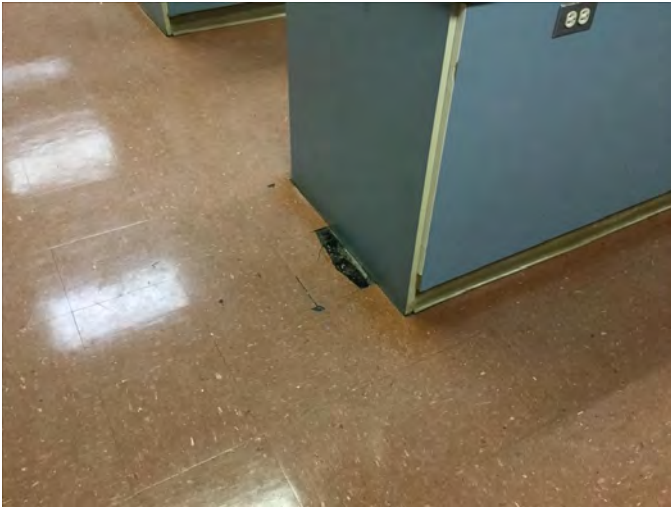
System: C3020 - Floor Finishes

Location: Second floor
Distress: Beyond Service Life
Category: Deferred Maintenance / Appearance
Priority: 3 - Necessary/Not Yet Critical (Years 2-5)
Correction: Replace vinyl tile flooring
Qty: 750.00
Unit of Measure: S.Y.
Estimate: \$80,635.50
Assessor Name: Eduardo Lopez
Date Created: 11/30/2016

Notes: The vinyl tiles are in poor condition and beyond their service life and should be replaced.

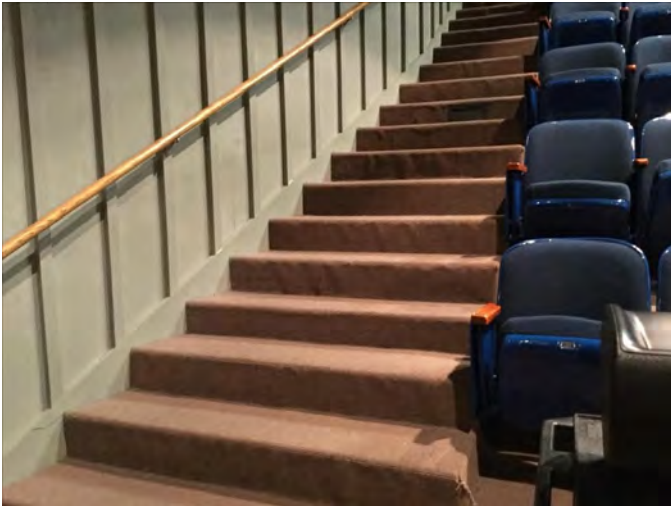
System: C3020 - Floor Finishes

Location: Throughout the building
Distress: Beyond Service Life
Category: Deferred Maintenance / Appearance
Priority: 3 - Necessary/Not Yet Critical (Years 2-5)
Correction: Replace carpet
Qty: 575.00
Unit of Measure: S.Y.
Estimate: \$49,152.84
Assessor Name: Eduardo Lopez
Date Created: 11/30/2016

Notes: The carpet is beyond its service life and should be replaced.

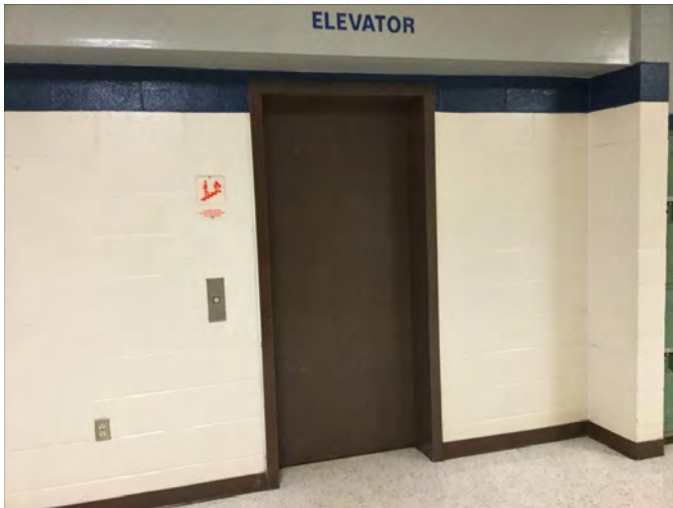
System: D1010 - Elevators and Lifts

Location: Throughout Building
Distress: Beyond Service Life
Category: Deferred Maintenance
Priority: 3 - Necessary/Not Yet Critical (Years 2-5)
Correction: Renew System
Qty: 246,550.00
Unit of Measure: S.F.
Estimate: \$265,781.00
Assessor Name: Eduardo Lopez
Date Created: 11/30/2016

Notes: The elevator system is beyond its service life and should be replaced.

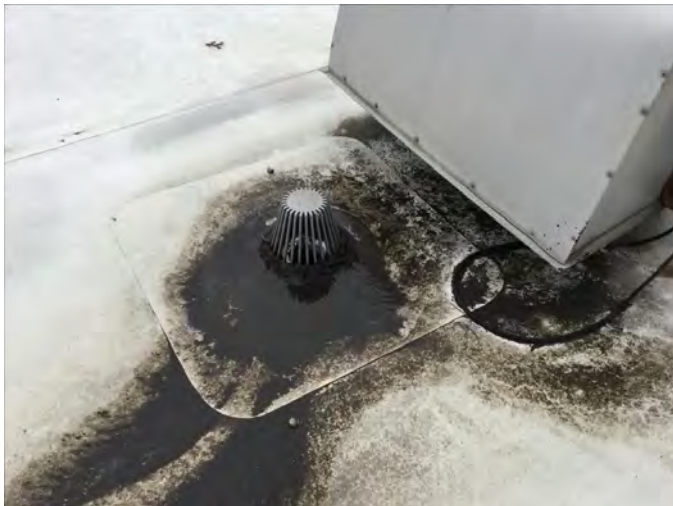
System: D2040 - Rain Water Drainage

Location: Roof
Distress: Beyond Service Life
Category: Deferred Maintenance
Priority: 3 - Necessary/Not Yet Critical (Years 2-5)
Correction: Renew System
Qty: 246,550.00
Unit of Measure: S.F.
Estimate: \$170,859.00
Assessor Name: Eduardo Lopez
Date Created: 11/30/2016

Notes: The rain water drainage system is beyond its service life and should be replaced.

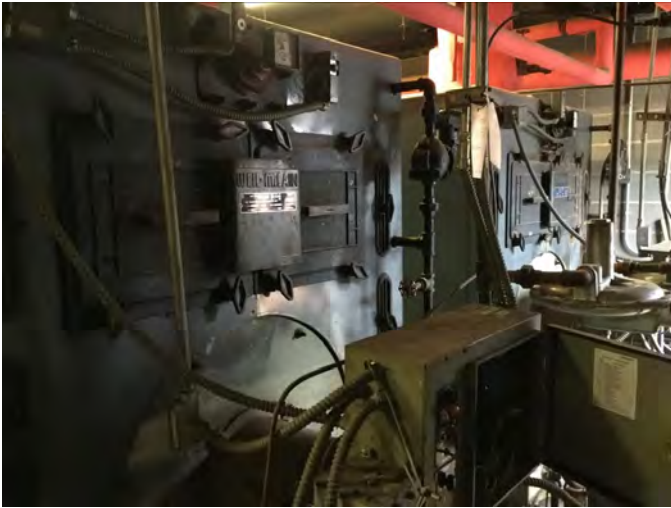
System: D3020 - Heat Generating Systems

Location: Mechanical Room
Distress: Beyond Service Life
Category: Deferred Maintenance
Priority: 3 - Necessary/Not Yet Critical (Years 2-5)
Correction: Renew System
Qty: 246,550.00
Unit of Measure: S.F.
Estimate: \$1,879,451.00
Assessor Name: Eduardo Lopez
Date Created: 11/30/2016

Notes: The natural gas boilers are beyond their service life and should be replaced.

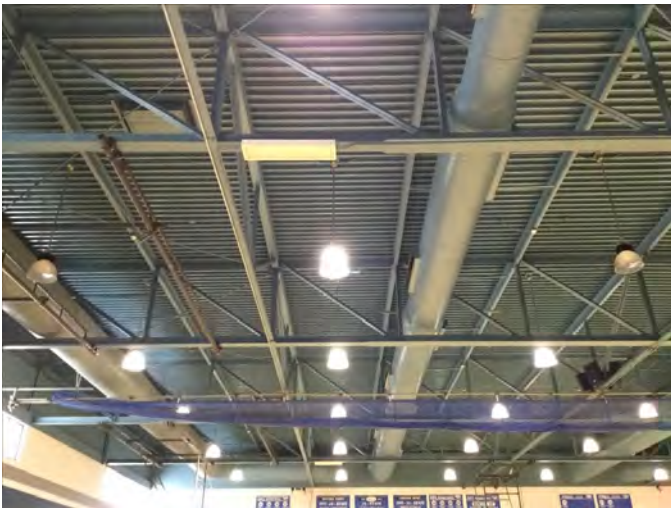
System: D3040 - Distribution Systems

Location: Roof
Distress: Beyond Service Life
Category: Deferred Maintenance
Priority: 3 - Necessary/Not Yet Critical (Years 2-5)
Correction: Renew System
Qty: 246,550.00
Unit of Measure: S.F.
Estimate: \$2,269,986.00
Assessor Name: Eduardo Lopez
Date Created: 11/30/2016

Notes: The rooftop units and the older air handling units are beyond their service life and should be replaced.

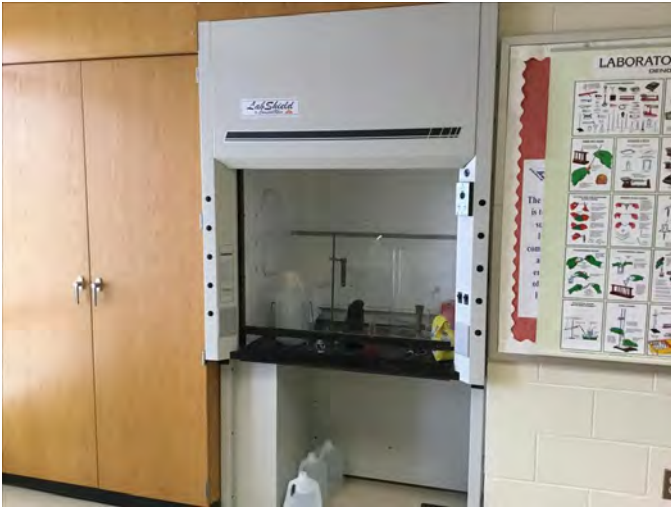
System: D3090 - Other HVAC Systems/Equip

Location: Throughout Building
Distress: Beyond Service Life
Category: Deferred Maintenance
Priority: 3 - Necessary/Not Yet Critical (Years 2-5)
Correction: Renew System
Qty: 246,550.00
Unit of Measure: S.F.
Estimate: \$376,975.00
Assessor Name: Eduardo Lopez
Date Created: 12/05/2016

Notes: The fumehoods, dust collectors, and welding exhaust are beyond their service life and should be replaced.

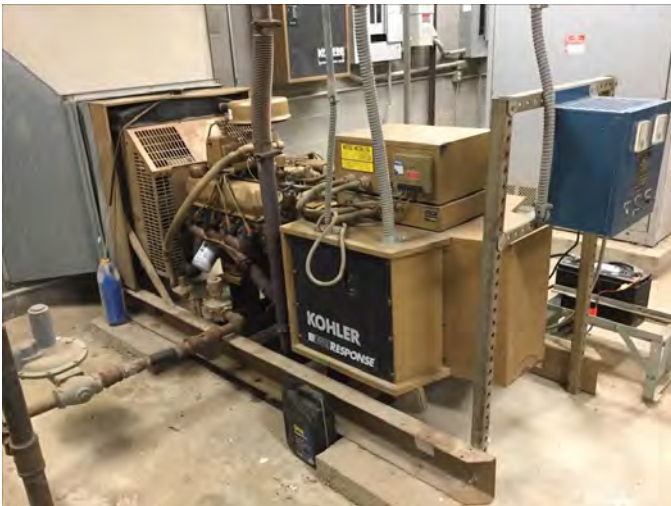
System: D5090 - Other Electrical Systems

Location: Mechanical Room
Distress: Beyond Service Life
Category: Deferred Maintenance
Priority: 3 - Necessary/Not Yet Critical (Years 2-5)
Correction: Renew System
Qty: 246,550.00
Unit of Measure: S.F.
Estimate: \$181,707.00
Assessor Name: Eduardo Lopez
Date Created: 11/30/2016

Notes: The generator system is beyond its service life and should be replaced.

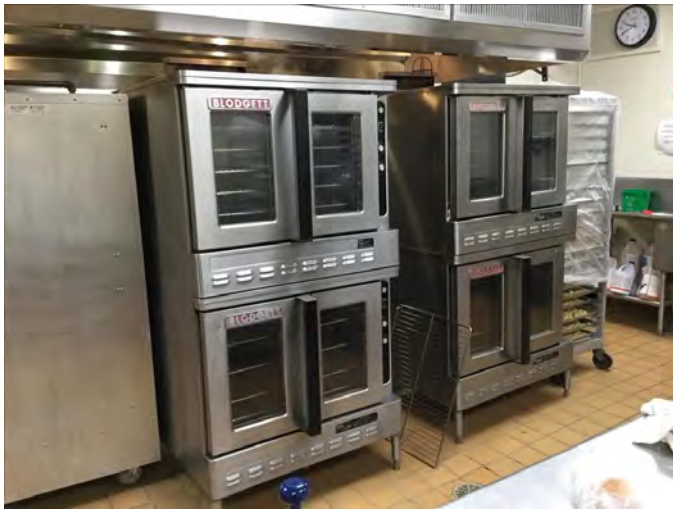
System: E1090 - Other Equipment

Location: Cafeteria
Distress: Beyond Service Life
Category: Deferred Maintenance
Priority: 3 - Necessary/Not Yet Critical (Years 2-5)
Correction: Renew System
Qty: 246,550.00
Unit of Measure: S.F.
Estimate: \$1,453,659.00
Assessor Name: Eduardo Lopez
Date Created: 11/30/2016

Notes: The kitchen equipment is beyond its service life and should be replaced.

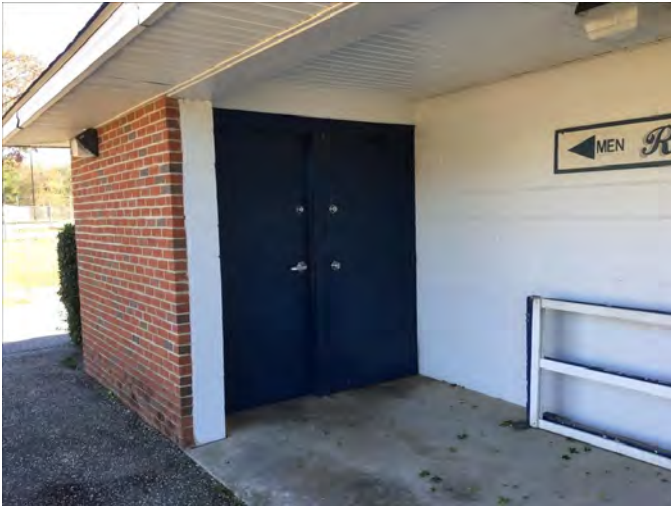
System: B2030 - Exterior Doors

Location: Exterior of the building
Distress: Beyond Service Life
Category: Deferred Maintenance
Priority: 3 - Necessary/Not Yet Critical (Years 2-5)
Correction: Renew System
Qty: 1,100.00
Unit of Measure: S.F.
Estimate: \$1,634.00
Assessor Name: Eduardo Lopez
Date Created: 11/30/2016

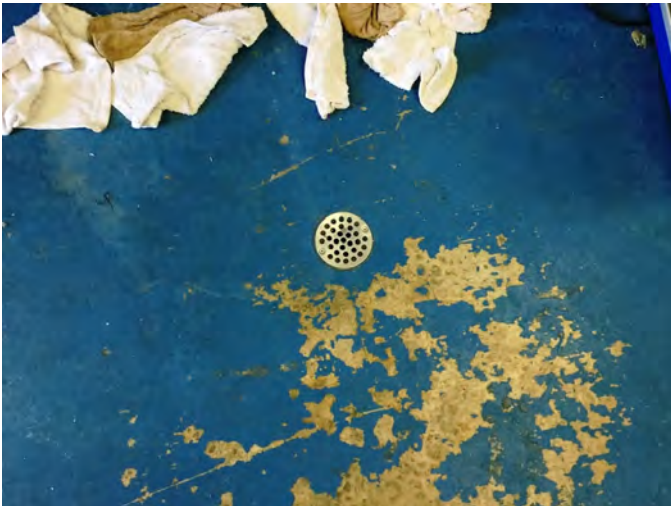
System: C3020 - Floor Finishes

Location: Concession Room
Distress: Failing
Category: Deferred Maintenance / Appearance
Priority: 3 - Necessary/Not Yet Critical (Years 2-5)
Correction: Replace epoxy flooring
Qty: 8.14
Unit of Measure: C.S.F.
Estimate: \$17,170.19
Assessor Name: Eduardo Lopez
Date Created: 12/06/2016

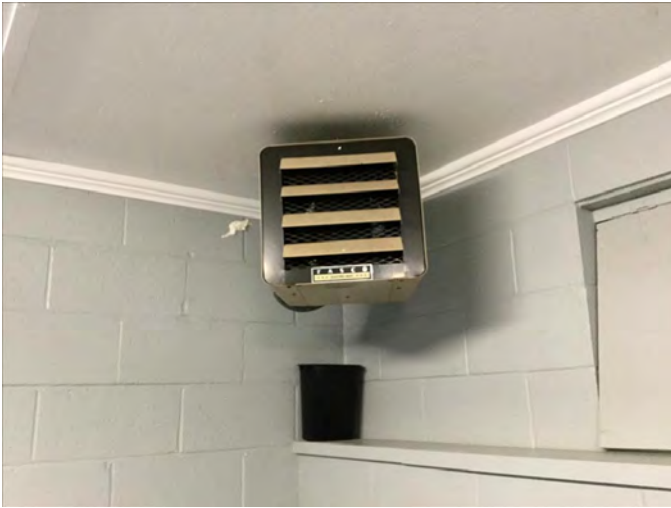
System: D3050 - Terminal & Package Units

Location: Throughout Building
Distress: Beyond Service Life
Category: Deferred Maintenance
Priority: 3 - Necessary/Not Yet Critical (Years 2-5)
Correction: Renew System
Qty: 1,100.00
Unit of Measure: S.F.
Estimate: \$20,522.00
Assessor Name: Eduardo Lopez
Date Created: 11/30/2016

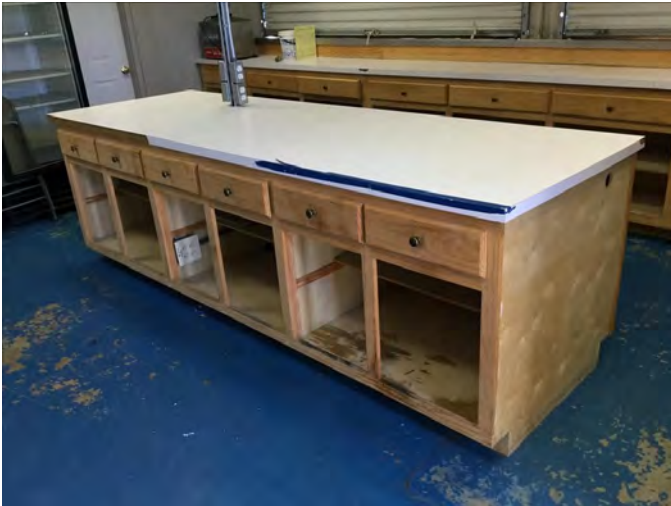
System: E2010 - Fixed Furnishings

Location: Concession Room
Distress: Beyond Service Life
Category: Deferred Maintenance / Appearance
Priority: 3 - Necessary/Not Yet Critical (Years 2-5)
Correction: Renew System
Qty: 1,100.00
Unit of Measure: S.F.
Estimate: \$6,147.00
Assessor Name: Eduardo Lopez
Date Created: 11/30/2016

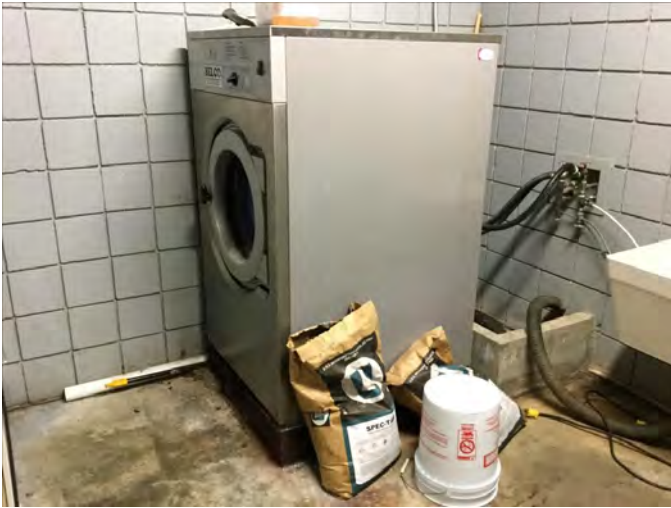
System: E1010 - Commercial Equipment

Location: Laundry Room
Distress: Beyond Service Life
Category: Deferred Maintenance
Priority: 3 - Necessary/Not Yet Critical (Years 2-5)
Correction: Renew System
Qty: 3,200.00
Unit of Measure: S.F.
Estimate: \$28,794.00
Assessor Name: Somnath Das
Date Created: 12/06/2016

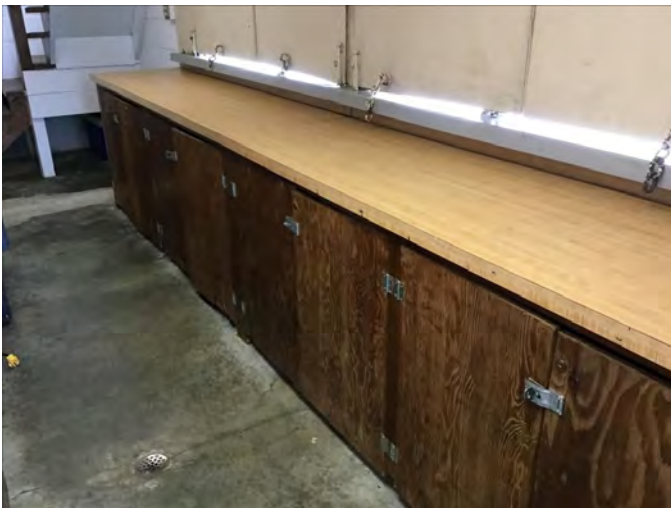
Location: Throughout Building
Distress: Beyond Service Life
Category: Deferred Maintenance / Appearance
Priority: 3 - Necessary/Not Yet Critical (Years 2-5)
Correction: Renew System
Qty: 250.00
Unit of Measure: S.F.
Estimate: \$2,571.00
Assessor Name: Eduardo Lopez
Date Created: 11/30/2016
