Wayne Avenue Elementary

Campus Assessment Report

March 11, 2017

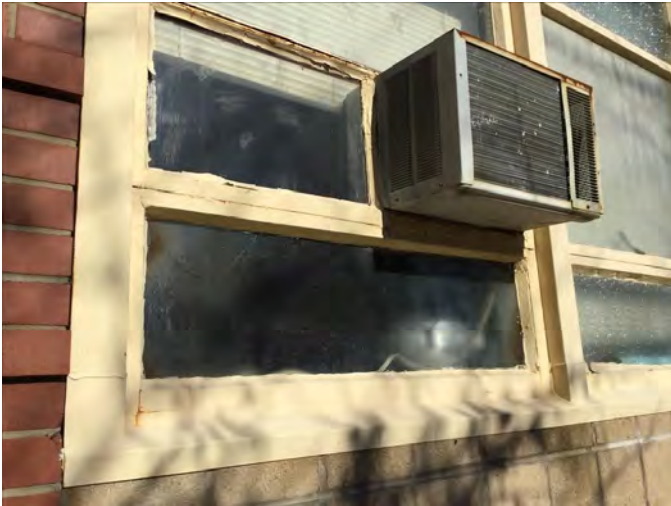
System: B2020 - Exterior Windows

Location: Exterior
Distress: Beyond Service Life
Category: Deferred Maintenance
Priority: 3 - Necessary/Not Yet Critical (Years 2-5)
Correction: Renew System
Qty: 27,822.00
Unit of Measure: S.F.
Estimate: \$287,373.00
Assessor Name: Terence Davis
Date Created: 12/08/2016

Notes: The aluminum frame single pane windows are aged, rusted, not energy efficient, and should be replaced.

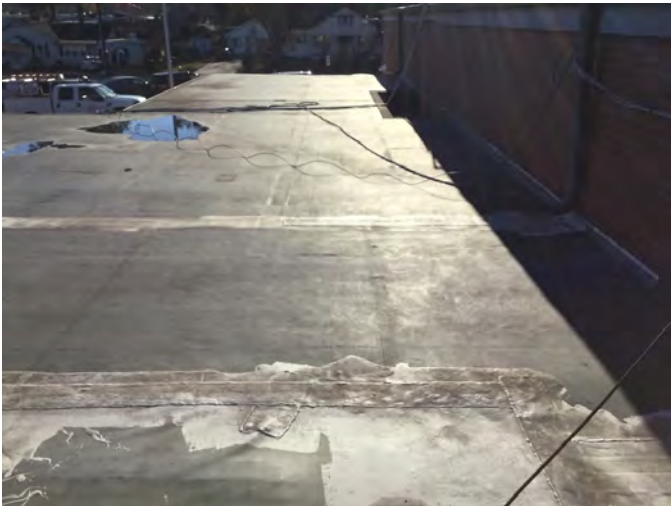
System: B3010120 - Single Ply Membrane

Location: Roof
Distress: Failing
Category: Deferred Maintenance
Priority: 3 - Necessary/Not Yet Critical (Years 2-5)
Correction: Renew System
Qty: 27,822.00
Unit of Measure: S.F.
Estimate: \$291,296.00
Assessor Name: Terence Davis
Date Created: 12/08/2016

Notes: The single ply adhered roof coverings are aging, showing signs of failure and should be replaced.

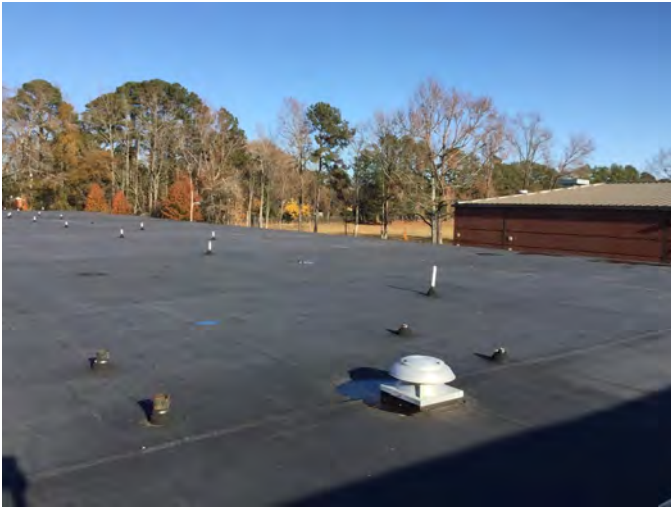
System: B3020 - Roof Openings

Location: Roof
Distress: Beyond Service Life
Category: Deferred Maintenance
Priority: 3 - Necessary/Not Yet Critical (Years 2-5)
Correction: Renew System
Qty: 27,822.00
Unit of Measure: S.F.
Estimate: \$8,875.00
Assessor Name: Terence Davis
Date Created: 12/08/2016

Notes: The roof openings should be inspected and repaired when the roof is replaced.

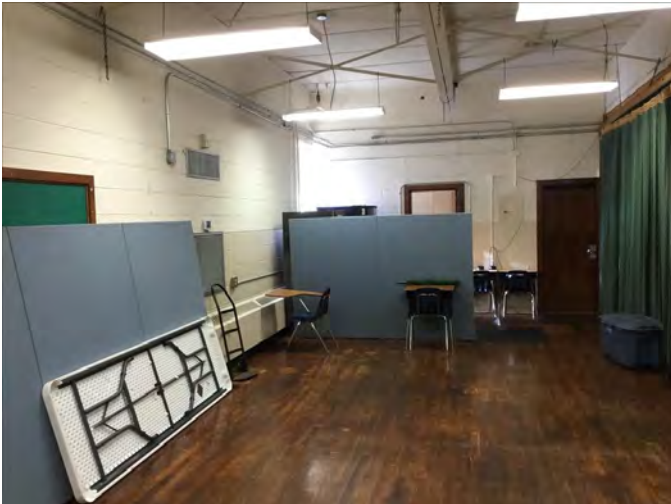
System: C3010 - Wall Finishes

Location: Throughout the building
Distress: Beyond Service Life
Category: Deferred Maintenance
Priority: 3 - Necessary/Not Yet Critical (Years 2-5)
Correction: Renew System
Qty: 27,822.00
Unit of Measure: S.F.
Estimate: \$85,386.00
Assessor Name: Terence Davis
Date Created: 12/08/2016

Notes: The wall finishes are aged, scuffed, fading, stained, and should be re-painted.

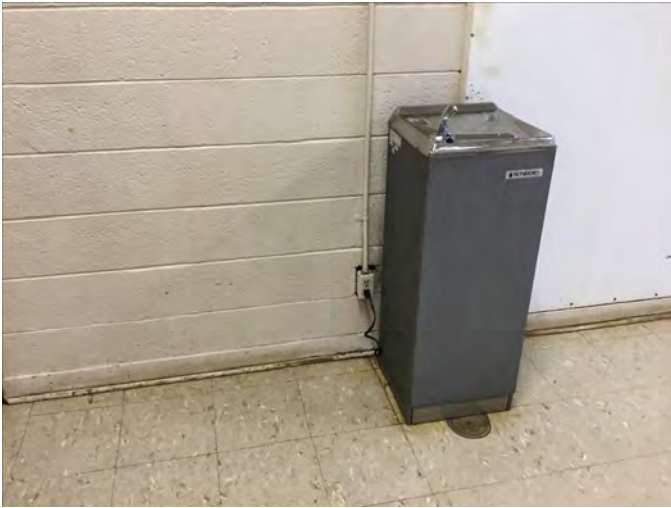
System: D2010 - Plumbing Fixtures

Location: Restroom
Distress: Beyond Service Life
Category: Deferred Maintenance
Priority: 3 - Necessary/Not Yet Critical (Years 2-5)
Correction: Renew System
Qty: 27,822.00
Unit of Measure: S.F.
Estimate: \$351,336.00
Assessor Name: Terence Davis
Date Created: 12/08/2016

Notes: Plumbing fixtures are in operational conditions. However, they are aged, not ADA compliant and should be replaced with a low-flow water fixtures.

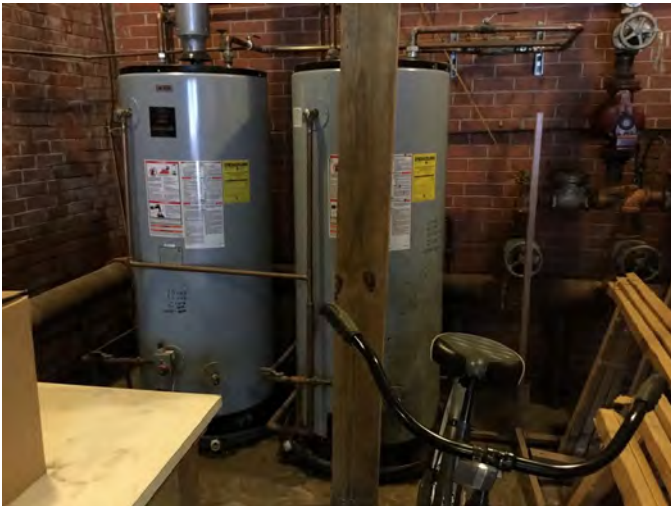
System: D2020 - Domestic Water Distribution

Location: Throughout the building
Distress: Beyond Service Life
Category: Deferred Maintenance
Priority: 3 - Necessary/Not Yet Critical (Years 2-5)
Correction: Renew System
Qty: 27,822.00
Unit of Measure: S.F.
Estimate: \$29,992.00
Assessor Name: Terence Davis
Date Created: 12/08/2016

Notes: There are no reported issues or observed deficiencies with the domestic water piping. Due to the age of the pipe there can be internal pitting corrosion that may be a costly problem that leads to the formation of pinhole leaks and possible water contamination.

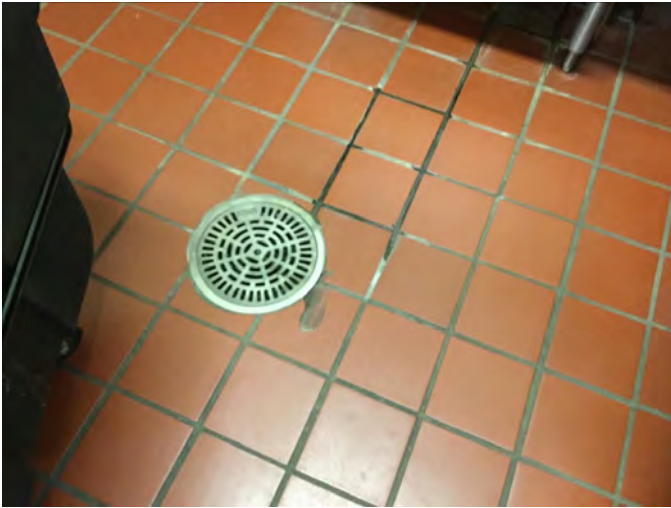
System: D2030 - Sanitary Waste

Location: Throughout the building
Distress: Beyond Service Life
Category: Deferred Maintenance
Priority: 3 - Necessary/Not Yet Critical (Years 2-5)
Correction: Renew System
Qty: 27,822.00
Unit of Measure: S.F.
Estimate: \$47,130.00
Assessor Name: Terence Davis
Date Created: 12/08/2016

Notes: The sanitary waste system is aged and should be replaced.

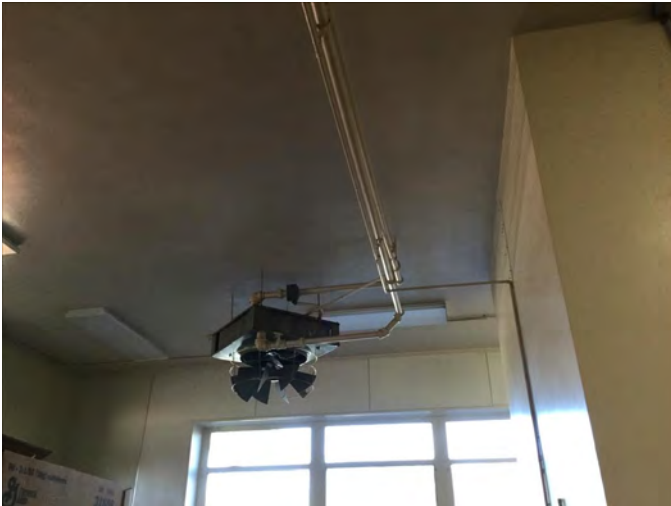
System: D3040 - Distribution Systems

Location: Throughout the building
Distress: Beyond Service Life
Category: Deferred Maintenance
Priority: 3 - Necessary/Not Yet Critical (Years 2-5)
Correction: Renew System
Qty: 27,822.00
Unit of Measure: S.F.
Estimate: \$191,582.00
Assessor Name: Terence Davis
Date Created: 12/08/2016

Notes: The distribution system is aged, in marginal condition, and should be replaced.

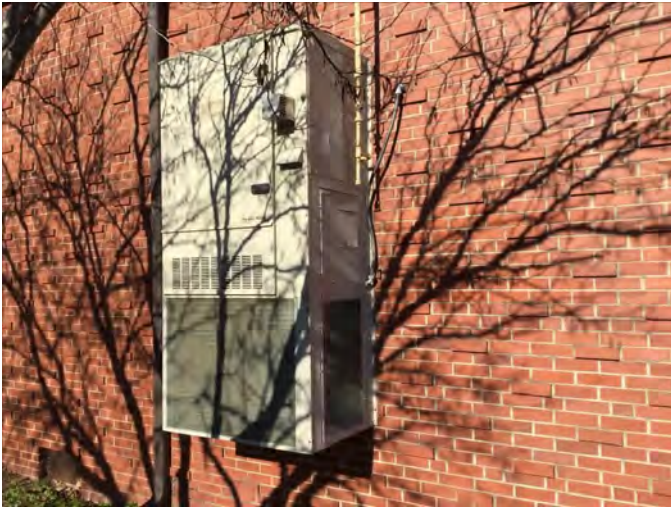
System: D3050 - Terminal & Package Units

Location: Exterior
Distress: Beyond Service Life
Category: Deferred Maintenance
Priority: 3 - Necessary/Not Yet Critical (Years 2-5)
Correction: Renew System
Qty: 27,822.00
Unit of Measure: S.F.
Estimate: \$417,747.00
Assessor Name: Terence Davis
Date Created: 12/08/2016

Notes: The wall mounted Carrier DX condensing units are aged and should be scheduled for replacement.

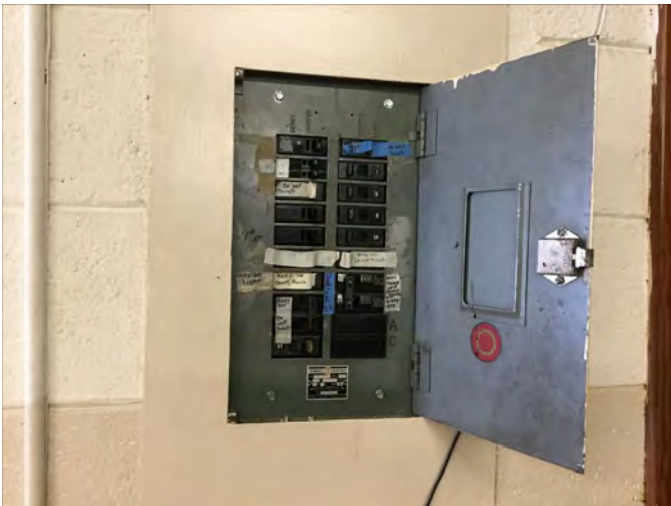
System: D5020 - Branch Wiring

Location: Throughout the building
Distress: Beyond Service Life
Category: Deferred Maintenance
Priority: 3 - Necessary/Not Yet Critical (Years 2-5)
Correction: Renew System
Qty: 27,822.00
Unit of Measure: S.F.
Estimate: \$154,857.00
Assessor Name: Terence Davis
Date Created: 12/08/2016

Notes: The original electrical service is operating, maxed to capacity and should be replaced.

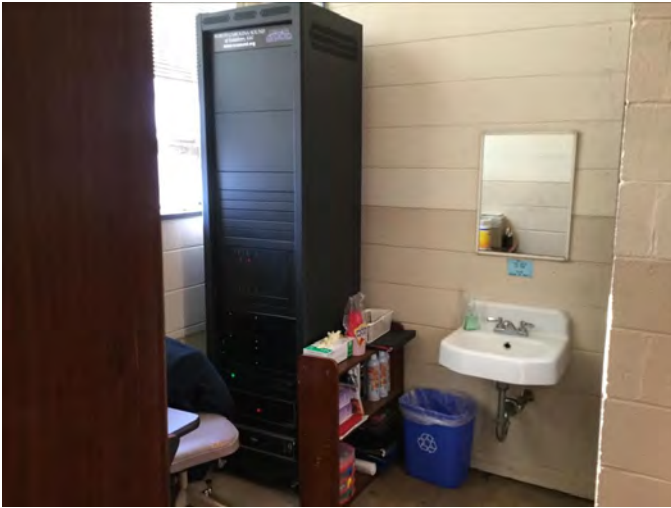
System: E1020 - Institutional Equipment

Location: kitchen
Distress: Beyond Service Life
Category: Deferred Maintenance
Priority: 3 - Necessary/Not Yet Critical (Years 2-5)
Correction: Renew System
Qty: 27,822.00
Unit of Measure: S.F.
Estimate: \$9,181.00
Assessor Name: Terence Davis
Date Created: 12/08/2016

Notes: The Library Equipment, Theater Stage Equipment, Audio-visual Equipment, Other Institutional Equipment is operating but is aged, becoming logistically un-supportable, and should be replaced.

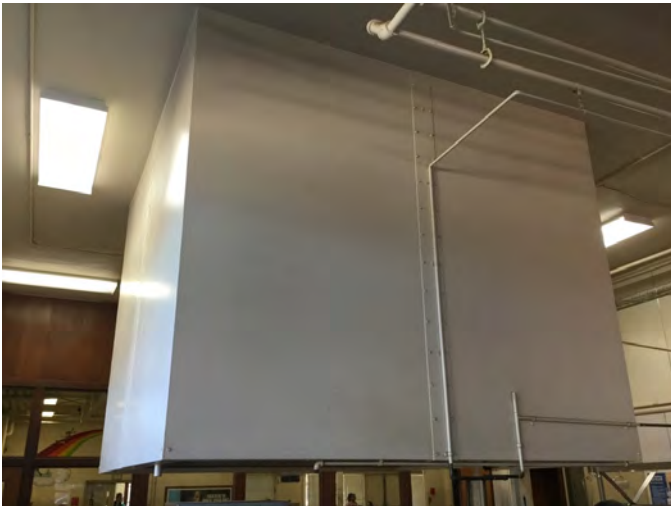
System: E1090 - Other Equipment

Location: Kitchen
Distress: Beyond Service Life
Category: Deferred Maintenance
Priority: 3 - Necessary/Not Yet Critical (Years 2-5)
Correction: Renew System
Qty: 27,822.00
Unit of Measure: S.F.
Estimate: \$58,148.00
Assessor Name: Terence Davis
Date Created: 12/08/2016

Notes: The Food Service Equipment is operating but is aged should be inspected and replaced or repaired as needed.

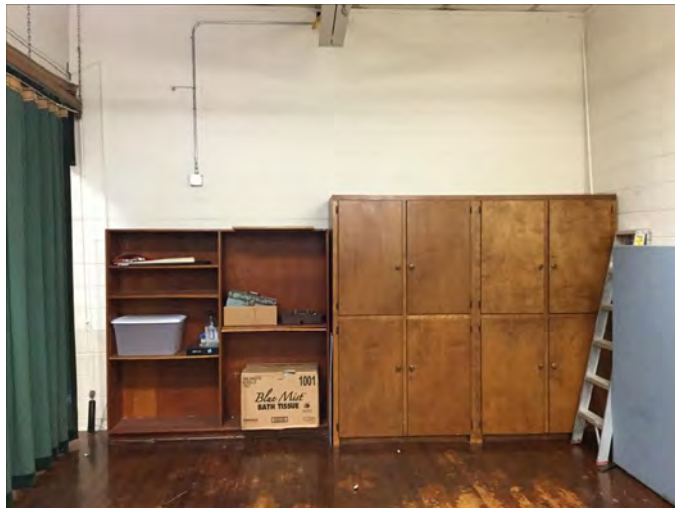
System: E2010 - Fixed Furnishings

Location: Throughout the building
Distress: Beyond Service Life
Category: Deferred Maintenance
Priority: 3 - Necessary/Not Yet Critical (Years 2-5)
Correction: Renew System
Qty: 27,822.00
Unit of Measure: S.F.
Estimate: \$178,422.00
Assessor Name: Terence Davis
Date Created: 12/08/2016

Notes: The fixed furnishings are aged, in marginal condition, and should be replaced.
