NC School District/300 Davie County/Elementary School

# Coolemee Elementary

## Campus Assessment Report

March 11, 2017

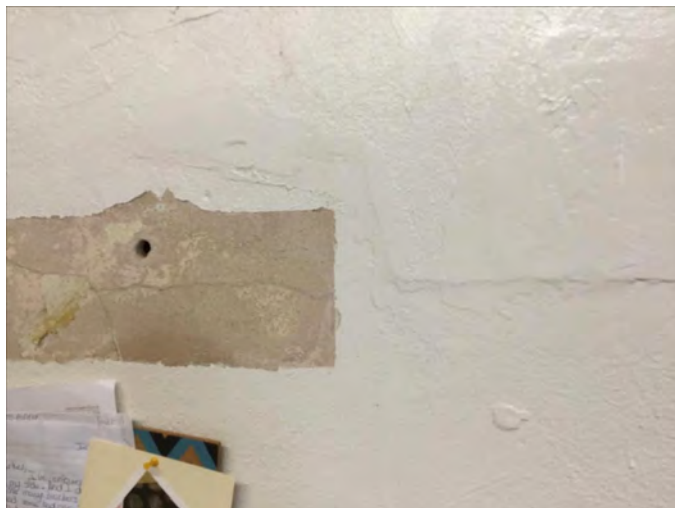
#### System: C1010 - Partitions

**Location:** South Interior Wall  
**Distress:** Inadequate  
**Category:** Deferred Maintenance  
**Priority:** 2 - Potentially Critical (Year 1)  
**Correction:** Engineering Study  
**Qty:** 1.00  
**Unit of Measure:** Ea.  
**Estimate:** \$13,200.00  
**Assessor Name:** Somnath Das  
**Date Created:** 02/15/2017

**Notes:** There is a moisture related issue on the South interior wall.

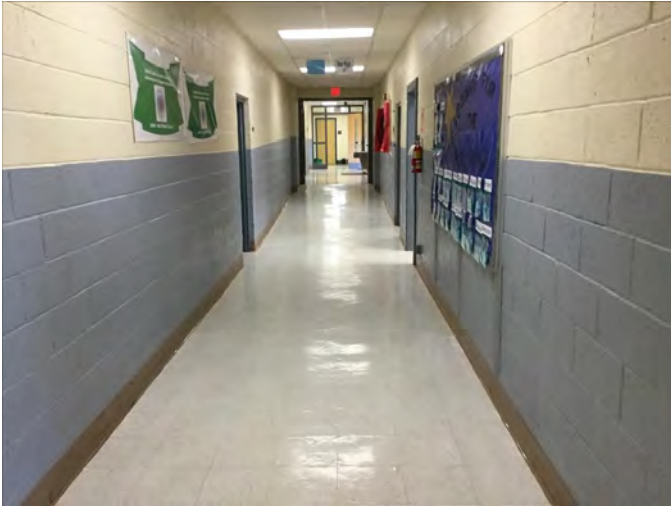
**System: C1030 - Fittings**

**Location:** Throughout the building  
**Distress:** Inadequate  
**Category:** Accessibility Code Compliance  
**Priority:** 3 - Necessary/Not Yet Critical (Years 2-5)  
**Correction:** Replace signage and toilet partitions  
**Qty:** 30.00  
**Unit of Measure:** Ea.  
**Estimate:** \$1,465.20  
**Assessor Name:** Somnath Das  
**Date Created:** 02/15/2017

**Notes:** Signage is missing in several areas throughout the building.

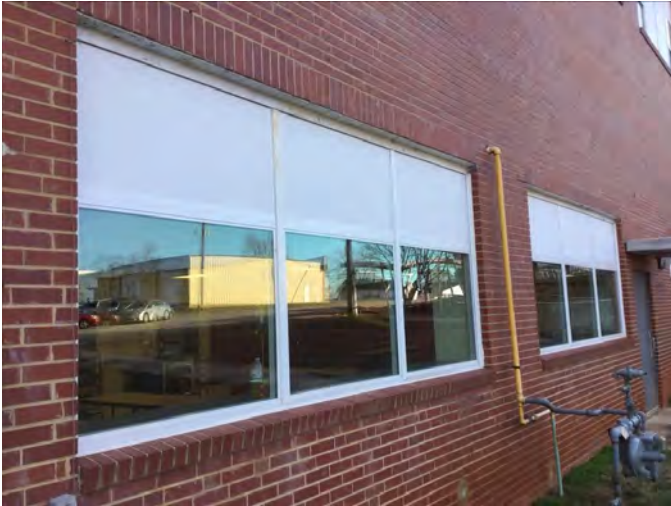
**System: B2020 - Exterior Windows**

**Location:** Exterior  
**Distress:** Inadequate  
**Category:** Deferred Maintenance  
**Priority:** 4 - Recommended (Years 6-10)  
**Correction:** Renew System  
**Qty:** 28,588.00  
**Unit of Measure:** S.F.  
**Estimate:** \$289,311.00  
**Assessor Name:** Somnath Das  
**Date Created:** 02/09/2017

**Notes:** The original metal frame, single pane, windows are aged, worn, inefficient and should be replaced.
