NC School District/430 Harnett County/Middle School

Overhills Middle

Campus Assessment Report

March 11, 2017

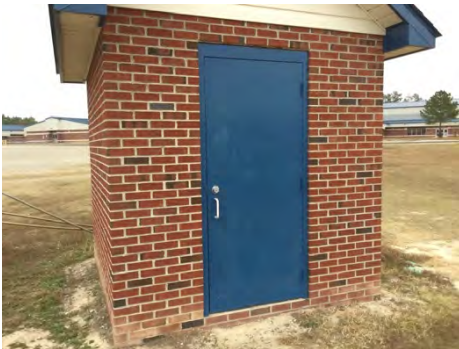
System: B2030 - Exterior Doors

Notes: The exterior doors are aged, rusted and should be replaced.

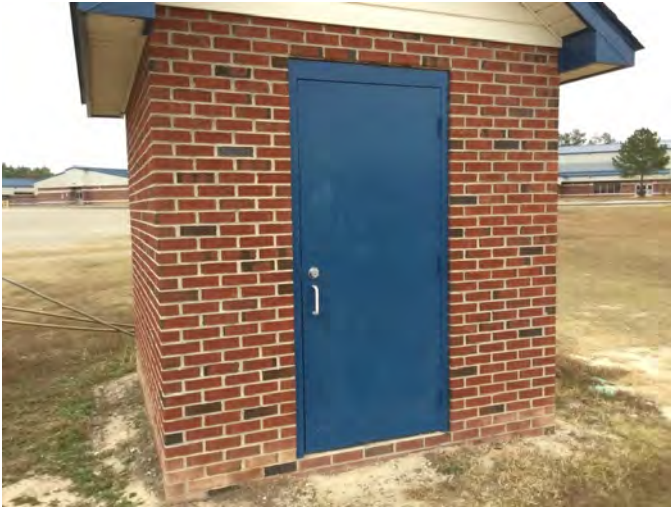
System: B2030 - Exterior Doors

Location: Exterior Walls
Distress: Beyond Service Life
Category: Deferred Maintenance
Priority: 3 - Necessary/Not Yet Critical (Years 2-5)
Correction: Renew System
Qty: 80.00
Unit of Measure: S.F.
Estimate: \$762.00
Assessor Name: Eduardo Lopez
Date Created: 12/08/2016

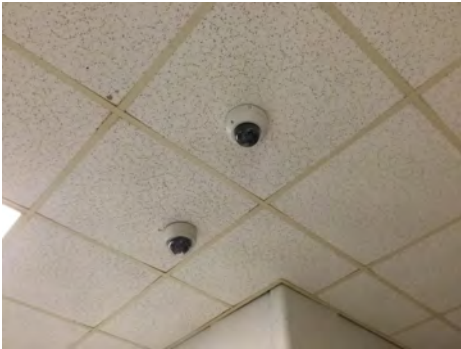
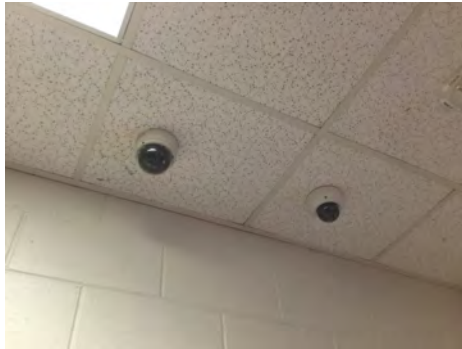
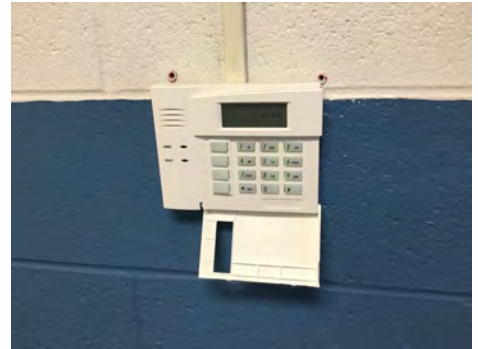
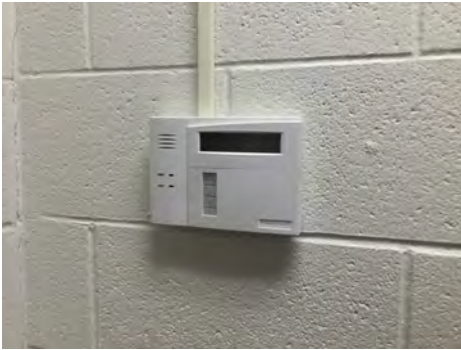
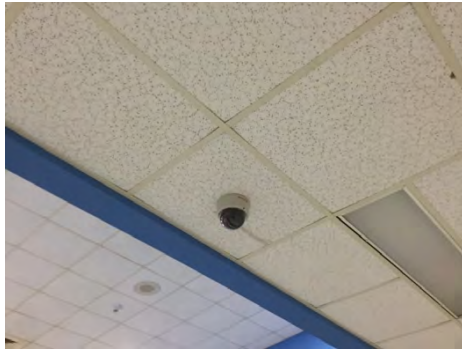
System: D5030810 - Security & Detection Systems

Notes: The security & detection system is beyond its expected service life and should be scheduled for replacement.

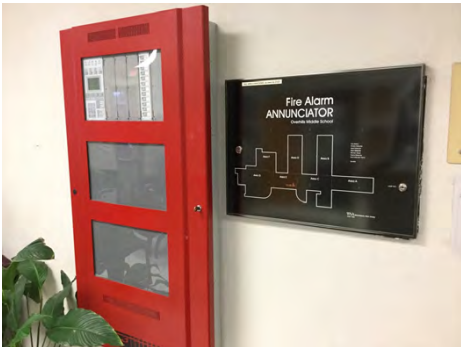
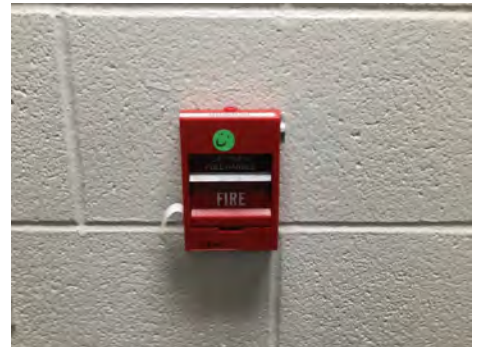
System: D5030910 - Fire Alarm Systems

Notes: The fire alarm system is beyond its expected service life and should be scheduled for replacement.

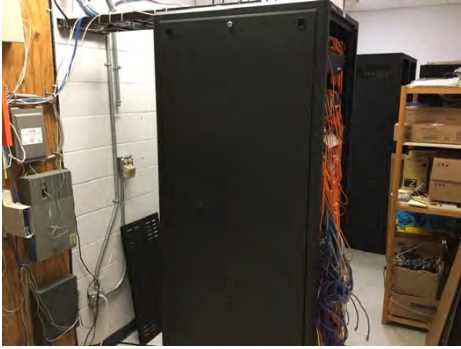
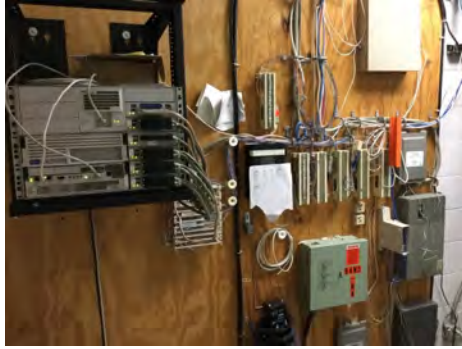
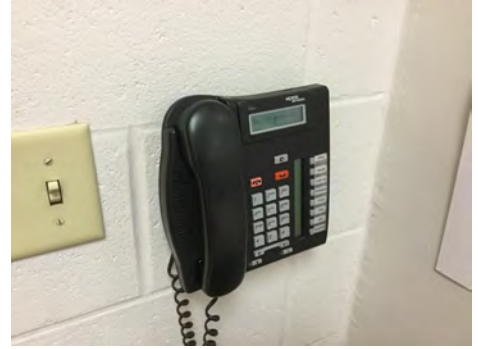
System: D5030920 - Data Communication

Notes: The data communication system is beyond its expected service life and should be scheduled for replacement.

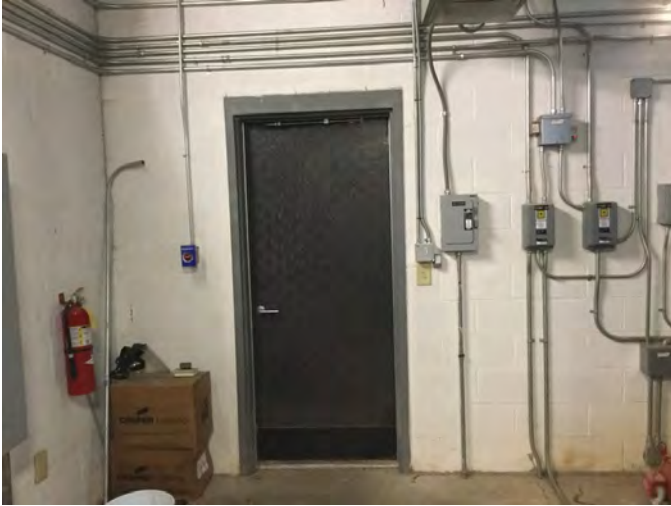
System: B2030 - Exterior Doors

Location: Electrical Room
Distress: Missing
Category: Building Code Compliance
Priority: 2 - Potentially Critical (Year 1)
Correction: Add panic hardware to exit door
Qty: 1.00
Unit of Measure: Ea.
Estimate: \$1,551.00
Assessor Name: Eduardo Lopez
Date Created: 12/08/2016

Notes: The electrical room exit access door doesn't have a panic hardware device installed and should be provided per Building Code compliance.

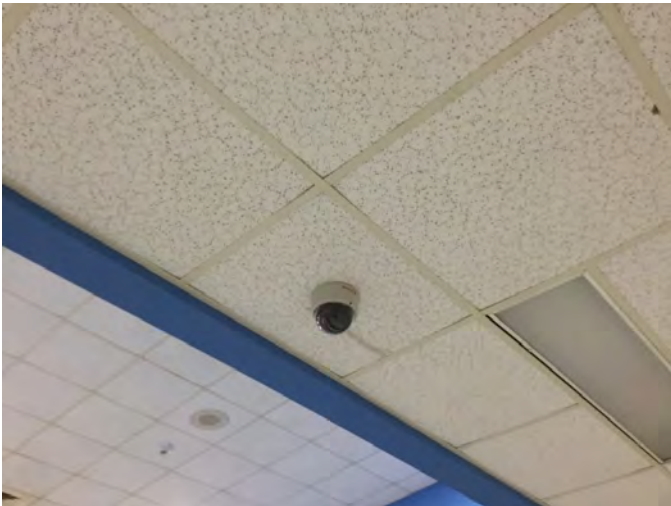
System: D5030810 - Security & Detection Systems

Location: Throughout the Building
Distress: Beyond Service Life
Category: Deferred Maintenance
Priority: 3 - Necessary/Not Yet Critical (Years 2-5)
Correction: Renew System
Qty: 136,947.00
Unit of Measure: S.F.
Estimate: \$341,957.00
Assessor Name: Eduardo Lopez
Date Created: 11/29/2016

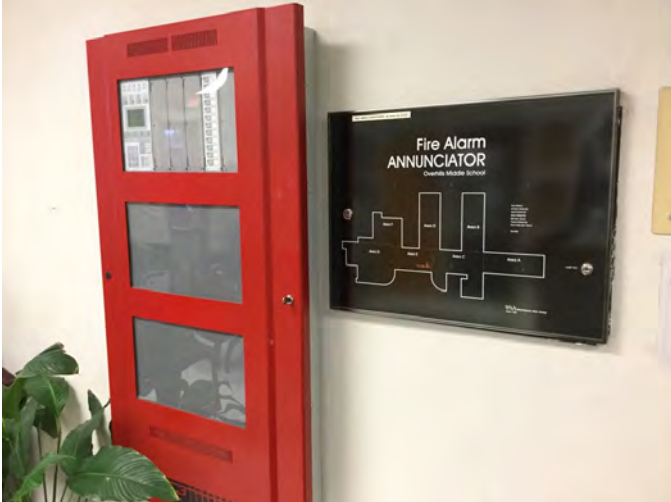
System: D5030910 - Fire Alarm Systems

Location: Throughout the Building
Distress: Beyond Service Life
Category: Deferred Maintenance
Priority: 3 - Necessary/Not Yet Critical (Years 2-5)
Correction: Renew System
Qty: 136,947.00
Unit of Measure: S.F.
Estimate: \$619,137.00
Assessor Name: Eduardo Lopez
Date Created: 11/29/2016

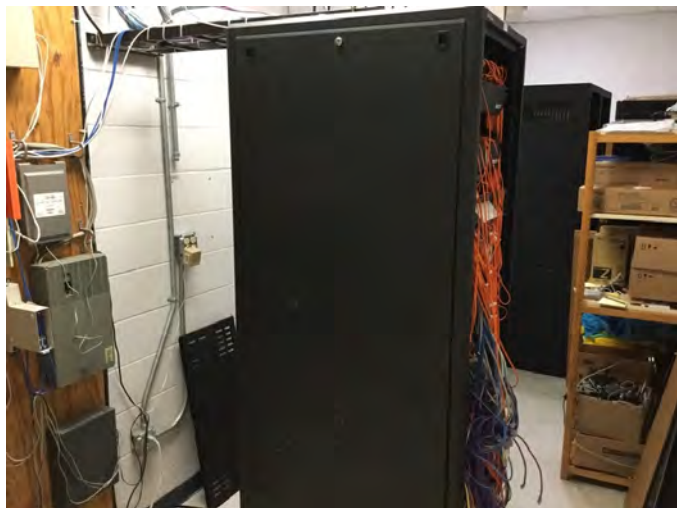
System: D5030920 - Data Communication

Location: Throughout the Building
Distress: Beyond Service Life
Category: Deferred Maintenance
Priority: 3 - Necessary/Not Yet Critical (Years 2-5)
Correction: Renew System
Qty: 136,947.00
Unit of Measure: S.F.
Estimate: \$801,414.00
Assessor Name: Eduardo Lopez
Date Created: 11/29/2016

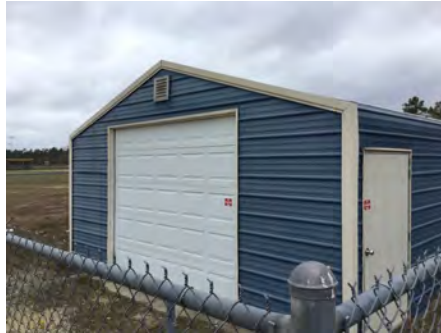
2). Southeast Elevation - Dec 05, 2016

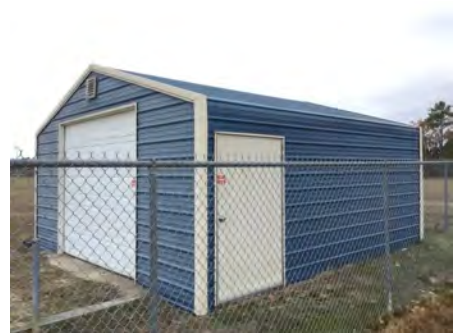
3). Northeast Elevation - Dec 05, 2016

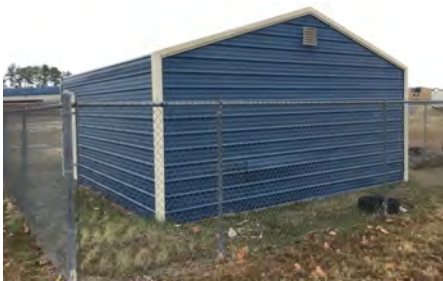
4). Northwest Elevation - Dec 05, 2016

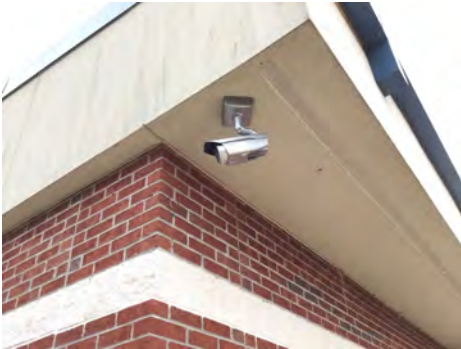
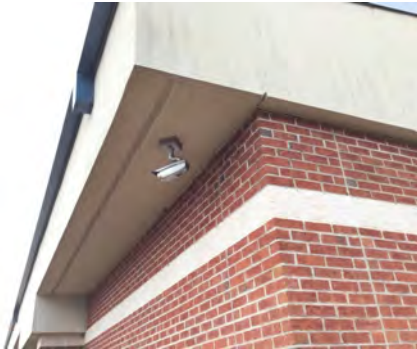
System: G4030 - Site Communications & Security

Notes: The site communication & security system is beyond its expected service life and should be scheduled for replacement.

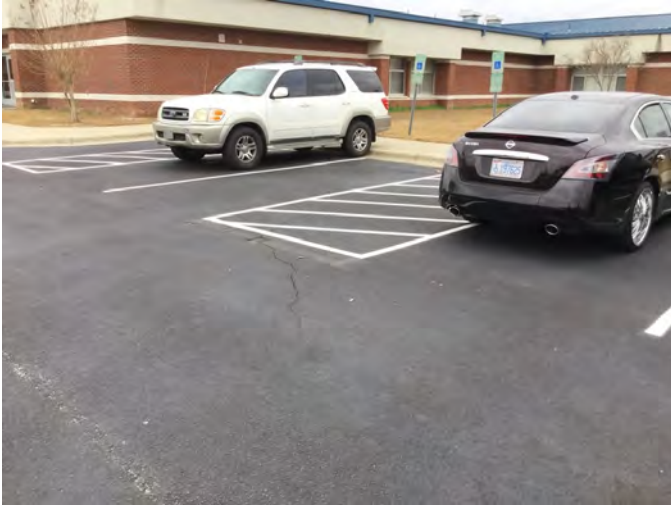
System: G2020 - Parking Lots

Location: Parking Lots
Distress: Missing
Category: Accessibility Code Compliance
Priority: 2 - Potentially Critical (Year 1)
Correction: Add handicap parking symbol
Qty: 5.00
Unit of Measure: Ea.
Estimate: \$396.00
Assessor Name: Eduardo Lopez
Date Created: 12/08/2016
