NC School District/040 Anson County/Middle School

Anson Middle

Campus Assessment Report

March 10, 2017

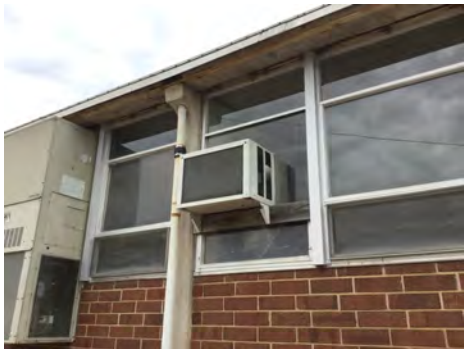
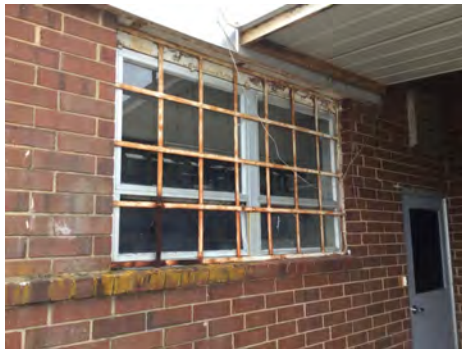
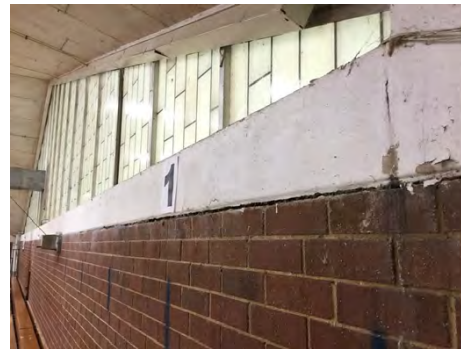
System: B2020 - Exterior Windows

Notes: The exterior windows are aged, rusted, not energy efficient and should be replaced.

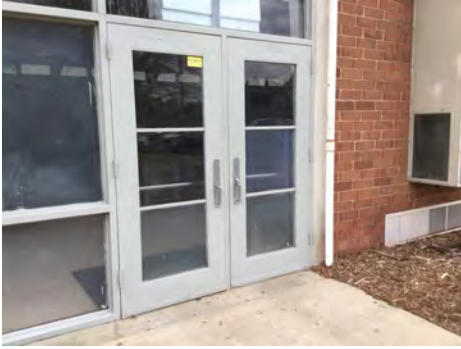
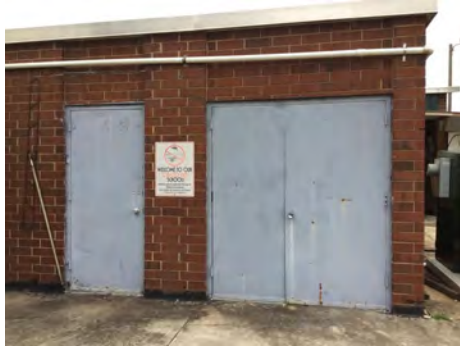
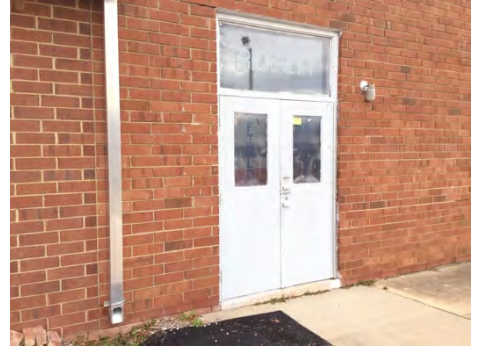
System: B2030 - Exterior Doors

Notes: The exterior doors are aged, rusted and should be replaced.

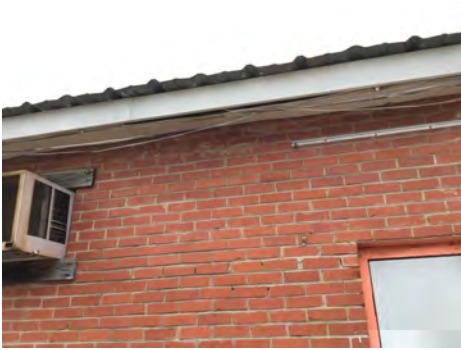
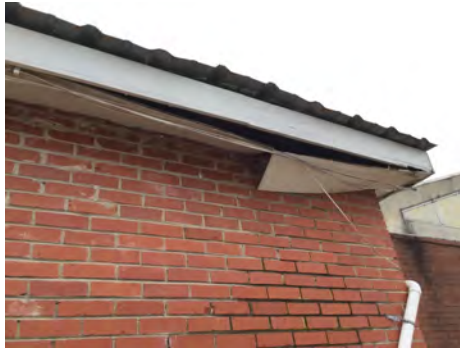
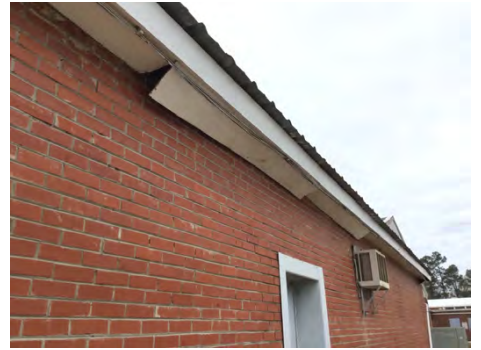
System: B3010130 - Preformed Metal Roofing

Notes: The metal roof covering is aged, showing signs of failure and should be replaced.

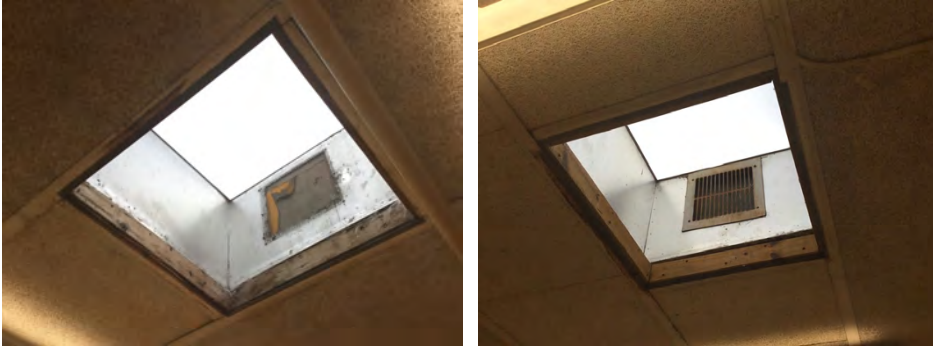
System: B3020 - Roof Openings

Notes: The roof openings are beyond service life and should be replaced.

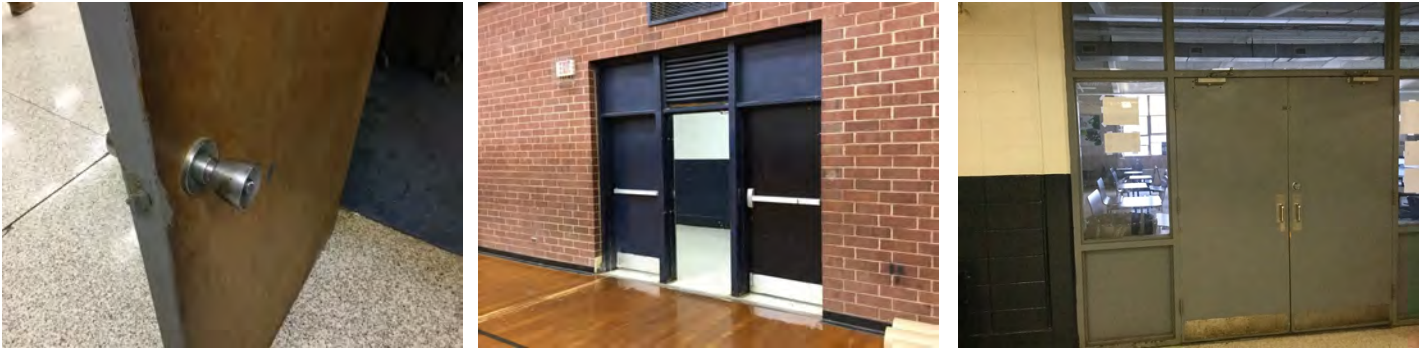
System: C1020 - Interior Doors

Notes: The interior doors are aged, failing, most hardware is not ADA or code compliant and should be replaced.

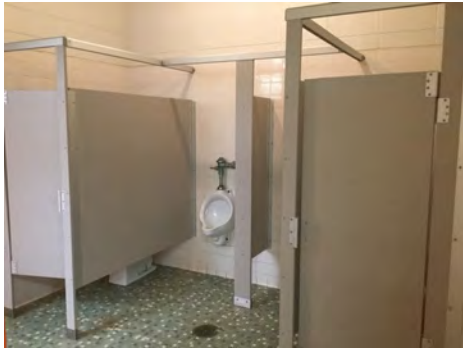
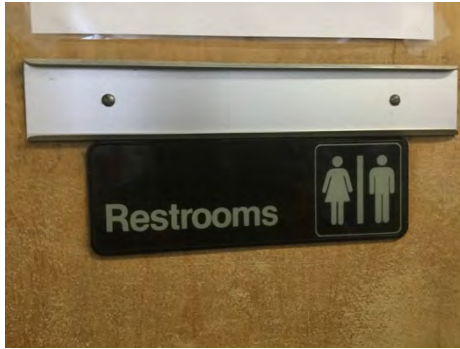
System: C1030 - Fittings

Notes: The fittings throughout the building are aged, in marginal condition, handrails and room signage are not ADA compliant and should be replaced.

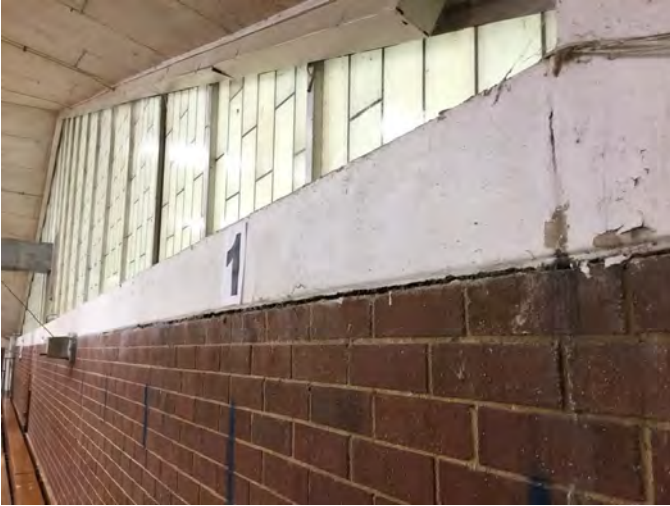
System: B2020 - Exterior Windows

Location: Exterior Walls
Distress: Beyond Service Life
Category: Deferred Maintenance
Priority: 3 - Necessary/Not Yet Critical (Years 2-5)
Correction: Renew System
Qty: 28,376.00
Unit of Measure: S.F.
Estimate: \$363,326.00
Assessor Name: Eduardo Lopez
Date Created: 01/11/2017

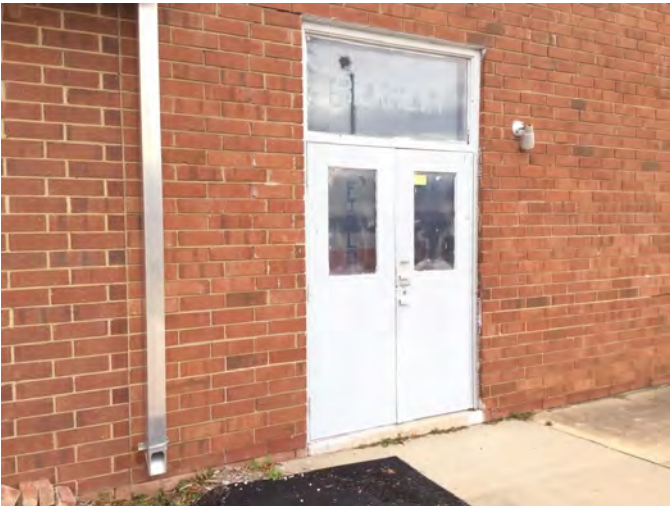
System: B2030 - Exterior Doors

Location: Exterior Walls
Distress: Beyond Service Life
Category: Deferred Maintenance
Priority: 3 - Necessary/Not Yet Critical (Years 2-5)
Correction: Renew System
Qty: 28,376.00
Unit of Measure: S.F.
Estimate: \$35,584.00
Assessor Name: Eduardo Lopez
Date Created: 01/11/2017

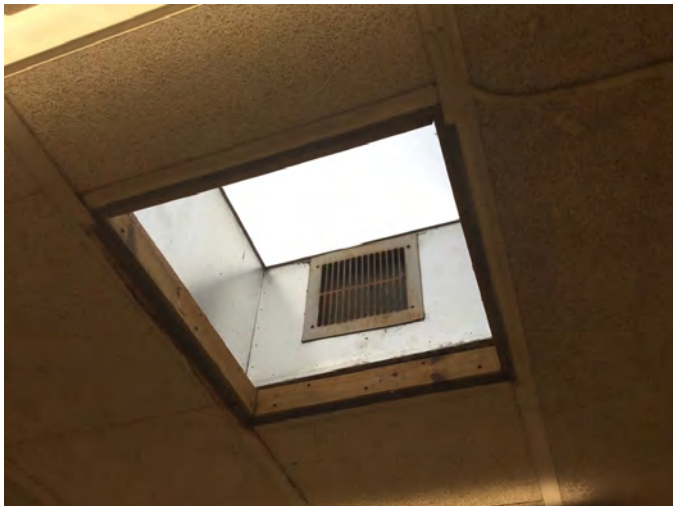
System: B3020 - Roof Openings

Location: Roof
Distress: Beyond Service Life
Category: Deferred Maintenance
Priority: 3 - Necessary/Not Yet Critical (Years 2-5)
Correction: Renew System
Qty: 28,376.00
Unit of Measure: S.F.
Estimate: \$8,116.00
Assessor Name: Eduardo Lopez
Date Created: 01/11/2017

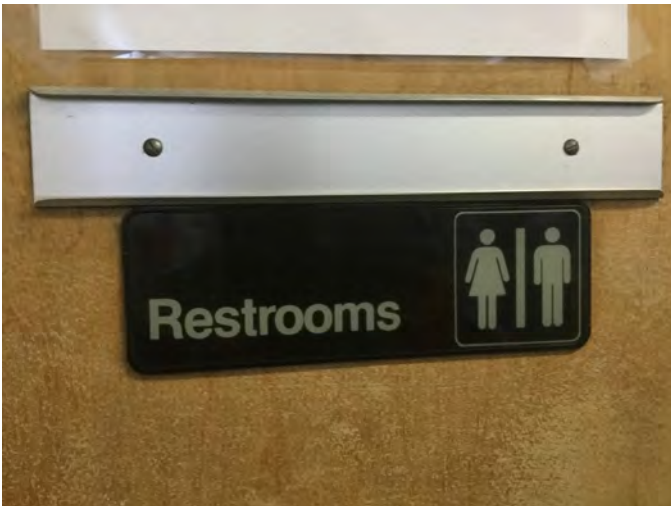
System: C1030 - Fittings

Location: Throughout the Building
Distress: Beyond Service Life
Category: Deferred Maintenance
Priority: 3 - Necessary/Not Yet Critical (Years 2-5)
Correction: Renew System
Qty: 28,376.00
Unit of Measure: S.F.
Estimate: \$452,909.00
Assessor Name: Eduardo Lopez
Date Created: 01/11/2017

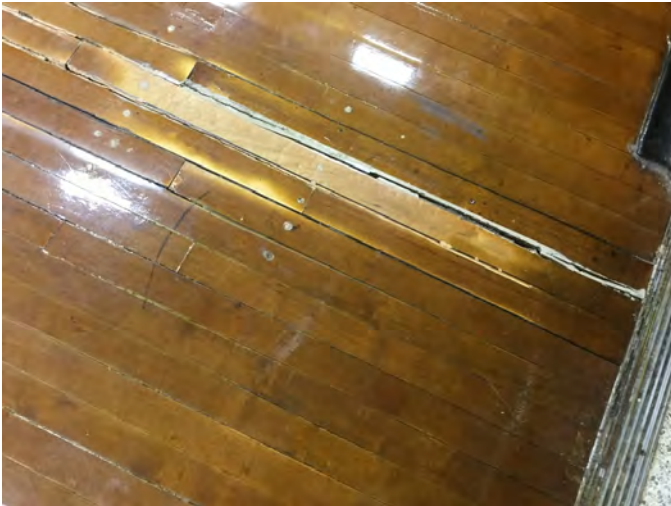
System: C3020 - Floor Finishes

Location: Throughout the Building
Distress: Beyond Service Life
Category: Deferred Maintenance
Priority: 3 - Necessary/Not Yet Critical (Years 2-5)
Correction: Renew System
Qty: 28,376.00
Unit of Measure: S.F.
Estimate: \$359,581.00
Assessor Name: Eduardo Lopez
Date Created: 01/11/2017

Notes: The original flooring is in poor conditions and should be replaced.

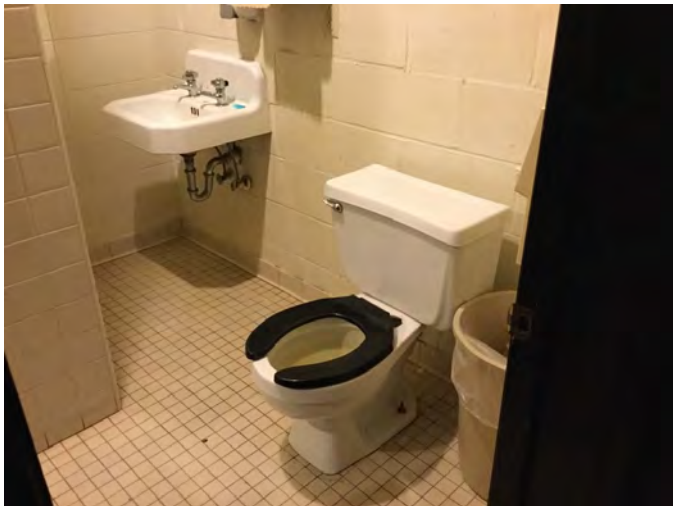
System: D2010 - Plumbing Fixtures

Location: Throughout the Building
Distress: Beyond Service Life
Category: Deferred Maintenance
Priority: 3 - Necessary/Not Yet Critical (Years 2-5)
Correction: Renew System
Qty: 28,376.00
Unit of Measure: S.F.
Estimate: \$333,049.00
Assessor Name: Eduardo Lopez
Date Created: 01/11/2017

Notes: Plumbing fixtures are in operational conditions. However, they are aged, not ADA compliant, and should be scheduled for replacement.

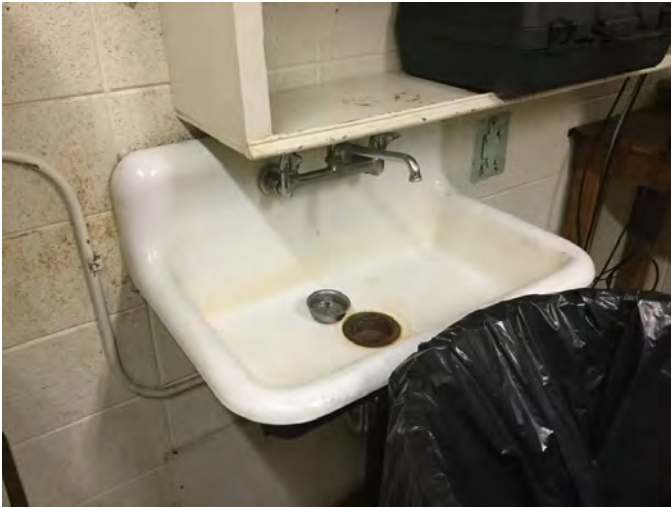
System: D2020 - Domestic Water Distribution

Location: Throughout the Building
Distress: Beyond Service Life
Category: Deferred Maintenance
Priority: 3 - Necessary/Not Yet Critical (Years 2-5)
Correction: Renew System
Qty: 28,376.00
Unit of Measure: S.F.
Estimate: \$35,584.00
Assessor Name: Eduardo Lopez
Date Created: 01/11/2017

Notes: The domestic water distribution system is aged and should be replaced.

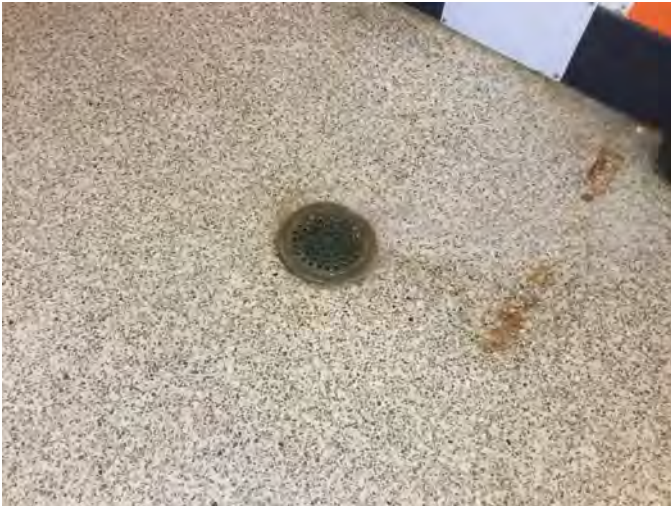
System: D2030 - Sanitary Waste

Location: Throughout the Building
Distress: Beyond Service Life
Category: Deferred Maintenance
Priority: 3 - Necessary/Not Yet Critical (Years 2-5)
Correction: Renew System
Qty: 28,376.00
Unit of Measure: S.F.
Estimate: \$56,184.00
Assessor Name: Eduardo Lopez
Date Created: 01/11/2017

Notes: The sanitary waste system is beyond its expected service life and should be replaced.

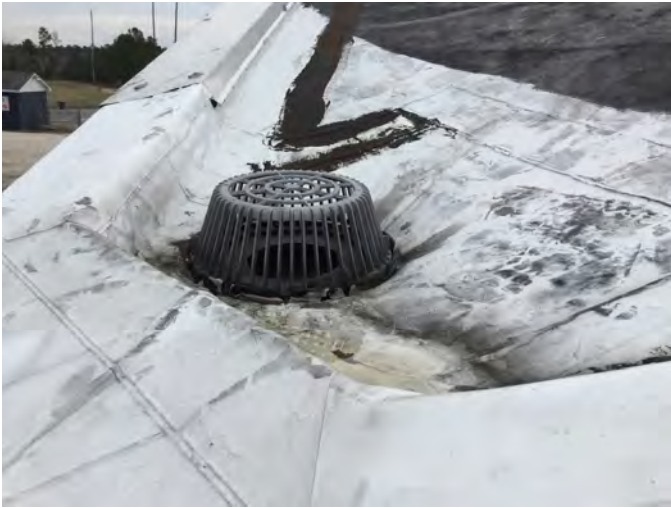
System: D2040 - Rain Water Drainage

Location: Roof
Distress: Beyond Service Life
Category: Deferred Maintenance
Priority: 3 - Necessary/Not Yet Critical (Years 2-5)
Correction: Renew System
Qty: 28,376.00
Unit of Measure: S.F.
Estimate: \$20,289.00
Assessor Name: Eduardo Lopez
Date Created: 01/11/2017

Notes: The rain water drainage system is aged and should be replaced.

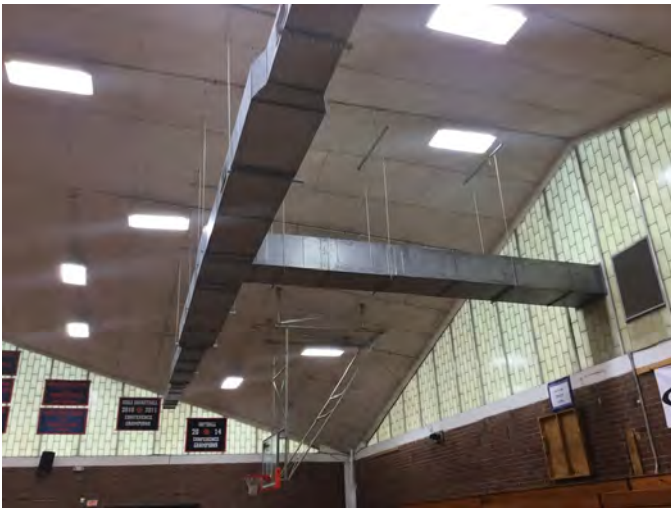
System: D3040 - Distribution Systems

Location: Throughout the Building
Distress: Beyond Service Life
Category: Deferred Maintenance
Priority: 3 - Necessary/Not Yet Critical (Years 2-5)
Correction: Renew System
Qty: 28,376.00
Unit of Measure: S.F.
Estimate: \$368,008.00
Assessor Name: Eduardo Lopez
Date Created: 01/11/2017

Notes: Distribution systems are aged, becoming logistically unsupportable, and should be replaced.

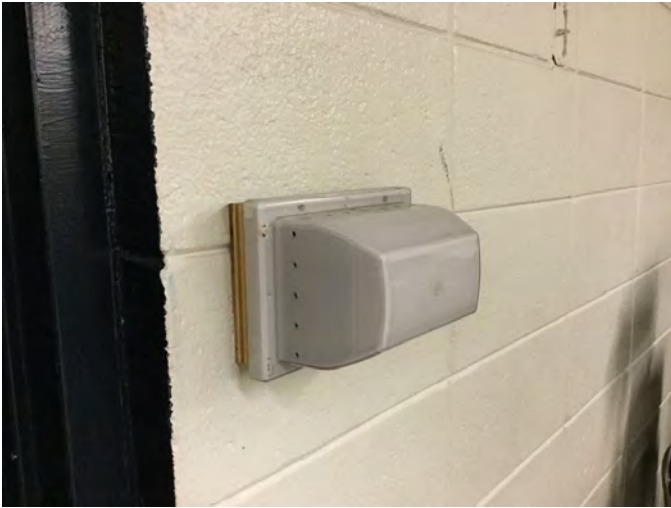
System: D3060 - Controls & Instrumentation

Location: Throughout the Building
Distress: Beyond Service Life
Category: Deferred Maintenance
Priority: 3 - Necessary/Not Yet Critical (Years 2-5)
Correction: Renew System
Qty: 28,376.00
Unit of Measure: S.F.
Estimate: \$115,490.00
Assessor Name: Eduardo Lopez
Date Created: 01/11/2017

Notes: The controls and instrumentation system is in marginal condition and should be schedule for replacement.

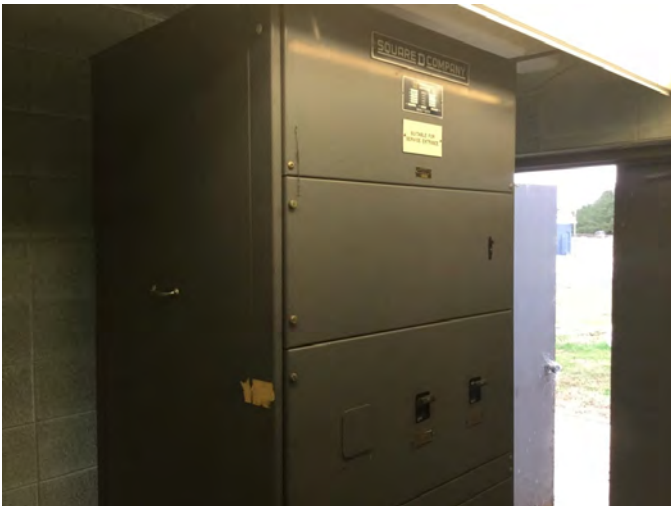
System: D5010 - Electrical Service/Distribution

Location: Throughout the Building
Distress: Beyond Service Life
Category: Deferred Maintenance
Priority: 3 - Necessary/Not Yet Critical (Years 2-5)
Correction: Renew System
Qty: 28,376.00
Unit of Measure: S.F.
Estimate: \$56,809.00
Assessor Name: Eduardo Lopez
Date Created: 01/11/2017

Notes: The original electrical service is operating but is in poor condition and should be replaced.

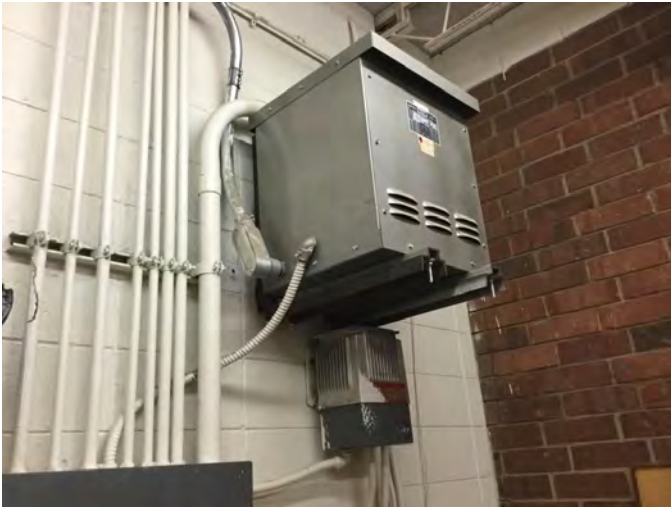
System: D5020 - Branch Wiring

Location: Throughout the Building
Distress: Beyond Service Life
Category: Deferred Maintenance
Priority: 3 - Necessary/Not Yet Critical (Years 2-5)
Correction: Renew System
Qty: 28,376.00
Unit of Measure: S.F.
Estimate: \$169,490.00
Assessor Name: Eduardo Lopez
Date Created: 01/11/2017

Notes: The original branch wiring system is operating but is aged, in marginal condition, and should be replaced.

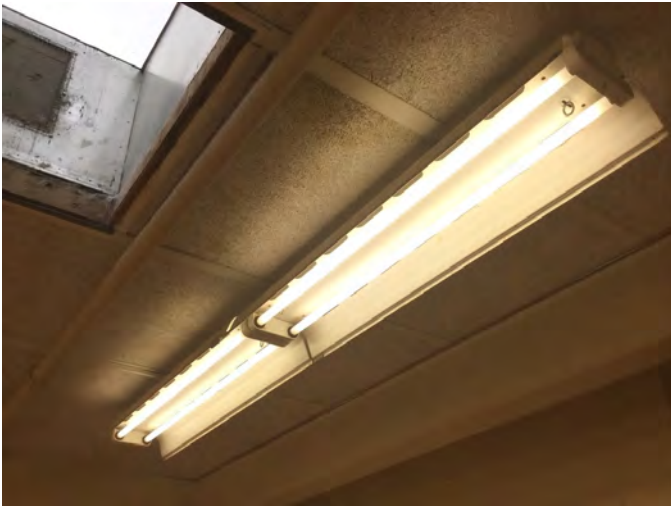
System: D5020 - Lighting

Location: Throughout the Building
Distress: Beyond Service Life
Category: Deferred Maintenance
Priority: 3 - Necessary/Not Yet Critical (Years 2-5)
Correction: Renew System
Qty: 28,376.00
Unit of Measure: S.F.
Estimate: \$395,164.00
Assessor Name: Eduardo Lopez
Date Created: 01/11/2017

Notes: The original branch wiring system is operating but is aged, in marginal condition, and should be replaced.

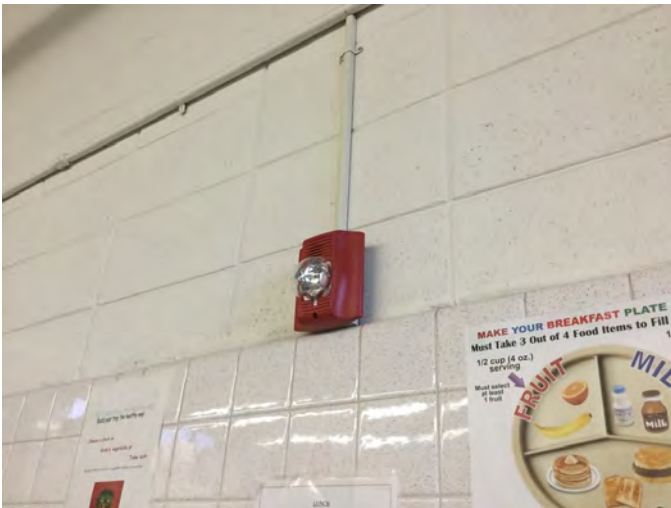
System: D5030910 - Fire Alarm Systems

Location: Throughout the Building
Distress: Beyond Service Life
Category: Deferred Maintenance
Priority: 3 - Necessary/Not Yet Critical (Years 2-5)
Correction: Renew System
Qty: 28,376.00
Unit of Measure: S.F.
Estimate: \$142,022.00
Assessor Name: Eduardo Lopez
Date Created: 01/11/2017

Notes: The fire alarm system is beyond its expected service life and should be scheduled for replacement.

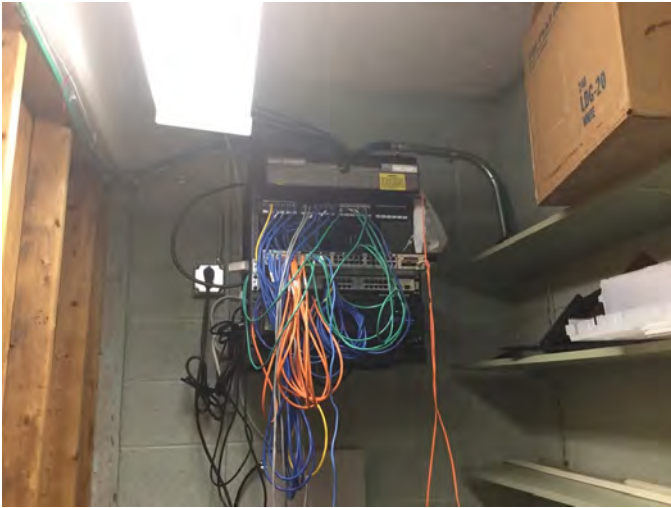
System: D5030920 - Data Communication

Location: Throughout the Building
Distress: Beyond Service Life
Category: Deferred Maintenance
Priority: 3 - Necessary/Not Yet Critical (Years 2-5)
Correction: Renew System
Qty: 28,376.00
Unit of Measure: S.F.
Estimate: \$183,848.00
Assessor Name: Eduardo Lopez
Date Created: 01/11/2017

Notes: The data communication system is beyond its expected service life and should be scheduled for replacement.

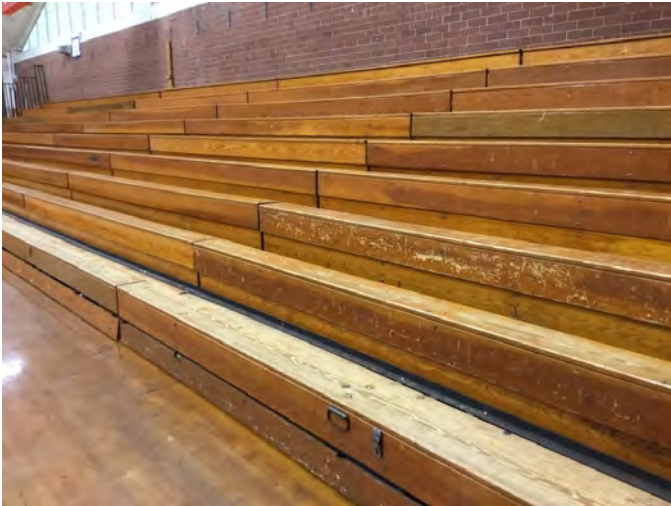
System: E1090 - Other Equipment

Location: Throughout the building
Distress: Beyond Service Life
Category: Deferred Maintenance
Priority: 3 - Necessary/Not Yet Critical (Years 2-5)
Correction: Renew System
Qty: 28,376.00
Unit of Measure: S.F.
Estimate: \$235,663.00
Assessor Name: Eduardo Lopez
Date Created: 01/11/2017

Notes: The other equipment system is beyond service life and should be replaced.

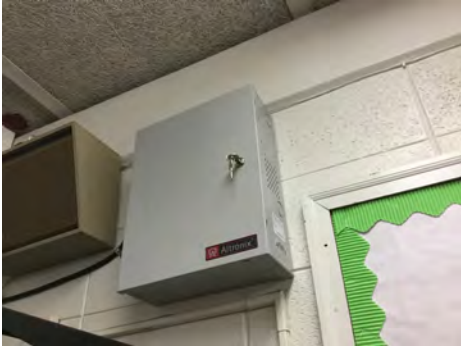
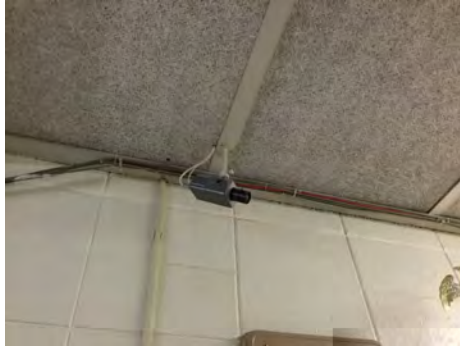
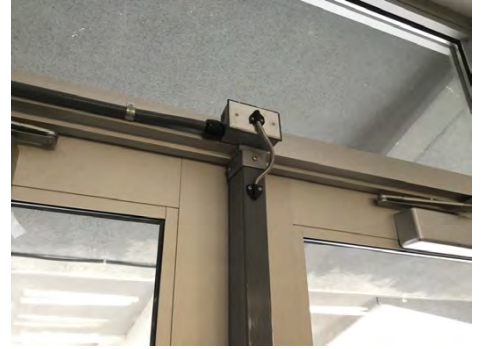
System: D5030810 - Security & Detection Systems

Notes: The security and CCTV system is beyond its expected service life and should be scheduled for replacement.

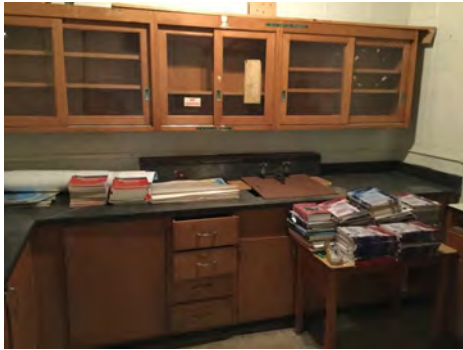
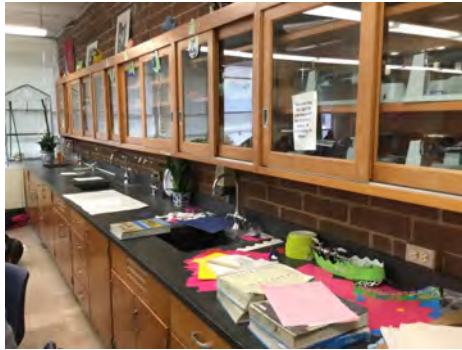
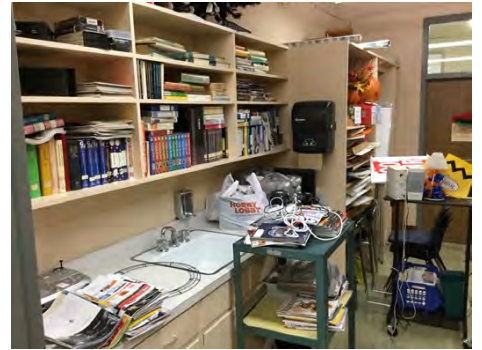
System: E2010 - Fixed Furnishings

Notes: The fixed furnishings are aged, in marginal condition, and should be replaced.

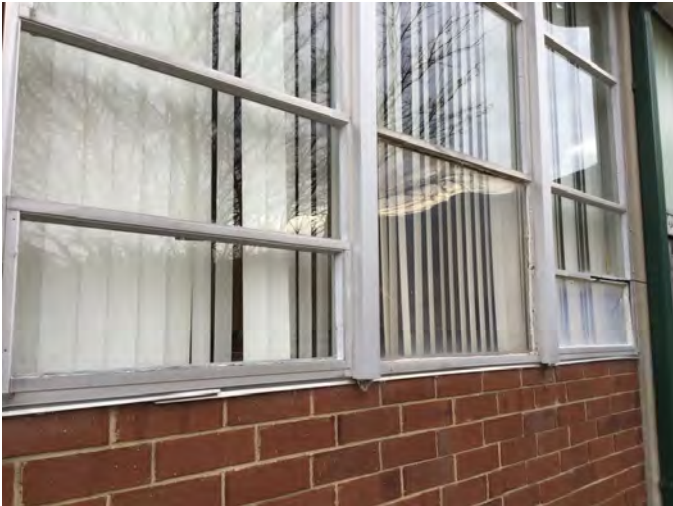
System: B2020 - Exterior Windows

Location: Exterior Walls
Distress: Beyond Service Life
Category: Deferred Maintenance
Priority: 3 - Necessary/Not Yet Critical (Years 2-5)
Correction: Renew System
Qty: 78,257.00
Unit of Measure: S.F.
Estimate: \$1,025,245.00
Assessor Name: Eduardo Lopez
Date Created: 01/13/2017

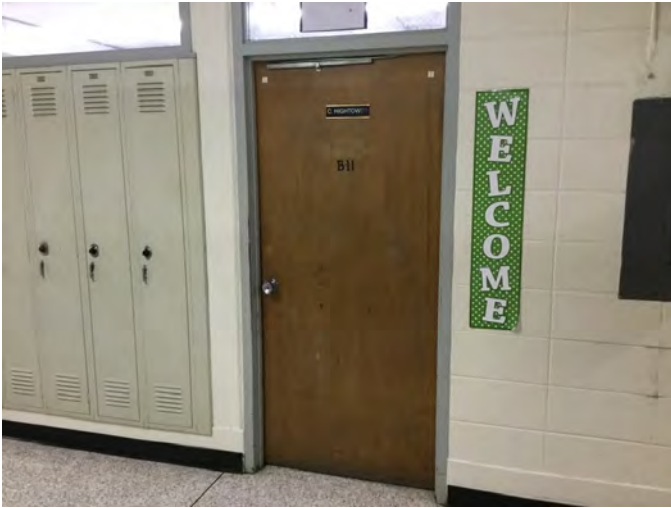
System: C1020 - Interior Doors

Location: Throughout the Building
Distress: Beyond Service Life
Category: Deferred Maintenance
Priority: 3 - Necessary/Not Yet Critical (Years 2-5)
Correction: Renew System
Qty: 78,257.00
Unit of Measure: S.F.
Estimate: \$240,171.00
Assessor Name: Eduardo Lopez
Date Created: 01/13/2017

Notes: The interior doors are aged, failing, most hardware is not ADA or code compliant and should be replaced.

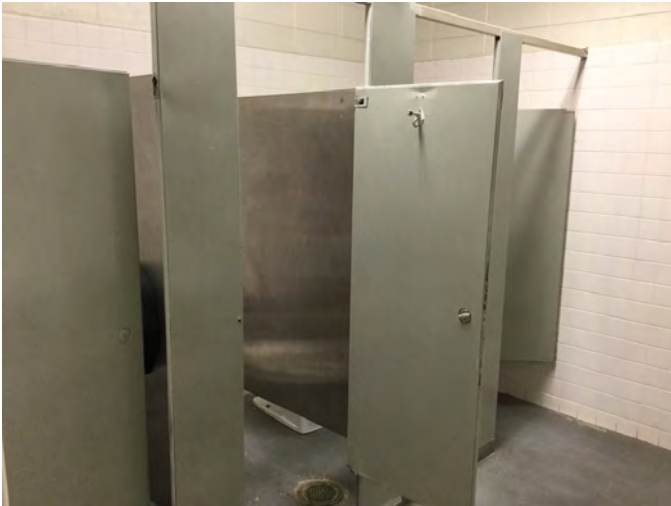
System: C1030 - Fittings

Location: Throughout the Building
Distress: Beyond Service Life
Category: Deferred Maintenance
Priority: 3 - Necessary/Not Yet Critical (Years 2-5)
Correction: Renew System
Qty: 78,257.00
Unit of Measure: S.F.
Estimate: \$1,275,746.00
Assessor Name: Eduardo Lopez
Date Created: 01/13/2017

Notes: The fittings throughout the building are aged, in marginal condition, handrails and room signage are not ADA compliant and should be replaced.

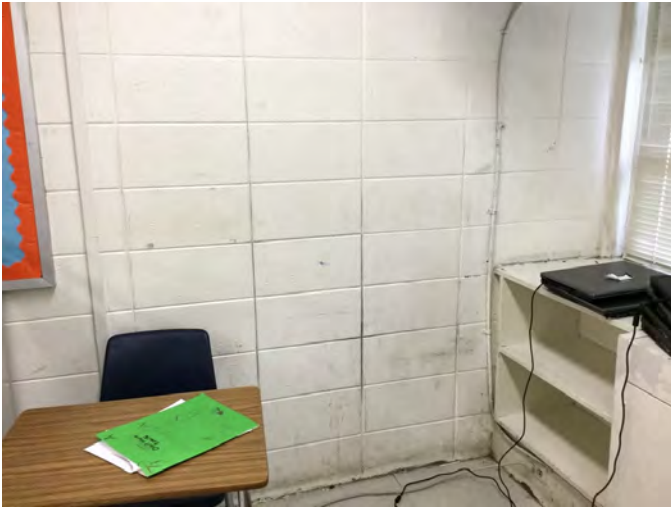
System: C3010 - Wall Finishes

Location: Throughout the Building
Distress: Beyond Service Life
Category: Deferred Maintenance
Priority: 3 - Necessary/Not Yet Critical (Years 2-5)
Correction: Renew System
Qty: 78,257.00
Unit of Measure: S.F.
Estimate: \$326,253.00
Assessor Name: Eduardo Lopez
Date Created: 01/13/2017

Notes: The wall finishes are aged, scuffed, fading, stained and should be replaced.

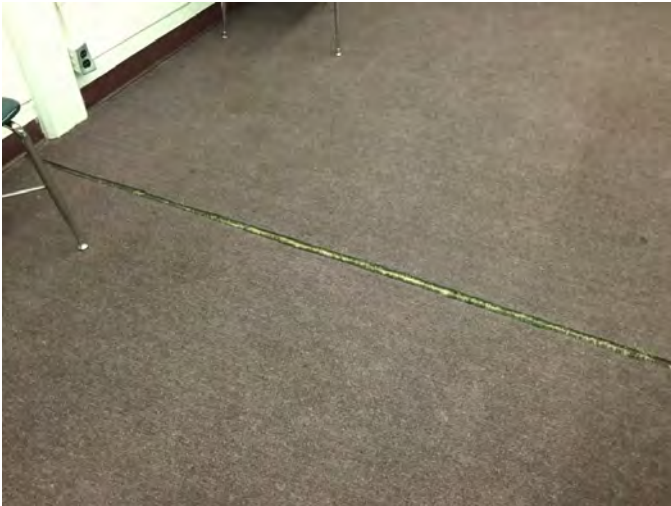
System: C3020 - Floor Finishes

Location: Throughout the Building
Distress: Beyond Service Life
Category: Deferred Maintenance
Priority: 3 - Necessary/Not Yet Critical (Years 2-5)
Correction: Renew System
Qty: 78,257.00
Unit of Measure: S.F.
Estimate: \$1,013,193.00
Assessor Name: Eduardo Lopez
Date Created: 01/13/2017

Notes: The original flooring is in poor conditions and should be replaced.

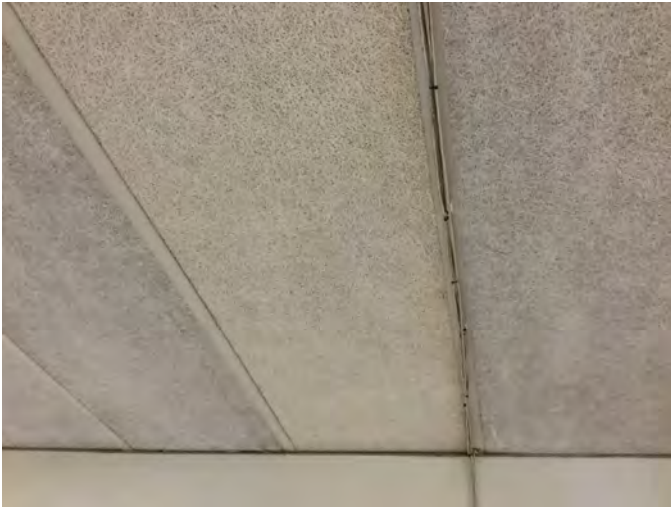
System: C3030 - Ceiling Finishes

Location: Throughout the Building
Distress: Beyond Service Life
Category: Deferred Maintenance
Priority: 3 - Necessary/Not Yet Critical (Years 2-5)
Correction: Renew System
Qty: 78,257.00
Unit of Measure: S.F.
Estimate: \$1,107,884.00
Assessor Name: Eduardo Lopez
Date Created: 01/13/2017

Notes: The original ceiling finishes are aged, failing and should be replaced.

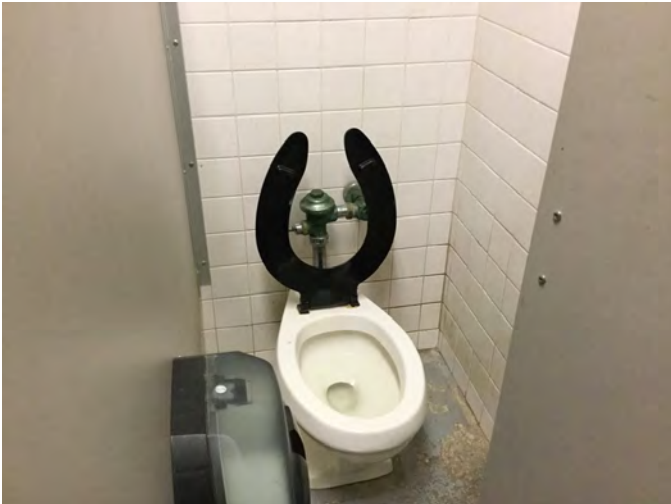
System: D2010 - Plumbing Fixtures

Location: Throughout the Building
Distress: Beyond Service Life
Category: Deferred Maintenance
Priority: 3 - Necessary/Not Yet Critical (Years 2-5)
Correction: Renew System
Qty: 78,257.00
Unit of Measure: S.F.
Estimate: \$940,023.00
Assessor Name: Eduardo Lopez
Date Created: 01/13/2017

Notes: Plumbing fixtures are in operational conditions. However, they are aged, not ADA compliant, and should be scheduled for replacement.

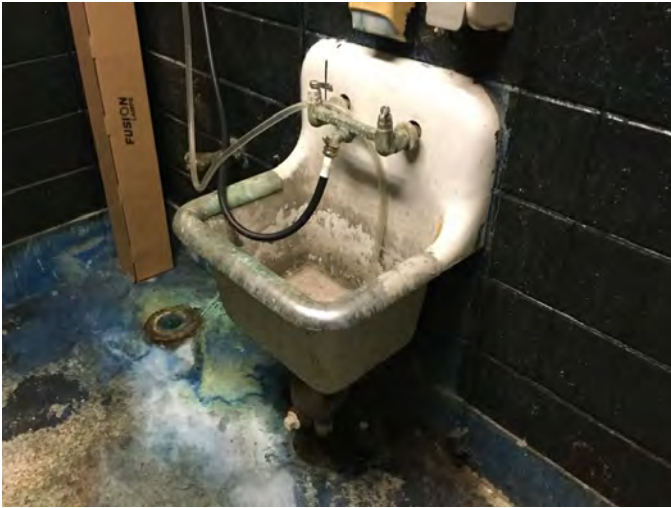
System: D2020 - Domestic Water Distribution

Location: Throughout the Building
Distress: Beyond Service Life
Category: Deferred Maintenance
Priority: 3 - Necessary/Not Yet Critical (Years 2-5)
Correction: Renew System
Qty: 78,257.00
Unit of Measure: S.F.
Estimate: \$100,717.00
Assessor Name: Eduardo Lopez
Date Created: 01/13/2017

Notes: The domestic water distribution system is aged and should be replaced.

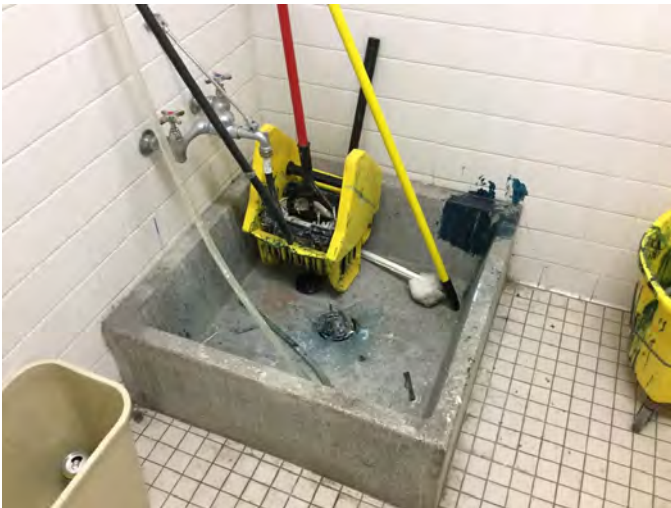
System: D2030 - Sanitary Waste

Location: Throughout the Building
Distress: Beyond Service Life
Category: Deferred Maintenance
Priority: 3 - Necessary/Not Yet Critical (Years 2-5)
Correction: Renew System
Qty: 78,257.00
Unit of Measure: S.F.
Estimate: \$157,531.00
Assessor Name: Eduardo Lopez
Date Created: 01/13/2017

Notes: The sanitary waste system is beyond its expected service life and should be replaced.

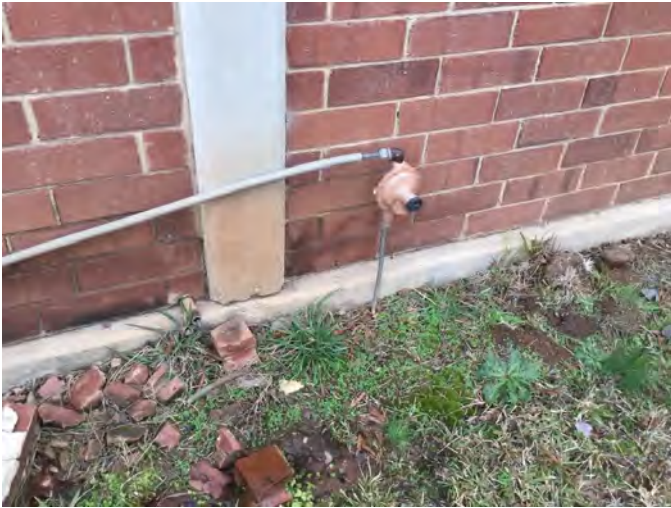
System: D2090 - Other Plumbing Systems -Nat Gas

Location: Throughout the Building
Distress: Beyond Service Life
Category: Deferred Maintenance
Priority: 3 - Necessary/Not Yet Critical (Years 2-5)
Correction: Renew System
Qty: 78,257.00
Unit of Measure: S.F.
Estimate: \$15,495.00
Assessor Name: Eduardo Lopez
Date Created: 02/06/2017

Notes: The natural gas system is beyond its expected service life and should be replaced.

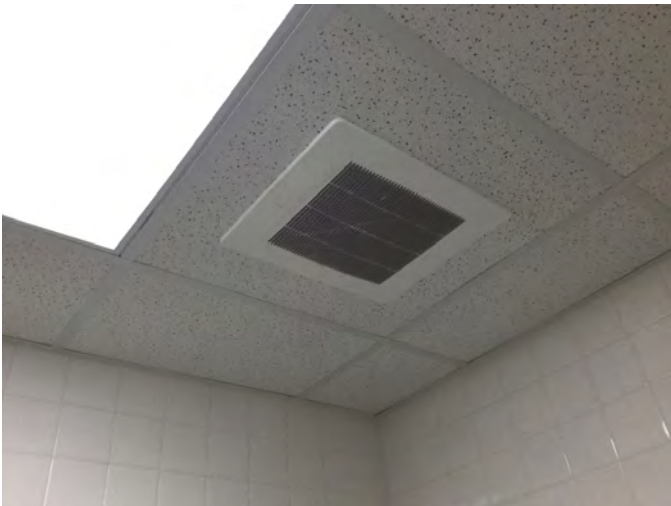
System: D3040 - Distribution Systems

Location: Throughout the Building
Distress: Beyond Service Life
Category: Deferred Maintenance
Priority: 3 - Necessary/Not Yet Critical (Years 2-5)
Correction: Renew System
Qty: 78,257.00
Unit of Measure: S.F.
Estimate: \$1,037,297.00
Assessor Name: Eduardo Lopez
Date Created: 01/13/2017

Notes: Distribution systems are aged, becoming logistically unsupportable, and should be replaced.

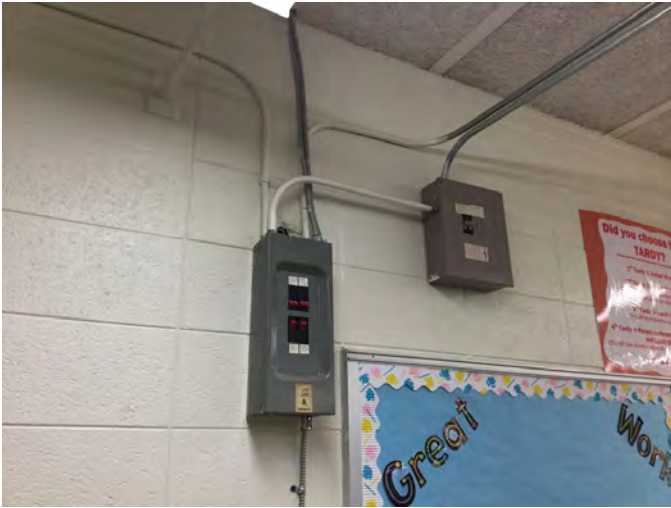
System: D5020 - Branch Wiring

Location: Throughout the Building
Distress: Beyond Service Life
Category: Deferred Maintenance
Priority: 3 - Necessary/Not Yet Critical (Years 2-5)
Correction: Renew System
Qty: 78,257.00
Unit of Measure: S.F.
Estimate: \$478,620.00
Assessor Name: Eduardo Lopez
Date Created: 01/13/2017

Notes: The original branch wiring system is operating but is aged, in marginal condition, and should be replaced.

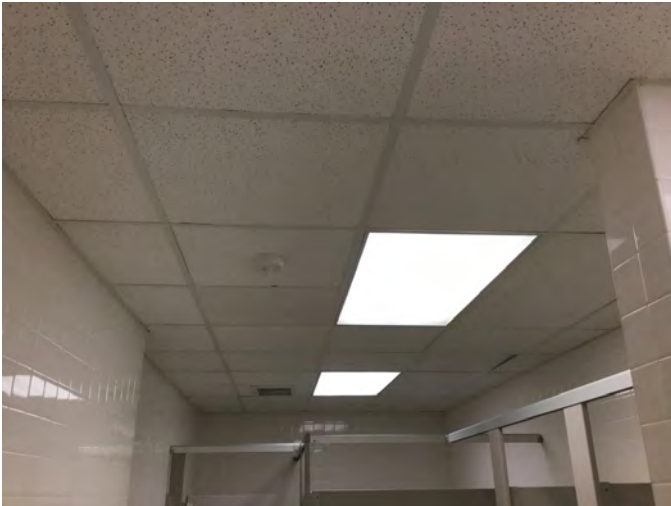
System: D5020 - Lighting

Location: Throughout the Building
Distress: Beyond Service Life
Category: Deferred Maintenance
Priority: 3 - Necessary/Not Yet Critical (Years 2-5)
Correction: Renew System
Qty: 78,257.00
Unit of Measure: S.F.
Estimate: \$1,113,910.00
Assessor Name: Eduardo Lopez
Date Created: 01/13/2017

Notes: The original branch wiring system is operating but is aged, in marginal condition, and should be replaced.

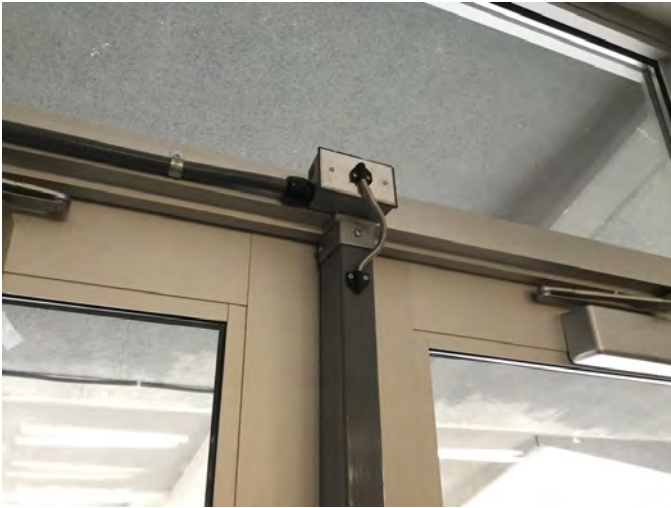
System: D5030810 - Security & Detection Systems

Location: Throughout the Building
Distress: Beyond Service Life
Category: Deferred Maintenance
Priority: 3 - Necessary/Not Yet Critical (Years 2-5)
Correction: Renew System
Qty: 78,257.00
Unit of Measure: S.F.
Estimate: \$221,233.00
Assessor Name: Eduardo Lopez
Date Created: 01/13/2017

Notes: The security and CCTV system is beyond its expected service life and should be scheduled for replacement.

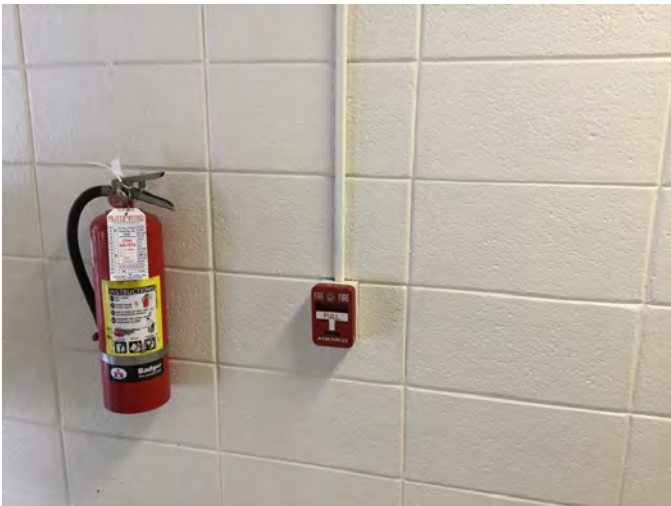
System: D5030910 - Fire Alarm Systems

Location: Throughout the Building
Distress: Beyond Service Life
Category: Deferred Maintenance
Priority: 3 - Necessary/Not Yet Critical (Years 2-5)
Correction: Renew System
Qty: 78,257.00
Unit of Measure: S.F.
Estimate: \$400,285.00
Assessor Name: Eduardo Lopez
Date Created: 01/13/2017

Notes: The fire alarm system is beyond its expected service life and should be scheduled for replacement.

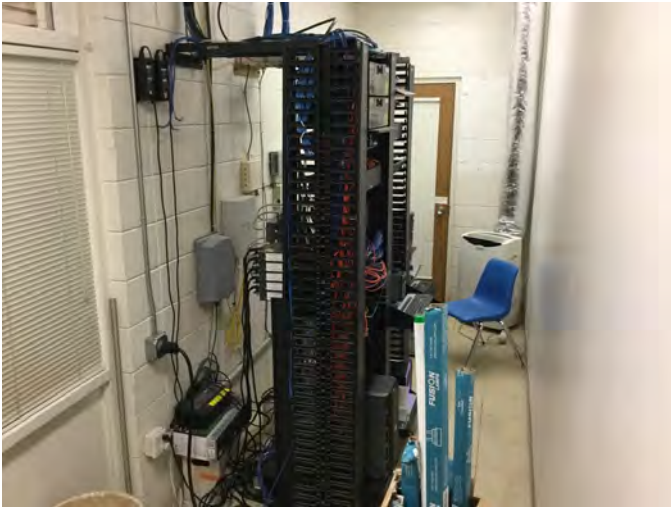
System: D5030920 - Data Communication

Location: Throughout the Building
Distress: Beyond Service Life
Category: Deferred Maintenance
Priority: 3 - Necessary/Not Yet Critical (Years 2-5)
Correction: Renew System
Qty: 78,257.00
Unit of Measure: S.F.
Estimate: \$518,218.00
Assessor Name: Eduardo Lopez
Date Created: 01/13/2017

Notes: The data communication system is beyond its expected service life and should be scheduled for replacement.

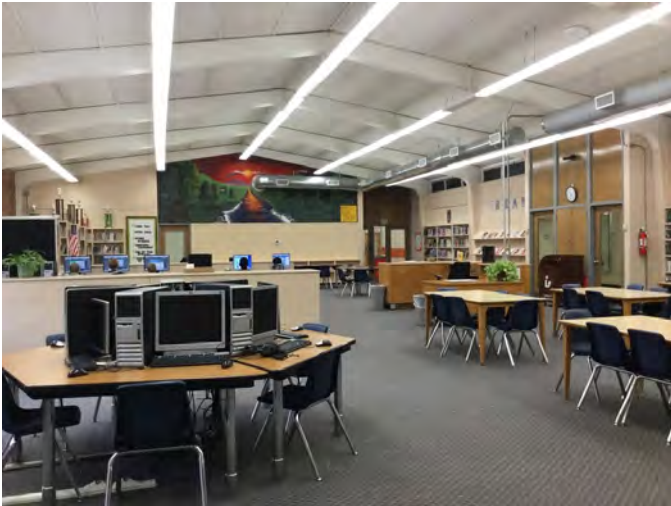
System: E1020 - Institutional Equipment

Location: Throughout the Building
Distress: Beyond Service Life
Category: Deferred Maintenance
Priority: 3 - Necessary/Not Yet Critical (Years 2-5)
Correction: Renew System
Qty: 78,257.00
Unit of Measure: S.F.
Estimate: \$265,996.00
Assessor Name: Eduardo Lopez
Date Created: 01/13/2017

Notes: The institutional equipment is in deteriorating conditions and should be replaced.

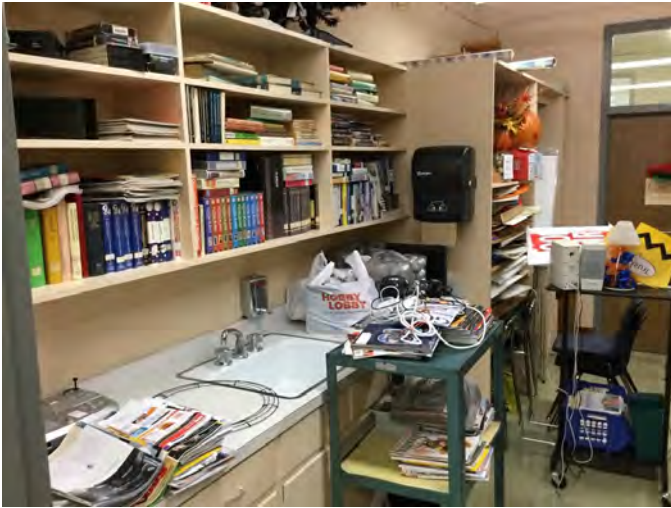
System: E2010 - Fixed Furnishings

Location: Throughout the Building
Distress: Beyond Service Life
Category: Deferred Maintenance
Priority: 3 - Necessary/Not Yet Critical (Years 2-5)
Correction: Renew System
Qty: 78,257.00
Unit of Measure: S.F.
Estimate: \$530,269.00
Assessor Name: Eduardo Lopez
Date Created: 01/13/2017

Notes: The fixed furnishings are aged, in marginal condition, and should be replaced.

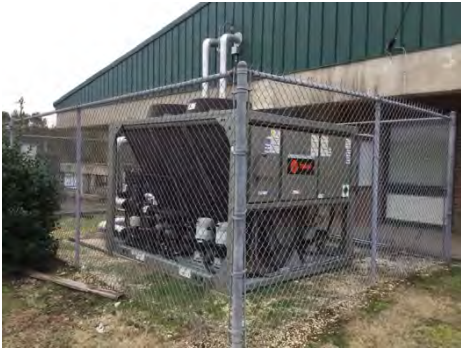
System: D3030 - Cooling Generating Systems

Notes: The cooling generating system is beyond its expected service life and should be scheduled for replacement.

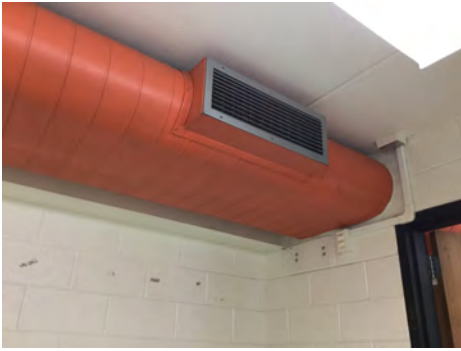
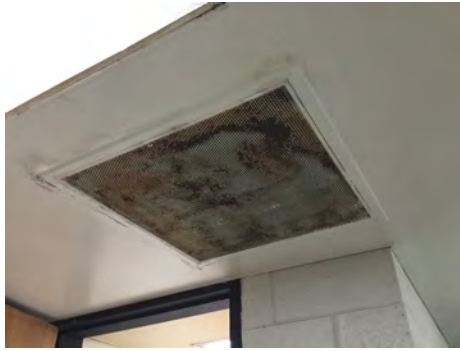
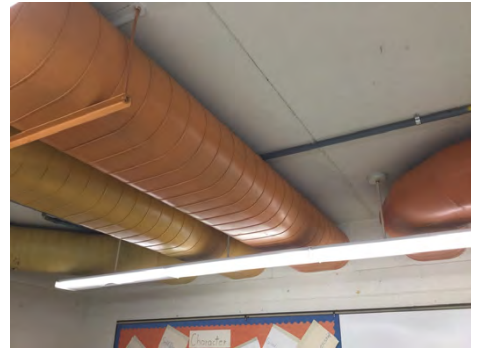
System: D3040 - Distribution Systems

Notes: The distribution systems are aged, becoming logistically unsupportable, and should be replaced.

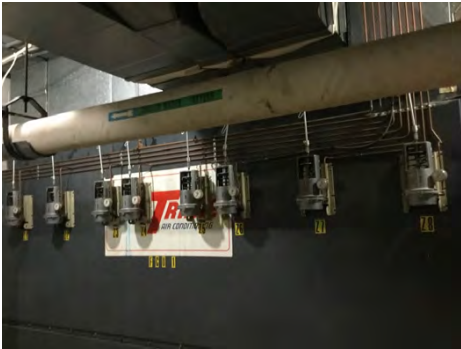
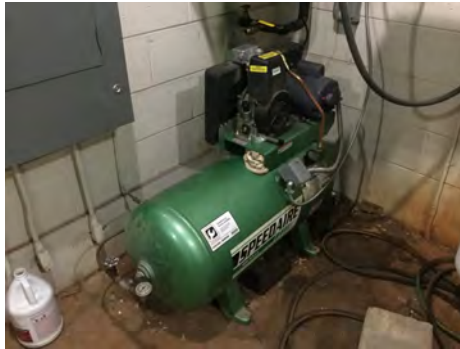
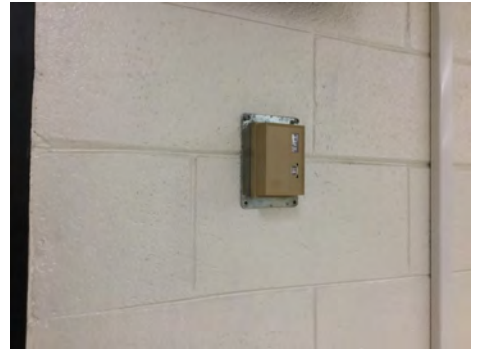
System: D3060 - Controls & Instrumentation

Notes: The controls and instrumentation system is in marginal condition and should be schedule for replacement.

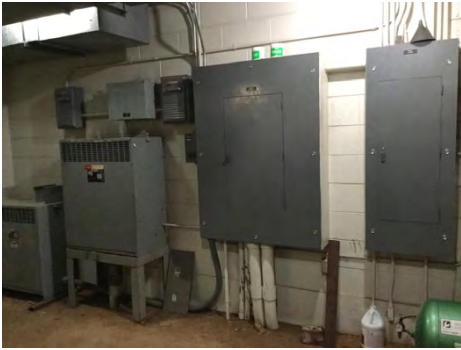
System: D5010 - Electrical Service/Distribution

Notes: The original electrical service is operating but is in poor condition and should be replaced.

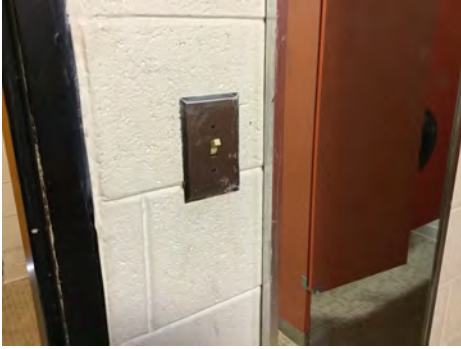
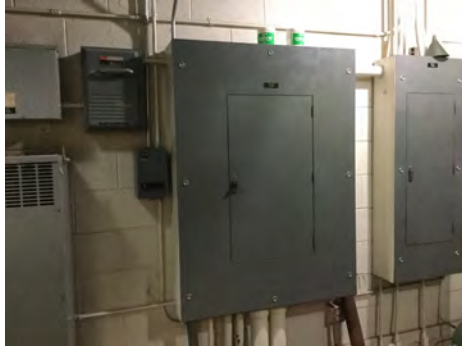
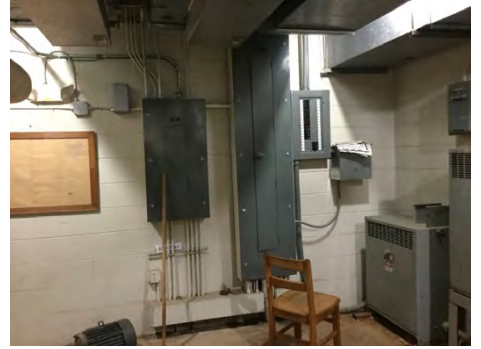
System: D5020 - Branch Wiring

Notes: The original branch wiring system is operating but is aged, in marginal condition, and should be replaced.

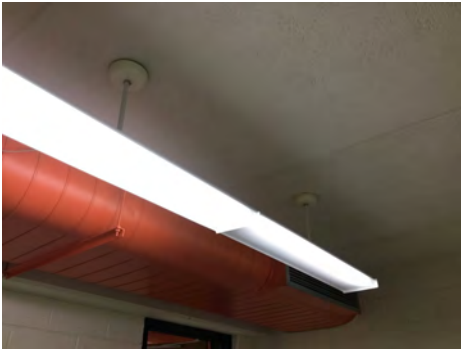
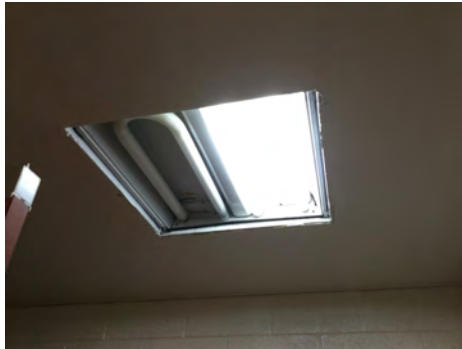
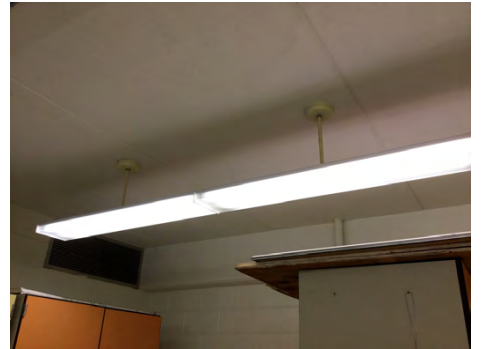
System: D5020 - Lighting

Notes: The original branch wiring system is operating but is aged, in marginal condition, and should be replaced.

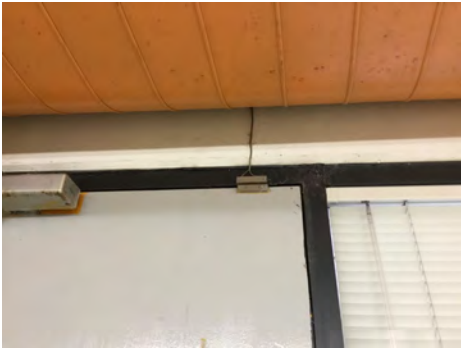
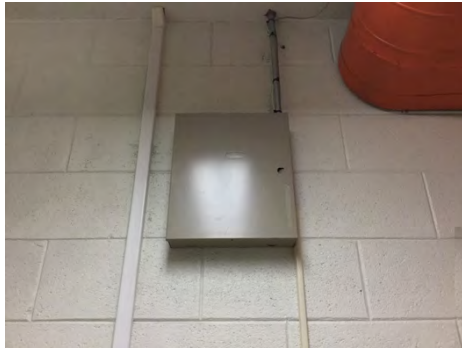
System: D5030810 - Security & Detection Systems

Notes: The security and CCTV system is beyond its expected service life and should be scheduled for replacement.
