NC School District/040 Anson County/Middle School

Anson Middle

Campus Assessment Report

March 10, 2017

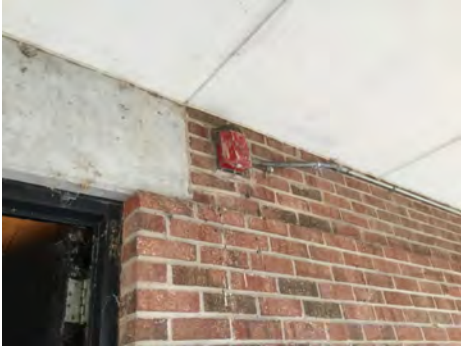
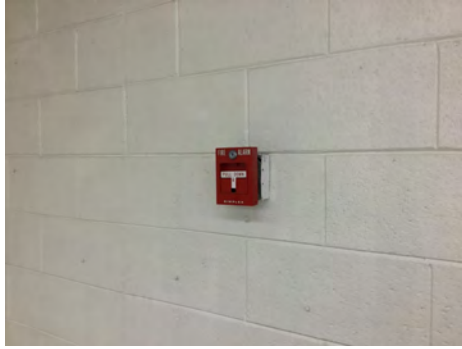
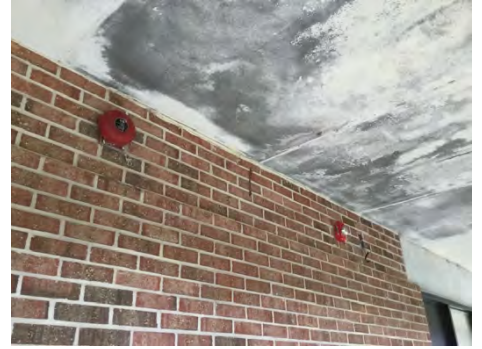
System: D5030910 - Fire Alarm Systems

Notes: The fire alarm system is beyond its expected service life and should be scheduled for replacement.

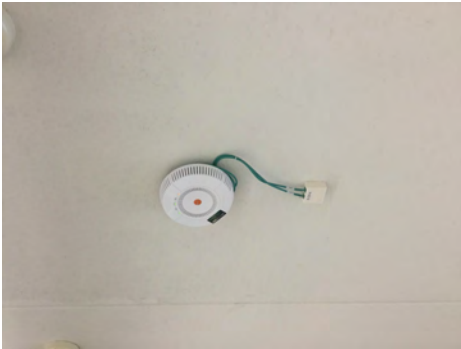
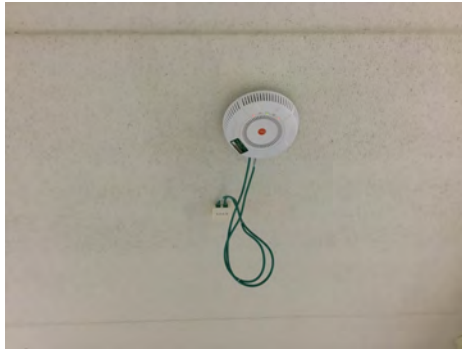
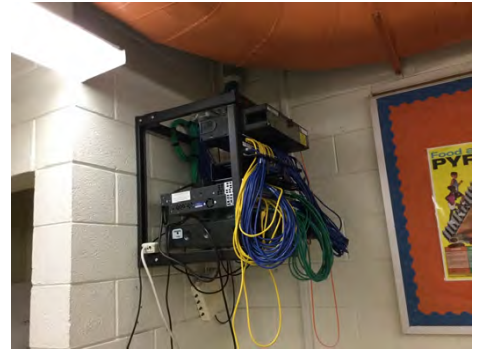
System: D5030920 - Data Communication

Notes: The data communication system is beyond its expected service life and should be scheduled for replacement.

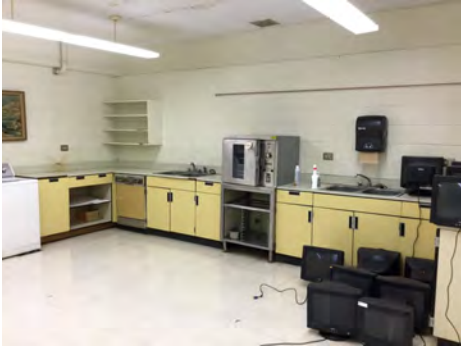
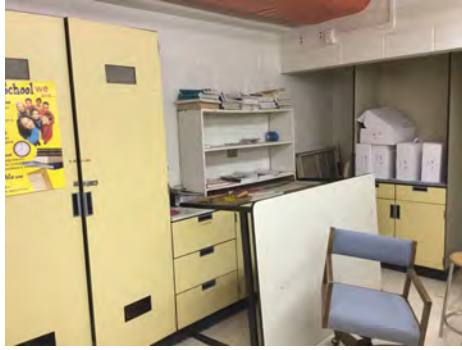
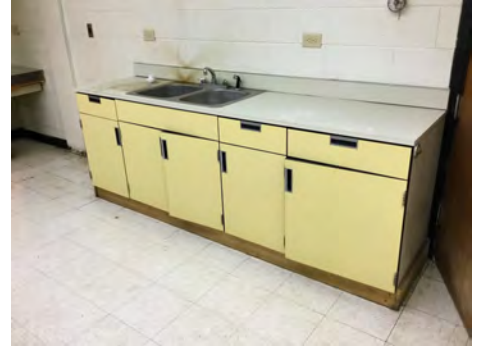
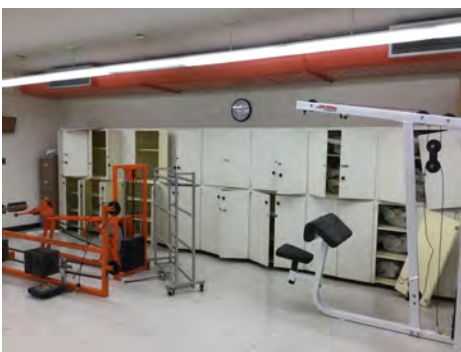
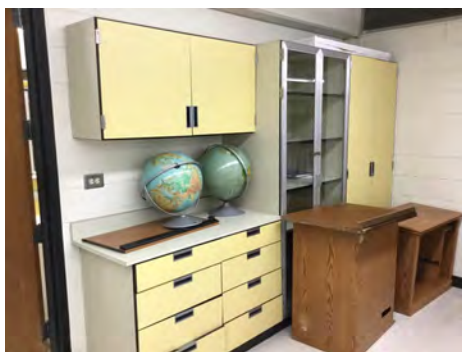
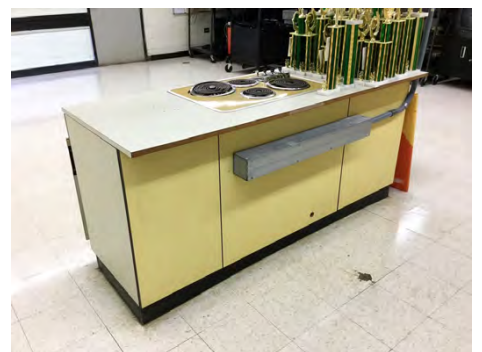
System: E2010 - Fixed Furnishings

Notes: The fixed furnishings are aged, in marginal condition, and should be replaced. Throughout

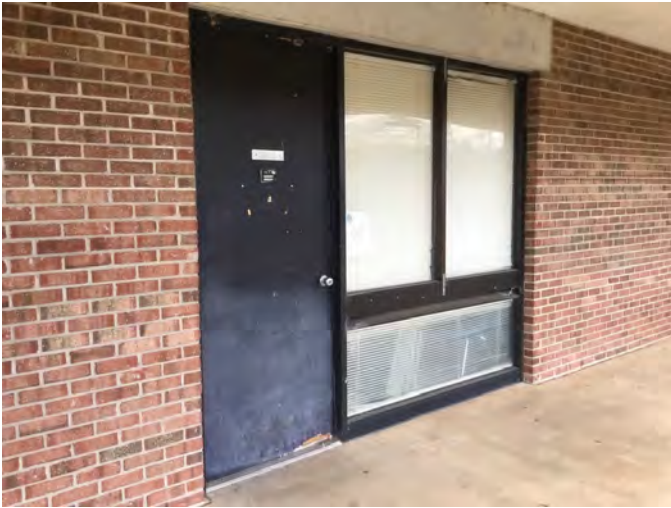
System: B2020 - Exterior Windows

Location: Exterior Walls
Distress: Beyond Service Life
Category: Deferred Maintenance
Priority: 3 - Necessary/Not Yet Critical (Years 2-5)
Correction: Renew System
Qty: 10,443.00
Unit of Measure: S.F.
Estimate: \$141,753.00
Assessor Name: Eduardo Lopez
Date Created: 02/06/2017

Notes: The exterior windows are aged, rusted, not energy efficient and should be replaced.

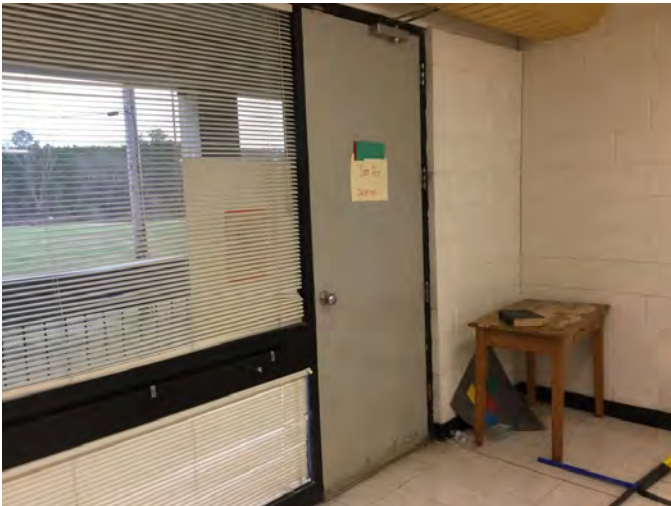
System: B2030 - Exterior Doors

Location: Exterior Walls
Distress: Beyond Service Life
Category: Deferred Maintenance
Priority: 3 - Necessary/Not Yet Critical (Years 2-5)
Correction: Renew System
Qty: 10,443.00
Unit of Measure: S.F.
Estimate: \$13,785.00
Assessor Name: Eduardo Lopez
Date Created: 02/06/2017

Notes: The exterior doors are aged, rusted and should be replaced.

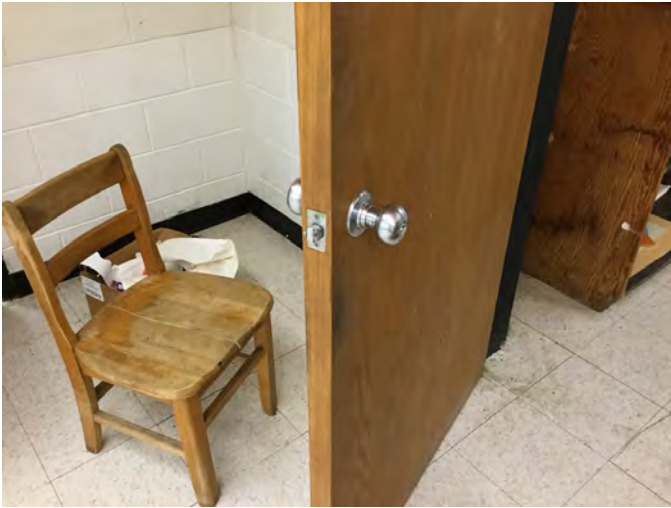
System: C1020 - Interior Doors

Location: Throughout the Building
Distress: Beyond Service Life
Category: Deferred Maintenance
Priority: 3 - Necessary/Not Yet Critical (Years 2-5)
Correction: Renew System
Qty: 10,443.00
Unit of Measure: S.F.
Estimate: \$33,198.00
Assessor Name: Eduardo Lopez
Date Created: 02/06/2017

Notes: The interior doors are aged, failing, most hardware is not ADA or code compliant and should be replaced.

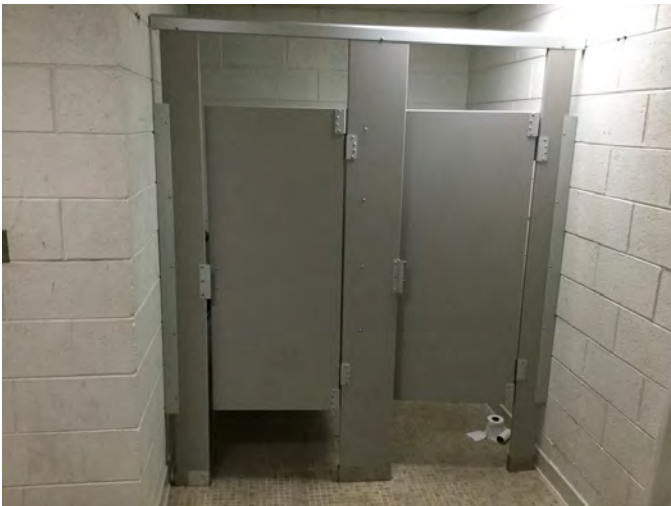
System: C1030 - Fittings

Location: Throughout the Building
Distress: Beyond Service Life
Category: Deferred Maintenance
Priority: 3 - Necessary/Not Yet Critical (Years 2-5)
Correction: Renew System
Qty: 10,443.00
Unit of Measure: S.F.
Estimate: \$176,675.00
Assessor Name: Eduardo Lopez
Date Created: 02/06/2017

Notes: The fittings throughout the building are aged, in marginal condition, handrails and room signage are not ADA compliant and should be replaced.

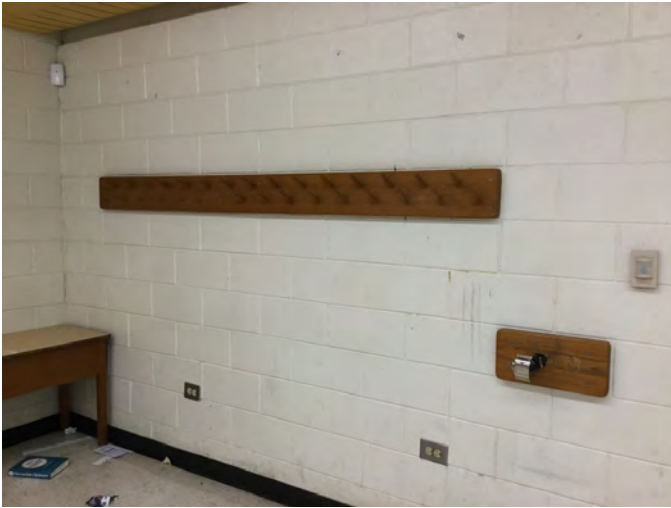
System: C3010 - Wall Finishes

Location: Throughout the Building
Distress: Beyond Service Life
Category: Deferred Maintenance
Priority: 3 - Necessary/Not Yet Critical (Years 2-5)
Correction: Renew System
Qty: 10,443.00
Unit of Measure: S.F.
Estimate: \$45,145.00
Assessor Name: Eduardo Lopez
Date Created: 02/06/2017

Notes: The wall finishes are aged, scuffed, fading, stained and should be replaced.

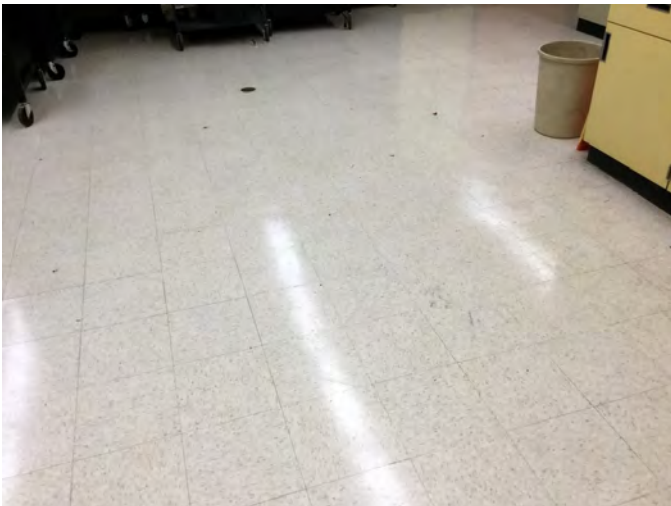
System: C3020 - Floor Finishes

Location: Throughout the Building
Distress: Beyond Service Life
Category: Deferred Maintenance
Priority: 3 - Necessary/Not Yet Critical (Years 2-5)
Correction: Renew System
Qty: 10,443.00
Unit of Measure: S.F.
Estimate: \$140,260.00
Assessor Name: Eduardo Lopez
Date Created: 02/06/2017

Notes: The original flooring is in poor conditions and should be replaced.

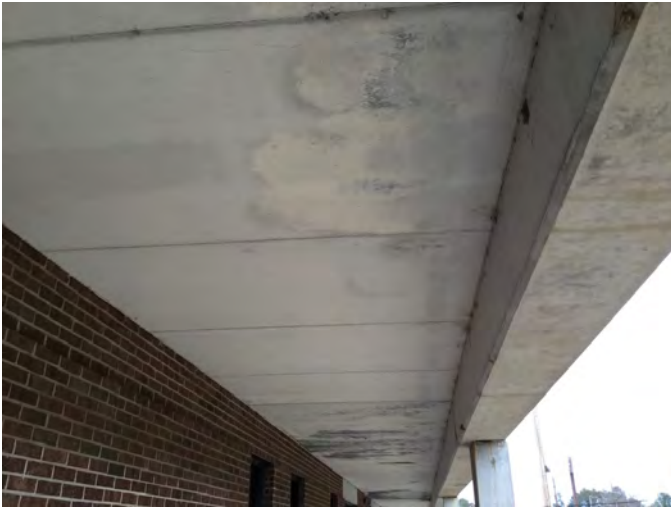
System: C3030 - Ceiling Finishes

Location: Throughout the Building
Distress: Beyond Service Life
Category: Deferred Maintenance
Priority: 3 - Necessary/Not Yet Critical (Years 2-5)
Correction: Renew System
Qty: 10,443.00
Unit of Measure: S.F.
Estimate: \$153,355.00
Assessor Name: Eduardo Lopez
Date Created: 02/06/2017

Notes: The original ceiling finishes are aged, failing and should be replaced.

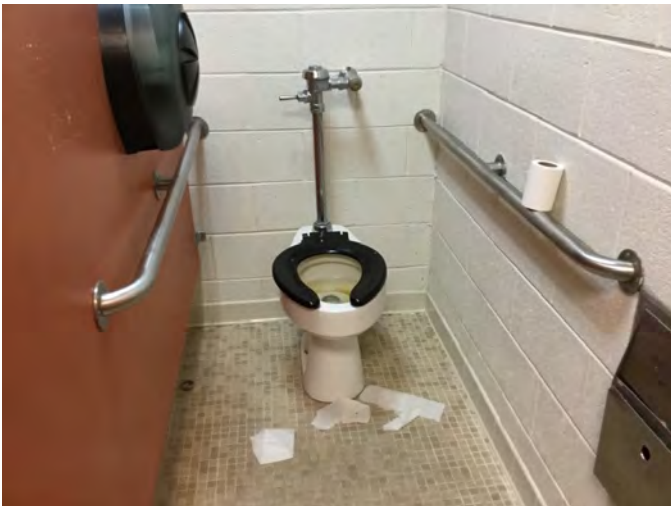
System: D2010 - Plumbing Fixtures

Location: Throughout the Building
Distress: Beyond Service Life
Category: Deferred Maintenance
Priority: 3 - Necessary/Not Yet Critical (Years 2-5)
Correction: Renew System
Qty: 10,443.00
Unit of Measure: S.F.
Estimate: \$129,921.00
Assessor Name: Eduardo Lopez
Date Created: 02/06/2017

Notes: Plumbing fixtures are in operational conditions. However, they are aged, not ADA compliant, and should be scheduled for replacement.

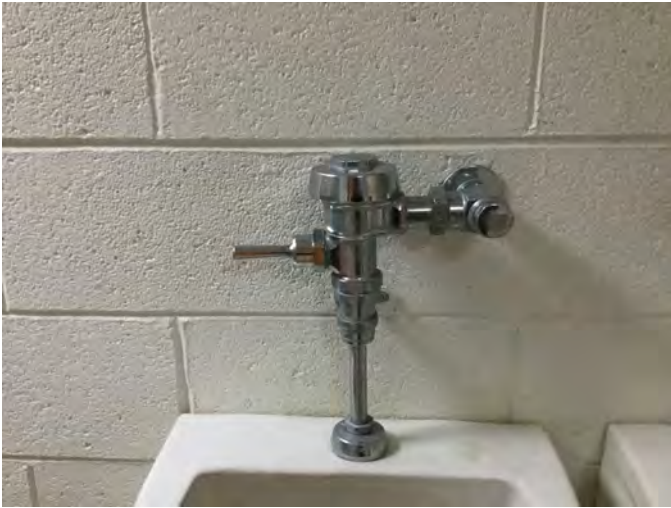
System: D2020 - Domestic Water Distribution

Location: Throughout the Building
Distress: Beyond Service Life
Category: Deferred Maintenance
Priority: 3 - Necessary/Not Yet Critical (Years 2-5)
Correction: Renew System
Qty: 10,443.00
Unit of Measure: S.F.
Estimate: \$13,900.00
Assessor Name: Eduardo Lopez
Date Created: 02/06/2017

Notes: The domestic water distribution system is aged and should be replaced.

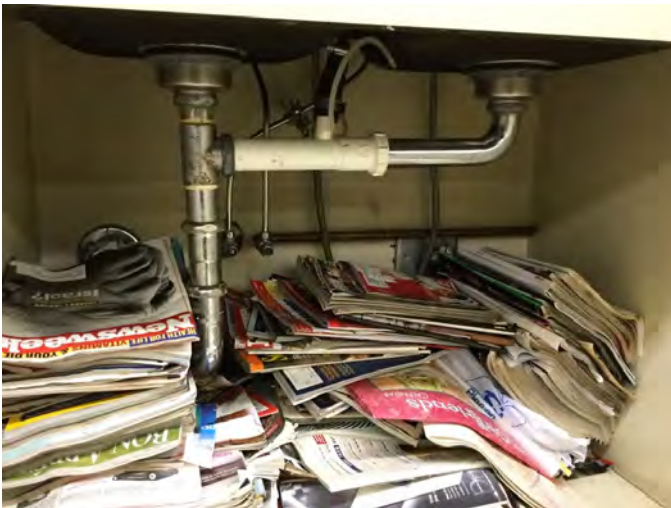
System: D2030 - Sanitary Waste

Location: Throughout the Building
Distress: Beyond Service Life
Category: Deferred Maintenance
Priority: 3 - Necessary/Not Yet Critical (Years 2-5)
Correction: Renew System
Qty: 10,443.00
Unit of Measure: S.F.
Estimate: \$21,826.00
Assessor Name: Eduardo Lopez
Date Created: 02/06/2017

Notes: The sanitary waste system is beyond its expected service life and should be replaced.

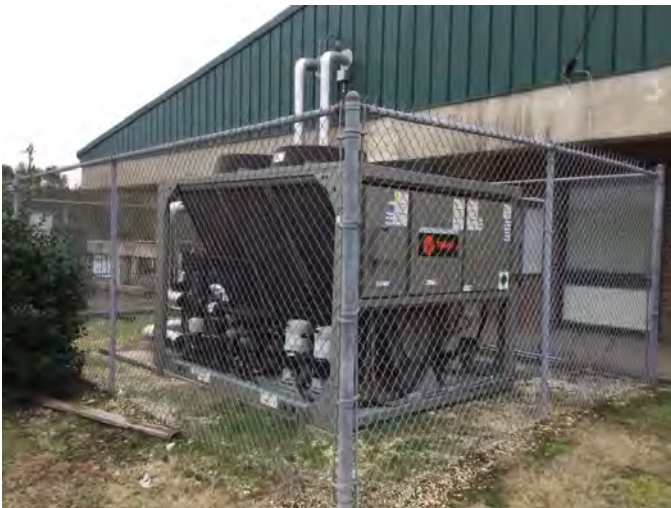
System: D3030 - Cooling Generating Systems

Location: Throughout the Building
Distress: Beyond Service Life
Category: Deferred Maintenance
Priority: 3 - Necessary/Not Yet Critical (Years 2-5)
Correction: Renew System
Qty: 10,443.00
Unit of Measure: S.F.
Estimate: \$121,191.00
Assessor Name: Eduardo Lopez
Date Created: 02/06/2017

Notes: The cooling generating system is beyond its expected service life and should be scheduled for replacement.

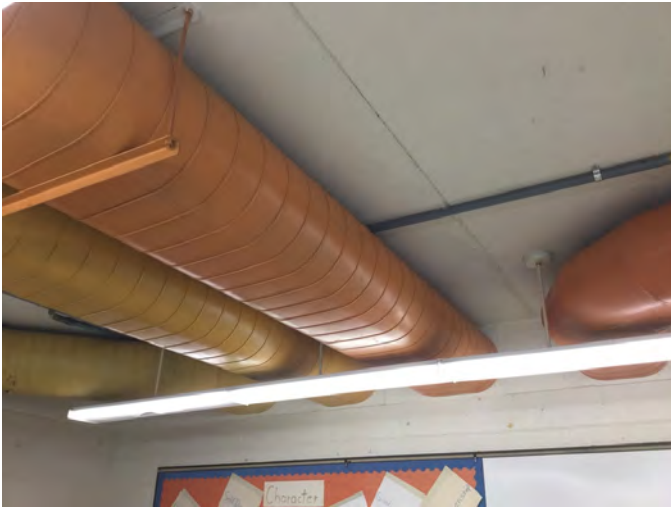
System: D3040 - Distribution Systems

Location: Throughout the Building
Distress: Beyond Service Life
Category: Deferred Maintenance
Priority: 3 - Necessary/Not Yet Critical (Years 2-5)
Correction: Renew System
Qty: 10,443.00
Unit of Measure: S.F.
Estimate: \$143,476.00
Assessor Name: Eduardo Lopez
Date Created: 02/06/2017

Notes: The distribution systems are aged, becoming logistically unsupportable, and should be replaced.

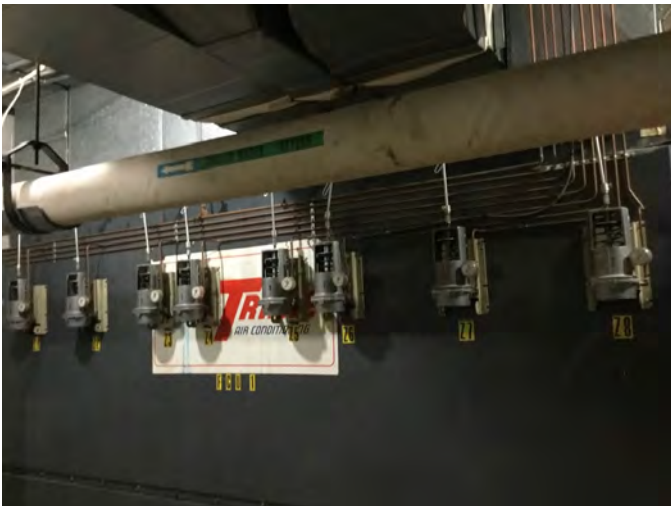
System: D3060 - Controls & Instrumentation

Location: Throughout the Building
Distress: Beyond Service Life
Category: Deferred Maintenance
Priority: 3 - Necessary/Not Yet Critical (Years 2-5)
Correction: Renew System
Qty: 10,443.00
Unit of Measure: S.F.
Estimate: \$44,915.00
Assessor Name: Eduardo Lopez
Date Created: 02/06/2017

Notes: The controls and instrumentation system is in marginal condition and should be schedule for replacement.

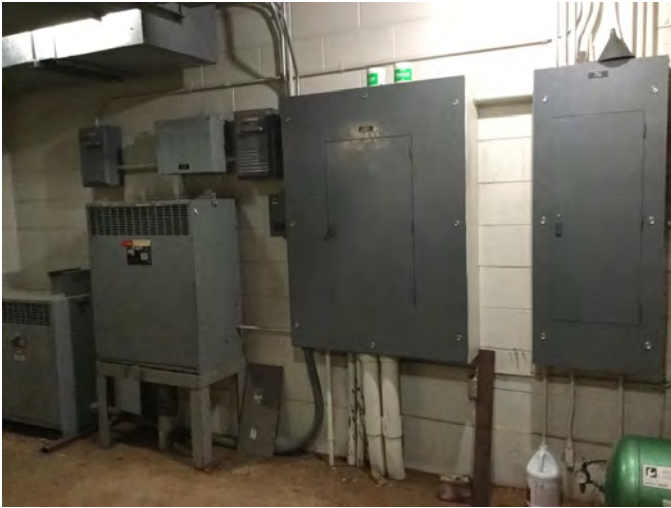
System: D5010 - Electrical Service/Distribution

Location: Throughout the Building
Distress: Beyond Service Life
Category: Deferred Maintenance
Priority: 3 - Necessary/Not Yet Critical (Years 2-5)
Correction: Renew System
Qty: 10,443.00
Unit of Measure: S.F.
Estimate: \$21,941.00
Assessor Name: Eduardo Lopez
Date Created: 02/06/2017

Notes: The original electrical service is operating but is in poor condition and should be replaced.

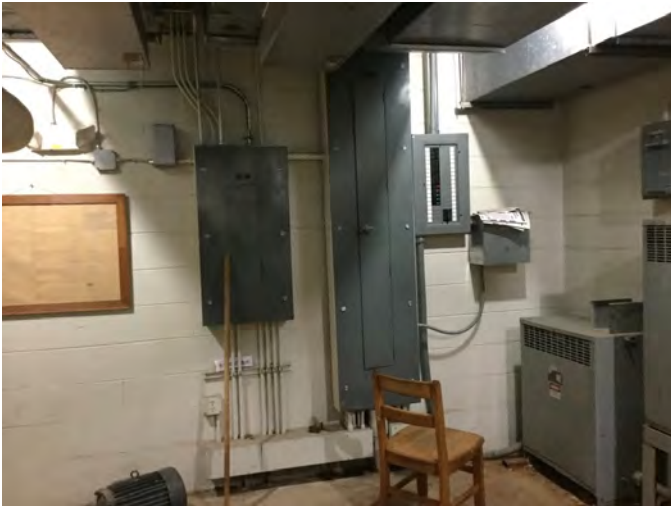
System: D5020 - Branch Wiring

Location: Throughout the Building
Distress: Beyond Service Life
Category: Deferred Maintenance
Priority: 3 - Necessary/Not Yet Critical (Years 2-5)
Correction: Renew System
Qty: 10,443.00
Unit of Measure: S.F.
Estimate: \$66,167.00
Assessor Name: Eduardo Lopez
Date Created: 02/06/2017

Notes: The original branch wiring system is operating but is aged, in marginal condition, and should be replaced.

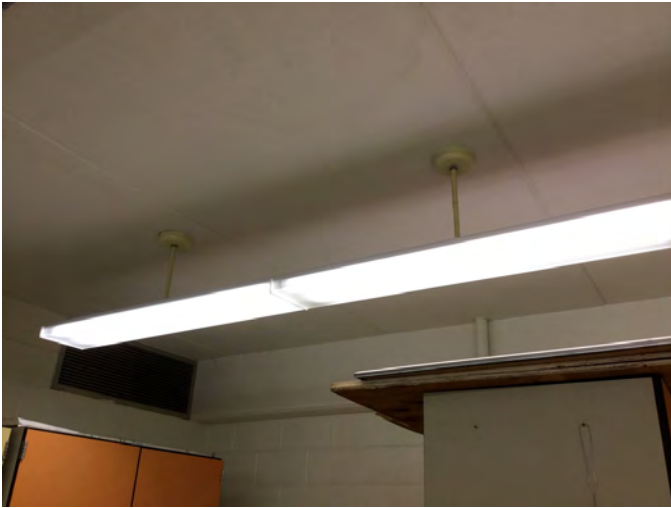
System: D5020 - Lighting

Location: Throughout the Building
Distress: Beyond Service Life
Category: Deferred Maintenance
Priority: 3 - Necessary/Not Yet Critical (Years 2-5)
Correction: Renew System
Qty: 10,443.00
Unit of Measure: S.F.
Estimate: \$154,160.00
Assessor Name: Eduardo Lopez
Date Created: 02/06/2017

Notes: The original branch wiring system is operating but is aged, in marginal condition, and should be replaced.

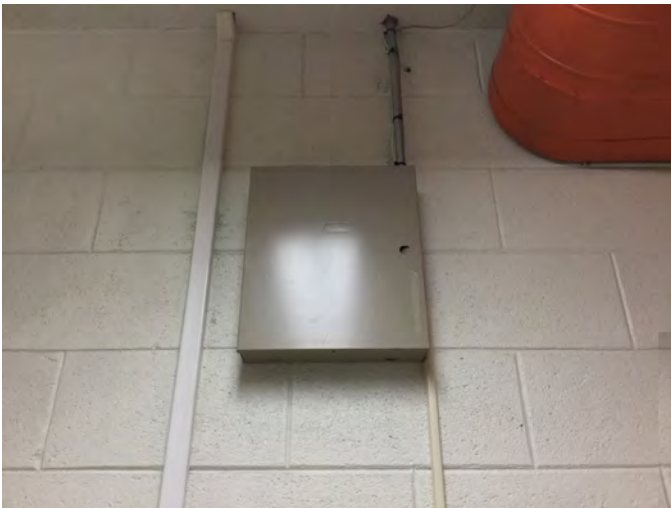
System: D5030810 - Security & Detection Systems

Location: Throughout the Building
Distress: Beyond Service Life
Category: Deferred Maintenance
Priority: 3 - Necessary/Not Yet Critical (Years 2-5)
Correction: Renew System
Qty: 10,443.00
Unit of Measure: S.F.
Estimate: \$30,671.00
Assessor Name: Eduardo Lopez
Date Created: 02/06/2017

Notes: The security and CCTV system is beyond its expected service life and should be scheduled for replacement.

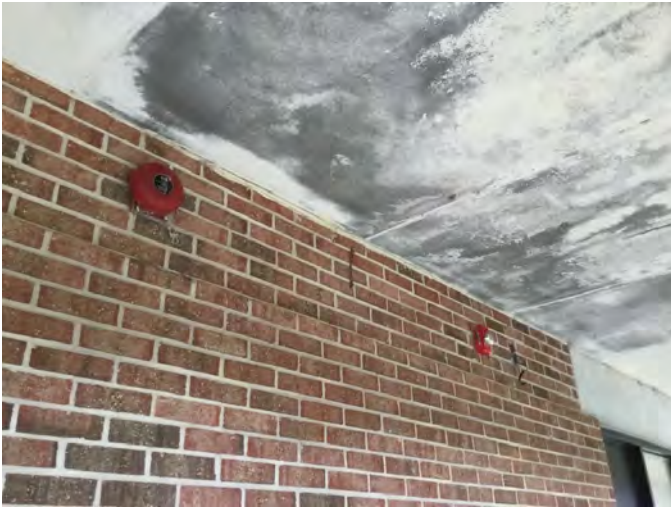
System: D5030910 - Fire Alarm Systems

Location: Throughout the Building
Distress: Beyond Service Life
Category: Deferred Maintenance
Priority: 3 - Necessary/Not Yet Critical (Years 2-5)
Correction: Renew System
Qty: 10,443.00
Unit of Measure: S.F.
Estimate: \$55,369.00
Assessor Name: Eduardo Lopez
Date Created: 02/06/2017

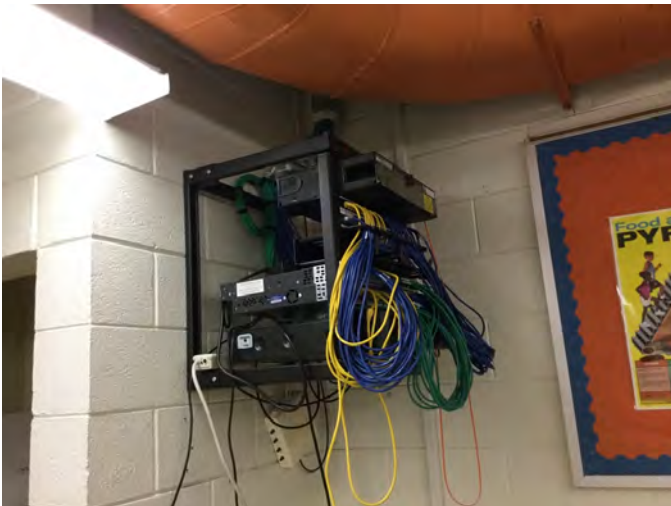
System: D5030920 - Data Communication

Location: Throughout the Building
Distress: Beyond Service Life
Category: Deferred Maintenance
Priority: 3 - Necessary/Not Yet Critical (Years 2-5)
Correction: Renew System
Qty: 10,443.00
Unit of Measure: S.F.
Estimate: \$71,681.00
Assessor Name: Eduardo Lopez
Date Created: 02/06/2017

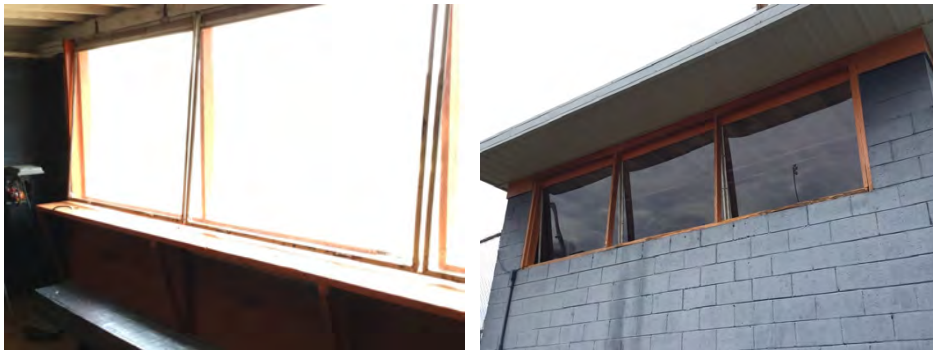
System: B2020 - Exterior Windows

Notes: The exterior windows are aged, rusted, not energy efficient and should be replaced.

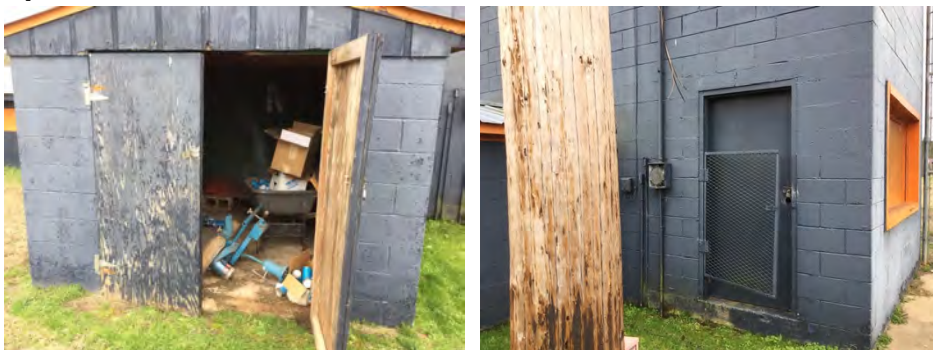
System: B2030 - Exterior Doors

Notes: The exterior doors are aged, rusted and should be replaced.

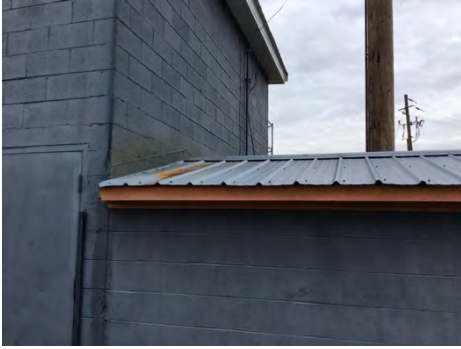
System: B3010130 - Preformed Metal Roofing

Notes: The metal roof covering is aged, showing signs of failure and should be replaced.

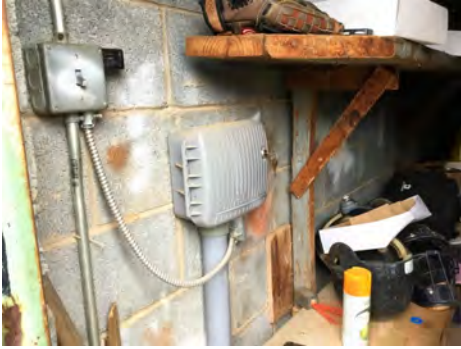
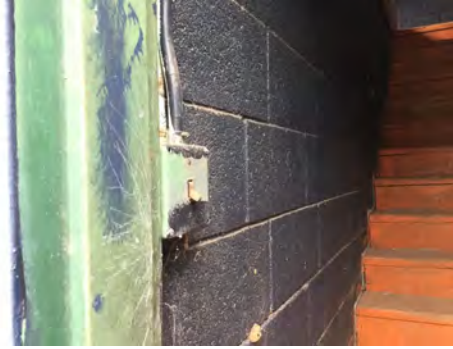
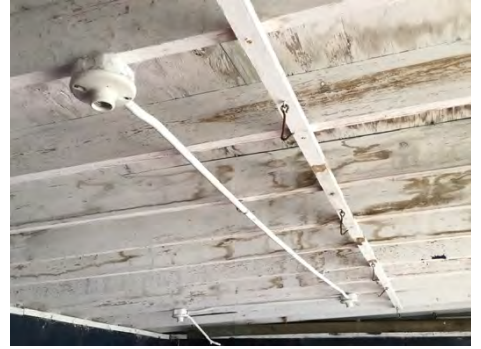
System: D5020 - Branch Wiring

Notes: The original branch wiring system is operating but is aged, in marginal condition, and should be replaced.

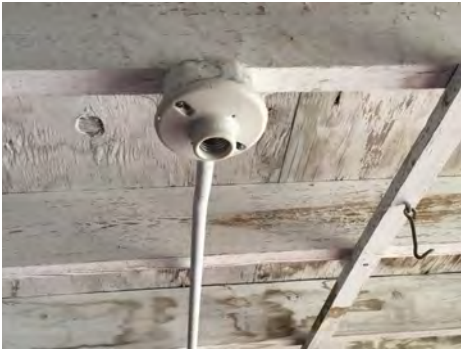
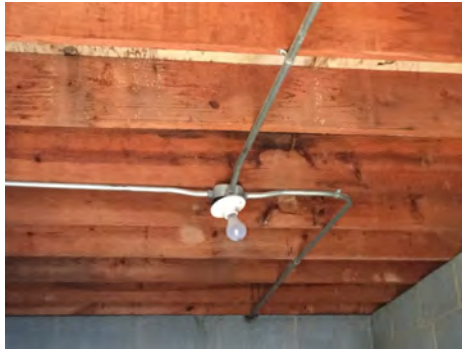
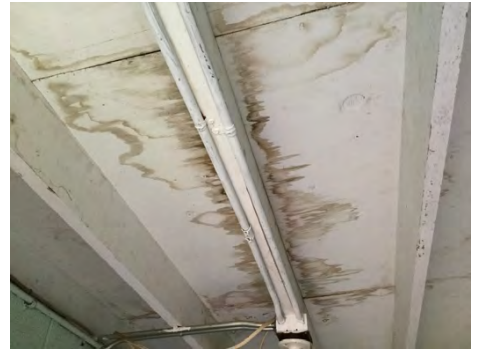
System: D5020 - Lighting

Notes: The original branch wiring system is operating but is aged, in marginal condition, and should be replaced.

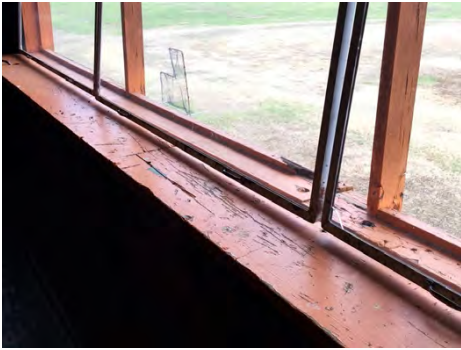
System: E2010 - Fixed Furnishings

Notes: The fixed furnishings are aged, in marginal condition, and should be replaced.

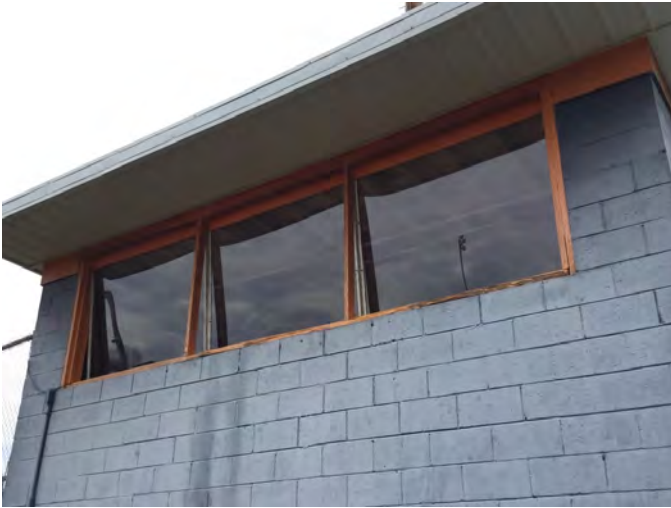
System: B2020 - Exterior Windows

Location: Exterior Walls
Distress: Beyond Service Life
Category: Deferred Maintenance
Priority: 3 - Necessary/Not Yet Critical (Years 2-5)
Correction: Renew System
Qty: 891.00
Unit of Measure: S.F.
Estimate: \$16,828.00
Assessor Name: Eduardo Lopez
Date Created: 01/12/2017

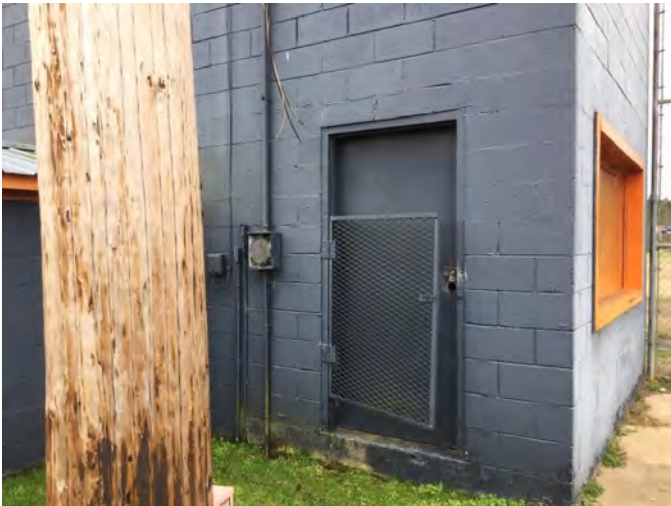
System: B2030 - Exterior Doors

Location: Exterior Walls
Distress: Beyond Service Life
Category: Deferred Maintenance
Priority: 3 - Necessary/Not Yet Critical (Years 2-5)
Correction: Renew System
Qty: 891.00
Unit of Measure: S.F.
Estimate: \$8,488.00
Assessor Name: Eduardo Lopez
Date Created: 01/12/2017

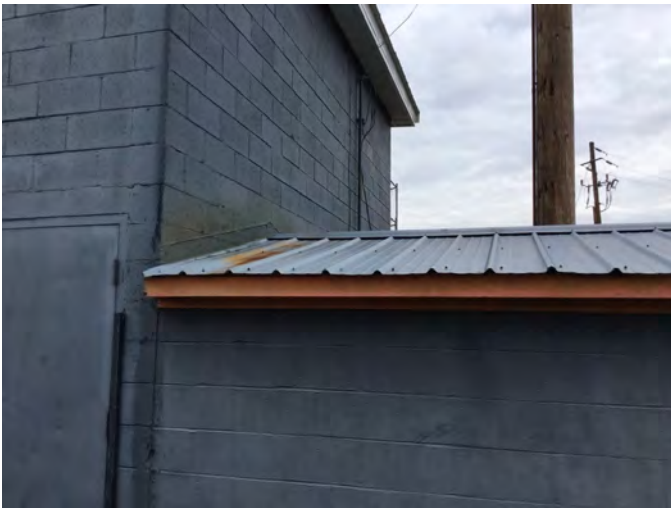
System: B3010130 - Preformed Metal Roofing

Location: Roof
Distress: Beyond Service Life
Category: Deferred Maintenance
Priority: 3 - Necessary/Not Yet Critical (Years 2-5)
Correction: Renew System
Qty: 891.00
Unit of Measure: S.F.
Estimate: \$11,878.00
Assessor Name: Eduardo Lopez
Date Created: 01/12/2017

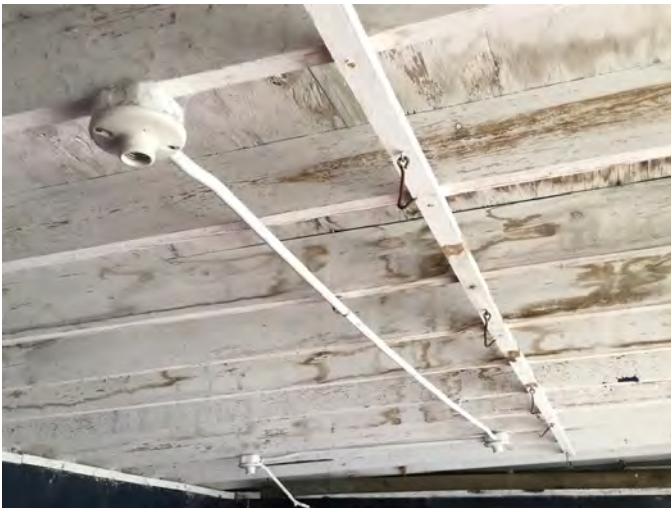
System: D5020 - Branch Wiring

Location: Throughout the Building
Distress: Beyond Service Life
Category: Deferred Maintenance
Priority: 3 - Necessary/Not Yet Critical (Years 2-5)
Correction: Renew System
Qty: 891.00
Unit of Measure: S.F.
Estimate: \$9,056.00
Assessor Name: Eduardo Lopez
Date Created: 01/12/2017

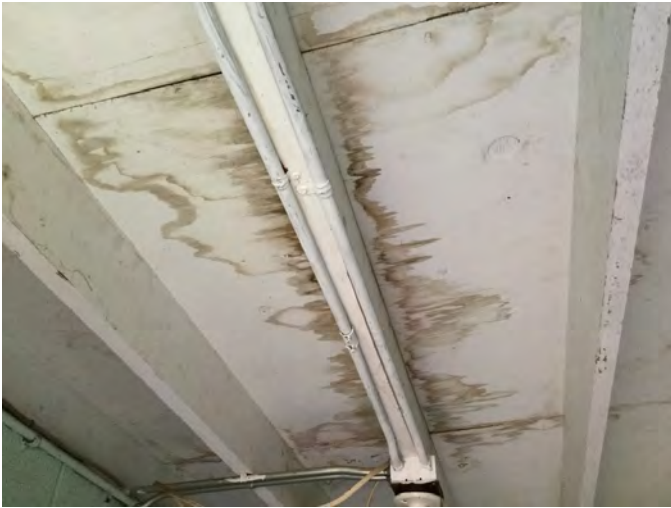
System: D5020 - Lighting

Location: Throughout the Building
Distress: Beyond Service Life
Category: Deferred Maintenance
Priority: 3 - Necessary/Not Yet Critical (Years 2-5)
Correction: Renew System
Qty: 891.00
Unit of Measure: S.F.
Estimate: \$8,409.00
Assessor Name: Eduardo Lopez
Date Created: 01/12/2017

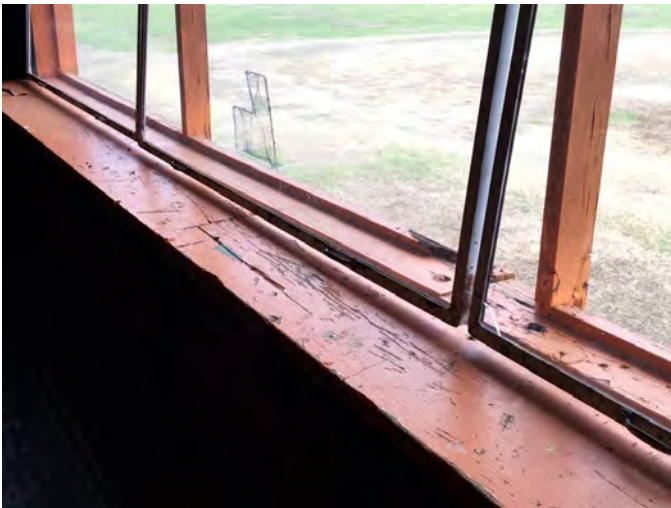
System: E2010 - Fixed Furnishings

Location: Throughout the Building
Distress: Beyond Service Life
Category: Deferred Maintenance
Priority: 3 - Necessary/Not Yet Critical (Years 2-5)
Correction: Renew System
Qty: 891.00
Unit of Measure: S.F.
Estimate: \$10,458.00
Assessor Name: Eduardo Lopez
Date Created: 01/12/2017

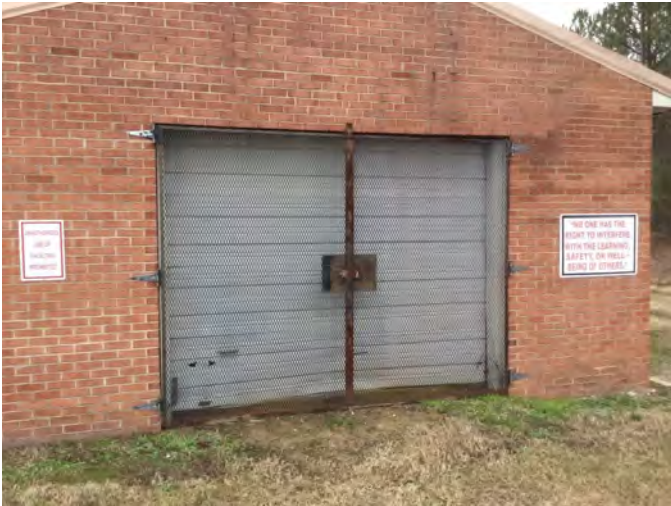
System: B2030 - Exterior Doors

Location: Exterior Walls
Distress: Beyond Service Life
Category: Deferred Maintenance
Priority: 3 - Necessary/Not Yet Critical (Years 2-5)
Correction: Renew System
Qty: 856.00
Unit of Measure: S.F.
Estimate: \$8,154.00
Assessor Name: Eduardo Lopez
Date Created: 01/12/2017

Notes: The exterior doors are aged, rusted and should be replaced.

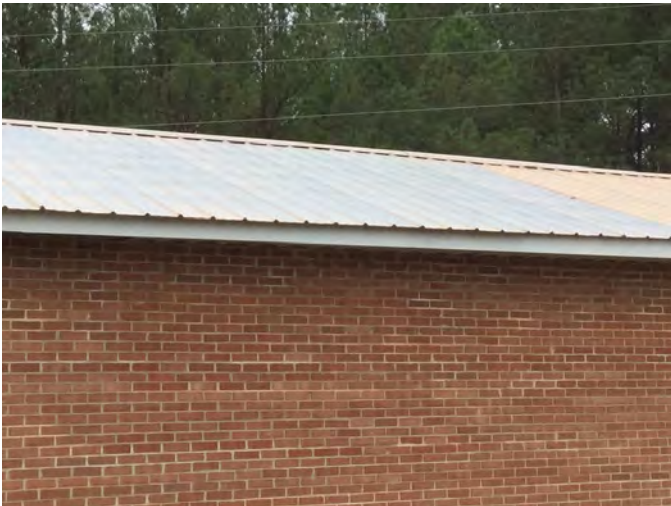
System: B3010130 - Preformed Metal Roofing

Location: Roof
Distress: Beyond Service Life
Category: Deferred Maintenance
Priority: 3 - Necessary/Not Yet Critical (Years 2-5)
Correction: Renew System
Qty: 856.00
Unit of Measure: S.F.
Estimate: \$11,411.00
Assessor Name: Eduardo Lopez
Date Created: 01/12/2017

Notes: The metal roof covering is aged, showing signs of failure and should be replaced.

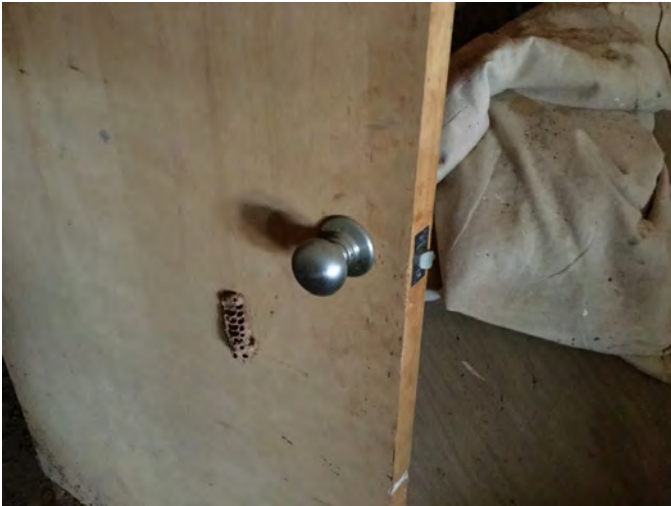
System: C1020 - Interior Doors

Location: Throughout the Building
Distress: Beyond Service Life
Category: Deferred Maintenance
Priority: 3 - Necessary/Not Yet Critical (Years 2-5)
Correction: Renew System
Qty: 856.00
Unit of Measure: S.F.
Estimate: \$1,215.00
Assessor Name: Eduardo Lopez
Date Created: 01/12/2017

Notes: The interior doors are aged, failing, most hardware is not ADA or code compliant and should be replaced.

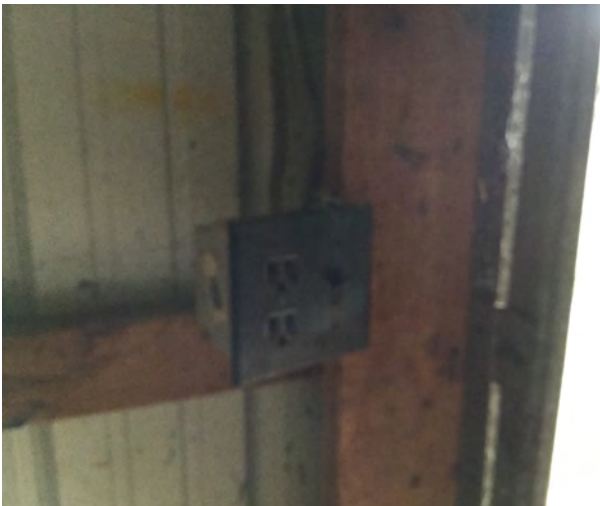
System: D5020 - Branch Wiring

Location: Throughout the Building
Distress: Beyond Service Life
Category: Deferred Maintenance
Priority: 3 - Necessary/Not Yet Critical (Years 2-5)
Correction: Renew System
Qty: 856.00
Unit of Measure: S.F.
Estimate: \$3,371.00
Assessor Name: Eduardo Lopez
Date Created: 01/12/2017

Notes: The original branch wiring system is operating but is aged, in marginal condition, and should be replaced.

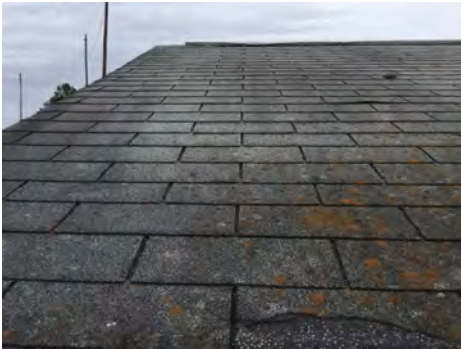
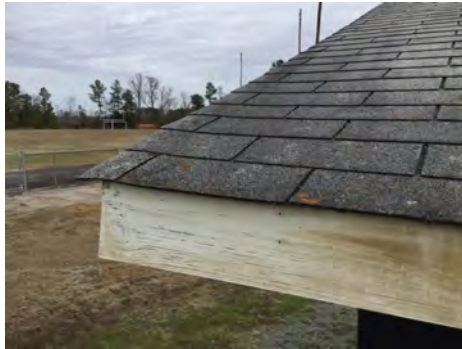
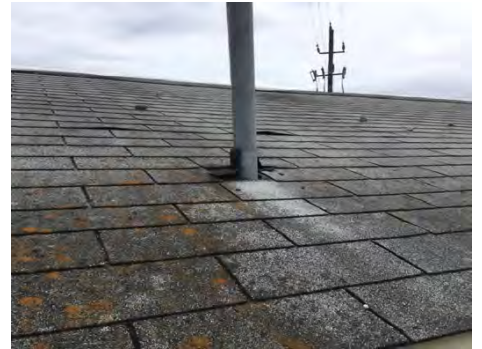
System: B3010140 - Asphalt Shingles

Notes: The asphalt shingles roof covering is aged, showing signs of failure and should be replaced.

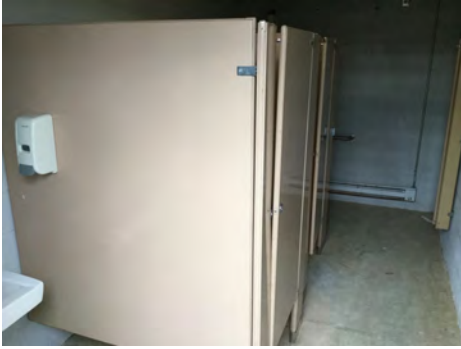
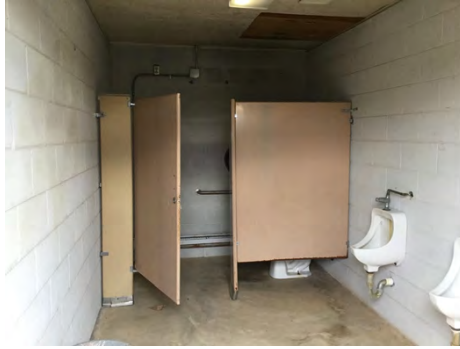
System: C1030 - Fittings

Notes: The fittings throughout the building are aged, in marginal condition, handrails and room signage are not ADA compliant and should be replaced.

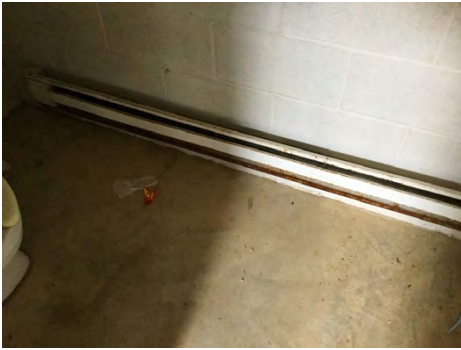
System: D3050 - Terminal & Package Units

Notes: Terminal and package units are beyond their expected service life and should be scheduled for replacement.

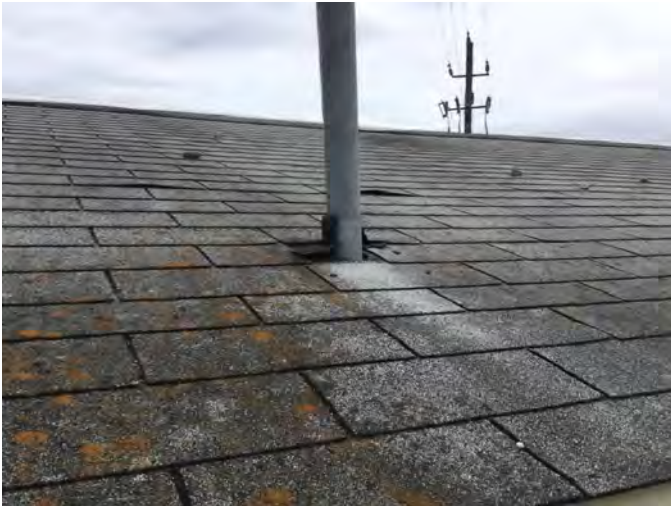
System: B3010140 - Asphalt Shingles

Location: Roof
Distress: Beyond Service Life
Category: Deferred Maintenance
Priority: 3 - Necessary/Not Yet Critical (Years 2-5)
Correction: Renew System
Qty: 800.00
Unit of Measure: S.F.
Estimate: \$5,046.00
Assessor Name: Eduardo Lopez
Date Created: 01/12/2017

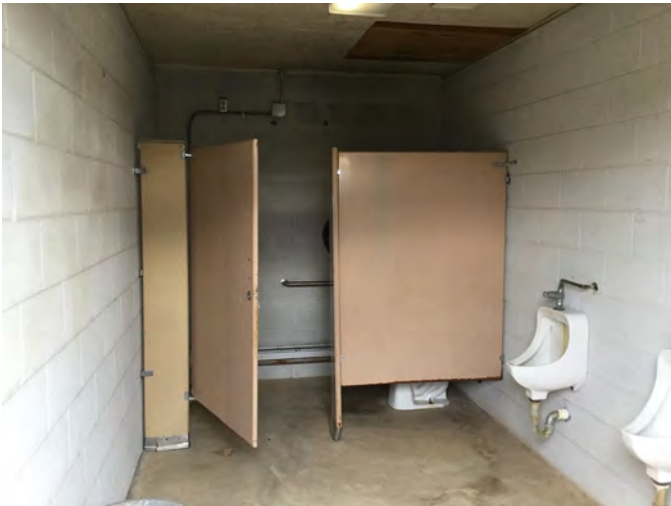
System: C1030 - Fittings

Location: Throughout the Building
Distress: Beyond Service Life
Category: Deferred Maintenance
Priority: 3 - Necessary/Not Yet Critical (Years 2-5)
Correction: Renew System
Qty: 800.00
Unit of Measure: S.F.
Estimate: \$9,812.00
Assessor Name: Eduardo Lopez
Date Created: 01/12/2017

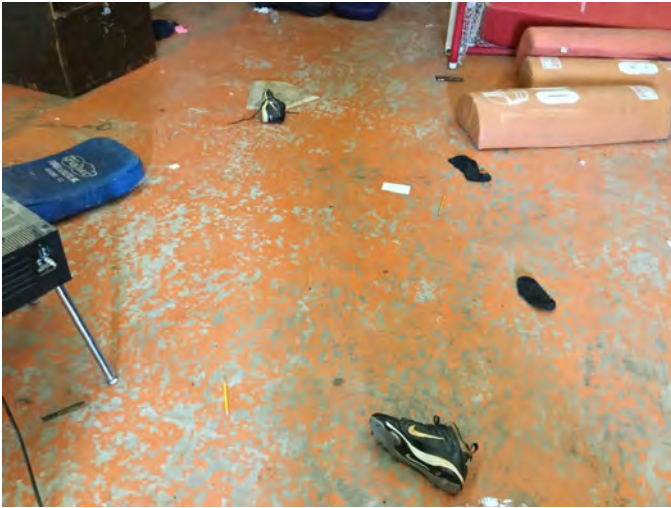
System: C3020 - Floor Finishes

Location: Throughout the Building
Distress: Beyond Service Life
Category: Deferred Maintenance
Priority: 3 - Necessary/Not Yet Critical (Years 2-5)
Correction: Renew System
Qty: 800.00
Unit of Measure: S.F.
Estimate: \$11,211.00
Assessor Name: Eduardo Lopez
Date Created: 01/12/2017

Notes: The original flooring is in poor conditions and should be replaced.

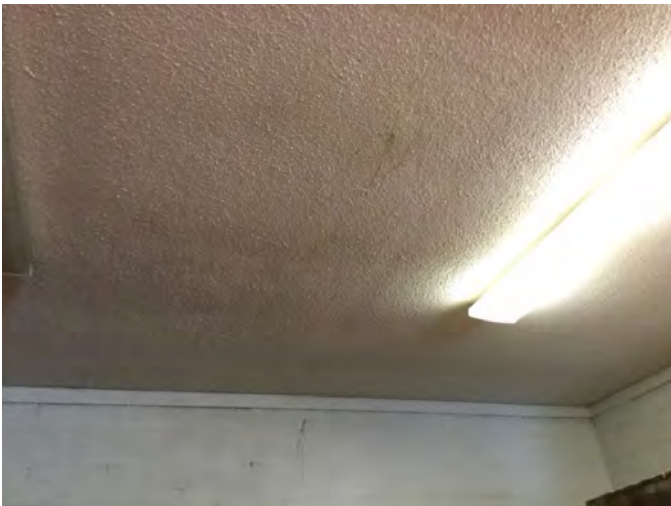
System: C3030 - Ceiling Finishes

Location: Throughout the Building
Distress: Beyond Service Life
Category: Deferred Maintenance
Priority: 3 - Necessary/Not Yet Critical (Years 2-5)
Correction: Renew System
Qty: 800.00
Unit of Measure: S.F.
Estimate: \$8,386.00
Assessor Name: Eduardo Lopez
Date Created: 01/12/2017

Notes: The original ceiling finishes are aged, failing and should be replaced.

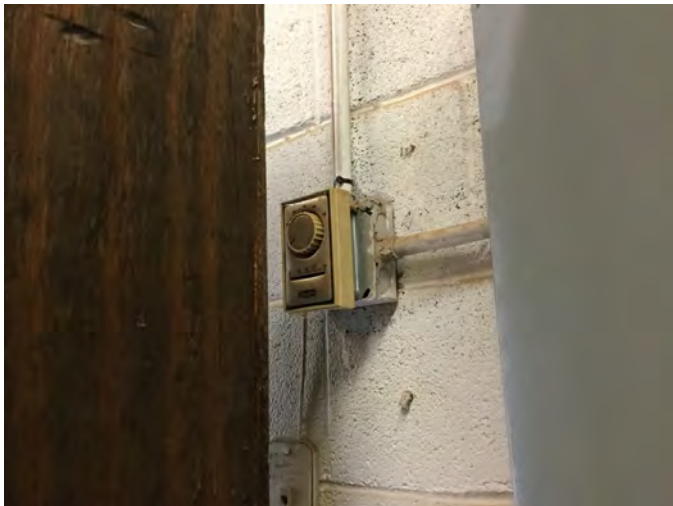
System: D3060 - Controls & Instrumentation

Location: Throughout the Building
Distress: Beyond Service Life
Category: Deferred Maintenance
Priority: 3 - Necessary/Not Yet Critical (Years 2-5)
Correction: Renew System
Qty: 800.00
Unit of Measure: S.F.
Estimate: \$3,062.00
Assessor Name: Eduardo Lopez
Date Created: 01/12/2017

Notes: The controls and instrumentation system is in marginal condition and should be schedule for replacement.

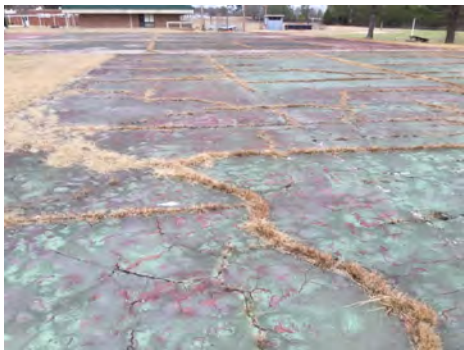
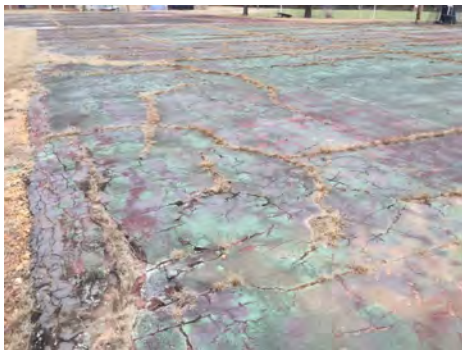
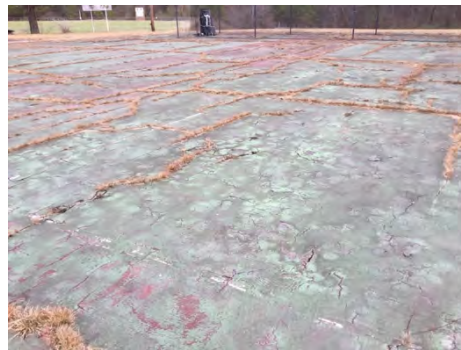
System: G2040950 - Hard Surface Play Area

Notes: The old tennis court surface is now used as playing area and the system is beyond its expected service life and should be scheduled for replacement.

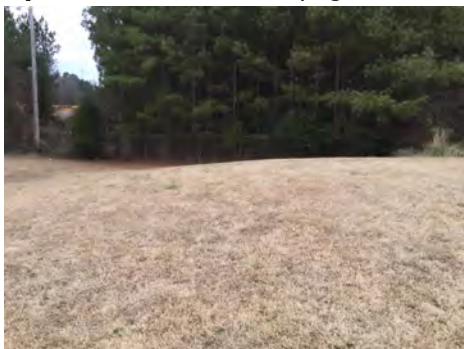
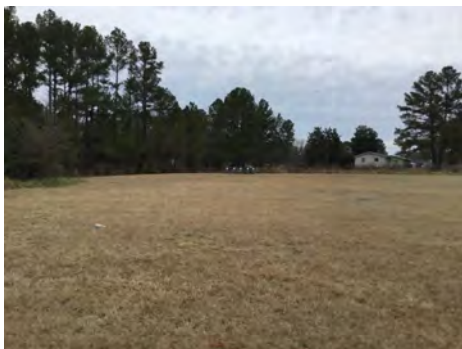
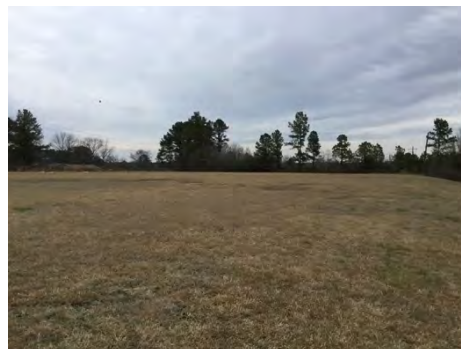
System: G2040950 - Playing Field

Notes: The playing field system is beyond its expected service life and should be scheduled for replacement.

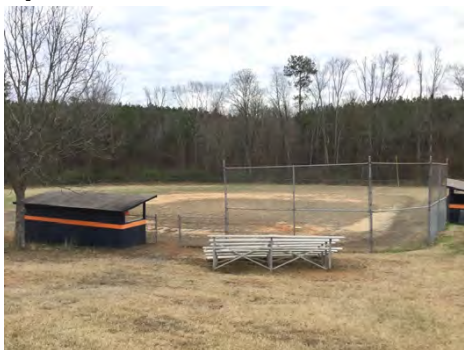
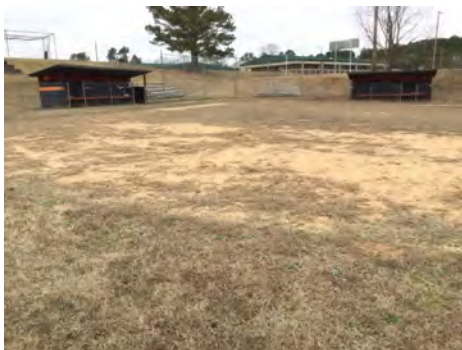
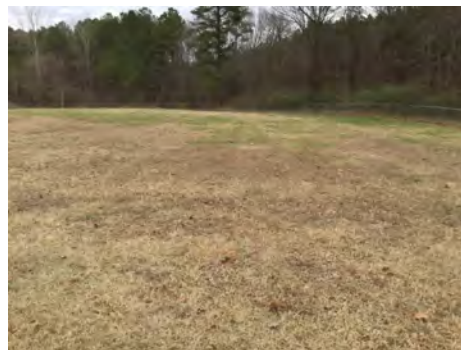
System: G2040950 - Softball Field

Notes: The softball field system is beyond its expected service life and should be scheduled for replacement.

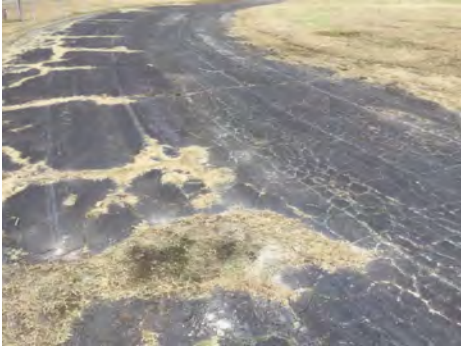
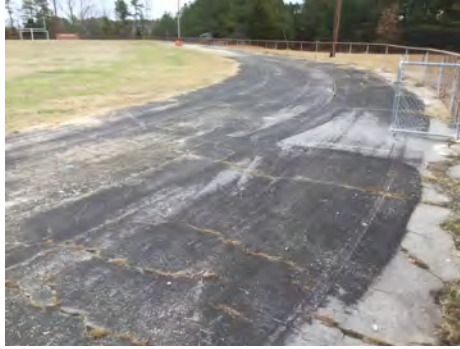
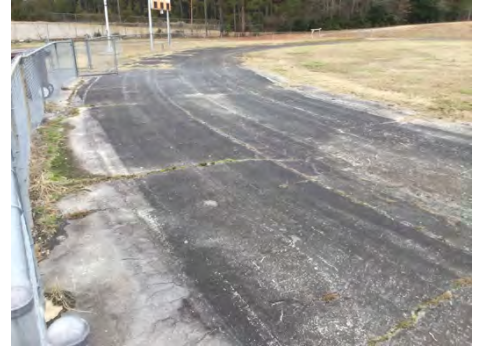
System: G2040950 - Track

Notes: The track system is beyond its expected service life and should be scheduled for replacement.
