NC School District/040 Anson County/Middle School

Anson Middle

Campus Assessment Report

March 10, 2017

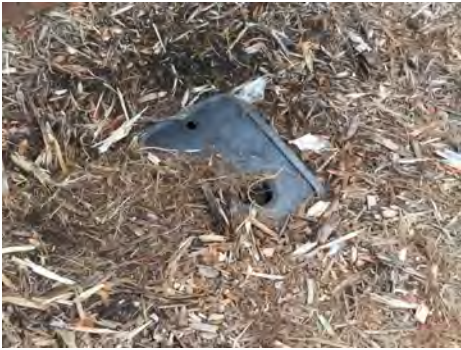
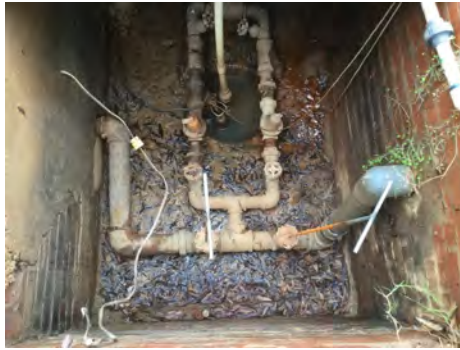
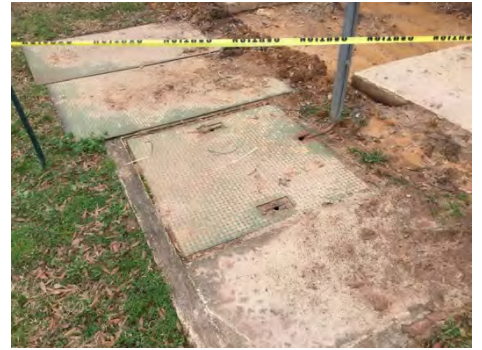
System: G3010 - Water Supply

Notes: The water supply system is beyond its expected service life and should be scheduled for replacement.

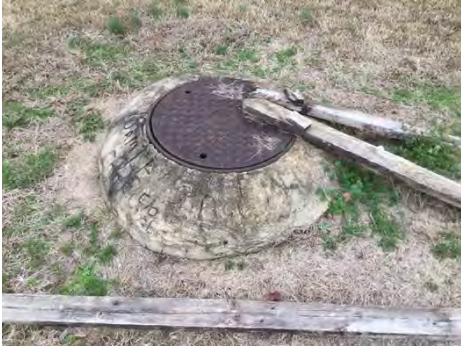
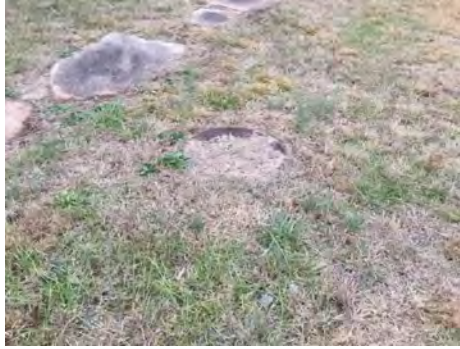
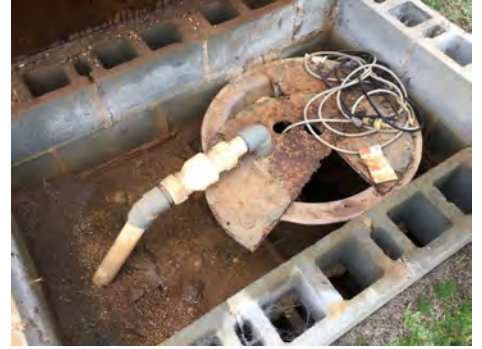
System: G3020 - Sanitary Sewer

Notes: The sanitary sewer system is beyond its expected service life and should be scheduled for replacement.

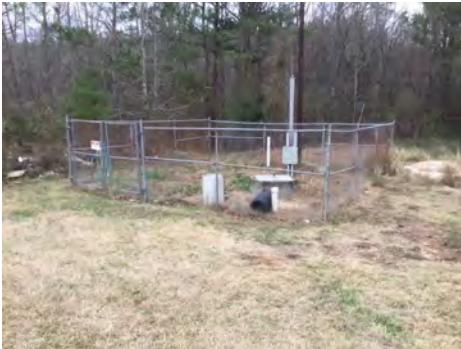
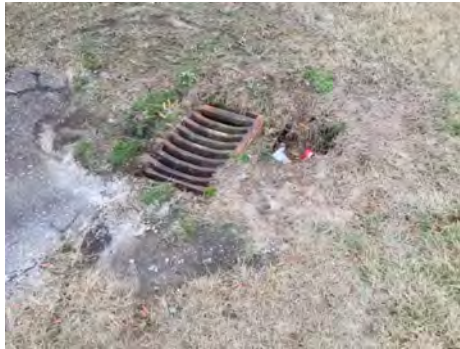
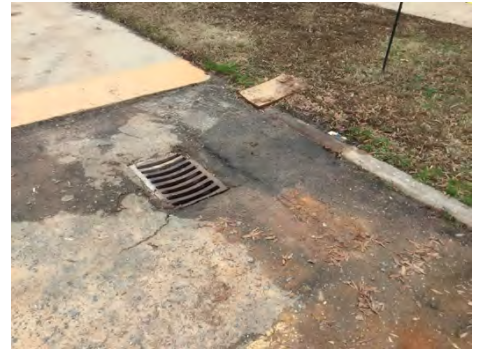
System: G3030 - Storm Sewer

Notes: The storm sewer system is beyond its expected service life and should be scheduled for replacement.

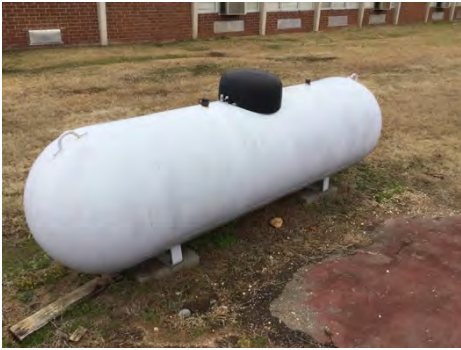
System: G3060 - Fuel Distribution

Notes: The fuel distribution system is beyond its expected service life and should be scheduled for replacement.

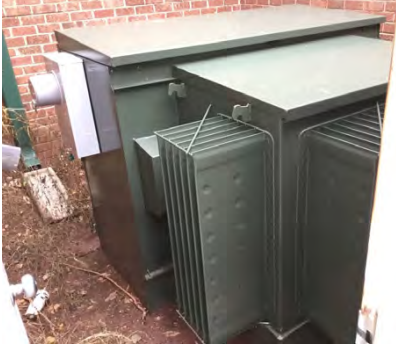
System: G4010 - Electrical Distribution

Notes: The electrical distribution system is beyond its expected service life and should be scheduled for replacement.

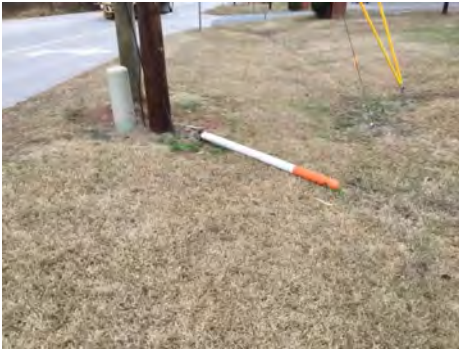
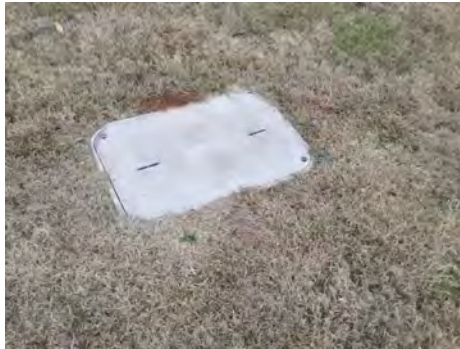
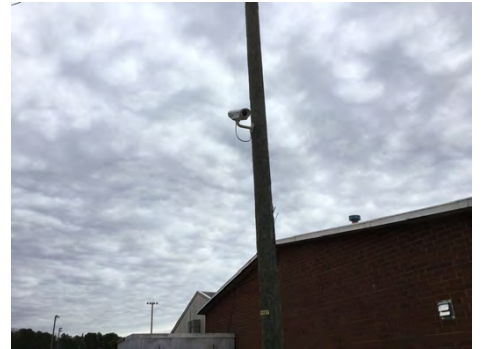
System: G4030 - Site Communications & Security

Notes: The site communication & security system is beyond its expected service life and should be scheduled for replacement.

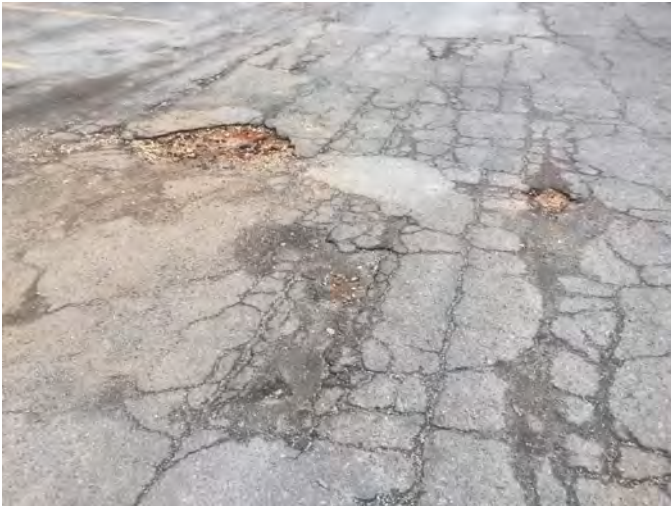
System: G2010 - Roadways

Location: Site
Distress: Beyond Service Life
Category: Deferred Maintenance
Priority: 3 - Necessary/Not Yet Critical (Years 2-5)
Correction: Renew System
Qty: 120,423.00
Unit of Measure: S.F.
Estimate: \$559,004.00
Assessor Name: Eduardo Lopez
Date Created: 02/06/2017

Notes: The original roadway is aged, has many road cuts, cracks, potholes and repairs and should be re-surfaced.

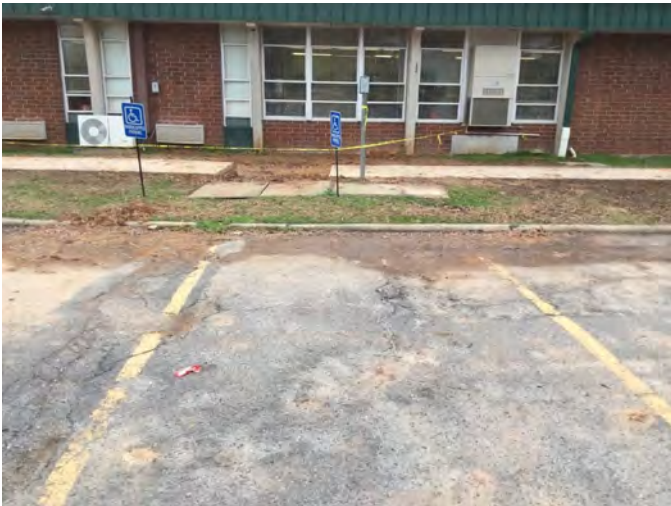
System: G2020 - Parking Lots

Location: Site
Distress: Beyond Service Life
Category: Deferred Maintenance
Priority: 3 - Necessary/Not Yet Critical (Years 2-5)
Correction: Renew System
Qty: 120,423.00
Unit of Measure: S.F.
Estimate: \$184,127.00
Assessor Name: Eduardo Lopez
Date Created: 02/06/2017

Notes: The parking lot is aged, has many repairs and potholes, and should be replaced and re-stripped.

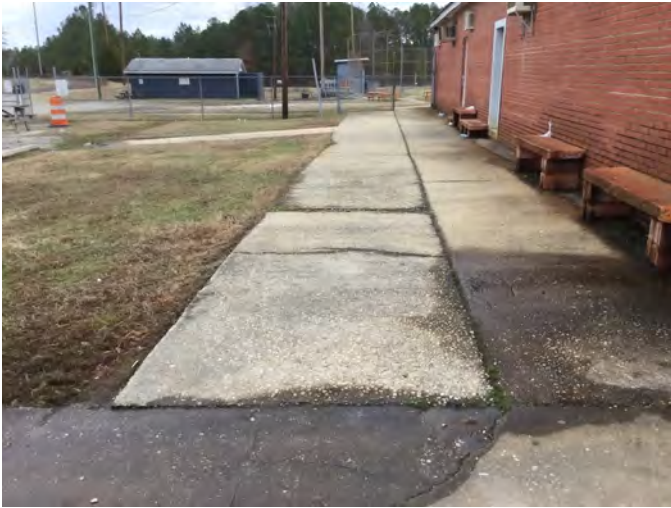
System: G2030 - Pedestrian Paving

Location: Site
Distress: Beyond Service Life
Category: Deferred Maintenance
Priority: 3 - Necessary/Not Yet Critical (Years 2-5)
Correction: Renew System
Qty: 120,423.00
Unit of Measure: S.F.
Estimate: \$262,281.00
Assessor Name: Eduardo Lopez
Date Created: 02/06/2017

Notes: The pedestrian paving are showing signs of age related and inclement weather damage and should be replaced.

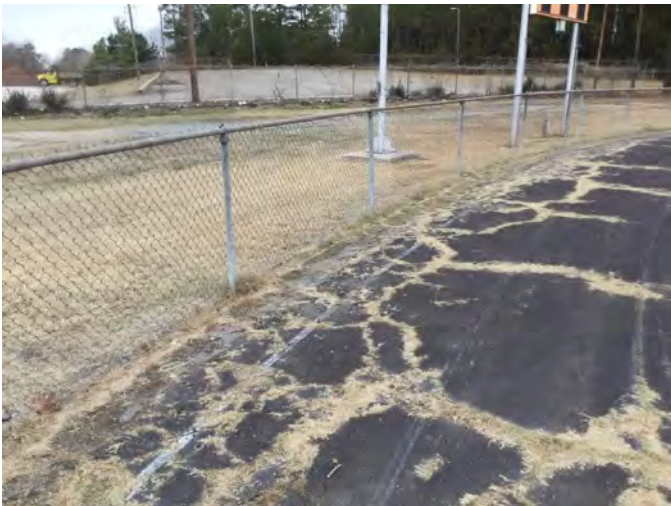
System: G2040105 - Fence & Guardrails

Location: Site
Distress: Beyond Service Life
Category: Deferred Maintenance
Priority: 3 - Necessary/Not Yet Critical (Years 2-5)
Correction: Renew System
Qty: 120,423.00
Unit of Measure: S.F.
Estimate: \$158,958.00
Assessor Name: Eduardo Lopez
Date Created: 02/06/2017

Notes: The fence & guardrails system is beyond its expected service life and should be scheduled for replacement.

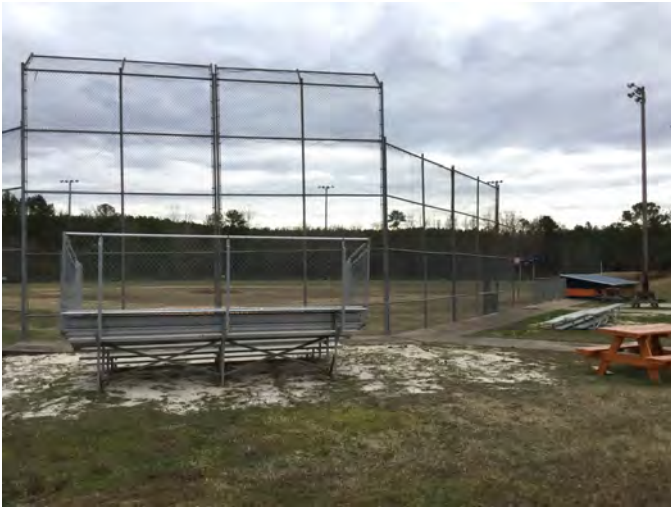
System: G2040950 - Baseball Field

Location: Site
Distress: Beyond Service Life
Category: Deferred Maintenance
Priority: 3 - Necessary/Not Yet Critical (Years 2-5)
Correction: Renew System
Qty: 120,423.00
Unit of Measure: S.F.
Estimate: \$937,854.00
Assessor Name: Eduardo Lopez
Date Created: 02/06/2017

Notes: The baseball field system is beyond its expected service life and should be scheduled for replacement.

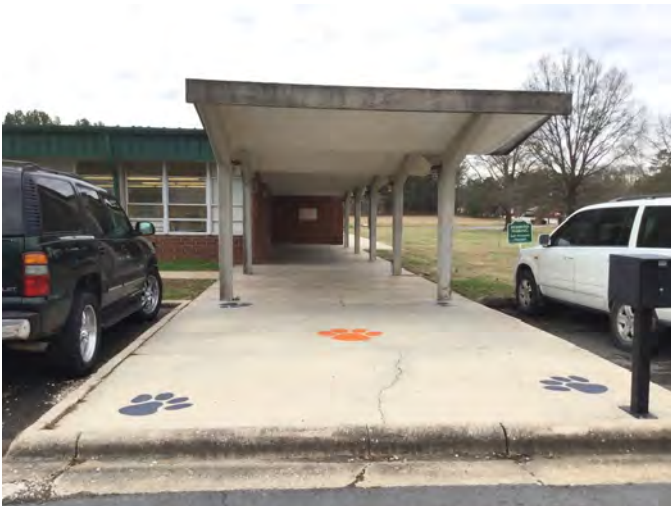
System: G2040950 - Covered Walkways

Location: Site
Distress: Beyond Service Life
Category: Deferred Maintenance
Priority: 3 - Necessary/Not Yet Critical (Years 2-5)
Correction: Renew System
Qty: 120,423.00
Unit of Measure: S.F.
Estimate: \$160,283.00
Assessor Name: Eduardo Lopez
Date Created: 02/06/2017

Notes: The covered walkway system is beyond its expected service life and should be scheduled for replacement.

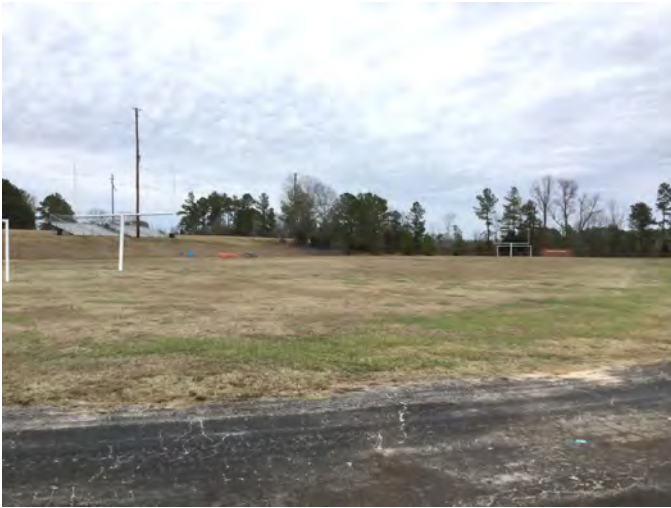
System: G2040950 - Football Field

Location: Site
Distress: Beyond Service Life
Category: Deferred Maintenance
Priority: 3 - Necessary/Not Yet Critical (Years 2-5)
Correction: Renew System
Qty: 120,423.00
Unit of Measure: S.F.
Estimate: \$626,561.00
Assessor Name: Eduardo Lopez
Date Created: 02/06/2017

Notes: The football field system is beyond its expected service life and should be scheduled for replacement.

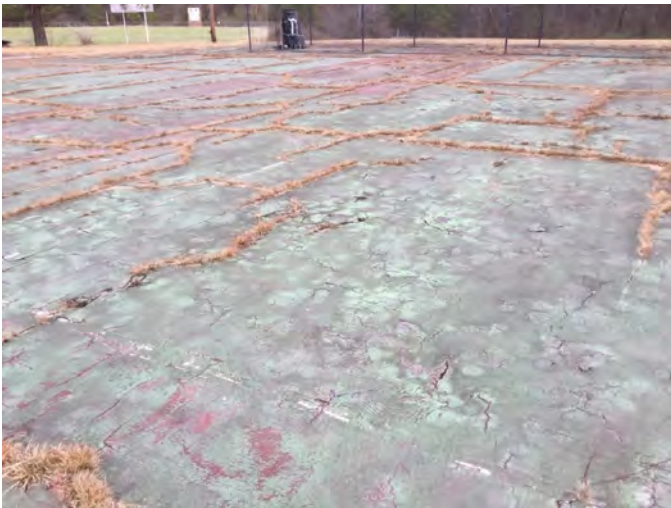
System: G2040950 - Hard Surface Play Area

Location: Site
Distress: Beyond Service Life
Category: Deferred Maintenance
Priority: 3 - Necessary/Not Yet Critical (Years 2-5)
Correction: Renew System
Qty: 120,423.00
Unit of Measure: S.F.
Estimate: \$86,102.00
Assessor Name: Eduardo Lopez
Date Created: 02/06/2017

Notes: The old tennis court surface is now used as playing area and the system is beyond its expected service life and should be scheduled for replacement.

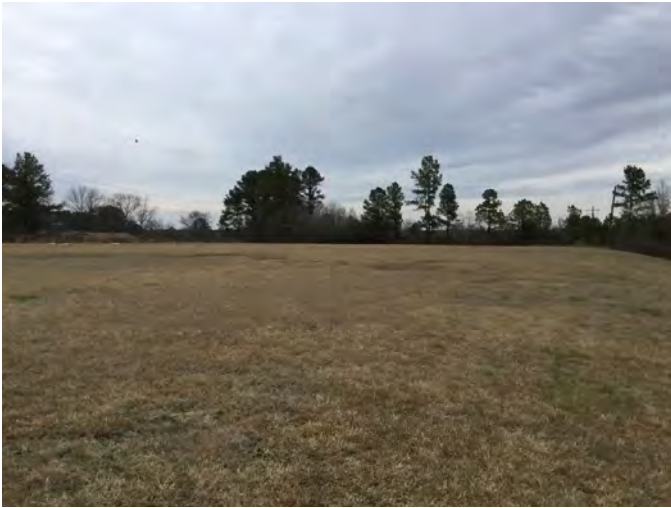
System: G2040950 - Playing Field

Location: Site
Distress: Beyond Service Life
Category: Deferred Maintenance
Priority: 3 - Necessary/Not Yet Critical (Years 2-5)
Correction: Renew System
Qty: 120,423.00
Unit of Measure: S.F.
Estimate: \$327,189.00
Assessor Name: Eduardo Lopez
Date Created: 02/06/2017

Notes: The playing field system is beyond its expected service life and should be scheduled for replacement.

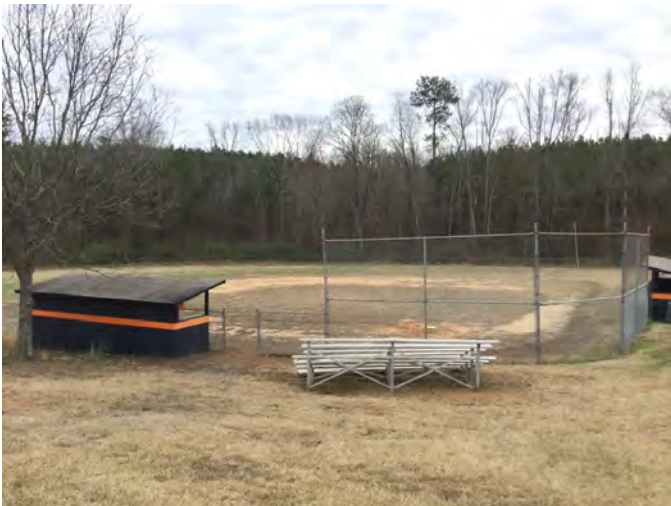
System: G2040950 - Softball Field

Location: Site
Distress: Beyond Service Life
Category: Deferred Maintenance
Priority: 3 - Necessary/Not Yet Critical (Years 2-5)
Correction: Renew System
Qty: 120,423.00
Unit of Measure: S.F.
Estimate: \$676,898.00
Assessor Name: Eduardo Lopez
Date Created: 02/06/2017

Notes: The softball field system is beyond its expected service life and should be scheduled for replacement.

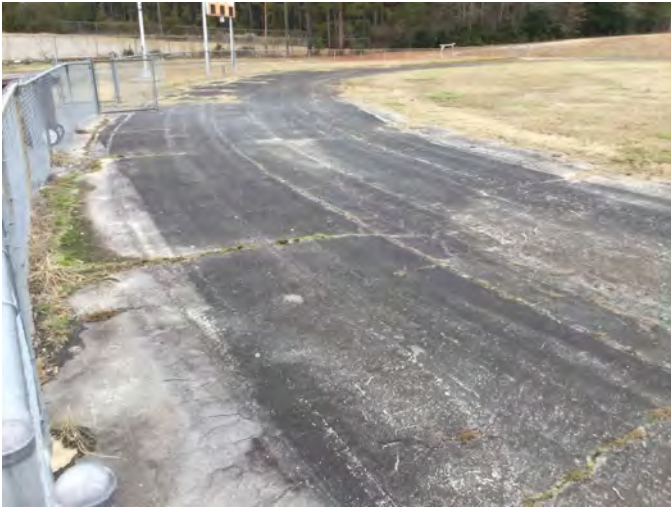
System: G2040950 - Track

Location: Site
Distress: Beyond Service Life
Category: Deferred Maintenance
Priority: 3 - Necessary/Not Yet Critical (Years 2-5)
Correction: Renew System
Qty: 120,423.00
Unit of Measure: S.F.
Estimate: \$262,281.00
Assessor Name: Eduardo Lopez
Date Created: 02/06/2017

Notes: The track system is beyond its expected service life and should be scheduled for replacement.

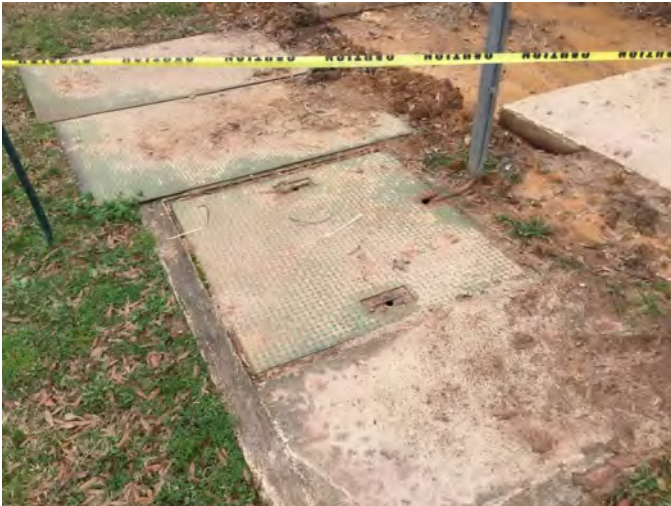
System: G3010 - Water Supply

Location: Site
Distress: Beyond Service Life
Category: Deferred Maintenance
Priority: 3 - Necessary/Not Yet Critical (Years 2-5)
Correction: Renew System
Qty: 120,423.00
Unit of Measure: S.F.
Estimate: \$320,566.00
Assessor Name: Eduardo Lopez
Date Created: 02/06/2017

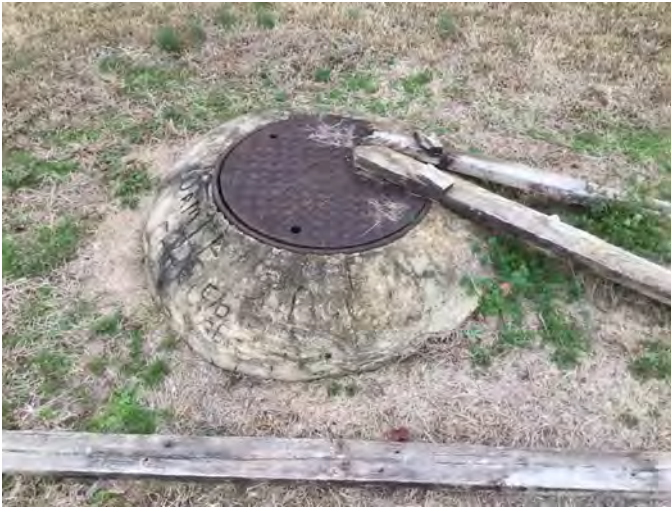
System: G3020 - Sanitary Sewer

Location: Site
Distress: Beyond Service Life
Category: Deferred Maintenance
Priority: 3 - Necessary/Not Yet Critical (Years 2-5)
Correction: Renew System
Qty: 120,423.00
Unit of Measure: S.F.
Estimate: \$201,347.00
Assessor Name: Eduardo Lopez
Date Created: 02/06/2017

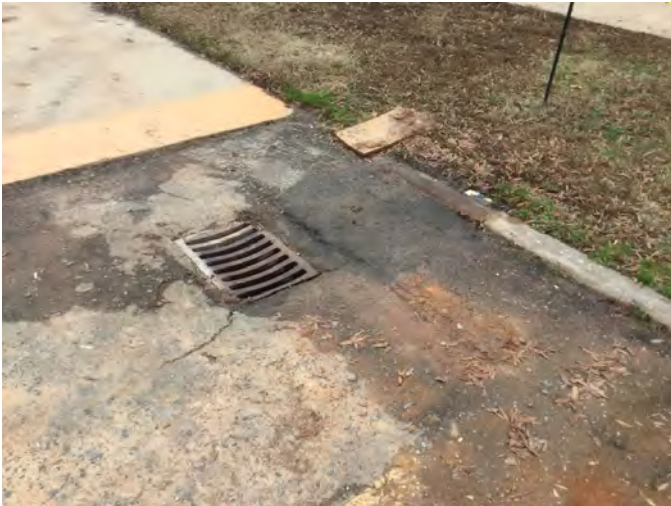
System: G3030 - Storm Sewer

Location: Site
Distress: Beyond Service Life
Category: Deferred Maintenance
Priority: 3 - Necessary/Not Yet Critical (Years 2-5)
Correction: Renew System
Qty: 120,423.00
Unit of Measure: S.F.
Estimate: \$618,613.00
Assessor Name: Eduardo Lopez
Date Created: 02/06/2017

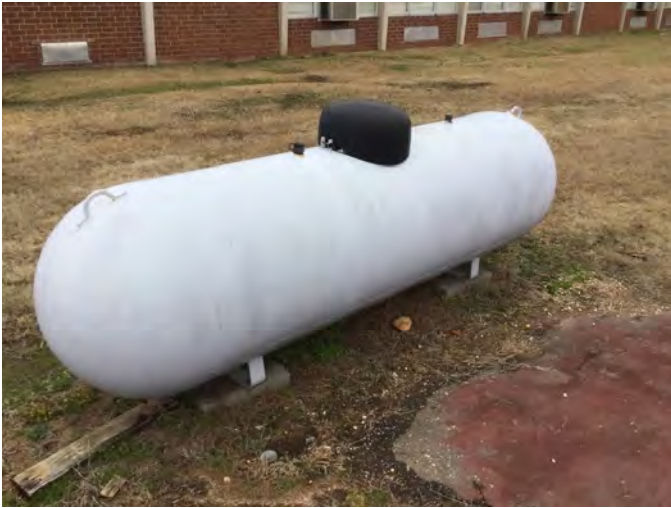
System: G3060 - Fuel Distribution

Location: Site
Distress: Beyond Service Life
Category: Deferred Maintenance
Priority: 3 - Necessary/Not Yet Critical (Years 2-5)
Correction: Renew System
Qty: 120,423.00
Unit of Measure: S.F.
Estimate: \$136,439.00
Assessor Name: Eduardo Lopez
Date Created: 02/06/2017

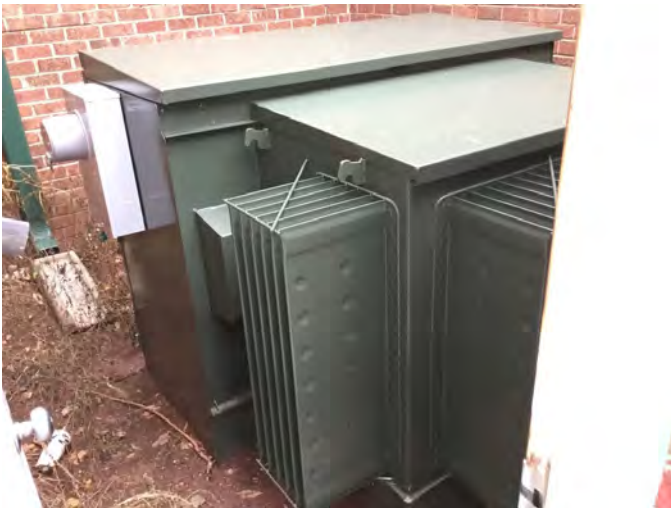
System: G4010 - Electrical Distribution

Location: Site
Distress: Beyond Service Life
Category: Deferred Maintenance
Priority: 3 - Necessary/Not Yet Critical (Years 2-5)
Correction: Renew System
Qty: 120,423.00
Unit of Measure: S.F.
Estimate: \$343,085.00
Assessor Name: Eduardo Lopez
Date Created: 02/06/2017
