NC School District/430 Harnett County/Middle School

Coats-Erwin Middle

Campus Assessment Report

March 11, 2017

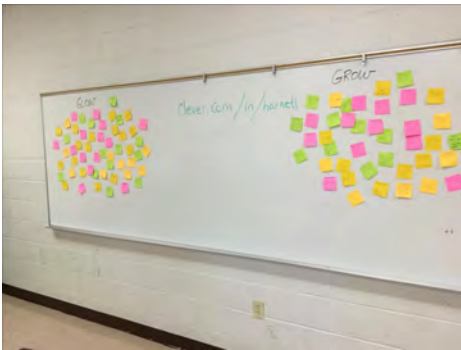
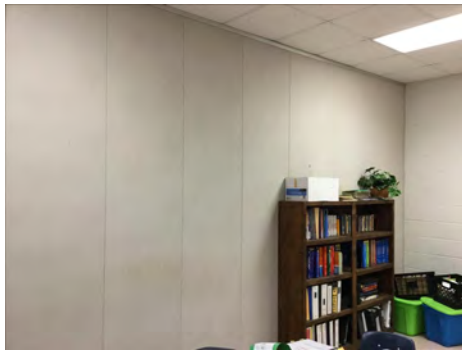
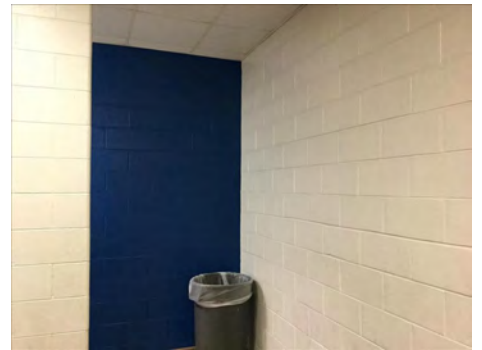
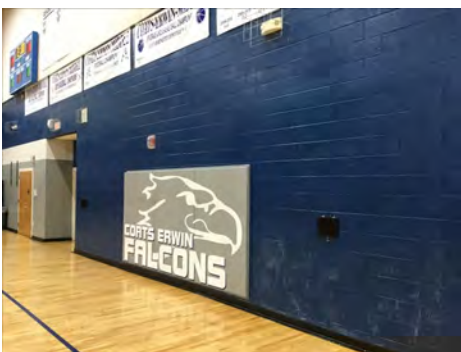
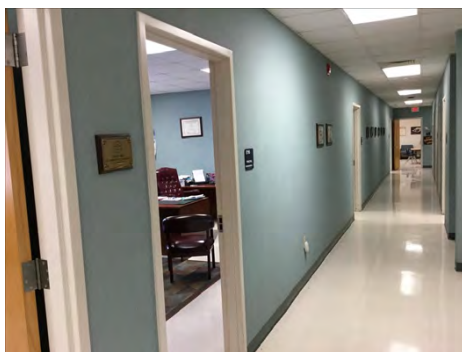
System: C1010 - Partitions

Location: Classroom F111
Distress: Failing
Category: Safety / Building Code Compliance
Priority: 1 - Currently Critical (Immediate)
Correction: Engineering Study
Qty: 1.00
Unit of Measure: Ea.
Estimate: \$13,200.00
Assessor Name: Eduardo Lopez
Date Created: 11/29/2016

Notes: There are visible cracks on the partition wall which should be studied by a professional engineer.

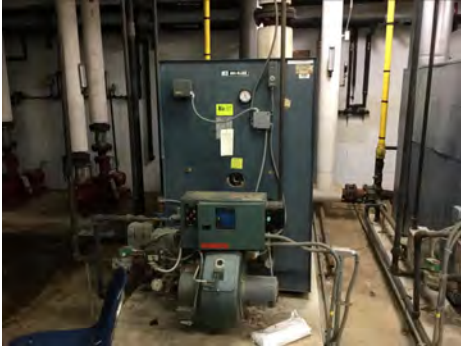
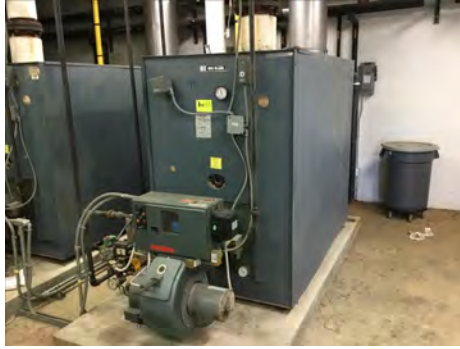
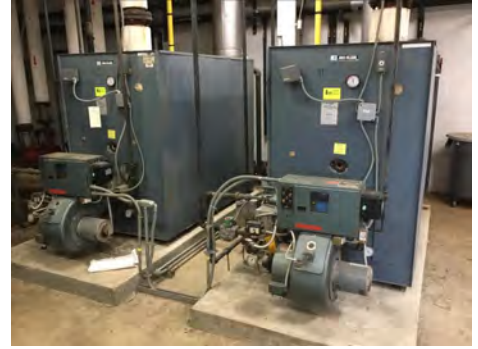
System: D3020 - Heat Generating Systems

Note: Natural gas boilers

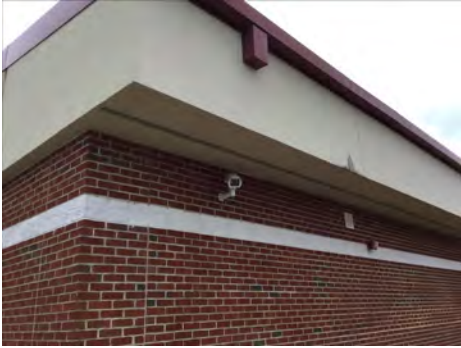
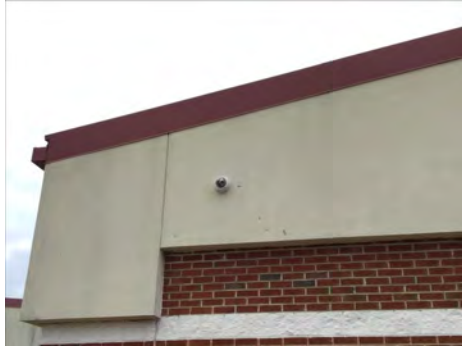
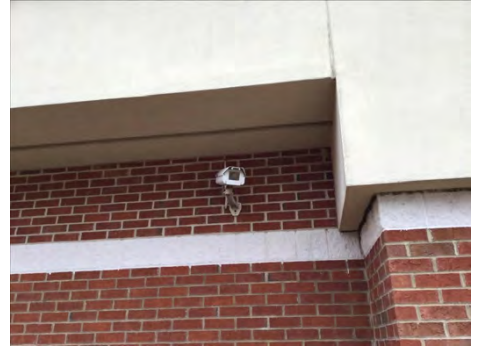
System: G4030 - Site Communications & Security

Notes: The camera are aged, in marginal condition, and should be replaced.
