Cornatzer Elementary

Campus Assessment Report

March 10, 2017

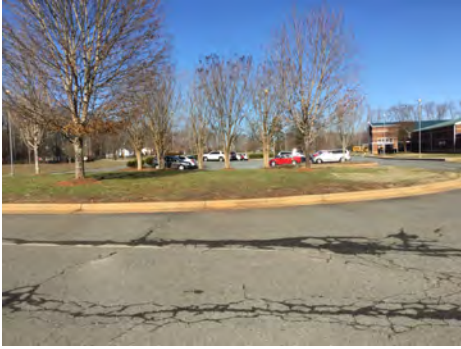
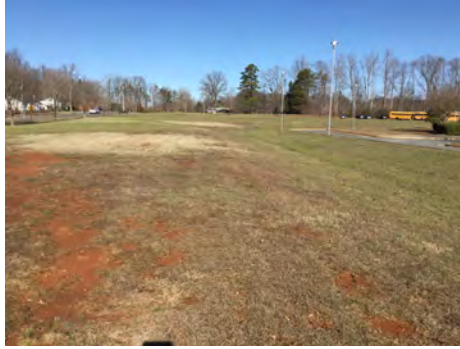
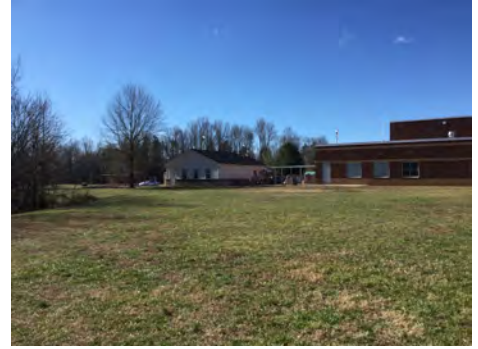
System: G2050 - Landscaping

Notes: Erosion occurring past the west end of the parking lot creates a potential hazard for mud/slippy conditions, and is unsightly.

Location: West end bus parking lot
Distress: Failing
Category: Safety
Priority: 2 - Potentially Critical (Year 1)
Correction: Erosion control; incl. soil preparation, topsoil and sodding
Qty: 5,000.00
Unit of Measure: S.F.
Estimate: \$7,642.80
Assessor Name: Somnath Das
Date Created: 02/11/2017
