NC School District/300 Davie County/Elementary School

# William R. Davie Elementary

## Campus Assessment Report

March 10, 2017

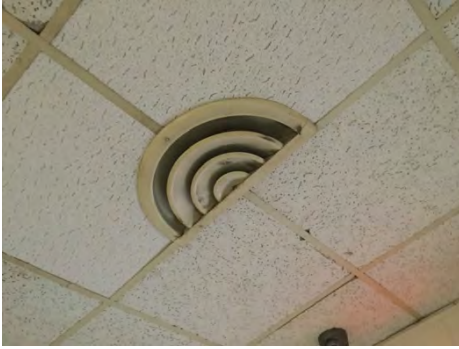
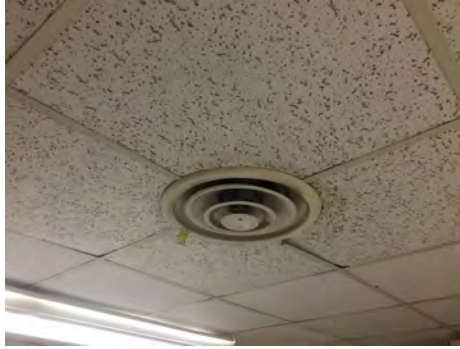
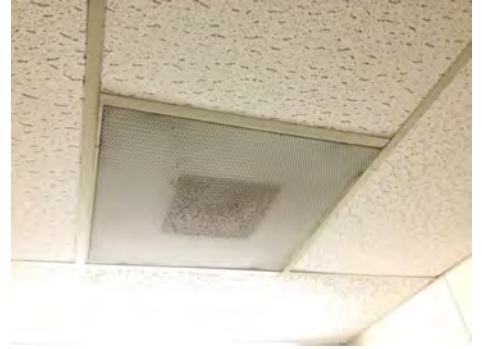
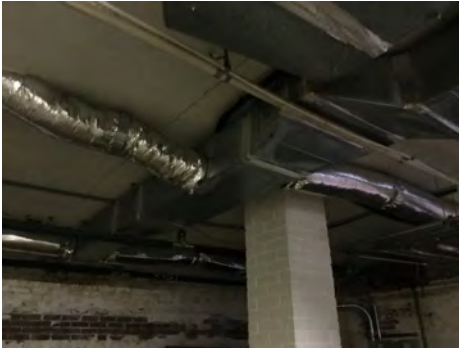
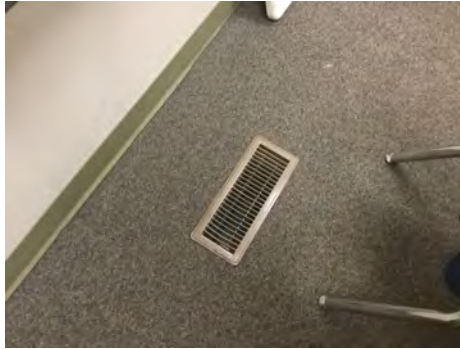
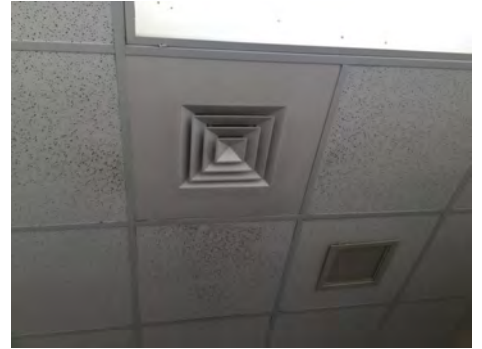
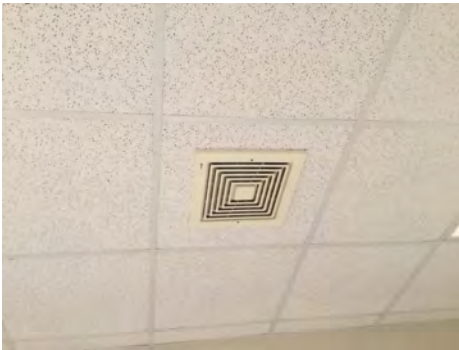
**System:** D3040 - Distribution Systems

**Notes:** Distribution systems are aged, becoming logistically unsupportable, and should be replaced.

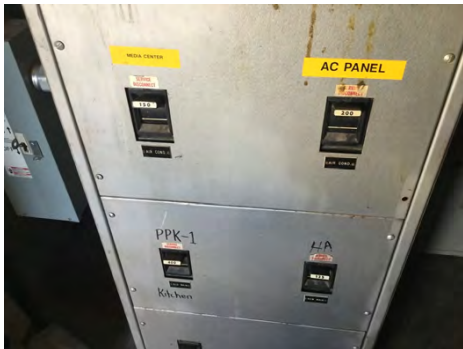
**System:** D5010 - Electrical Service/Distribution

**Notes:** The original electrical service is operating but is in poor condition and should be replaced.

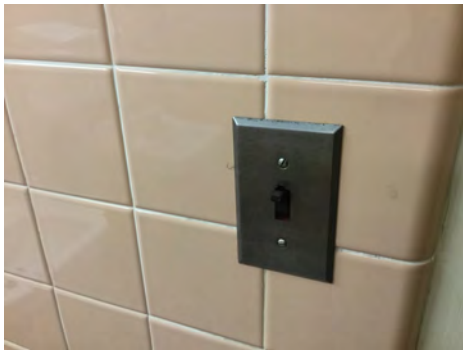
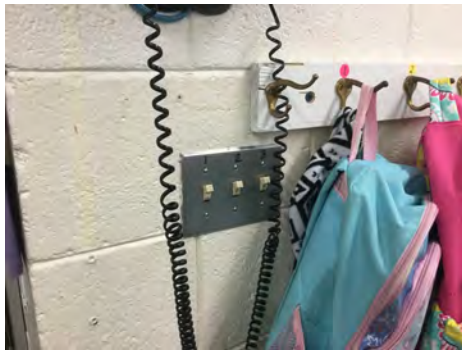
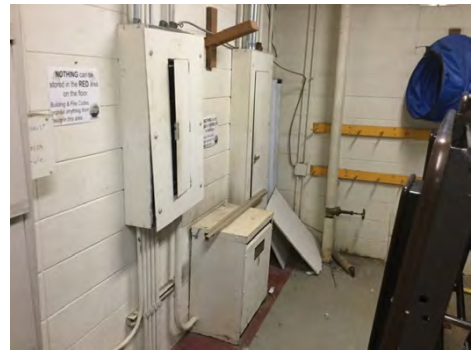
**System:** D5020 - Branch Wiring

**Notes:** The original branch wiring system is operating but is aged, in marginal condition, and should be replaced.

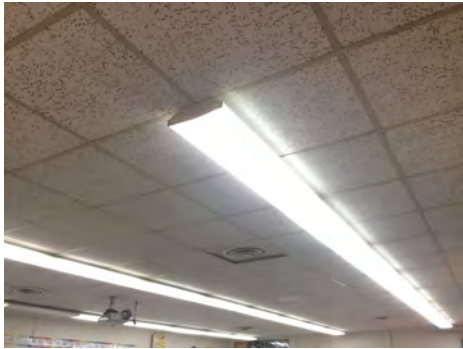
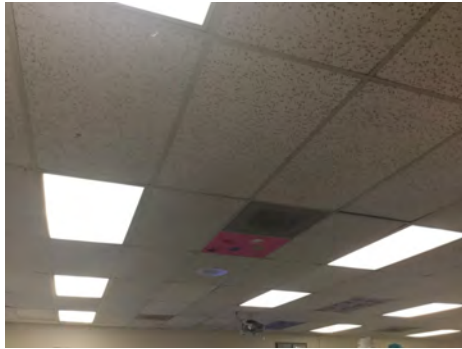
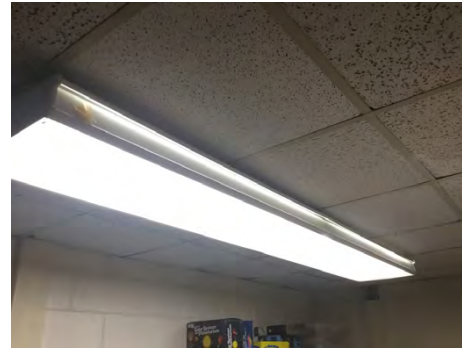
**System:** D5020 - Lighting

**Notes:** The original lighting system is operating but is aged, in marginal condition, and should be replaced.

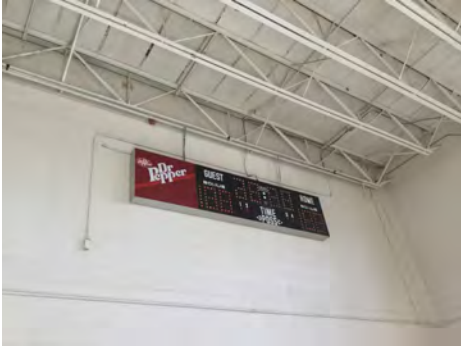
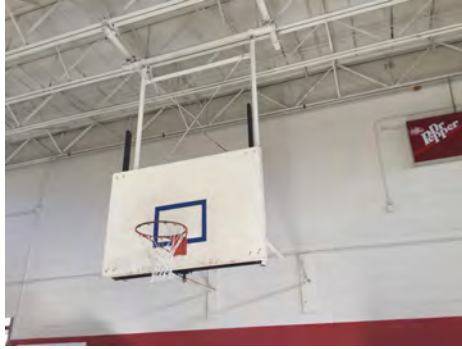
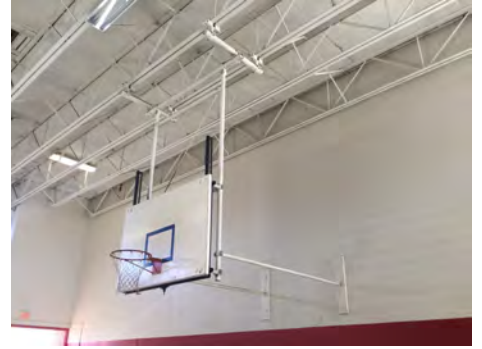
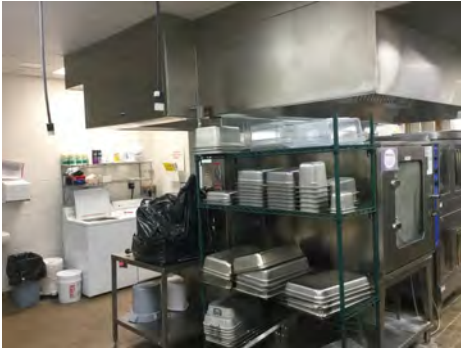
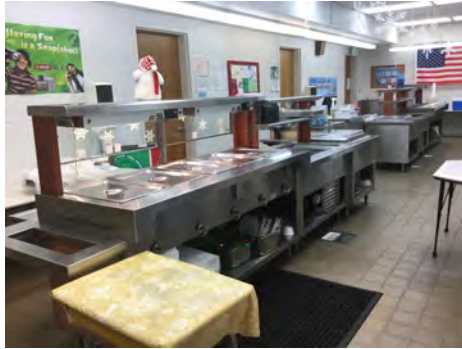
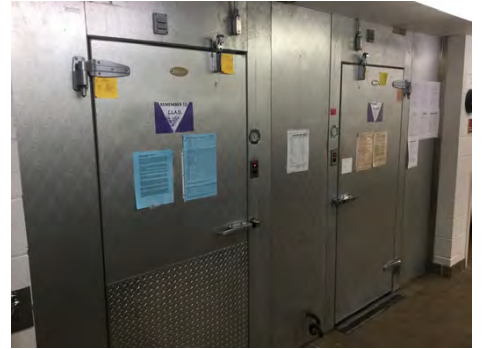
**System:** E1090 - Other Equipment

**Notes:** The other equipment is in deteriorating conditions and should be replaced.

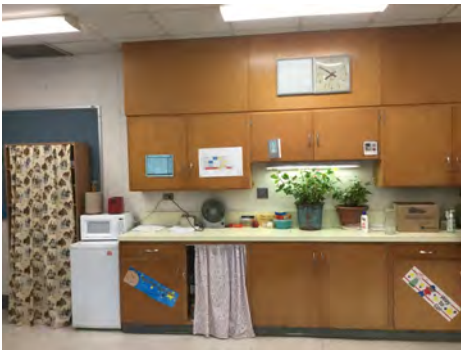
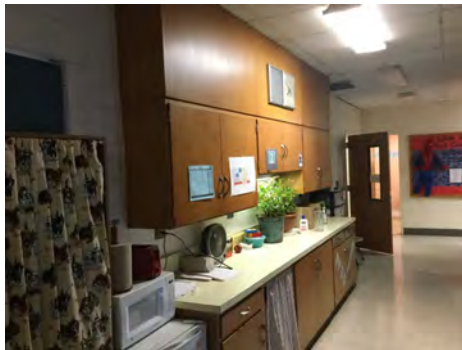
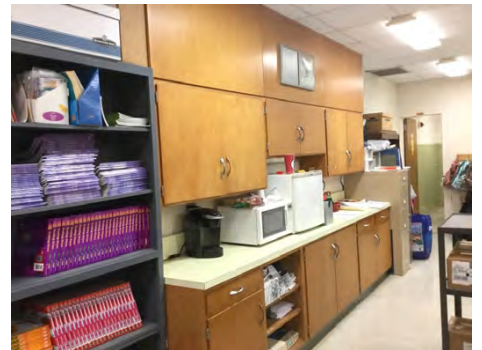
**System:** E2010 - Fixed Furnishings

**Notes:** The fixed furnishings are aged, in marginal condition, and should be replaced.

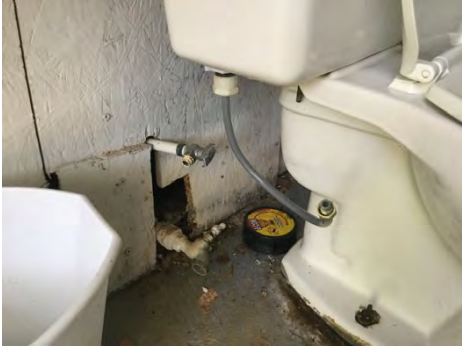
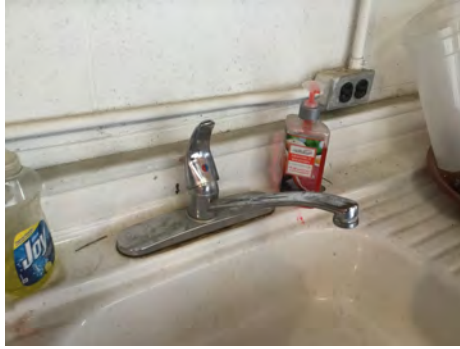
**System:** D2020 - Domestic Water Distribution

**Notes:** The domestic water distribution system is aged and should be replaced.

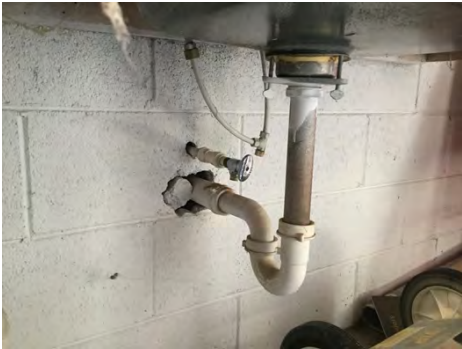
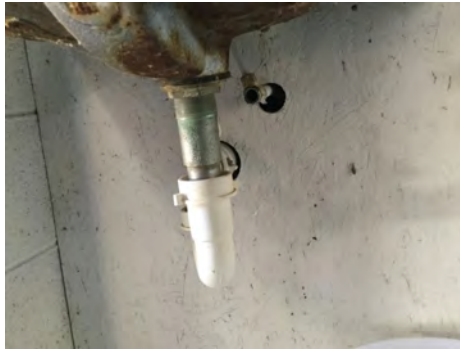
**System:** D2030 - Sanitary Waste

**Notes:** The sanitary waste system is beyond its expected service life and should be replaced.

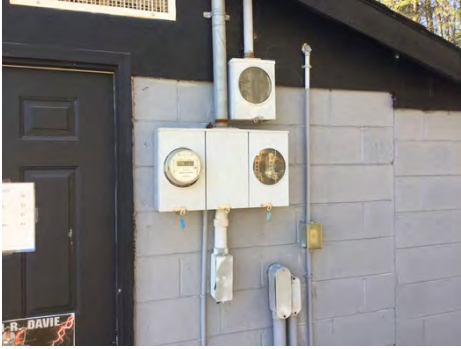
**System:** D5010 - Electrical Service/Distribution

**Notes:** The original electrical service is operating but is in poor condition and should be replaced.

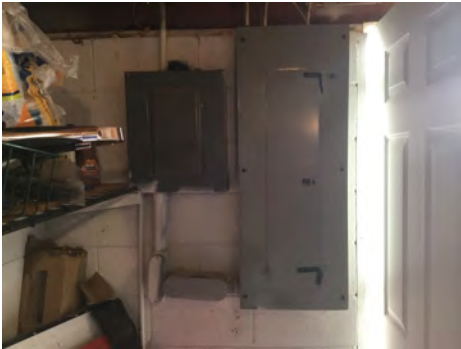
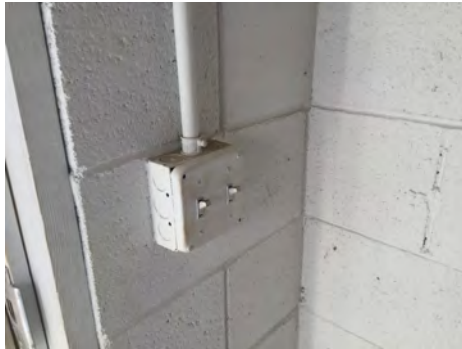
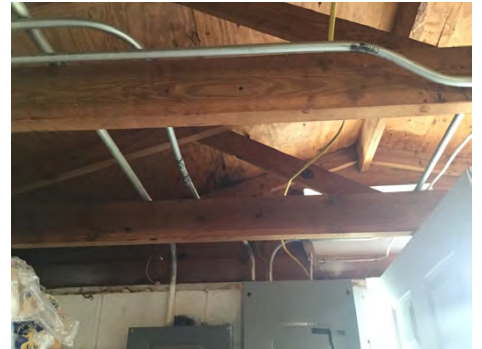
**System:** D5020 - Branch Wiring

**Notes:** The original branch wiring system is operating but is aged, in marginal condition, and should be replaced.

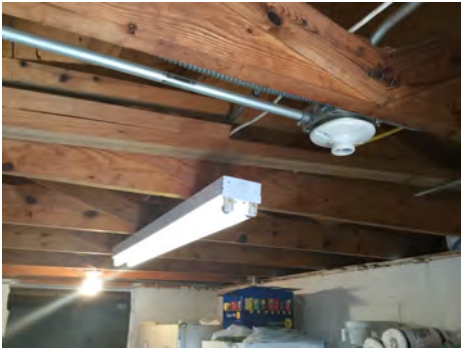
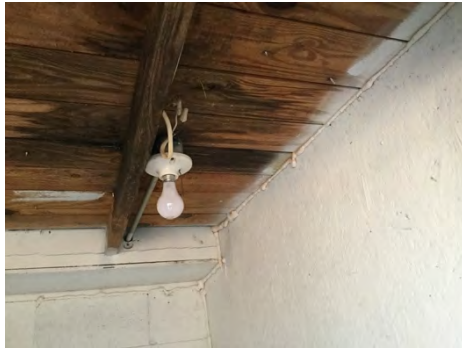
**System:** D5020 - Lighting

**Notes:** The original lighting system is operating but is aged, in marginal condition, and should be replaced.

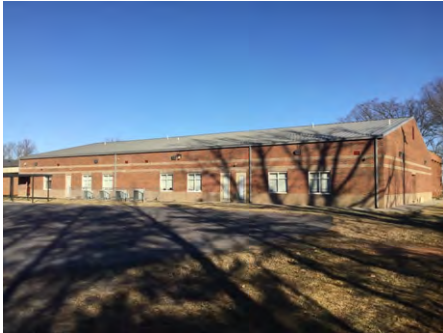
1). West Elevation - Feb 10, 2017

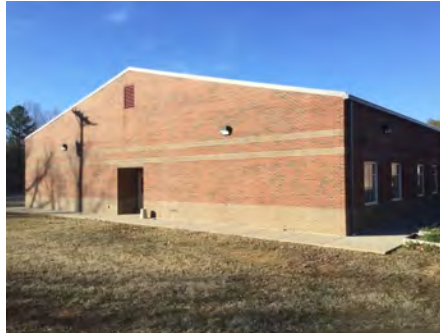
2). South Elevation - Feb 10, 2017

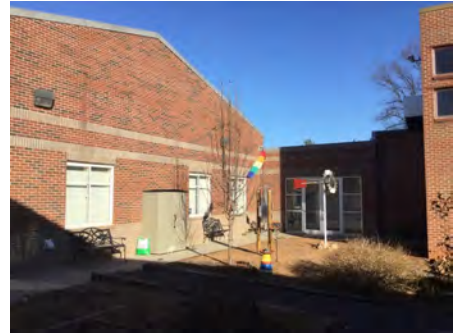
3). Southeast Elevation - Feb 10, 2017

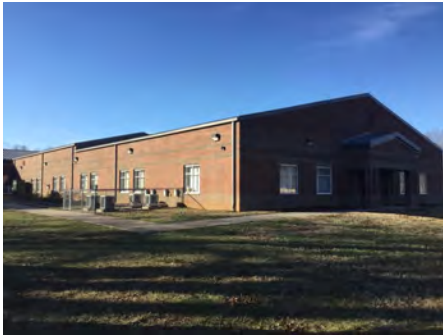
4). East Elevation - Feb 10, 2017

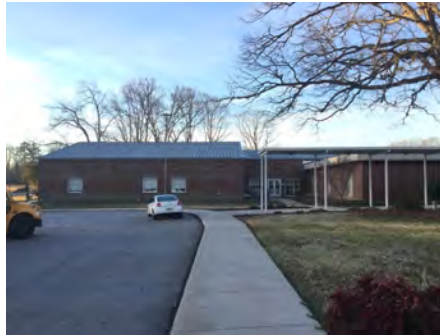
5). North Elevation - Feb 10, 2017

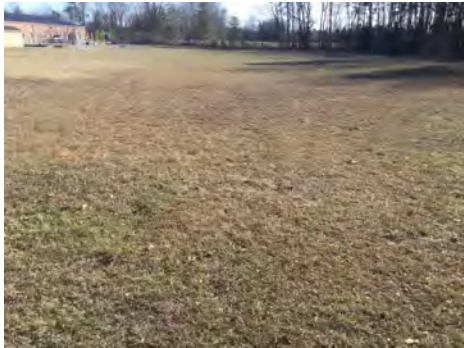
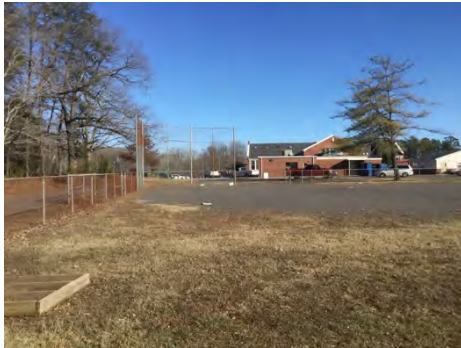
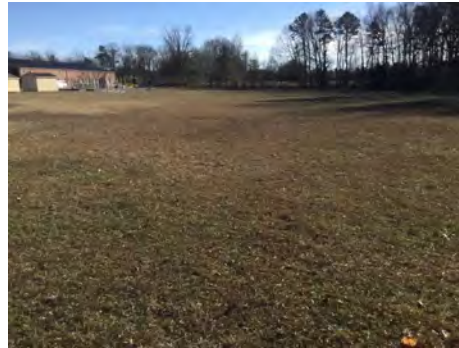
**System:** G2040950 - Playing Field

**Notes:** The playing field is in poor conditions, beyond service life and should be scheduled for replaced.

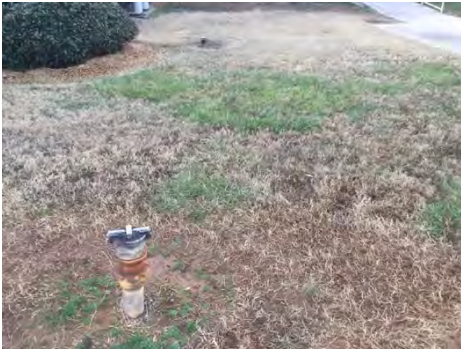
**System:** G3060 - Fuel Distribution

**Notes:** The under ground fuel tank is beyond service life and should be scheduled for replacement.
