NC School District/220 Clay County/High School

Hayesville High

Campus Assessment Report

March 13, 2017

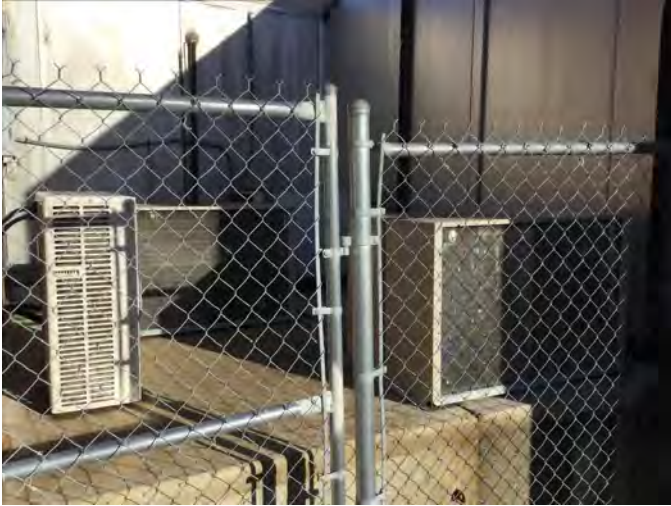
System: D3040 - Distribution Systems

Location: 1972 Cafeteria
Distress: Beyond Service Life
Category: Deferred Maintenance
Priority: 3 - Necessary/Not Yet Critical (Years 2-5)
Correction: Replace fan coil unit, 5 ton
Qty: 2.00
Unit of Measure: Ea.
Estimate: \$7,798.56
Assessor Name: Terence Davis
Date Created: 02/24/2017

Notes: The DX units are passed their useful life and should be replaced.

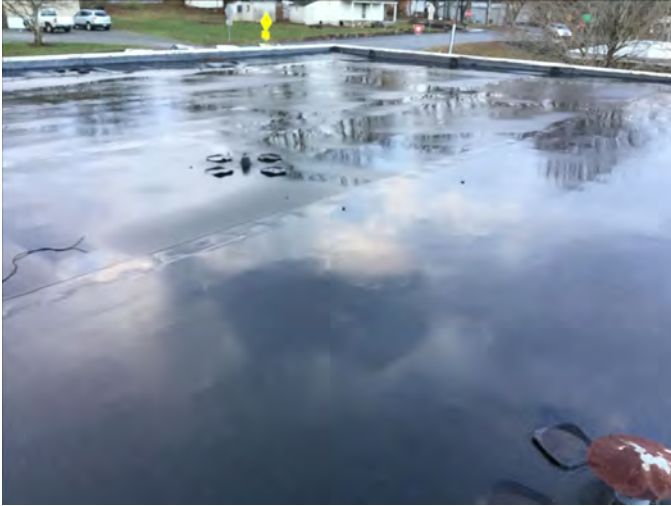
System: B3010120 - Single Ply Membrane

Location: Roof
Distress: Damaged
Category: Deferred Maintenance
Priority: 2 - Potentially Critical (Year 1)
Correction: Renew System
Qty: 25,270.00
Unit of Measure: S.F.
Estimate: \$264,577.00
Assessor Name: Eduardo Lopez
Date Created: 02/09/2017

Notes: The roof covering has deteriorated flashing, several repairs, empty pitch pockets, open membrane seams, debris and ponding, open caulk joints, loss of top surface, blisters, damaged and should be replaced.

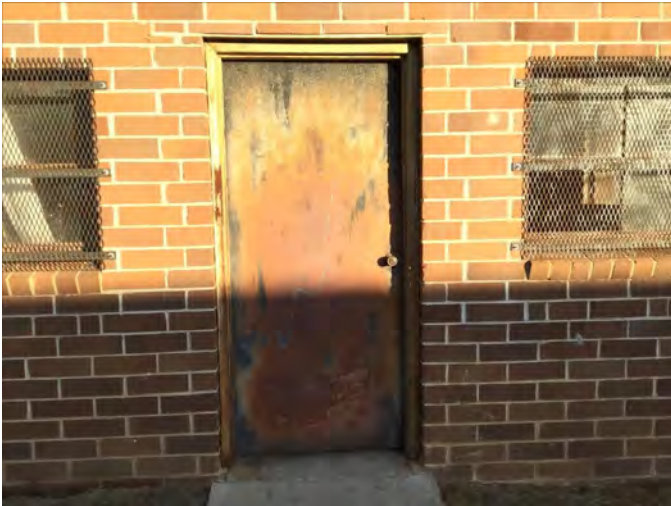
System: B2030 - Exterior Doors

Location: Exterior
Distress: Damaged
Category: Deferred Maintenance
Priority: 3 - Necessary/Not Yet Critical (Years 2-5)
Correction: Renew System
Qty: 1,000.00
Unit of Measure: S.F.
Estimate: \$902.00
Assessor Name: Terence Davis
Date Created: 02/24/2017

Notes: Exterior doors are damaged.

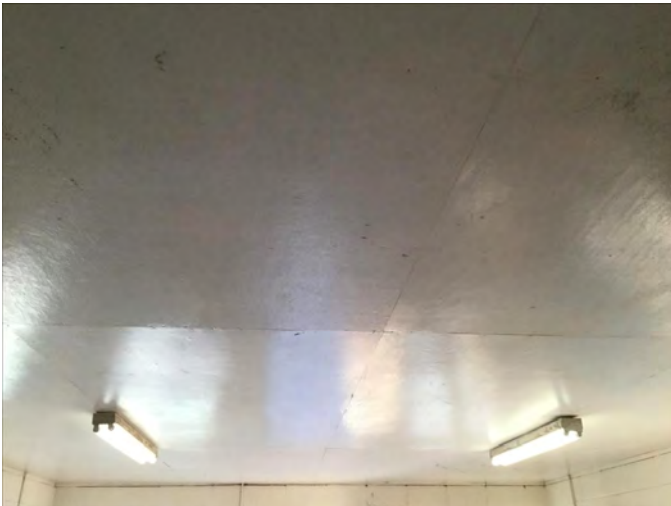
System: C3030 - Ceiling Finishes

Location: Interior
Distress: Damaged
Category: Deferred Maintenance
Priority: 3 - Necessary/Not Yet Critical (Years 2-5)
Correction: Renew System
Qty: 1,000.00
Unit of Measure: S.F.
Estimate: \$11,847.00
Assessor Name: Terence Davis
Date Created: 02/09/2017

Notes: The original painted ceiling finish is aged, chipped, stained and should be replaced.

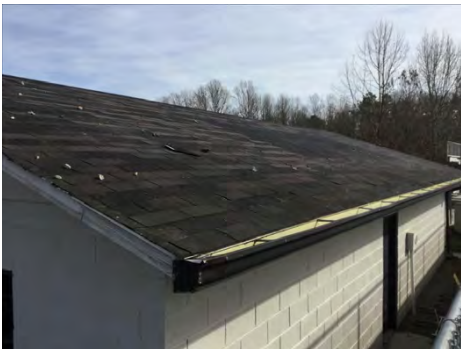
System: B3010140 - Asphalt Shingles

Location: Roof
Distress: Damaged
Category: Deferred Maintenance
Priority: 2 - Potentially Critical (Year 1)
Correction: Renew System
Qty: 1,000.00
Unit of Measure: S.F.
Estimate: \$6,307.00
Assessor Name: Eduardo Lopez
Date Created: 02/28/2017

Notes: The asphalt shingles are damaged and the covering should be replaced.

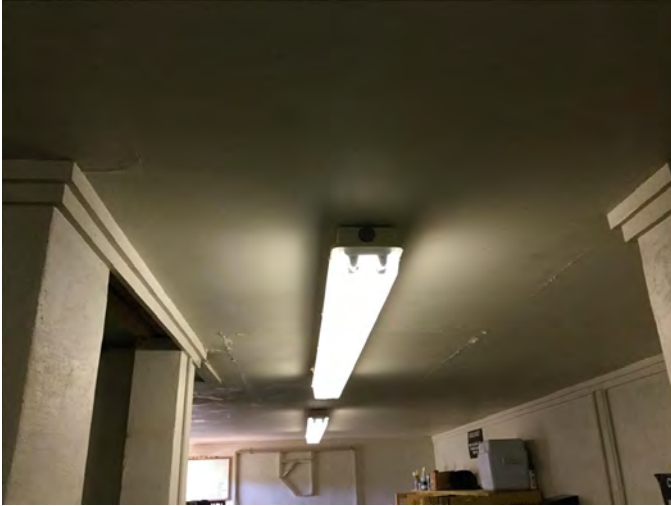
System: C3030 - Ceiling Finishes

Location: Interior
Distress: Damaged
Category: Deferred Maintenance
Priority: 3 - Necessary/Not Yet Critical (Years 2-5)
Correction: Renew System
Qty: 1,000.00
Unit of Measure: S.F.
Estimate: \$10,483.00
Assessor Name: Eduardo Lopez
Date Created: 02/14/2017

Notes: The original drywall ceiling finish is aged, chipped, stained, damaged and should be replaced.

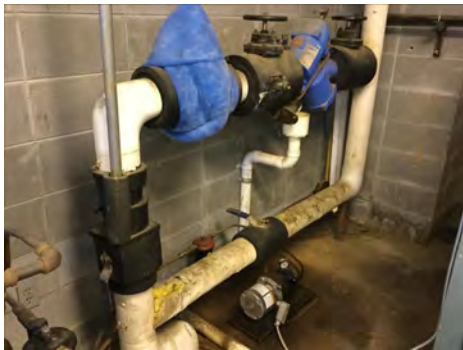
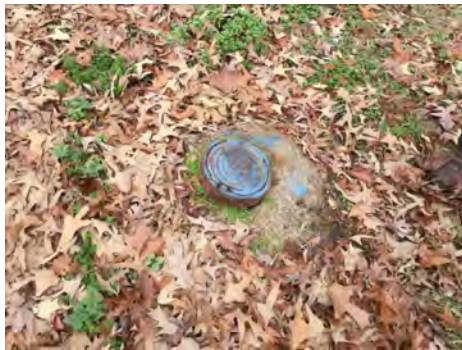
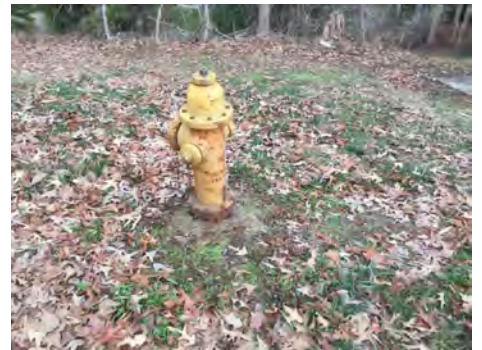
System: G3010 - Water Supply

Note: Supplies elementary, middle and high school

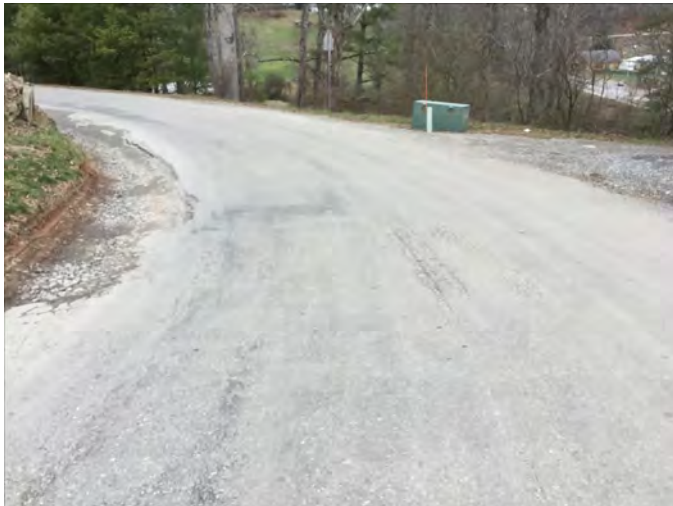
System: G2010 - Roadways

Location: Site
Distress: Damaged
Category: Deferred Maintenance
Priority: 3 - Necessary/Not Yet Critical (Years 2-5)
Correction: Renew System
Qty: 147,030.00
Unit of Measure: S.F.
Estimate: \$616,203.00
Assessor Name: Eduardo Lopez
Date Created: 02/09/2017

Notes: The asphaltic roadways are aged, have many road cuts, pot holes, significant cracking, and need re-surfacing.
