NC School District/430 Harnett County/Elementary School

Johnsonville Elementary

Campus Assessment Report

March 11, 2017

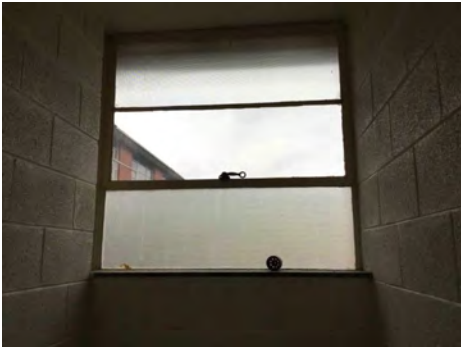
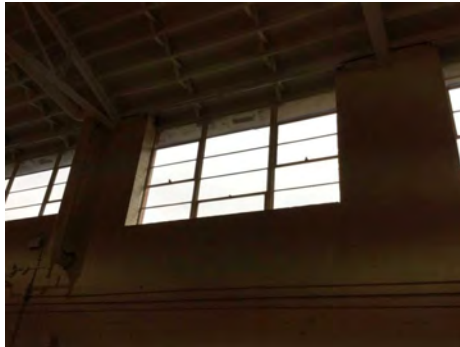
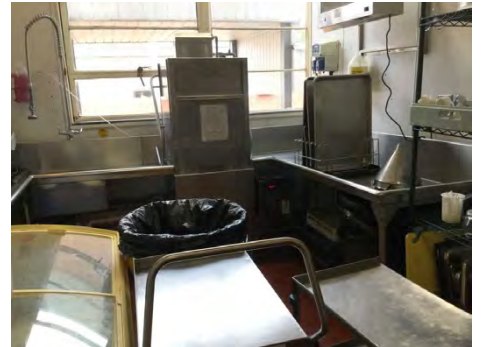
System: B2020 - Exterior Windows

Notes: The aluminum frame, operable, single pane windows are aged, rusted, not energy efficient, and should be replaced.

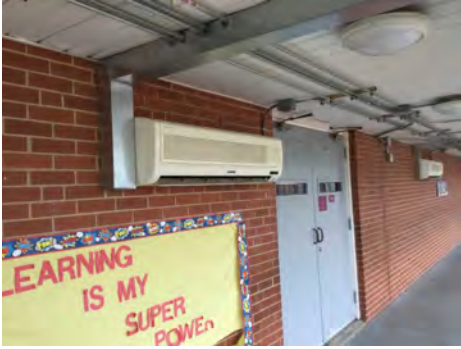
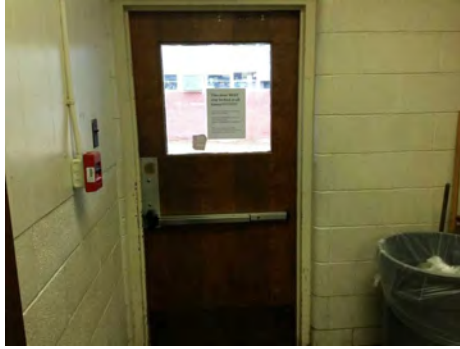
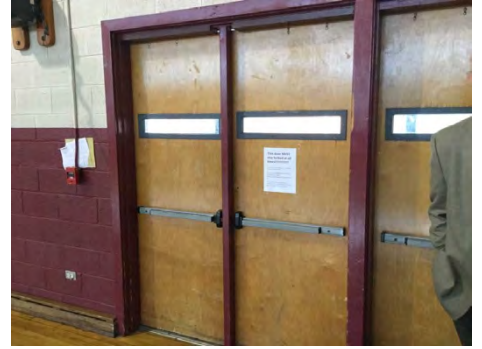
System: B2030 - Exterior Doors

Notes: The original exterior doors are aged, warped, and should be replaced.

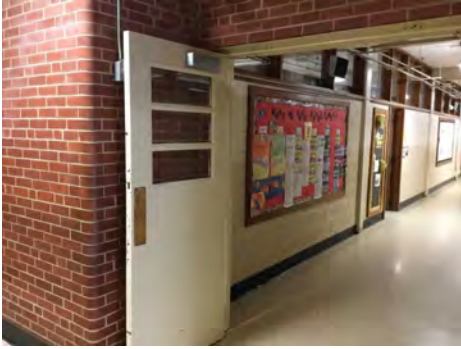
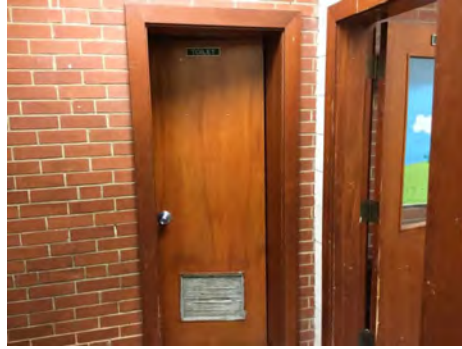
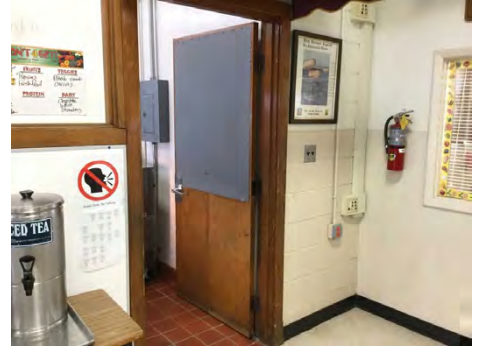
System: C1020 - Interior Doors

Notes: The interior doors are aged, failing, hardware is not ADA compliant and should be replaced.

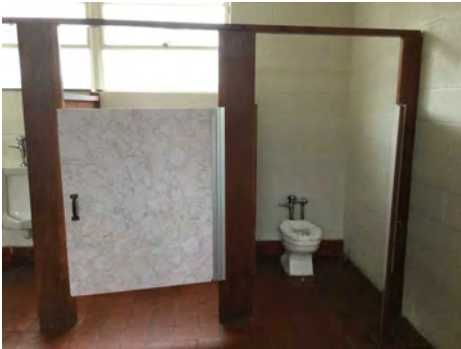
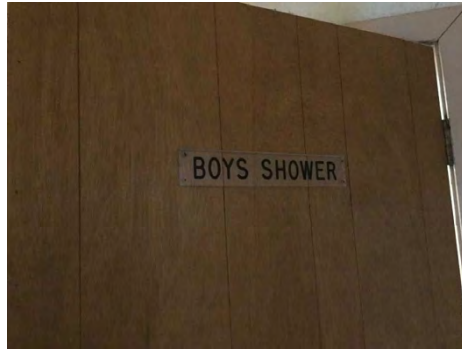
System: C1030 - Fittings

Notes: The fittings throughout the building are aged, in marginal condition, handrails and room signage are ADA non-compliance and system should be replaced.

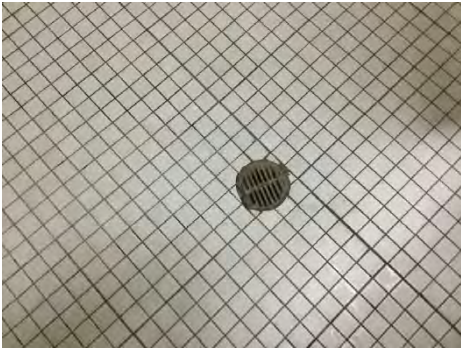
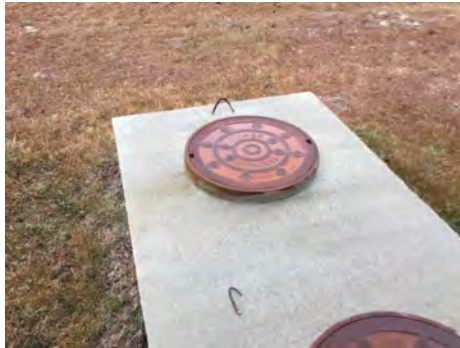
System: D2030 - Sanitary Waste

Notes: The sanitary waste system is aged, has reported periodic failures, and should be replaced.

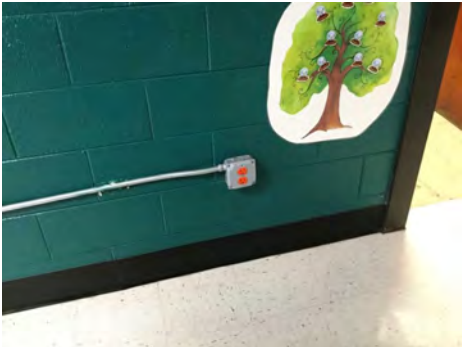
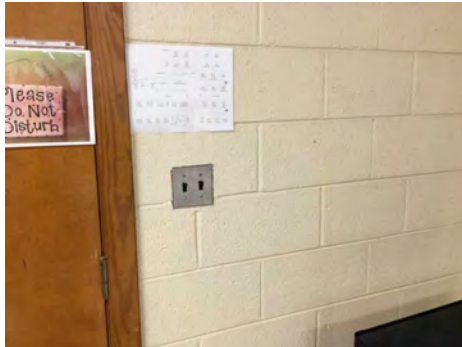
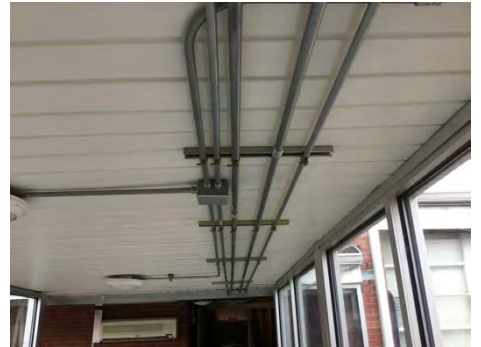
System: D5020 - Branch Wiring

Notes: The original branch wiring system is operating, but is aged, in poor condition, and should be replaced.

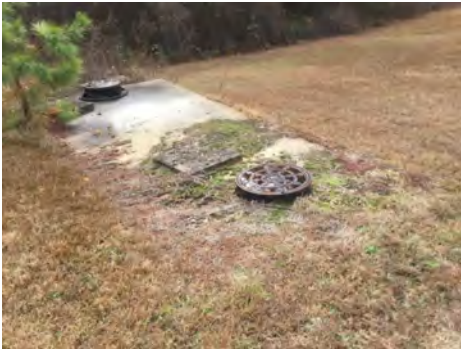
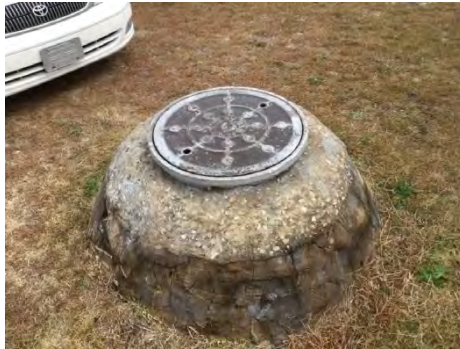
System: G3020 - Sanitary Sewer

Notes: The sanitary waste system is aged, has reported periodic failures, and should be replaced.

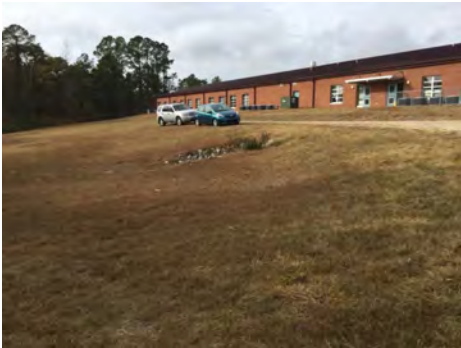
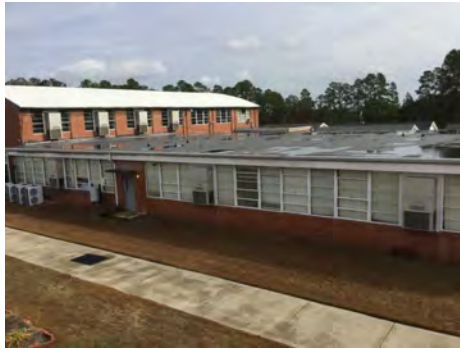
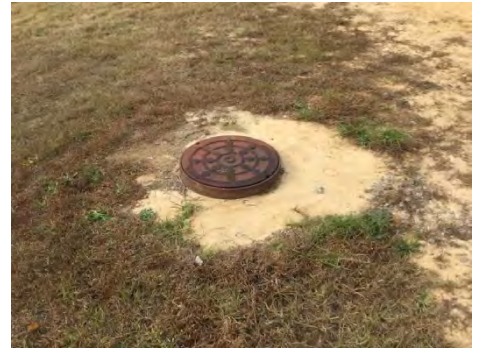
System: G3030 - Storm Sewer

Notes: The storm sewer system is aged, has reported periodic failures, and should be replaced.

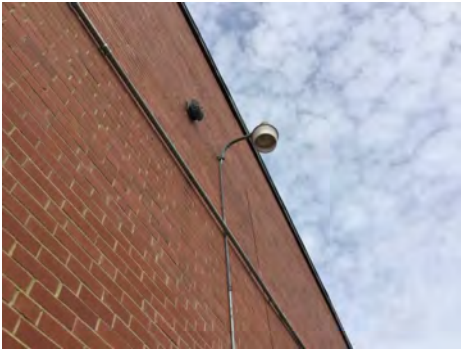
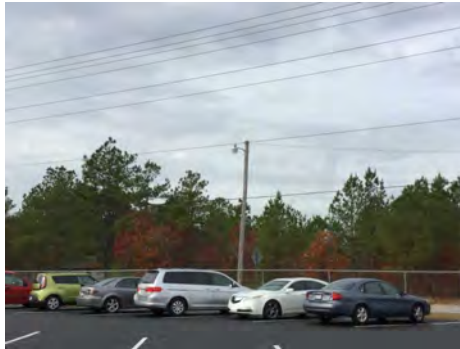
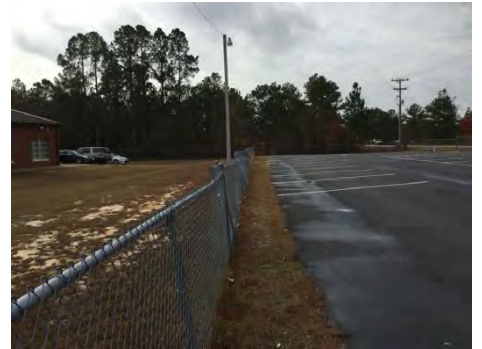
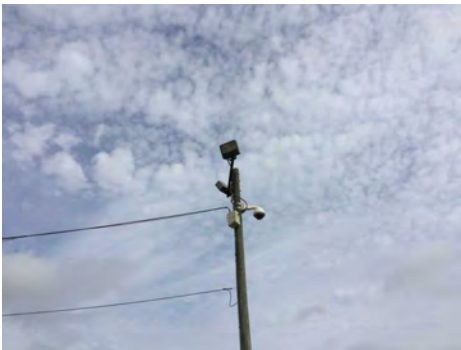
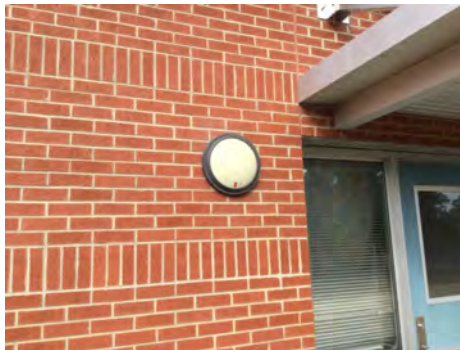
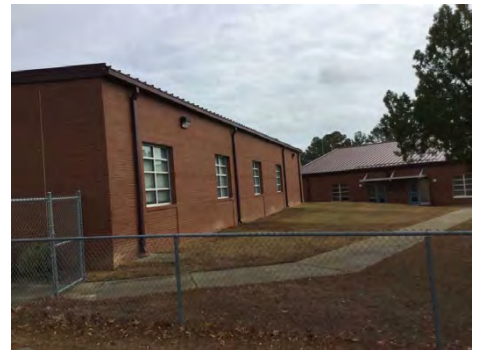
System: G4020 - Site Lighting

Notes: Site lighting system is aged does not adequately cover site and should be replaced.

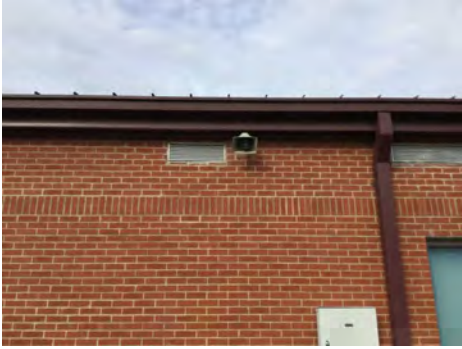
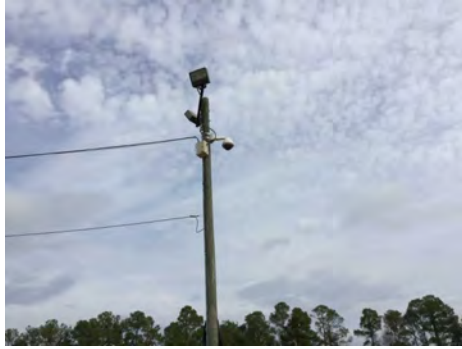
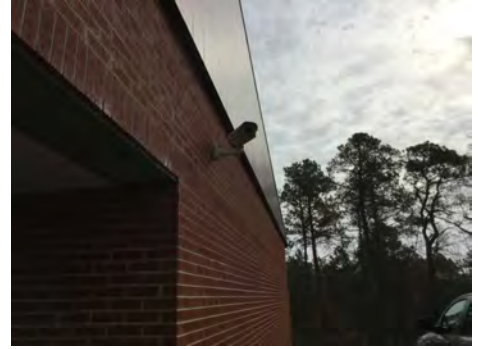
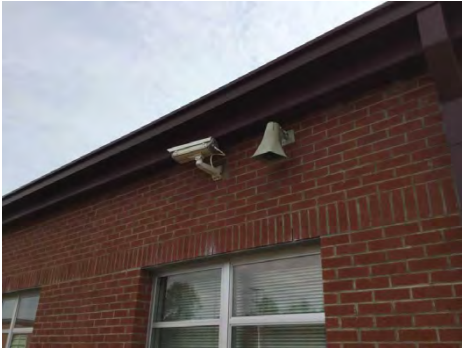
System: G4030 - Site Communications & Security

Notes: Site security system is aged and not adequate. System should be replaced with digital system.
