NC School District/430 Harnett County/Elementary School

Lafayette Elementary

Campus Assessment Report

March 11, 2017

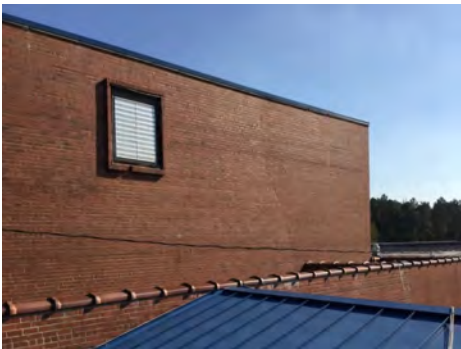
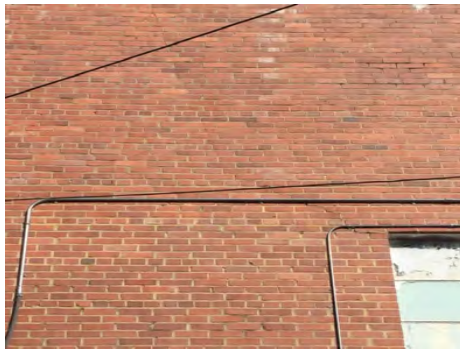
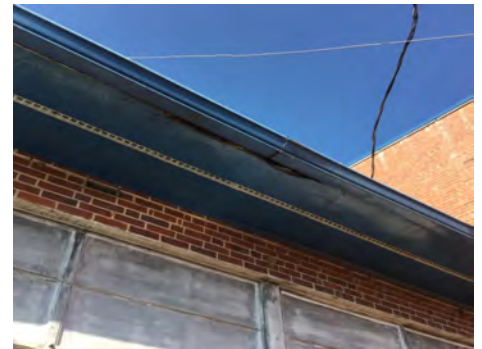
System: B2010 - Exterior Walls

Location: Exterior walls
Distress: Failing
Category: Deferred Maintenance / Safety
Priority: 1 - Currently Critical (Immediate)
Correction: Engineering Study-2016-11-15 17:41:59
Qty: 1.00
Unit of Measure: Ea.
Estimate: \$13,200.00
Assessor Name: Eduardo Lopez
Date Created: 12/07/2016

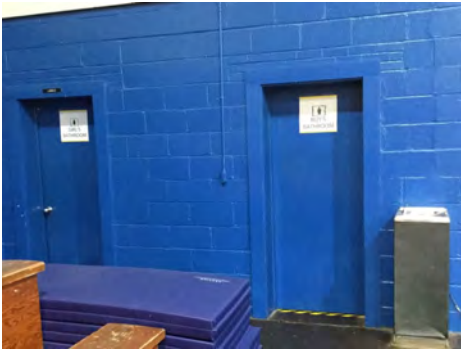
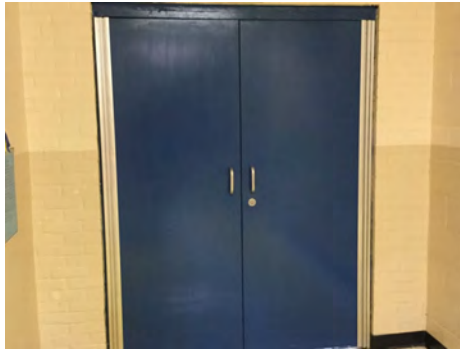
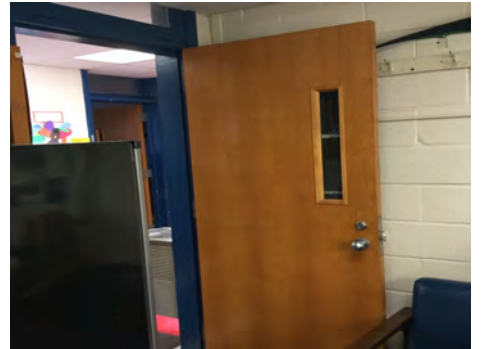
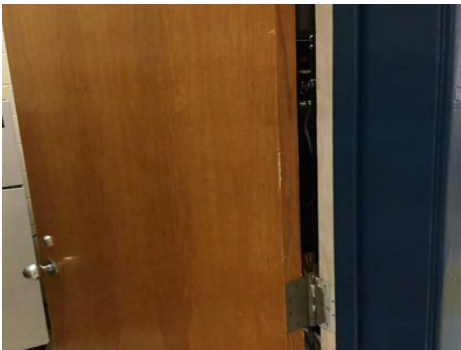
System: C1020 - Interior Doors

Notes: The interior doors are aged, hardware is not ADA compliant and they should be replaced.

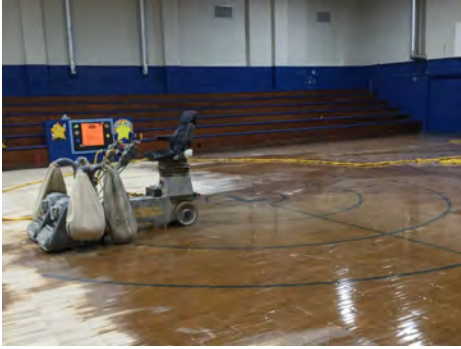
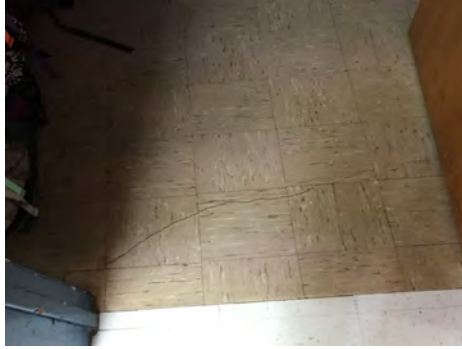
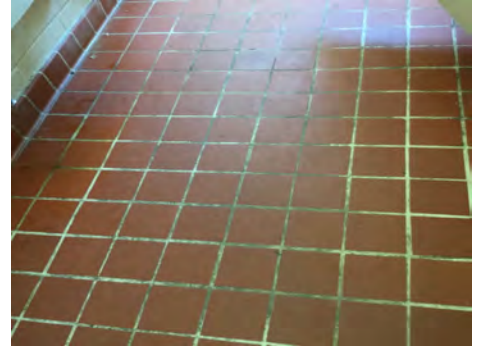
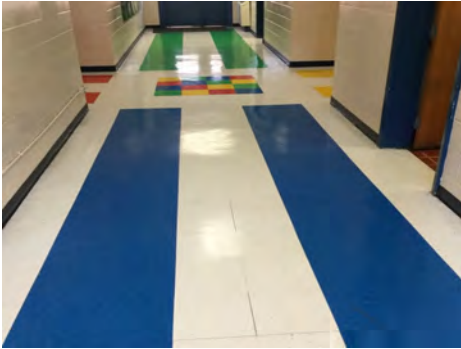
System: C3020 - Floor Finishes

Note: Corridors replaced approx. 2010. Gym floor being repaired and refinished 2016 during assessment. Quarry tile floors in toilet rooms in poor condition. Some VAT occurs in classrooms and misc. rooms.

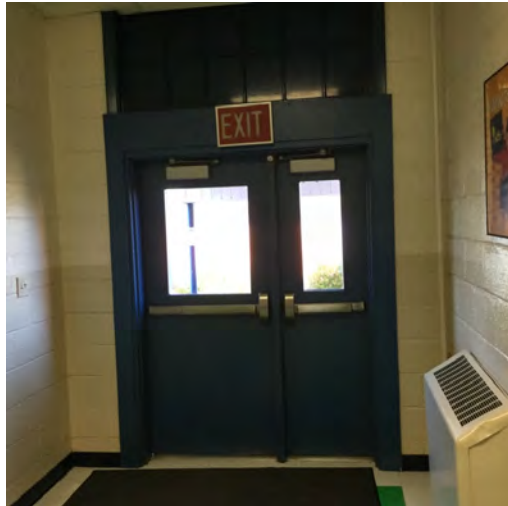
System: D5090 - Other Electrical Systems

Location: Throughout the building
Distress: Beyond Service Life
Category: Deferred Maintenance / Life Safety Code Compliance
Priority: 2 - Potentially Critical (Year 1)
Correction: Renew System
Qty: 19,764.00
Unit of Measure: S.F.
Estimate: \$2,609.00
Assessor Name: Eduardo Lopez
Date Created: 11/15/2016

Notes: Emergency/egress lighting systems are beyond their expected life. Exit signage and egress lighting are inadequate with some non-illuminated signage and missing egress lighting.

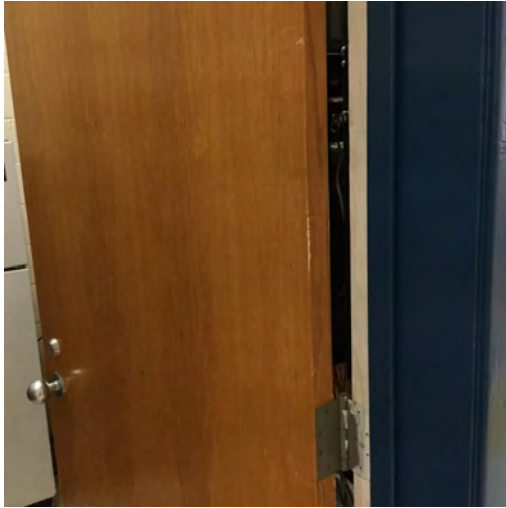
System: C1020 - Interior Doors

Location: Interior doors
Distress: Beyond Service Life
Category: Deferred Maintenance
Priority: 3 - Necessary/Not Yet Critical (Years 2-5)
Correction: Renew System
Qty: 19,764.00
Unit of Measure: S.F.
Estimate: \$53,916.00
Assessor Name: Eduardo Lopez
Date Created: 11/15/2016

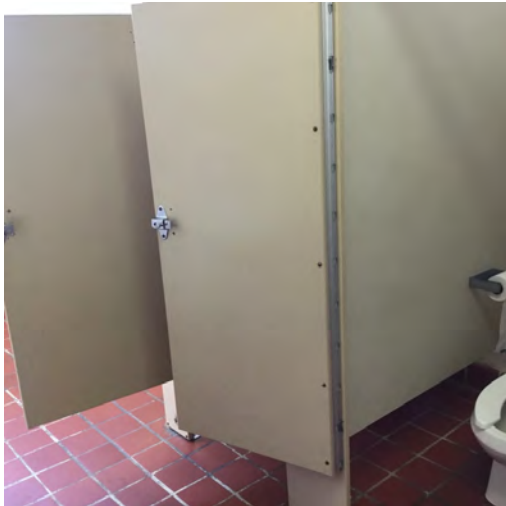
System: C1030 - Fittings

Location: Throughout the building
Distress: Beyond Service Life
Category: Deferred Maintenance
Priority: 3 - Necessary/Not Yet Critical (Years 2-5)
Correction: Renew System
Qty: 19,764.00
Unit of Measure: S.F.
Estimate: \$207,403.00
Assessor Name: Eduardo Lopez
Date Created: 11/15/2016

Notes: The fittings throughout the building are aged, in marginal condition, not ADA compliant and should be replaced.

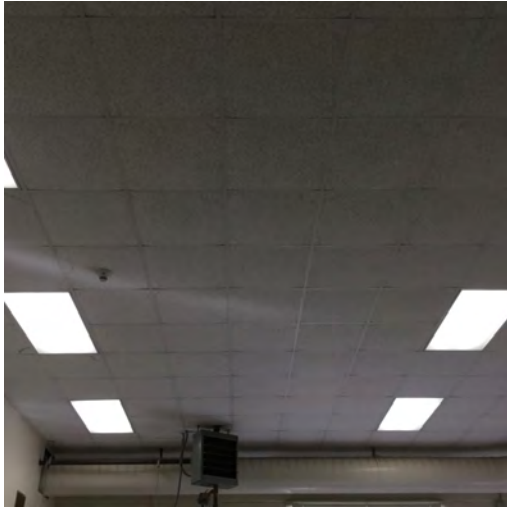
System: C3030 - Ceiling Finishes

Location: Interiors
Distress: Beyond Service Life
Category: Deferred Maintenance
Priority: 3 - Necessary/Not Yet Critical (Years 2-5)
Correction: Renew System
Qty: 19,764.00
Unit of Measure: S.F.
Estimate: \$233,492.00
Assessor Name: Eduardo Lopez
Date Created: 12/07/2016

Notes: The ceiling tiles have been replaced as needed. However the system is beyond its expected life and should be replaced. Some ceiling tiles show water damage, likely the result of roof leaks.

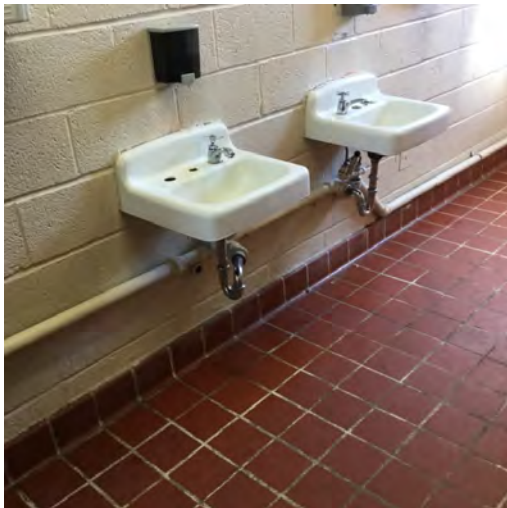
System: D2010 - Plumbing Fixtures

Location: Throughout the building
Distress: Beyond Service Life
Category: Deferred Maintenance
Priority: 3 - Necessary/Not Yet Critical (Years 2-5)
Correction: Renew System
Qty: 19,764.00
Unit of Measure: S.F.
Estimate: \$244,797.00
Assessor Name: Eduardo Lopez
Date Created: 11/15/2016

Notes: Plumbing fixtures are in operational conditions. However, they are typically aged, not ADA compliant and should be replaced with a low-flow water fixtures.

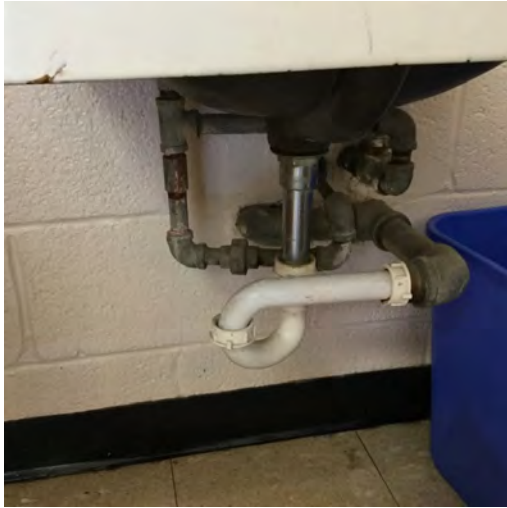
System: D2020 - Domestic Water Distribution

Location: Throughout the building.
Distress: Beyond Service Life
Category: Deferred Maintenance
Priority: 3 - Necessary/Not Yet Critical (Years 2-5)
Correction: Renew System
Qty: 19,764.00
Unit of Measure: S.F.
Estimate: \$20,871.00
Assessor Name: Eduardo Lopez
Date Created: 11/15/2016

Notes: Galvanized and copper pipe were observed in the building without dielectric connections. The entire plumbing supply system is beyond its expected life and replacement is recommended.

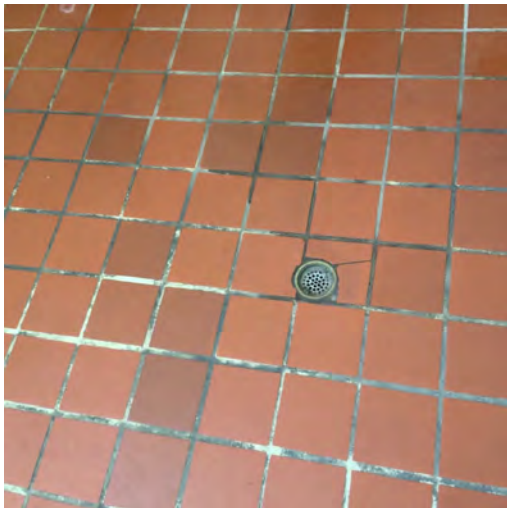
System: D2030 - Sanitary Waste

Location: Throughout the building
Distress: Beyond Service Life
Category: Deferred Maintenance
Priority: 3 - Necessary/Not Yet Critical (Years 2-5)
Correction: Renew System
Qty: 19,764.00
Unit of Measure: S.F.
Estimate: \$33,045.00
Assessor Name: Eduardo Lopez
Date Created: 11/15/2016

Notes: The sanitary waste system is aged beyond its expected service life and should be replaced.

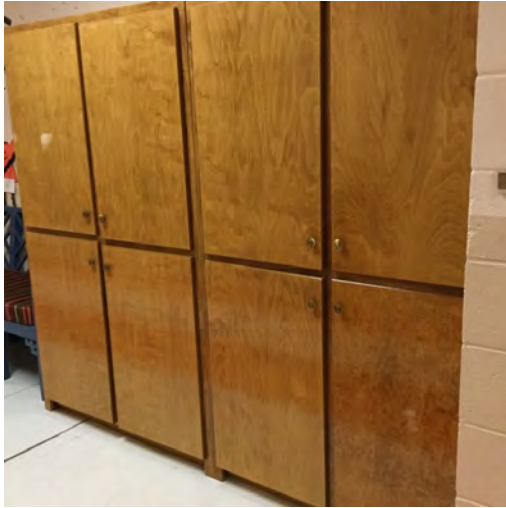
System: E2010 - Fixed Furnishings

Location: Interiors - classrooms
Distress: Beyond Service Life
Category: Deferred Maintenance
Priority: 3 - Necessary/Not Yet Critical (Years 2-5)
Correction: Renew System
Qty: 19,764.00
Unit of Measure: S.F.
Estimate: \$124,355.00
Assessor Name: Eduardo Lopez
Date Created: 11/15/2016

Notes: Fixed furnishings are beyond their expected useful life and are showing some signs of wear and tear. System renewal is recommended.

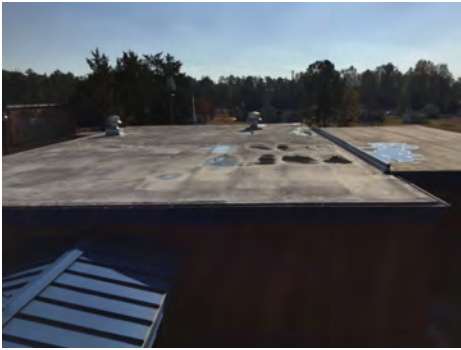
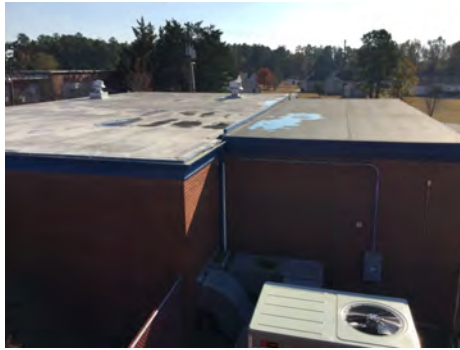
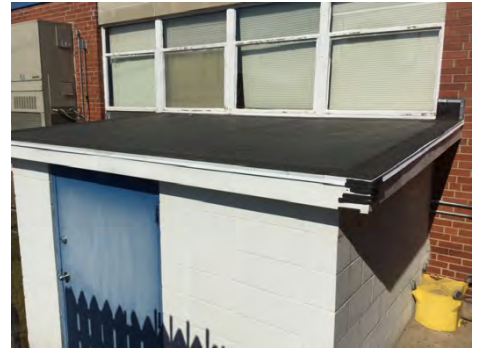
System: B3010120 - Single Ply Membrane

Note: Areas "D" and "O" in Rooftop Systems Engineers report from 2015. System renewal recommended as area O is in poor condition and comprises the majority of the roof area of this building. Area D is in fair condition and requires ongoing maintenance to remain leak-free. Roofs observed by Parsons from adjacent "Main" building.

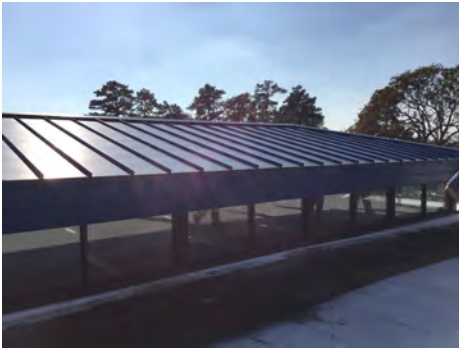
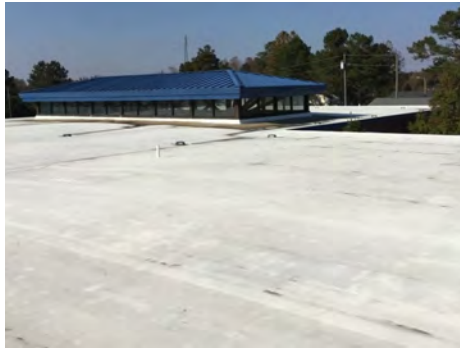
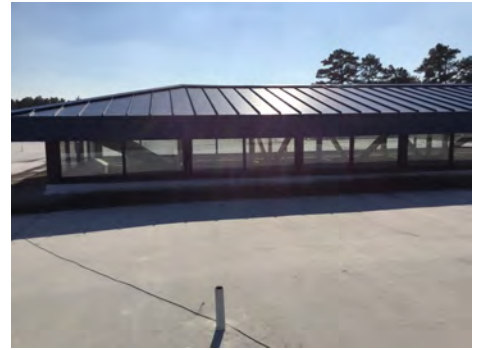
System: B3010130 - Preformed Metal Roofing

Note: Roof recoated in 2012 with 10 year life extension.

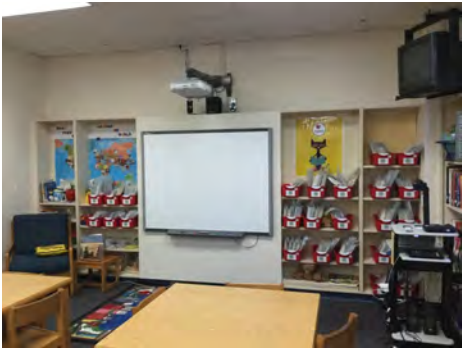
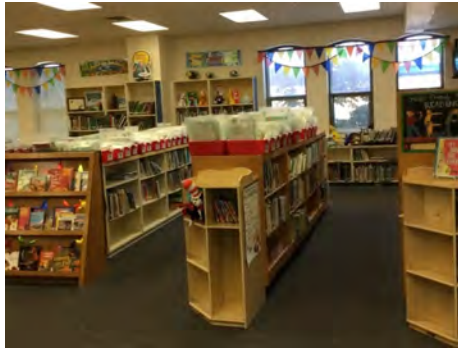
System: E1020 - Institutional Equipment

Note: Library shelving appears to be in good condition. Smartboards are up to date. System renewal date given 6 more years expected useful life.

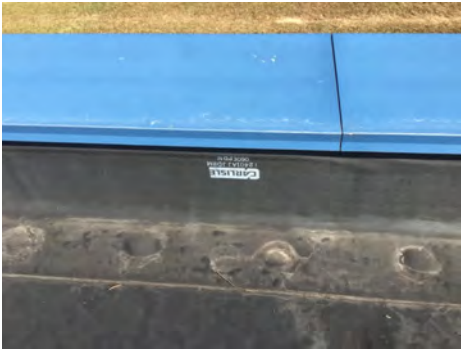
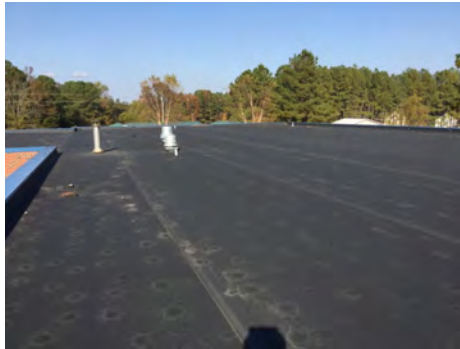
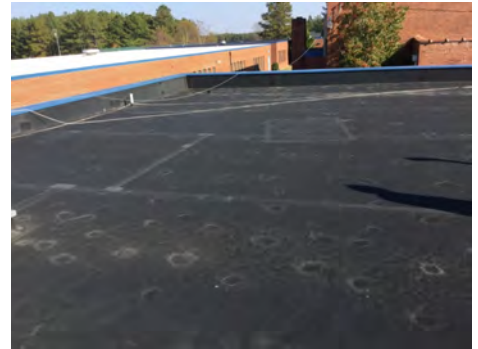
System: B3010120 - Single Ply Membrane

Note: Roof consultant report recommends 15 year life span for this roof.

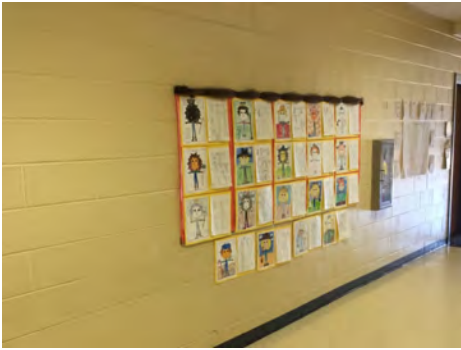
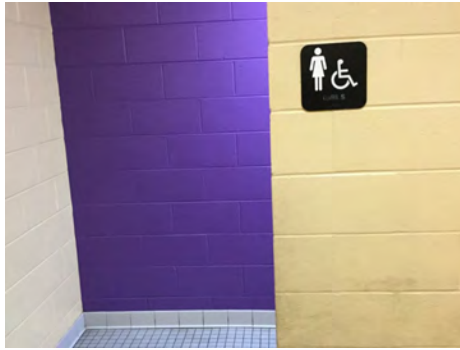
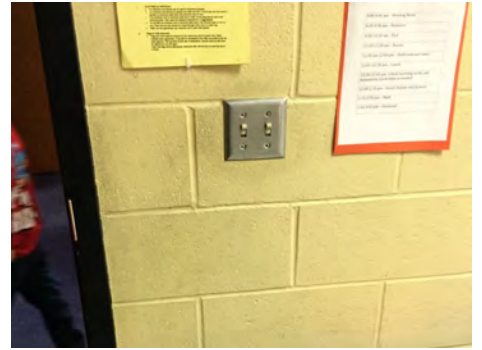
System: C3010 - Wall Finishes

Note: Wall finishes are generally well maintained on an ongoing basis. Some scuffing/dirt noted in high traffic areas.

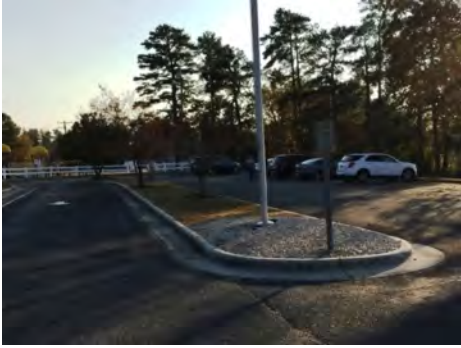
System: G2010 - Roadways

Note: Renewal date per district schedule for sealing/coating/stripping.

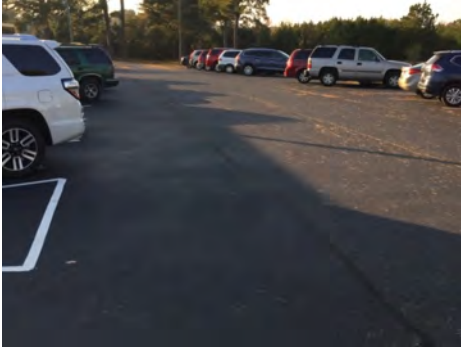
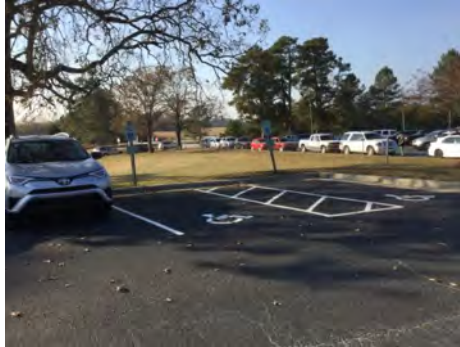
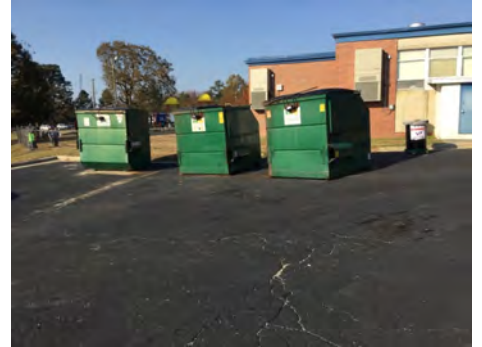
System: G2020 - Parking Lots

Note: Renewal date per district schedule for sealing/coating/stripping.

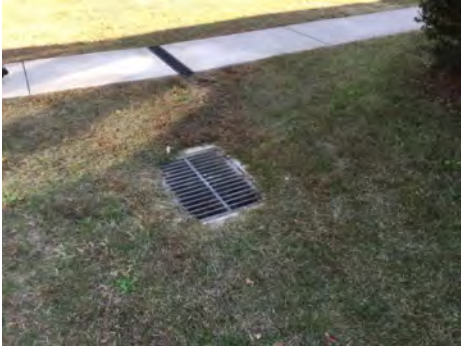
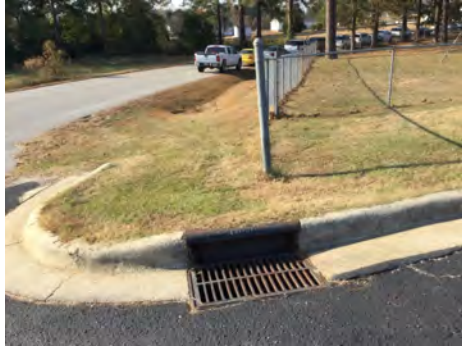
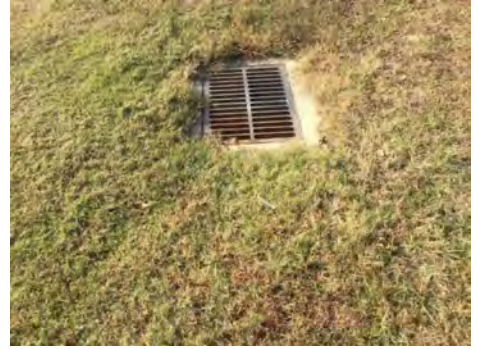
System: G3030 - Storm Sewer

Note: Storm sewer floods gym floor in very heavy rains (3 - 4 incidents over 20 years). A project is pending to lower the sewer line to prevent this flooding and damage to the wood gym floor.

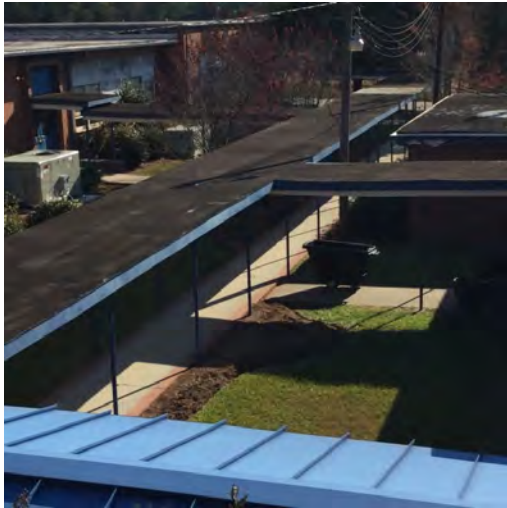
System: G2040950 - Covered Walkways

Location: Covered walkways between buildings
Distress: Beyond Service Life
Category: Deferred Maintenance
Priority: 3 - Necessary/Not Yet Critical (Years 2-5)
Correction: Renew System
Qty: 74,152.00
Unit of Measure: S.F.
Estimate: \$123,982.00
Assessor Name: Eduardo Lopez
Date Created: 11/15/2016

Notes: Roofing at covered walkways is expired. System renewal is recommended.
