NC School District/520 Jones County/Elementary School

# Maysville Elementary

## Campus Assessment Report

March 11, 2017

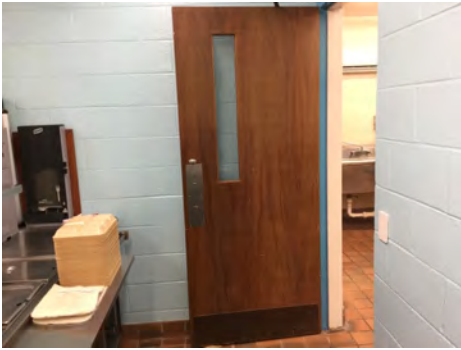
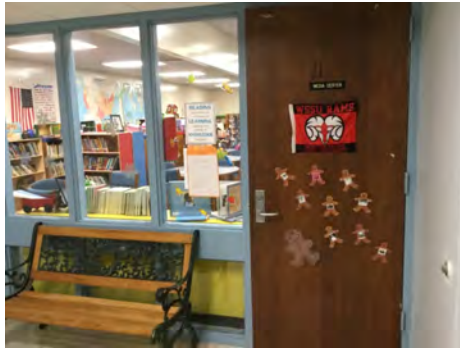
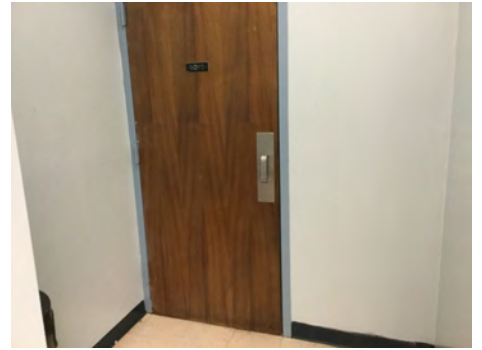
**System:** C1020 - Interior Doors

**Note:** Interior doors typically have lever hardware.

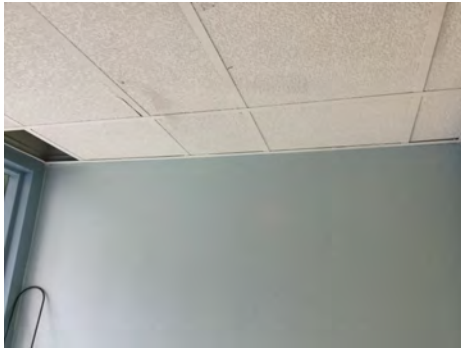
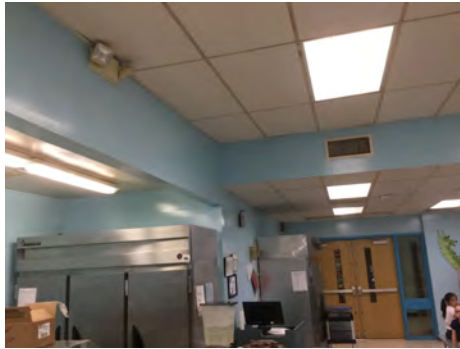
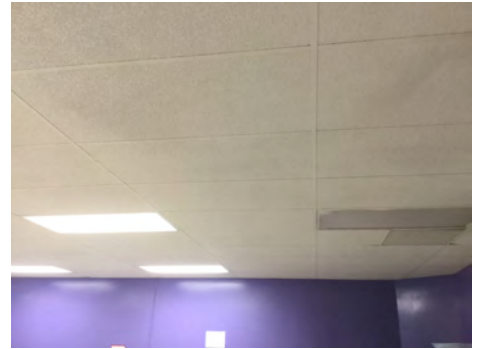
**System:** C3030 - Ceiling Finishes

**Note:** It appears that original ceiling tile and grid have been spray painted.

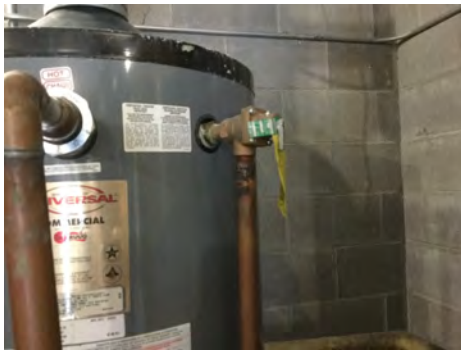
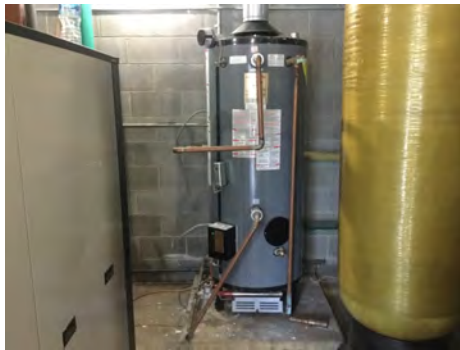
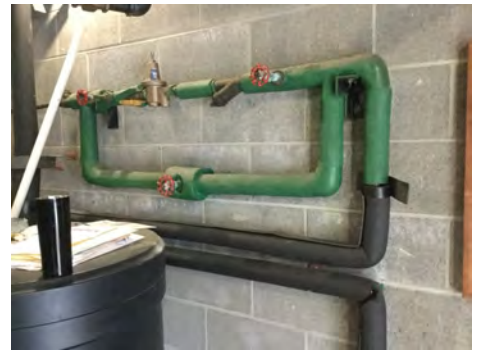
**System:** D2020 - Domestic Water Distribution

**Note:** No apparent or reported issues with water distribution system. Water heaters are up to date. System renewal put at 5 years.

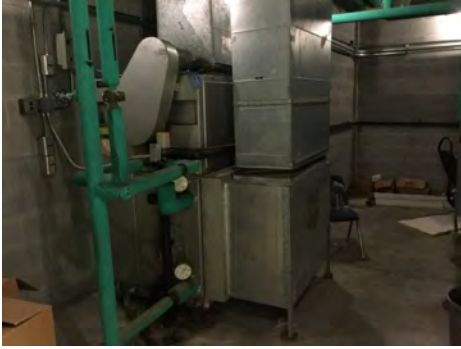
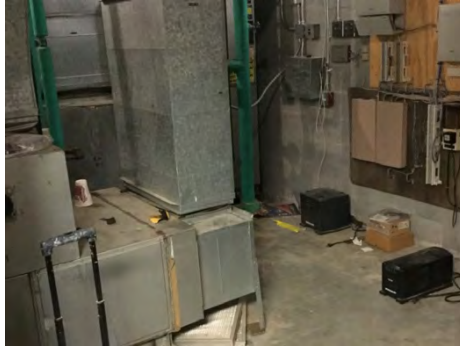
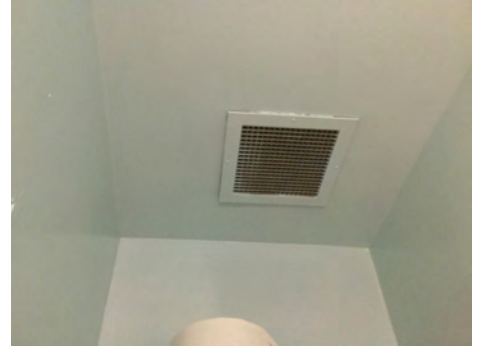
**System:** D3040 - Distribution Systems

**Notes:** The air distribution system is aged, has internally lined ductwork, and should be replaced. Provide cooling supply to data closets. Toilet room exhaust systems are cruddy.

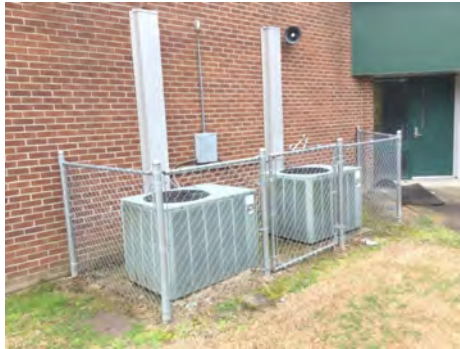
**System:** D3050 - Terminal & Package Units

**Note:** Air conditioning not included in 1998 upgrades. Community paid for retrofit of cooling coils in AHUs and condensing units in 2005.

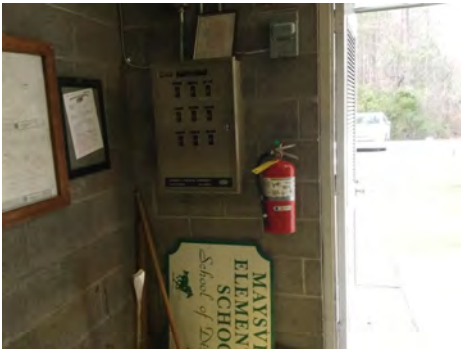
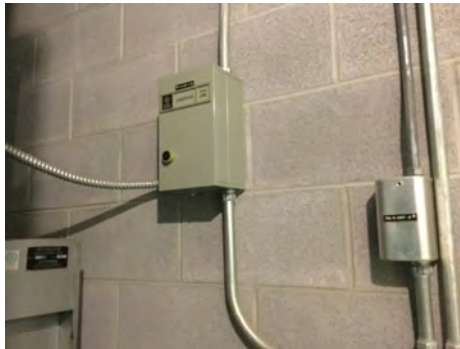
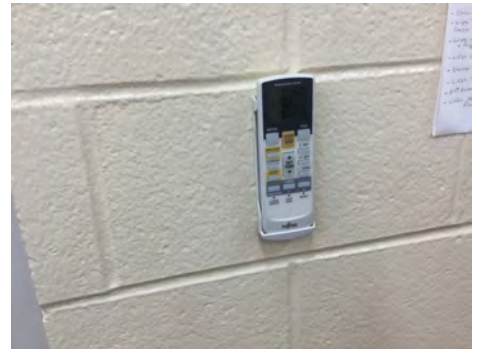
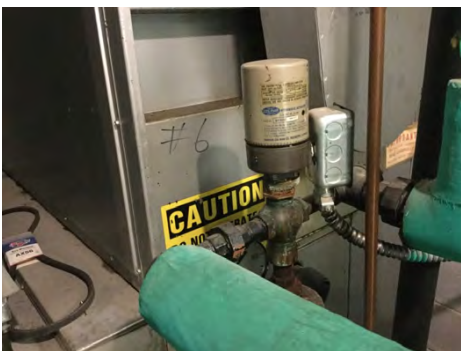
**System:** D3060 - Controls & Instrumentation

**Notes:** Building controls are locally controlled. Installation of a modern digital system with remote monitoring and control capability for energy conservation is recommended.

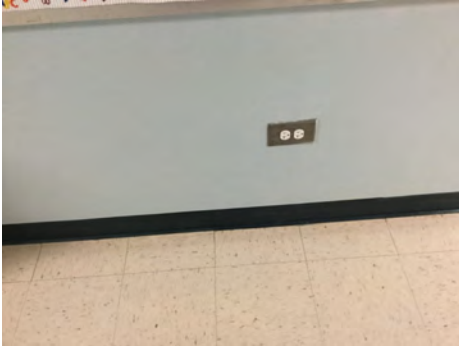
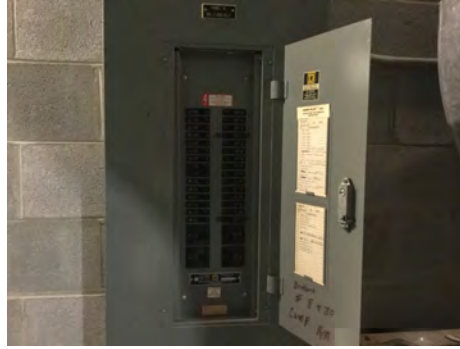
### System: D5020 - Branch Wiring

**Note:** Deficiencies, if any, assumed to have been addressed in 1998 renovations. GFI outlets seen in wet areas. Sufficient power outlets for computer needs. Power strips used for surge protection. No use of extension cords observed.

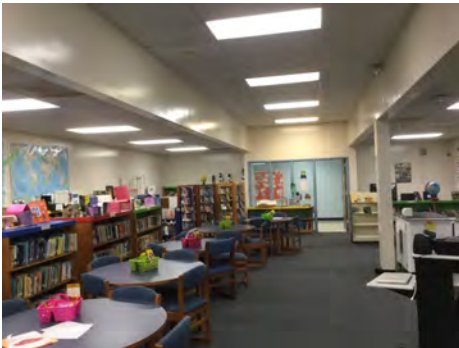
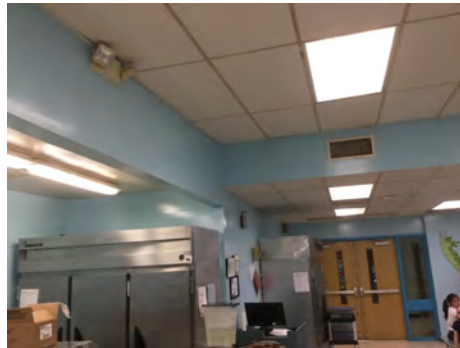
### System: D5020 - Lighting

**Note:** Upgraded existing fixtures with new ballasts and T-8 lamps 2011.

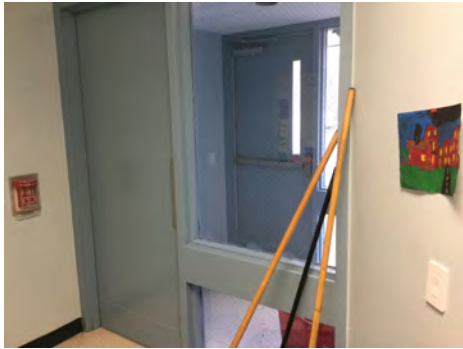
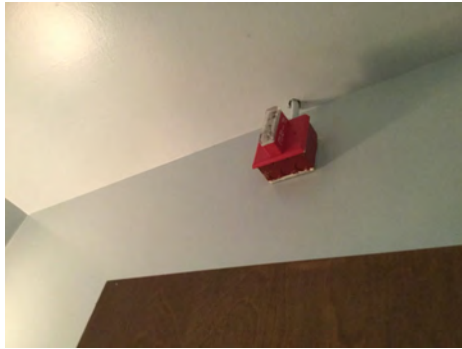
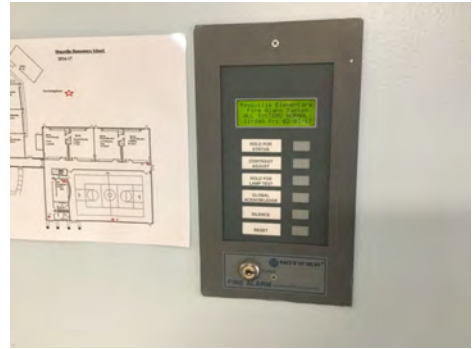
**System:** D5030910 - Fire Alarm Systems

**Notes:** The fire alarm system is beyond its expected life. System renewal is recommended to ensure reliability of this life safety system.

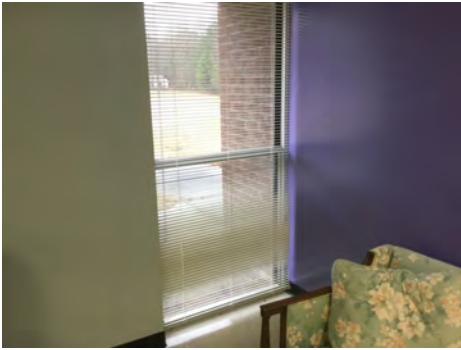
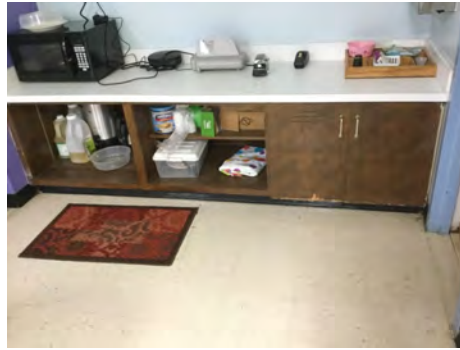
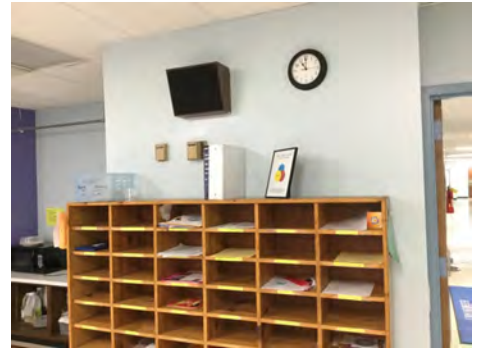
**System:** E2010 - Fixed Furnishings

**Notes:** Fixed furnishings are typically original, are beyond their expected useful life and are showing wear and tear. System renewal is recommended.

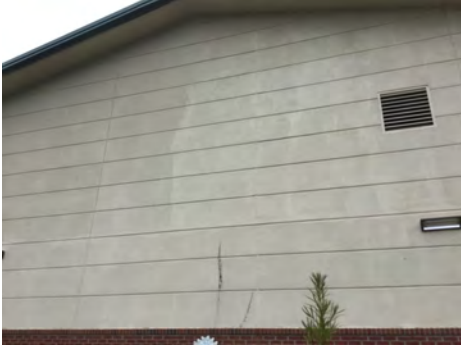
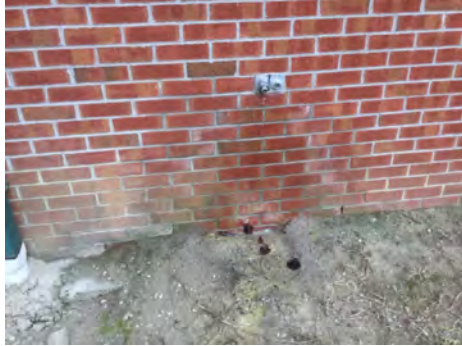
**System:** B2010 - Exterior Walls

**Note:** Walls painted 2016
