NC School District/300 Davie County/Elementary School

Mocksville Elementary

Campus Assessment Report

March 10, 2017

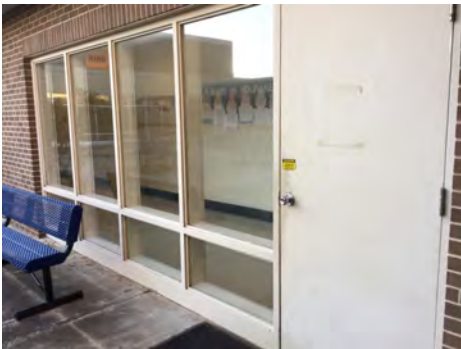
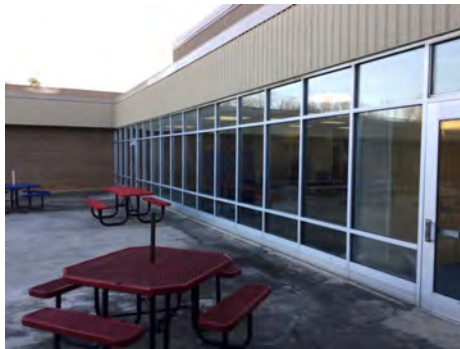
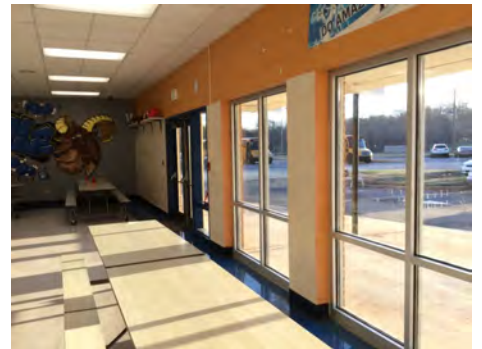
System: B2020 - Exterior Windows

Note: Aluminum framed windows appear to match gym addition and are therefore assumed new in 2005.

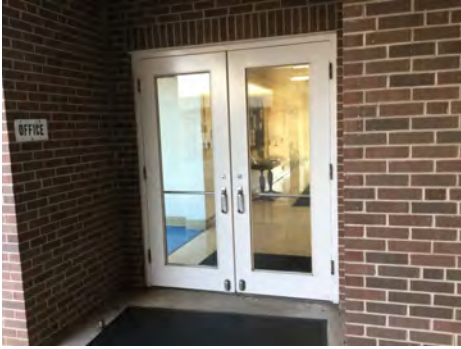
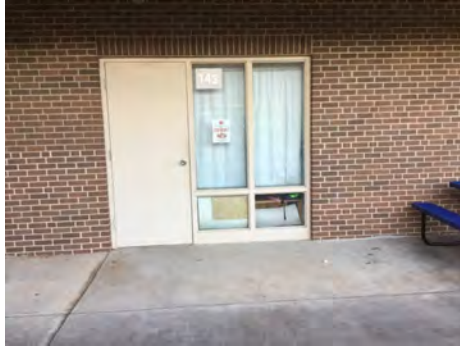
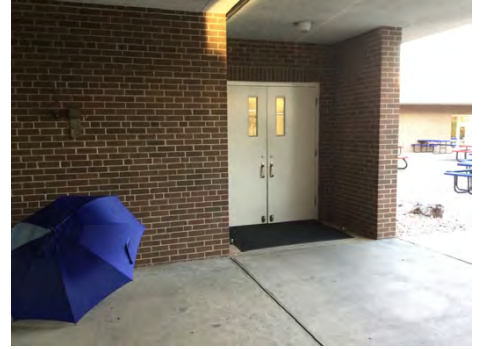
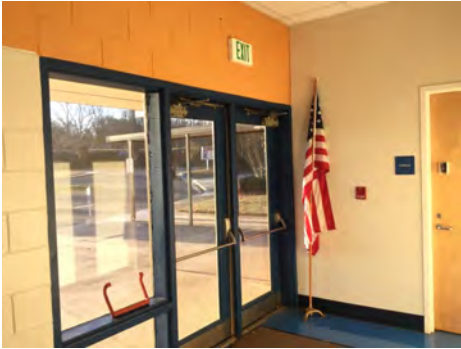
System: B2030 - Exterior Doors

Notes: Although the main entry doors have been replaced, and the side breezeway has been enclosed with a door assembly for security reasons, most exterior doors are beyond their expected life and should be replaced.

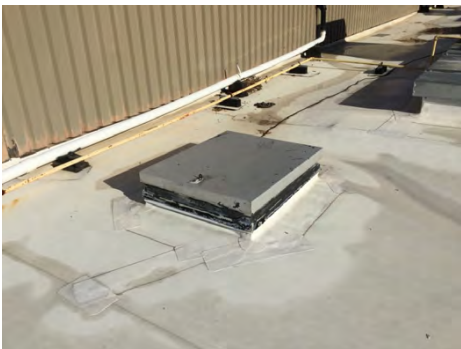
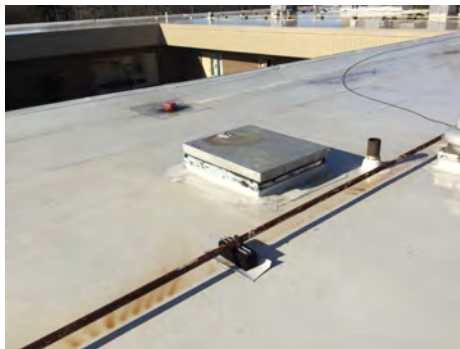
System: B3020 - Roof Openings

Notes: The roof hatch is beyond its expected life. Replacement is recommended.

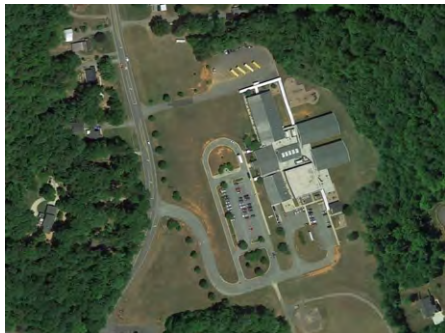
- 1). Aerial Image of Mocksville Elementary School - Feb 25, 2017
