NC School District/300 Davie County/Middle School

# North Davie Middle

## Campus Assessment Report

March 10, 2017

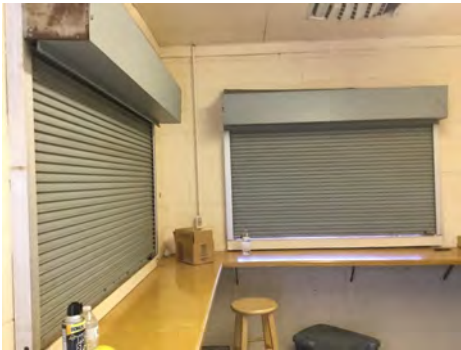
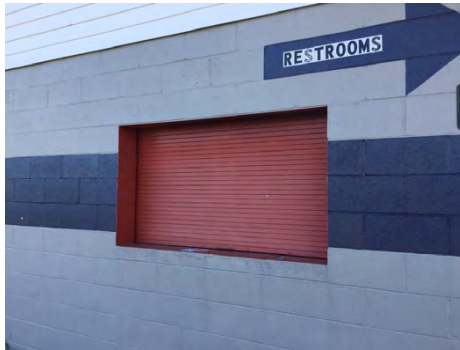
**System:** B2020 - Exterior Windows

**Notes:** The exterior windows are aged, and should be replaced.

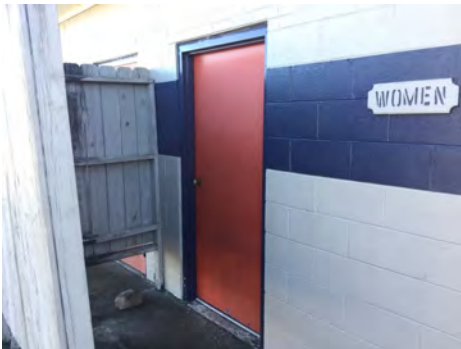
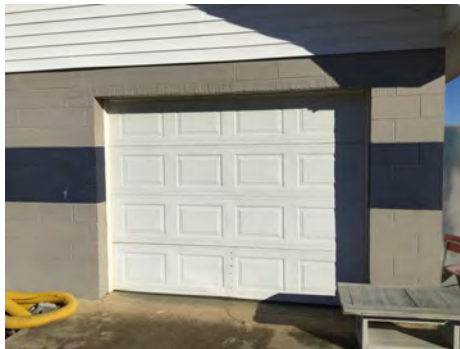
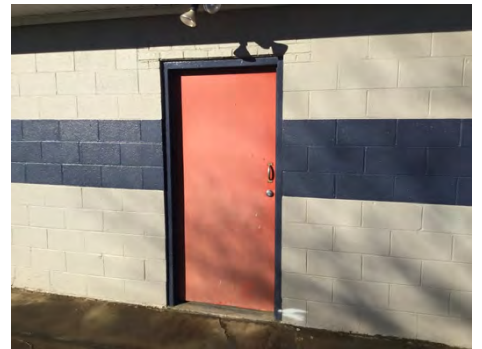
**System:** B2030 - Exterior Doors

**Notes:** The exterior doors are aged, and should be replaced.

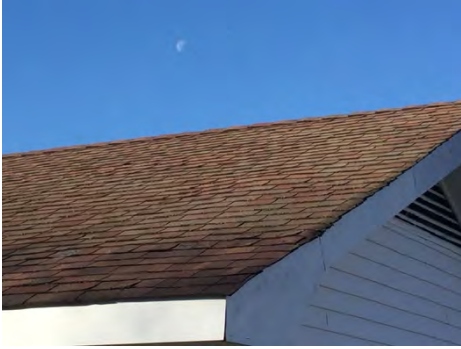
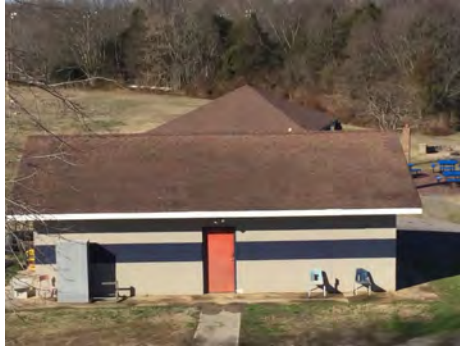
**System:** B3010140 - Asphalt Shingles

**Notes:** The asphalt shingles roof covering is aged, showing signs of failure and should be replaced.

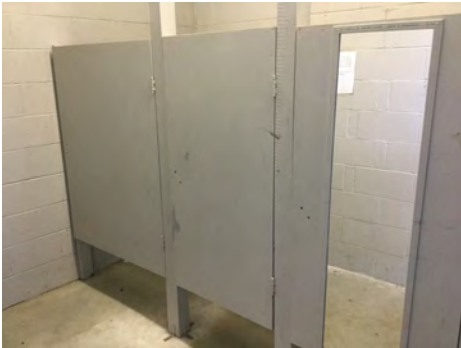
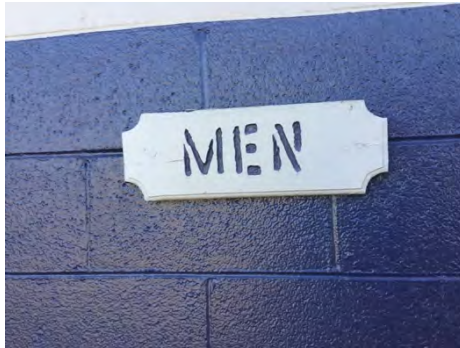
**System:** C1030 - Fittings

**Notes:** The fittings throughout the building are aged, in marginal condition, partitions and signage are not ADA compliant and should be replaced.

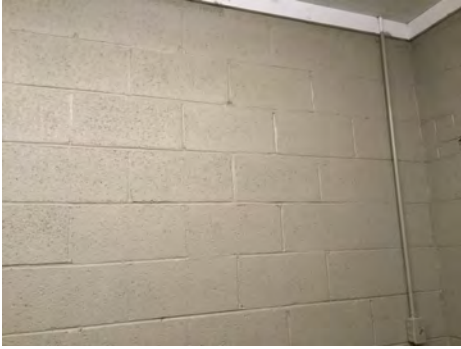
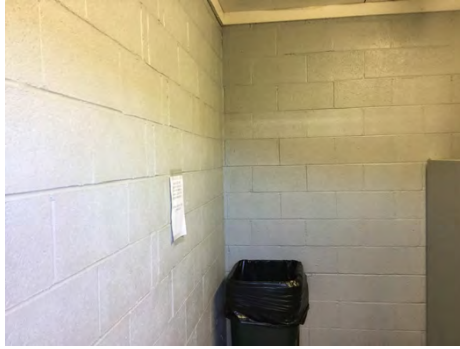
**System:** C3010 - Wall Finishes

**Notes:** The wall finishes are aged, scuffed, fading, stained and should be replaced.

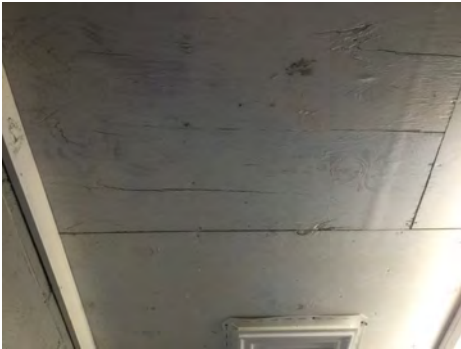
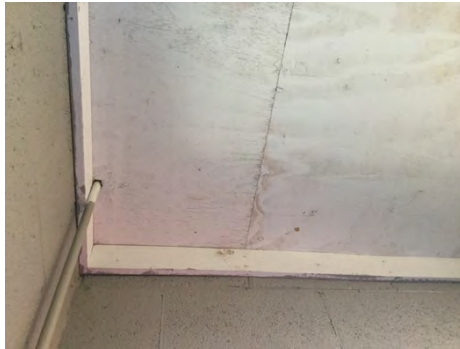
**System:** C3030 - Ceiling Finishes

**Notes:** The original ceiling finishes are aged, failing and should be replaced.

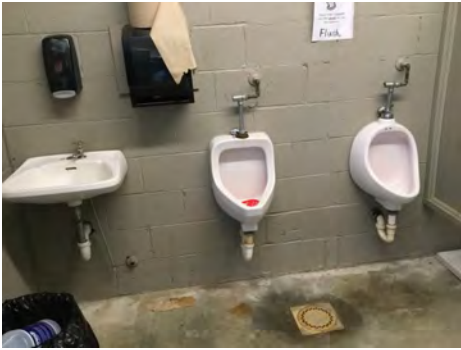
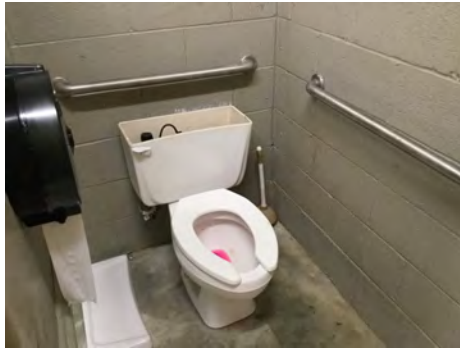
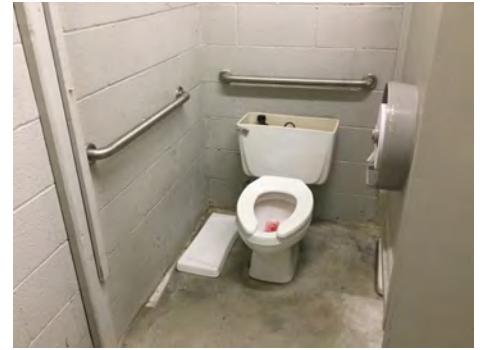
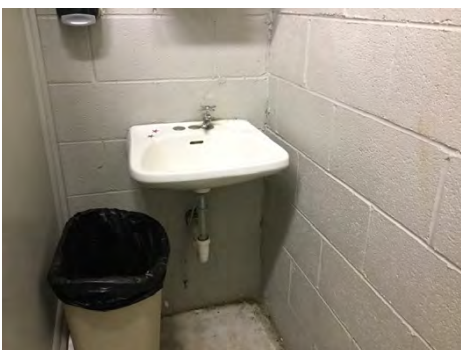
**System:** D2010 - Plumbing Fixtures

**Notes:** Plumbing fixtures are in operational conditions. However, they are aged, not ADA compliant, and should be scheduled for replacement.

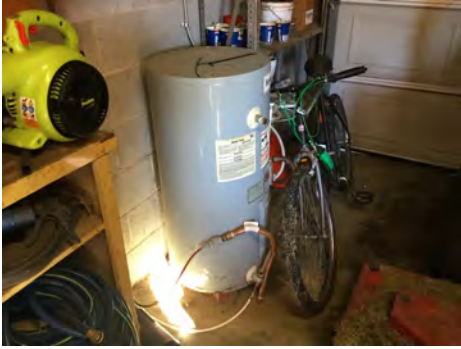
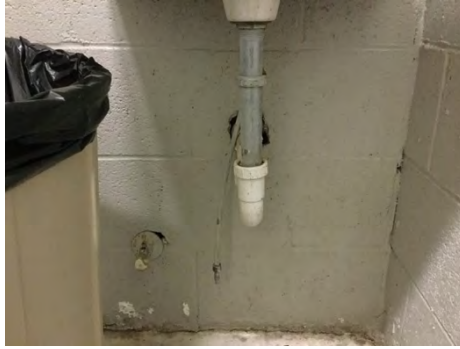
**System:** D2020 - Domestic Water Distribution

**Notes:** The domestic water distribution system is aged and should be replaced.

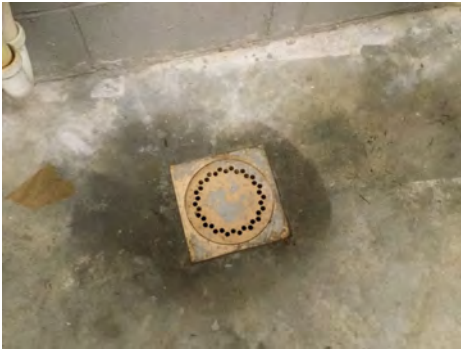
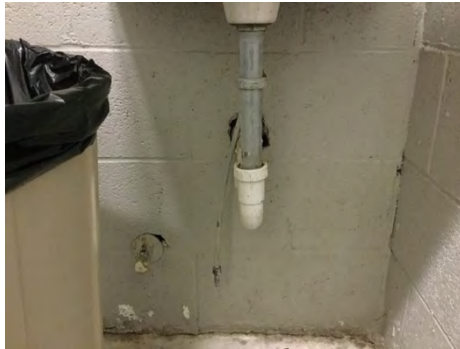
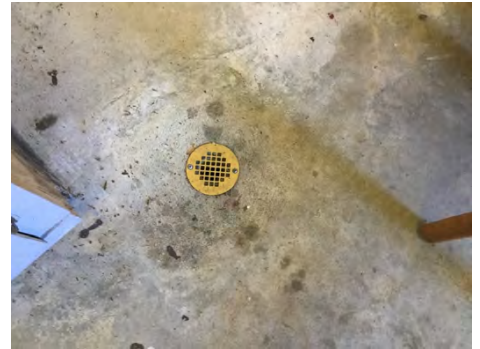
**System:** D2030 - Sanitary Waste

**Notes:** The sanitary waste system is beyond its expected service life and should be replaced.

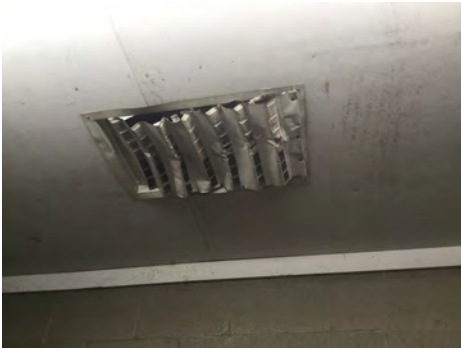
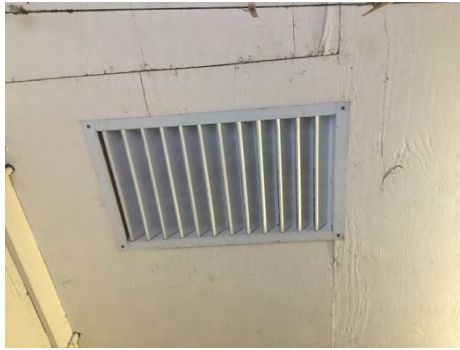
**System:** D3040 - Distribution Systems

**Notes:** Distribution systems are aged, becoming logistically unsupportable, and should be replaced.

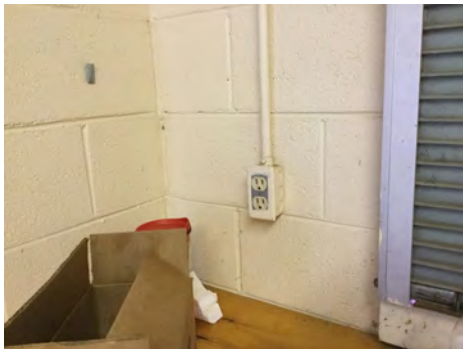
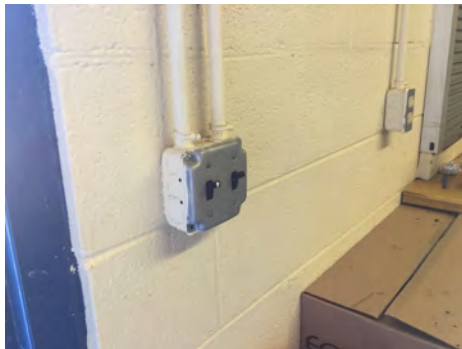
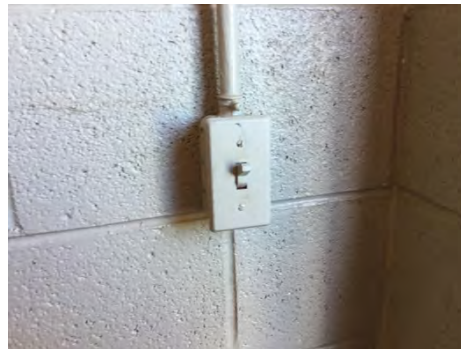
**System:** D5020 - Branch Wiring

**Notes:** The original branch wiring system is operating but is aged, in marginal condition, and should be replaced.

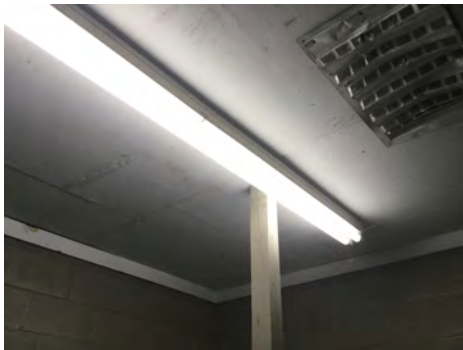
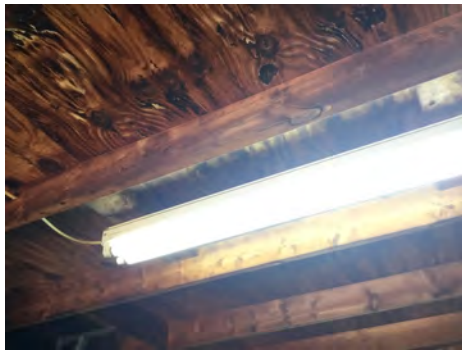
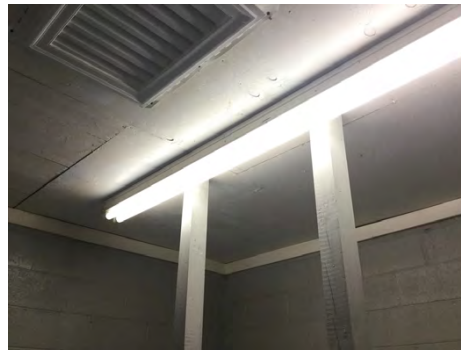
**System:** D5020 - Lighting

**Notes:** The original lighting system is operating but is aged, in marginal condition, and should be replaced.

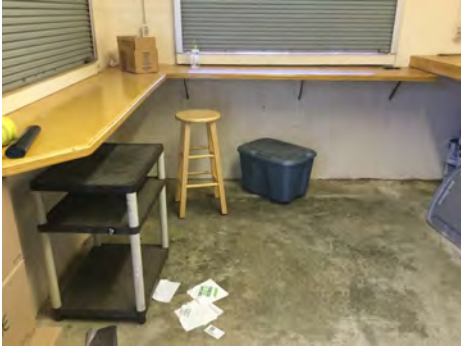
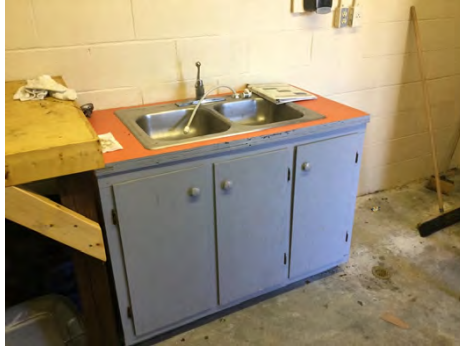
**System:** E2010 - Fixed Furnishings

**Notes:** The fixed furnishings are aged, in marginal condition, and should be replaced.

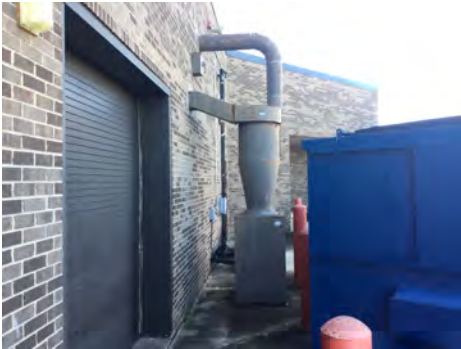
**System:** D3090 - Other HVAC Systems/Equip

**Note:** No longer in use.

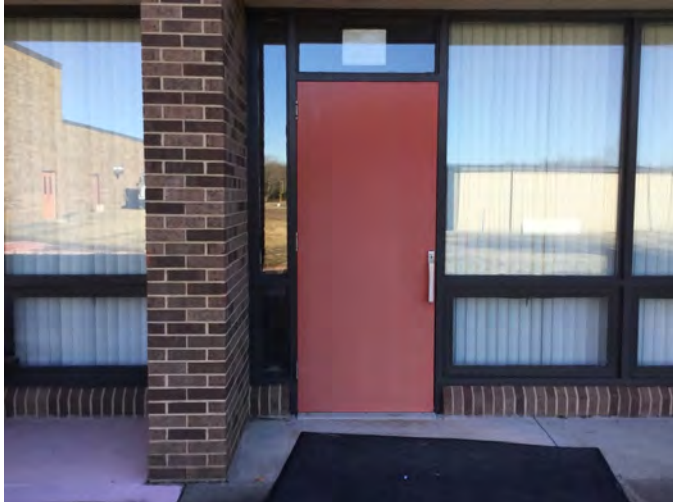
**System: B2030 - Exterior Doors**

**Location:** Exterior Walls  
**Distress:** Beyond Service Life  
**Category:** Deferred Maintenance / Building Code Compliance  
**Priority:** 3 - Necessary/Not Yet Critical (Years 2-5)  
**Correction:** Renew System  
**Qty:** 72,876.00  
**Unit of Measure:** S.F.  
**Estimate:** \$81,767.00  
**Assessor Name:** Eduardo Lopez  
**Date Created:** 01/19/2017

**Notes:** The exterior doors are aged, rusted and should be replaced. Including the electrical room exit door doesn't comply with current Building Codes.

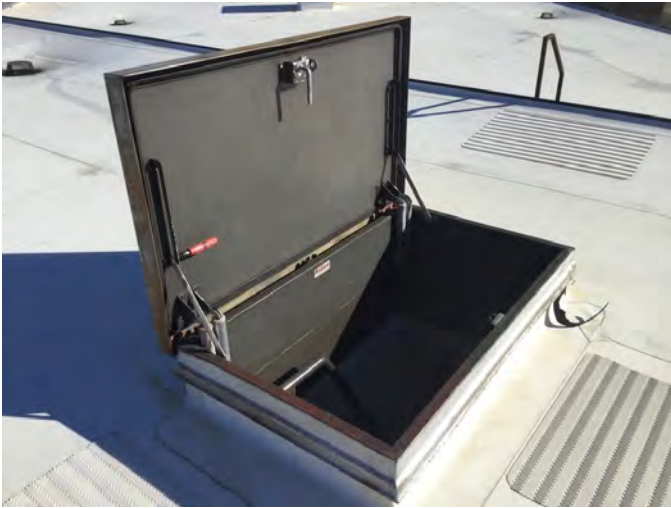
**System: B3020 - Roof Openings**

**Location:** Roof  
**Distress:** Beyond Service Life  
**Category:** Deferred Maintenance  
**Priority:** 3 - Necessary/Not Yet Critical (Years 2-5)  
**Correction:** Renew System  
**Qty:** 72,876.00  
**Unit of Measure:** S.F.  
**Estimate:** \$19,239.00  
**Assessor Name:** Eduardo Lopez  
**Date Created:** 01/19/2017

**Notes:** Roof hatch does not comply with OSHA standards; roof opening protection and proper extension of fixed ladder to platform is not provided.
