NC School District/520 Jones County/Elementary School

Pollocksville Elementary

Campus Assessment Report

March 11, 2017

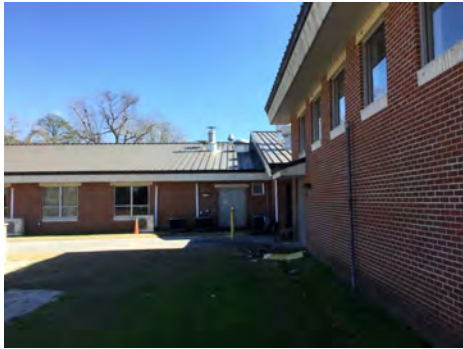
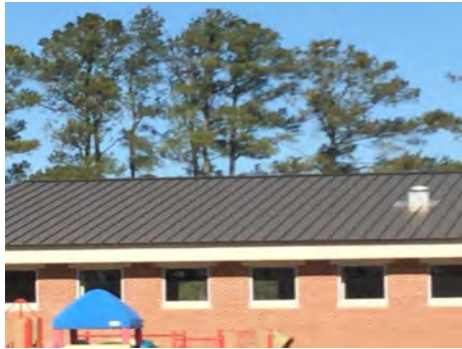
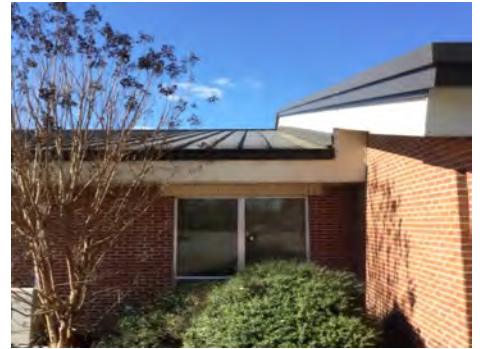
System: B3010130 - Preformed Metal Roofing

Location: Roof
Distress: Missing
Category: Deferred Maintenance
Priority: 3 - Necessary/Not Yet Critical (Years 2-5)
Correction: Install gutters and downspouts
Qty: 1,500.00
Unit of Measure: L.F.
Estimate: \$21,210.75
Assessor Name: Ann Buerger Linden
Date Created: 02/15/2017

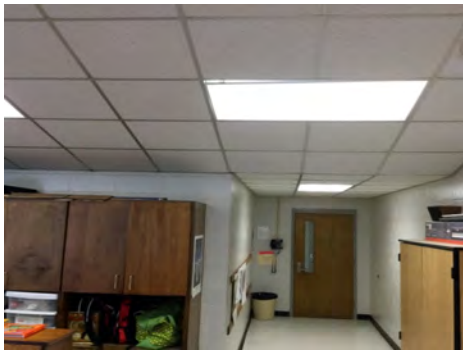
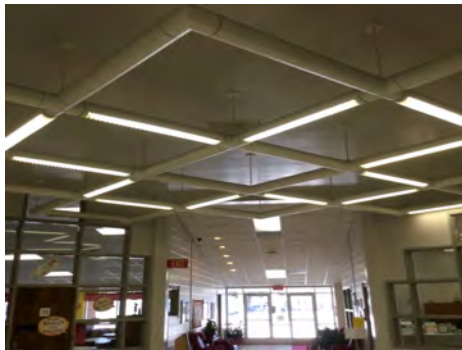
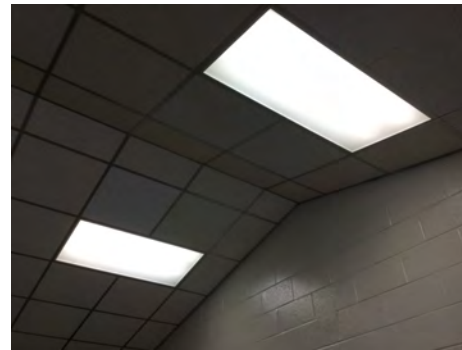
System: D5020 - Lighting

Note: Lighting upgraded to T-8 lamps and ballasts in existing fixtures, 2011.

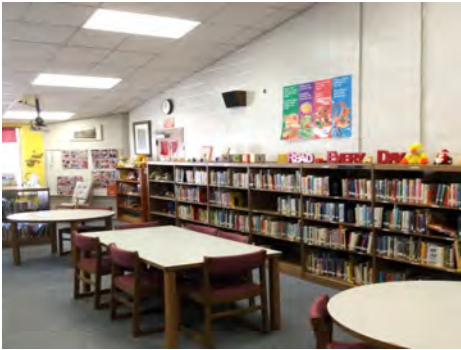
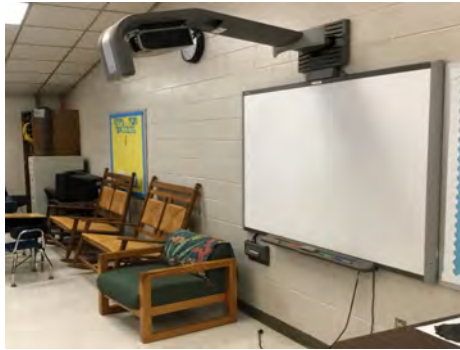
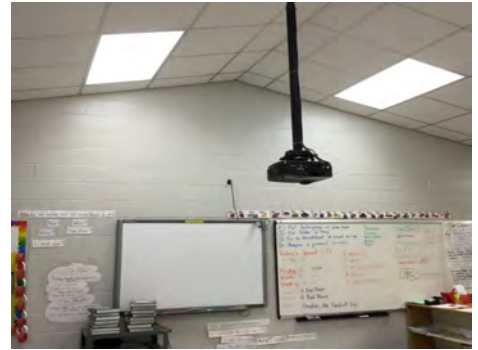
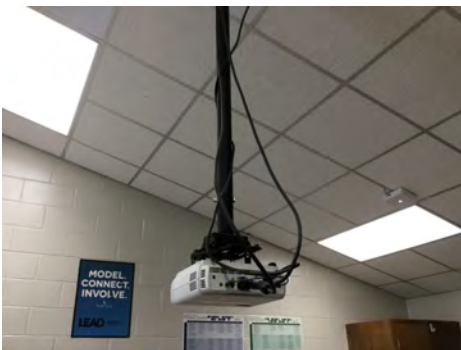
System: E1020 - Institutional Equipment

Notes: Library equipment and other institutional equipment is typically original and in fair condition. System renewal is recommended.

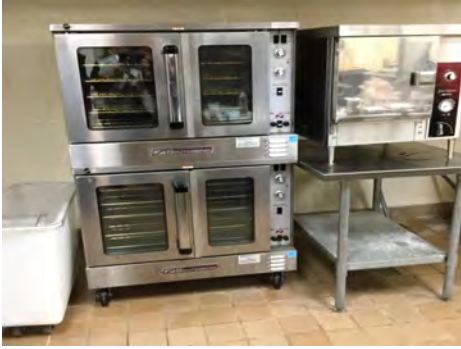
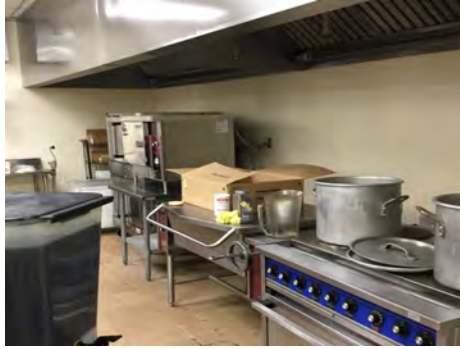
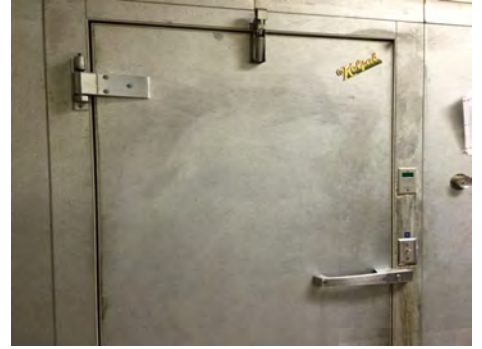
System: E1090 - Other Equipment

Notes: Kitchen equipment is typically original and beyond its expected useful life. Walk-in compressors are near failure. system renewal is recommended.

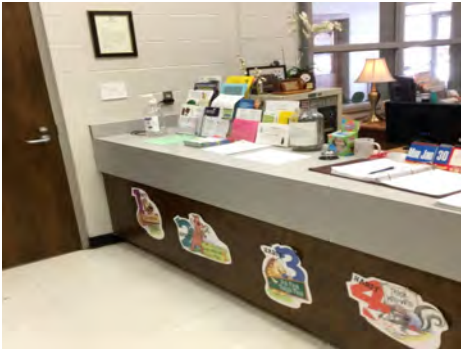
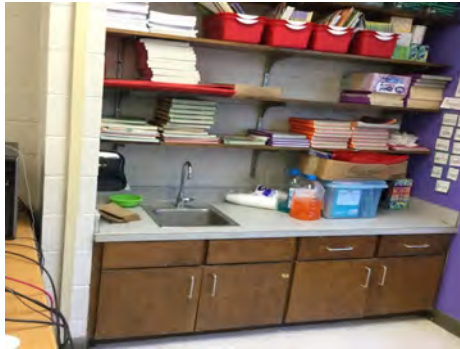
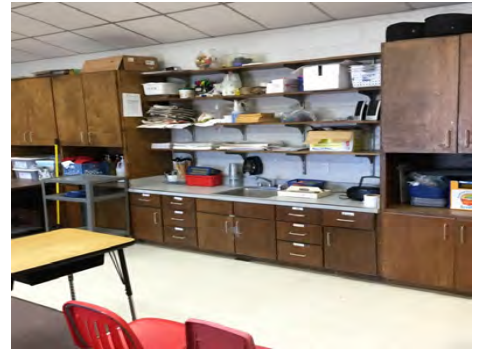
System: E2010 - Fixed Furnishings

Notes: Classroom millwork and other fixed furnishing throughout the building is original and in well maintained but worn condition. System renewal is recommended.

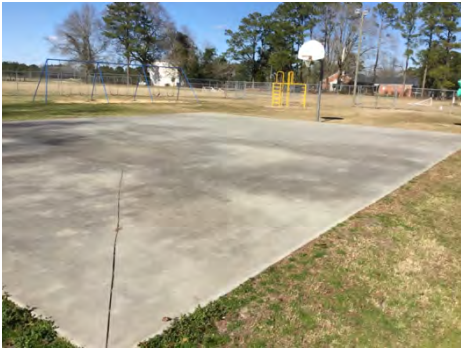
System: G2040950 - Hard Surface Play Area

Notes: The basketball court is cracked. System renewal is recommended.

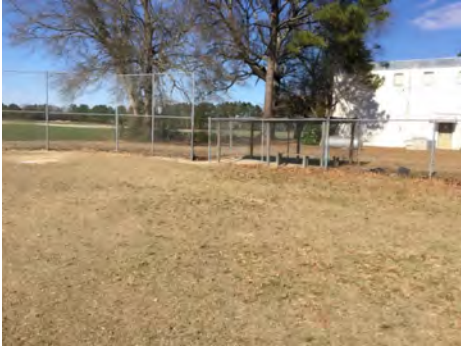
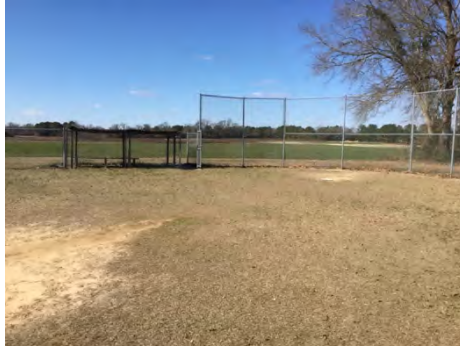
System: G2040950 - Playing Field

Notes: The playing field is worn and beyond its expected life. Dugouts are poorly constructed. System renewal is recommended.
