NC School District/300 Davie County/Elementary School

# Shady Grove Elementary

## Campus Assessment Report

March 10, 2017

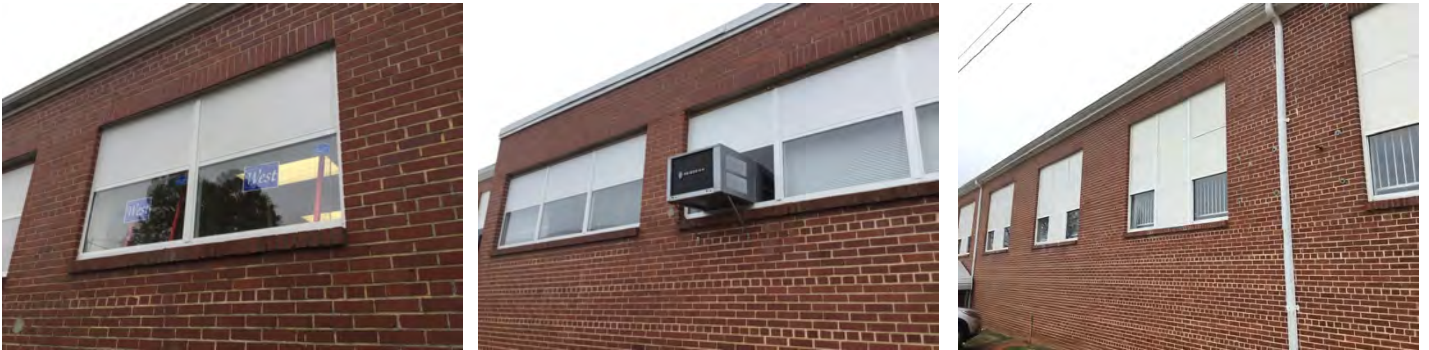
**System:** B2020 - Exterior Windows

**Notes:** The exterior windows are aged, not energy efficient and should be replaced.

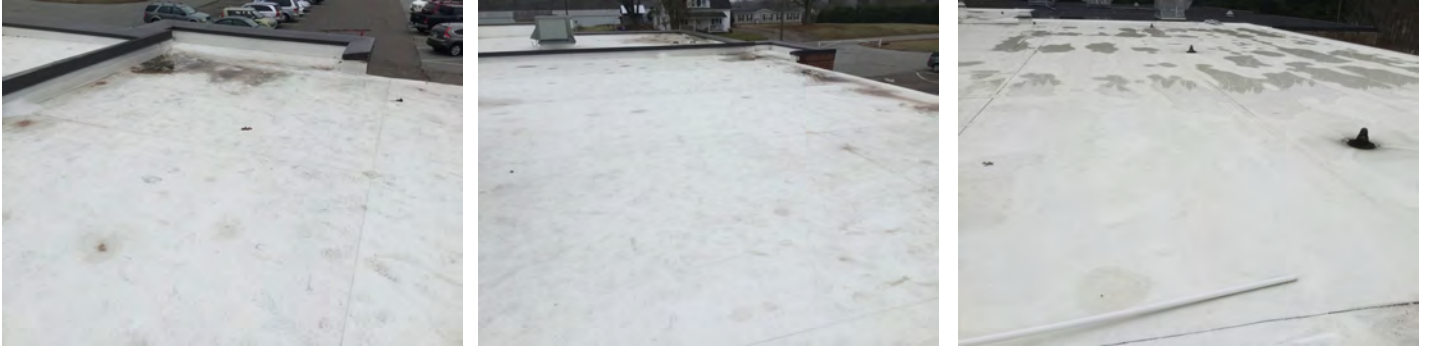
**System:** B3010120 - Single Ply Membrane

**Location:** Above Cafeteria and Kitchen  
**Distress:** Inadequate  
**Category:** Deferred Maintenance  
**Priority:** 2 - Potentially Critical (Year 1)  
**Correction:** Minor thermoplastic membrane repairs, 2% of roof area  
**Qty:** 50.00  
**Unit of Measure:** Sq.  
**Estimate:** \$27,449.40  
**Assessor Name:** Eduardo Lopez  
**Date Created:** 01/24/2017

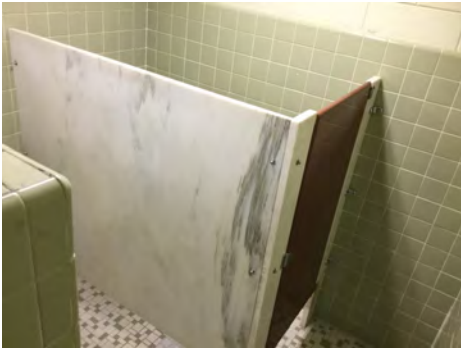
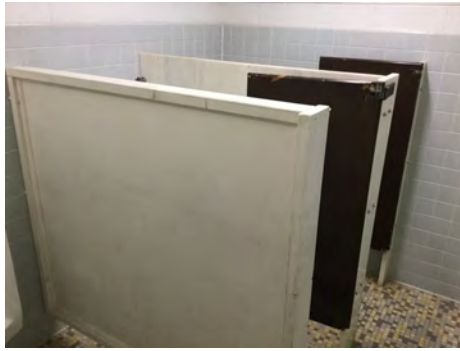
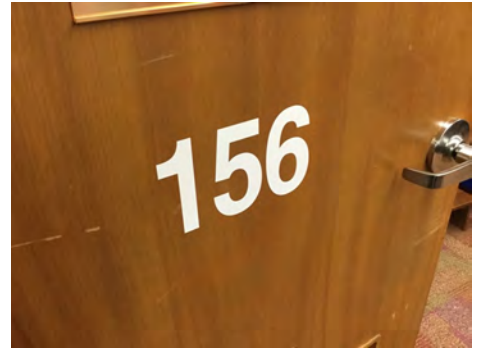
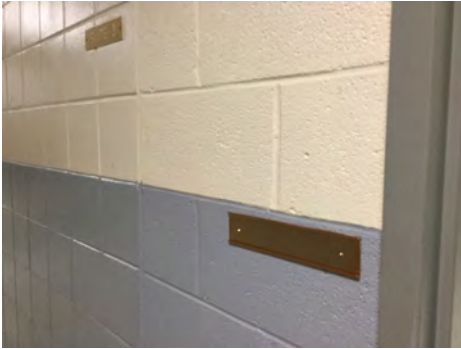
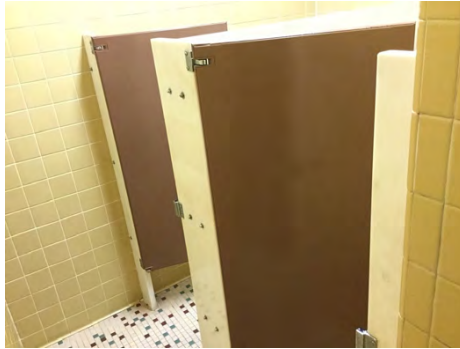
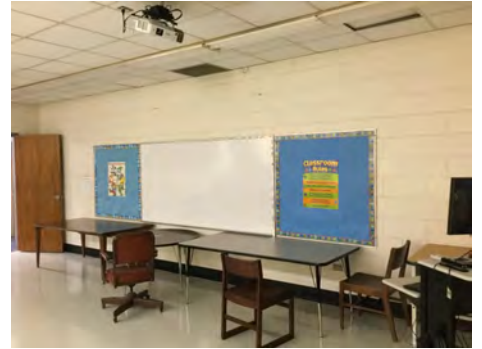
**System:** C1030 - Fittings

**Notes:** The fittings throughout the building are aged, in marginal condition, room signage are not ADA compliant and should be replaced.

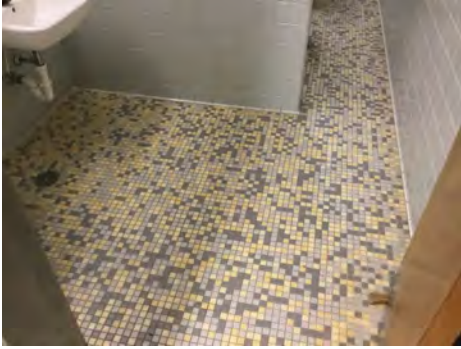
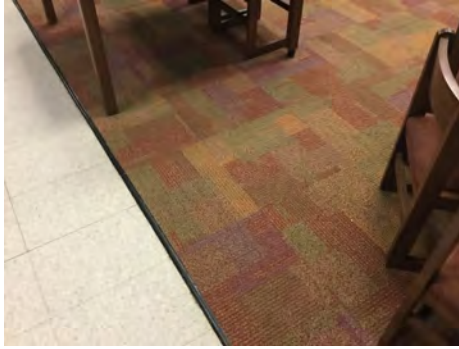
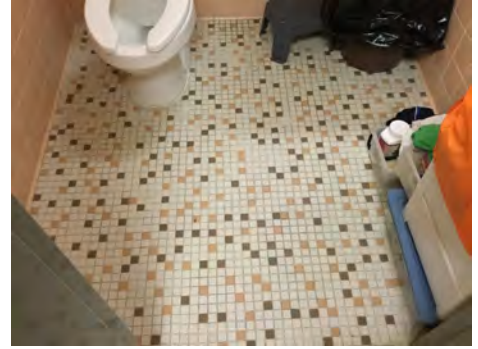
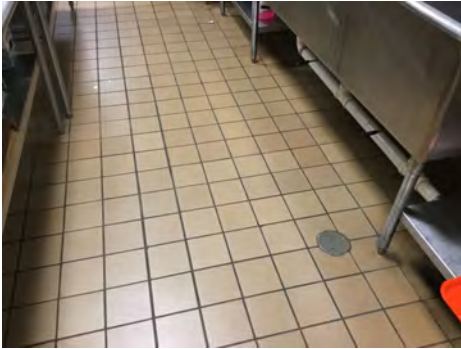
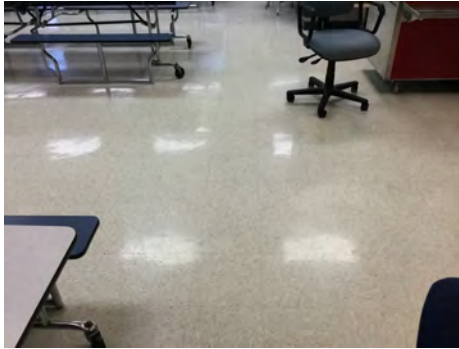
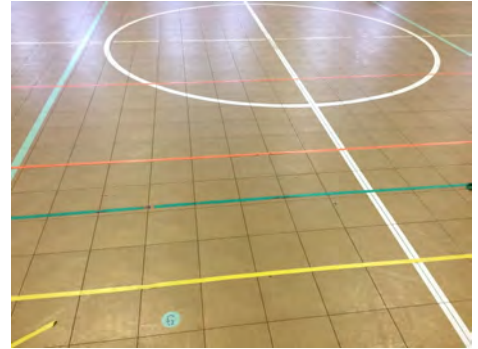
**System:** C3020 - Floor Finishes

**Location:** Gym  
**Distress:** Beyond Service Life  
**Category:** Deferred Maintenance / Safety  
**Priority:** 3 - Necessary/Not Yet Critical (Years 2-5)  
**Correction:** Replace vinyl sheet flooring  
**Qty:** 700.00  
**Unit of Measure:** S.Y.  
**Estimate:** \$119,750.40  
**Assessor Name:** Eduardo Lopez  
**Date Created:** 02/13/2017

**Notes:** Gym flooring has moisture seeping and tiles are uneven causing a trip hazard and should be replaced.

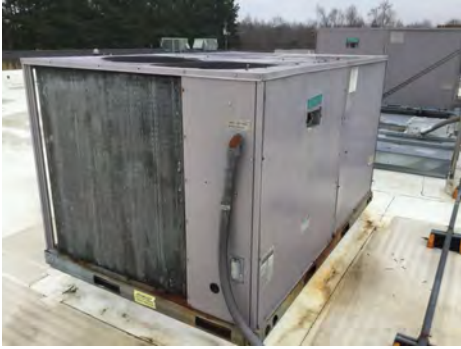
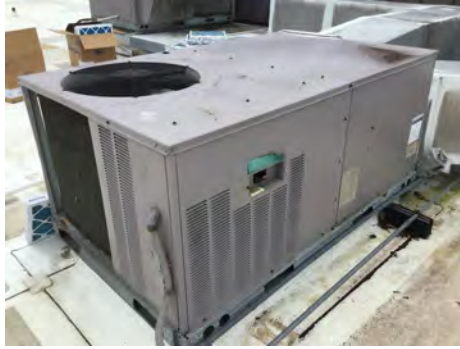
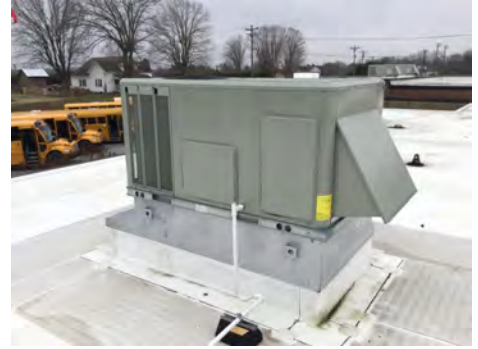
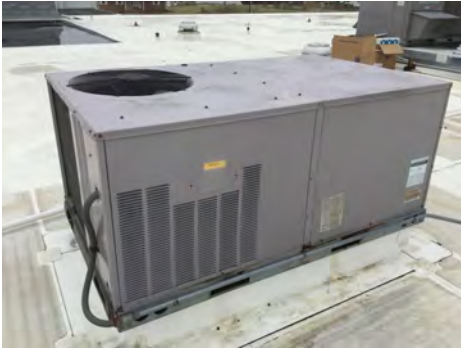
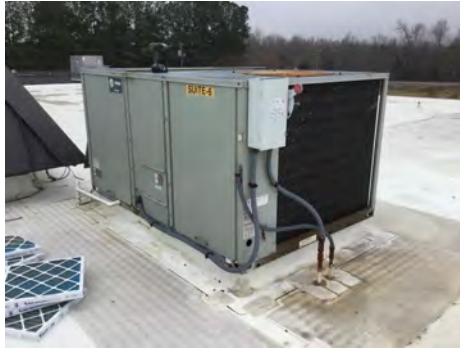
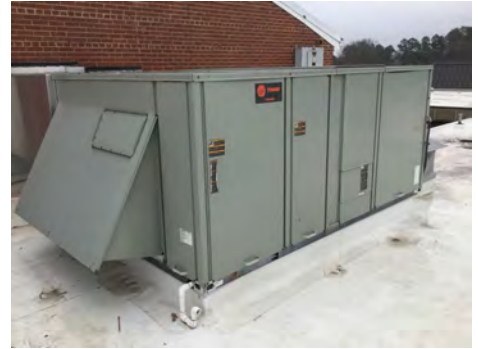
**System:** D3050 - Terminal & Package Units

**Note:** Different dates between 2003 and 2016

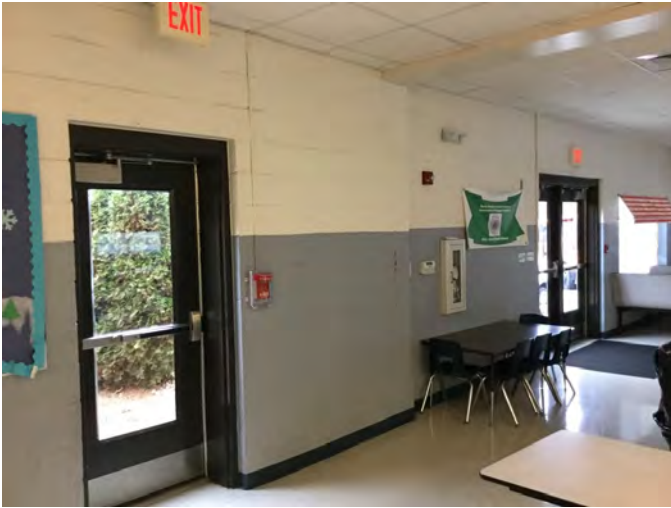
**System: D5090 - Other Electrical Systems**

**Location:** 1950, 1970 Main Building  
**Distress:** Beyond Service Life  
**Category:** Deferred Maintenance  
**Priority:** 3 - Necessary/Not Yet Critical (Years 2-5)  
**Correction:** Renew System  
**Qty:** 43,725.00  
**Unit of Measure:** S.F.  
**Estimate:** \$5,772.00  
**Assessor Name:** Eduardo Lopez  
**Date Created:** 02/27/2017

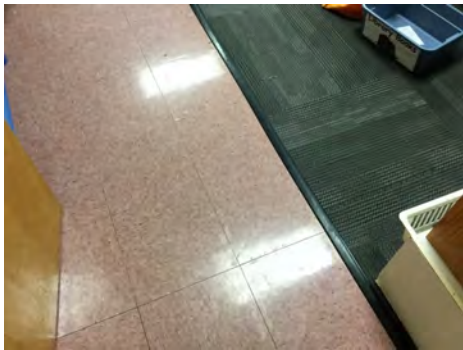
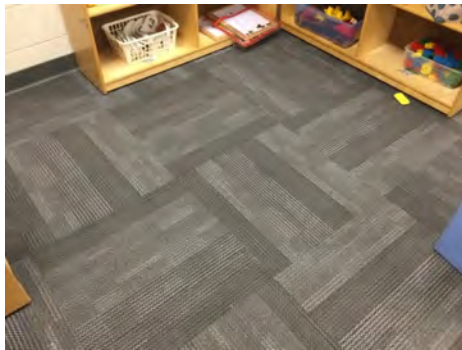
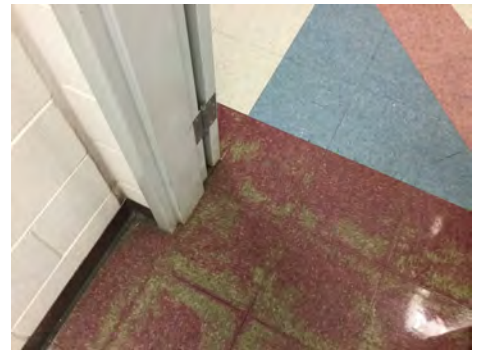
**System:** C3020 - Floor Finishes

**Note:** Carpet replaced in 2016
