NC School District/300 Davie County/Middle School

South Davie Middle

Campus Assessment Report

March 10, 2017

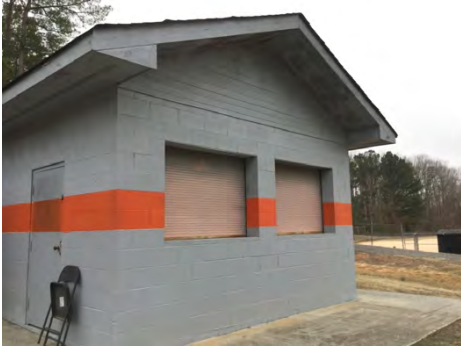
System: B2020 - Exterior Windows

Note: Service counter windows.

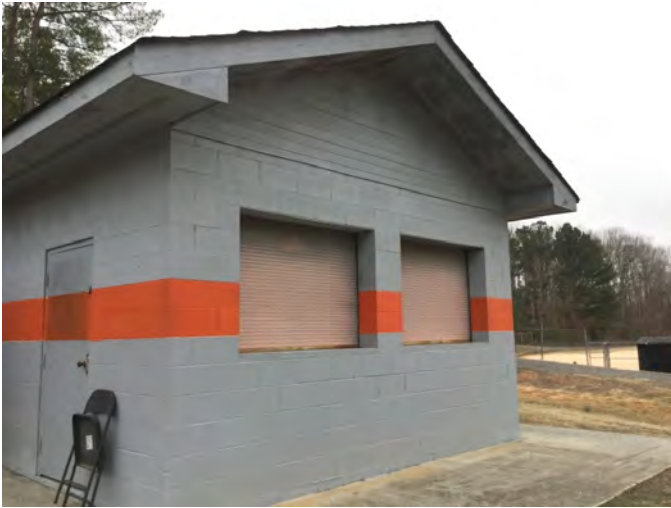
System: B2020 - Exterior Windows

Location: Concessions
Distress: Beyond Service Life
Category: Deferred Maintenance
Priority: 3 - Necessary/Not Yet Critical (Years 2-5)
Correction: Renew System
Qty: 1,100.00
Unit of Measure: S.F.
Estimate: \$6,232.00
Assessor Name: Eduardo Lopez
Date Created: 01/24/2017

Notes: Service counter windows are beyond their expected useful life.

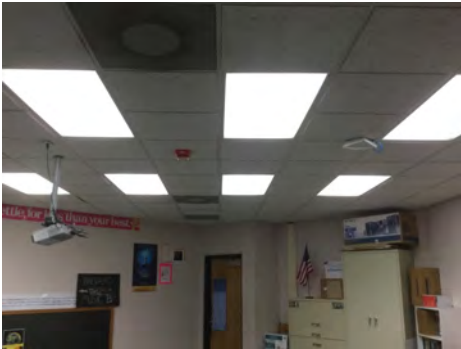
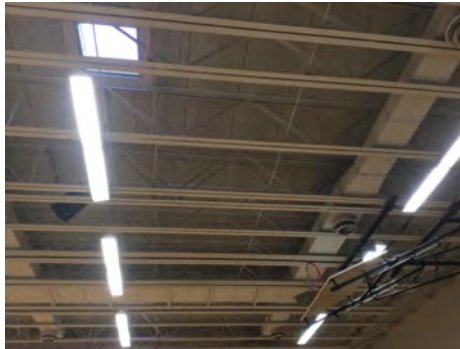
System: C3030 - Ceiling Finishes

Note: Ceiling finishes are generally well maintained in fair to good condition. A few water stained tiles noted should be replaced on a maintenance basis. System renewal put at 5 years hence.

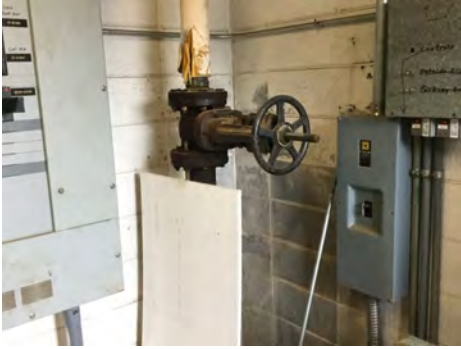
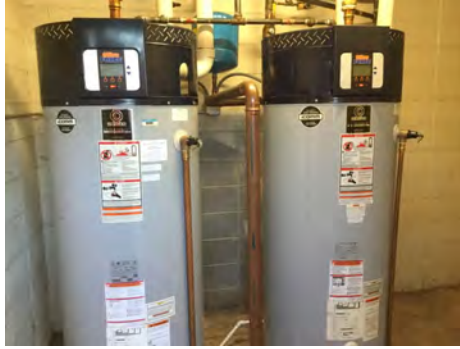
System: D2020 - Domestic Water Distribution

Note: Water heater manufacture dates are 2010 and 2012.

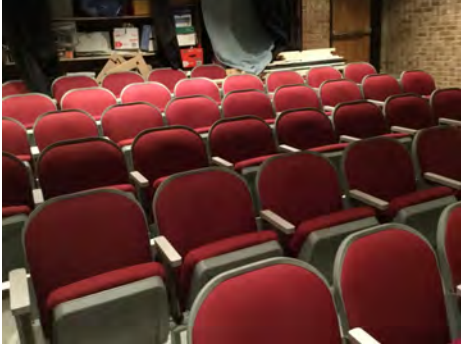
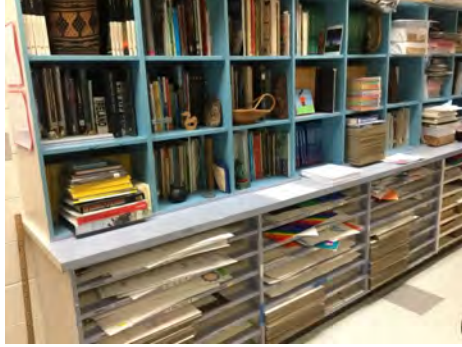
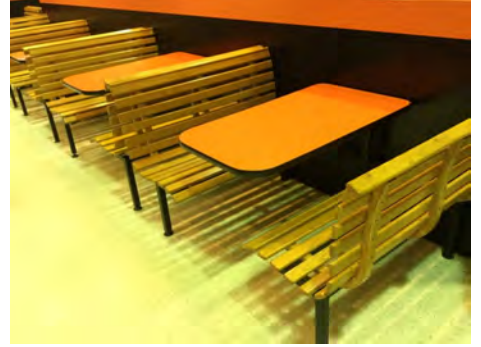
System: E2010 - Fixed Furnishings

Note: Auditorium seating looks new/not original. Estimated install date.

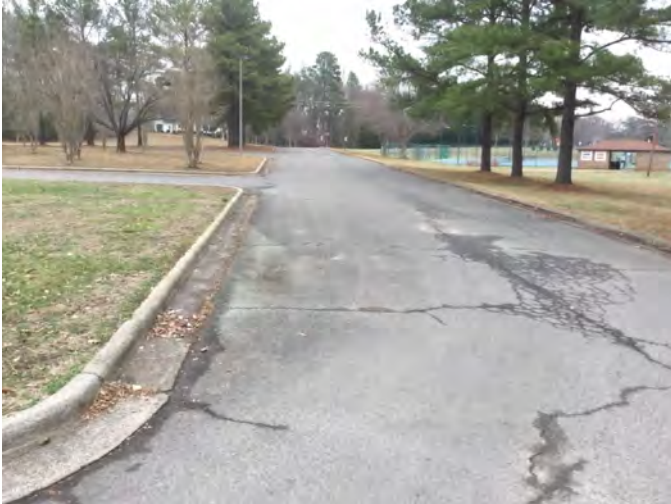
System: G2010 - Roadways

Location: Site
Distress: Beyond Service Life
Category: Deferred Maintenance
Priority: 3 - Necessary/Not Yet Critical (Years 2-5)
Correction: Renew System
Qty: 80,770.00
Unit of Measure: S.F.
Estimate: \$374,934.00
Assessor Name: Ann Buerger Linden
Date Created: 12/13/2016

Notes: The parking lot is aged, has many repairs and potholes, and should be replaced and re-striped. ADA signs height needs to be added per minimum ADA standards.

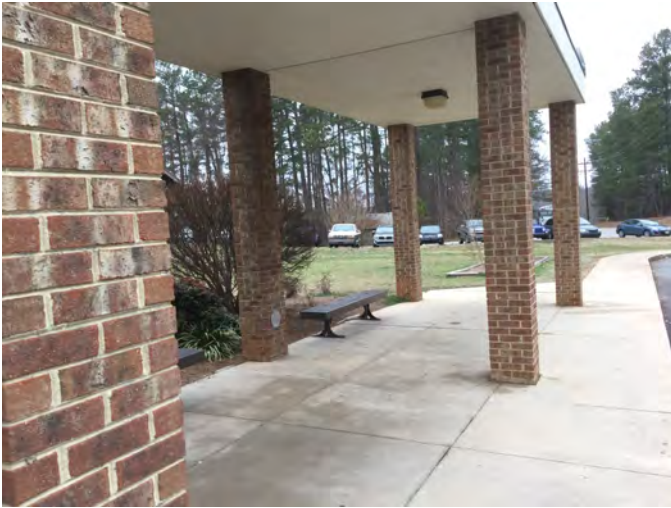
System: G2030 - Pedestrian Paving

Location: Site
Distress: Beyond Service Life
Category: Deferred Maintenance
Priority: 3 - Necessary/Not Yet Critical (Years 2-5)
Correction: Renew System
Qty: 80,770.00
Unit of Measure: S.F.
Estimate: \$175,917.00
Assessor Name: Ann Buerger Linden
Date Created: 12/13/2016

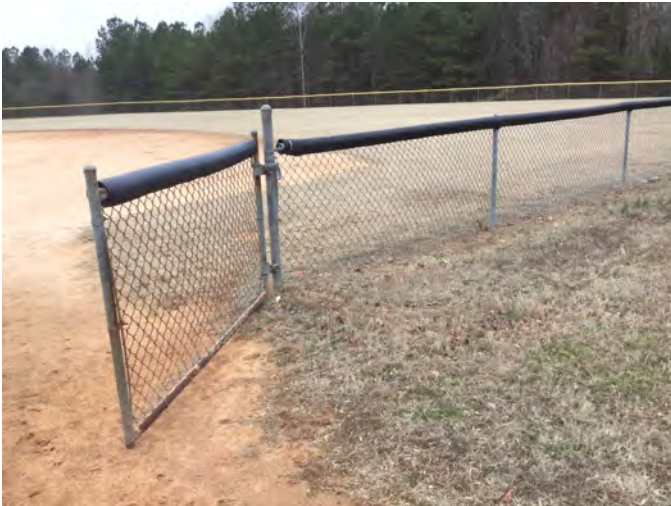
System: G2040105 - Fence & Guardrails

Location: Site
Distress: Beyond Service Life
Category: Deferred Maintenance
Priority: 3 - Necessary/Not Yet Critical (Years 2-5)
Correction: Renew System
Qty: 80,770.00
Unit of Measure: S.F.
Estimate: \$106,616.00
Assessor Name: Ann Buerger Linden
Date Created: 12/13/2016

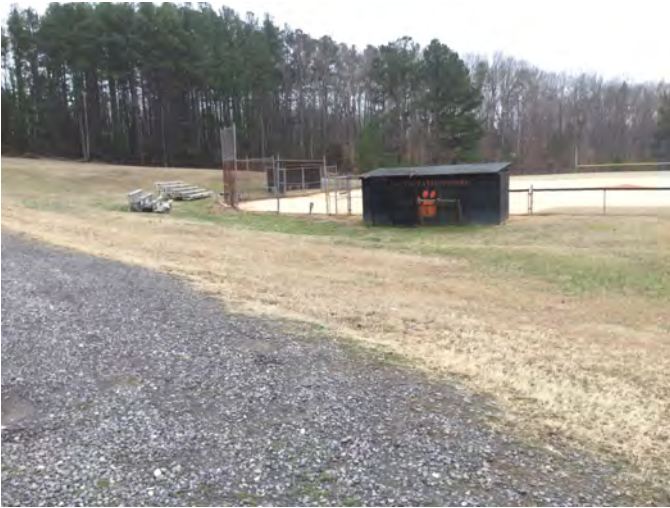
System: G2040950 - Baseball Field

Location: Site
Distress: Beyond Service Life
Category: Deferred Maintenance
Priority: 3 - Necessary/Not Yet Critical (Years 2-5)
Correction: Renew System
Qty: 80,770.00
Unit of Measure: S.F.
Estimate: \$629,037.00
Assessor Name: Ann Buerger Linden
Date Created: 12/13/2016

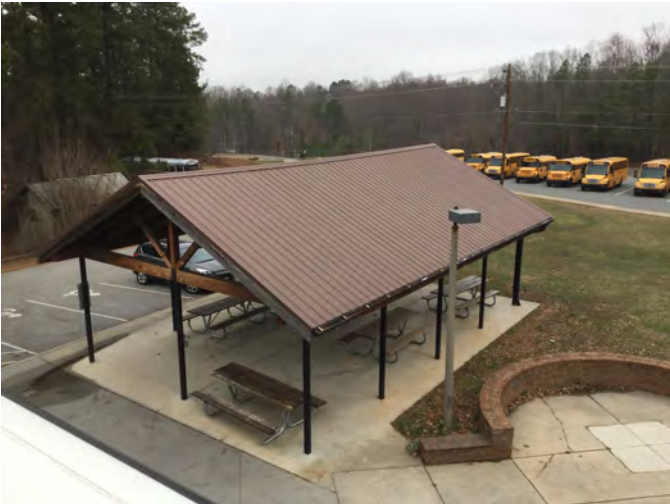
System: G2040950 - Canopies

Location: Site
Distress: Beyond Service Life
Category: Deferred Maintenance
Priority: 3 - Necessary/Not Yet Critical (Years 2-5)
Correction: Renew System
Qty: 80,770.00
Unit of Measure: S.F.
Estimate: \$21,323.00
Assessor Name: Ann Buerger Linden
Date Created: 12/13/2016

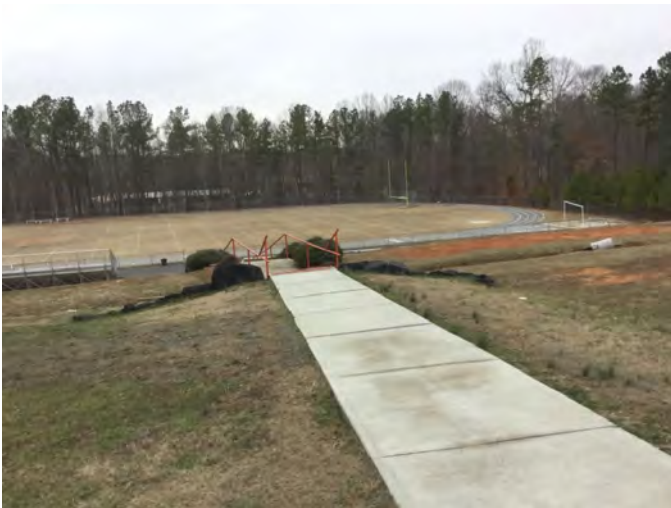
System: G2040950 - Football Field

Location: Site
Distress: Beyond Service Life
Category: Deferred Maintenance
Priority: 3 - Necessary/Not Yet Critical (Years 2-5)
Correction: Renew System
Qty: 80,770.00
Unit of Measure: S.F.
Estimate: \$420,246.00
Assessor Name: Ann Buerger Linden
Date Created: 12/13/2016

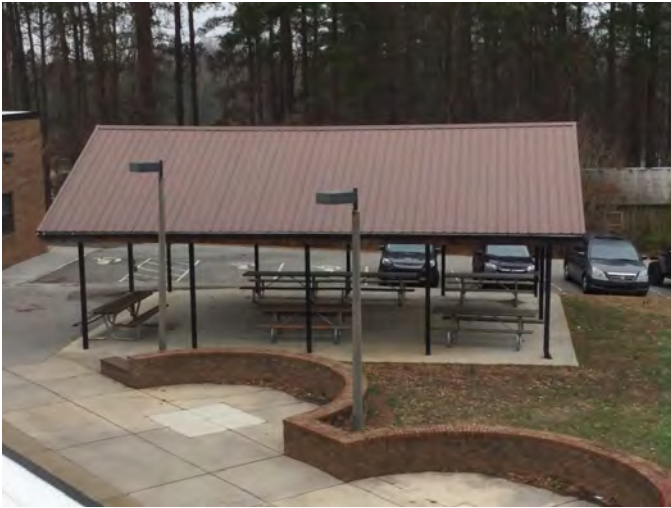
System: G4020 - Site Lighting

Location: Site
Distress: Beyond Service Life
Category: Deferred Maintenance
Priority: 3 - Necessary/Not Yet Critical (Years 2-5)
Correction: Renew System
Qty: 80,770.00
Unit of Measure: S.F.
Estimate: \$135,047.00
Assessor Name: Ann Buerger Linden
Date Created: 12/13/2016

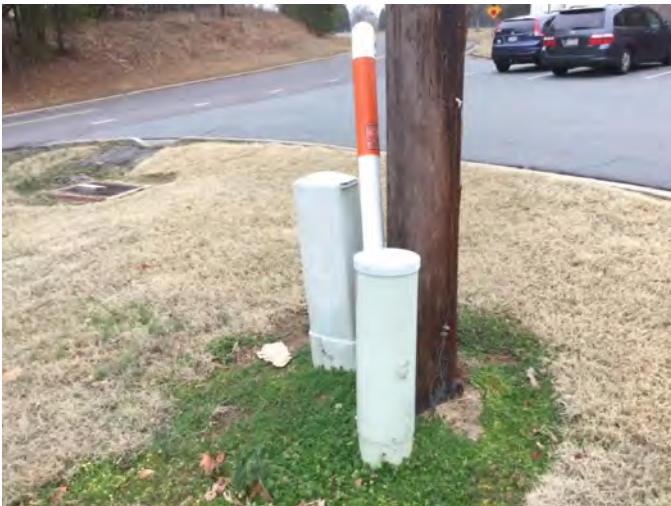
System: G4030 - Site Communications & Security

Location: Site
Distress: Beyond Service Life
Category: Deferred Maintenance
Priority: 3 - Necessary/Not Yet Critical (Years 2-5)
Correction: Renew System
Qty: 80,770.00
Unit of Measure: S.F.
Estimate: \$78,185.00
Assessor Name: Ann Buerger Linden
Date Created: 12/13/2016
