NC School District/430 Harnett County/Elementary School

South Harnett Elementary

Campus Assessment Report

March 11, 2017

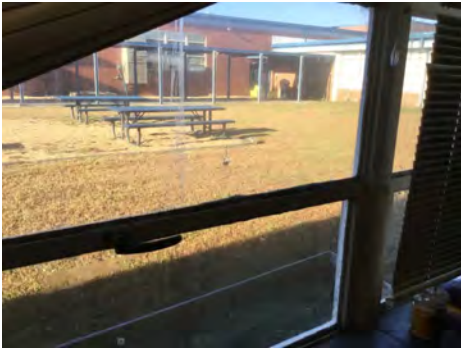
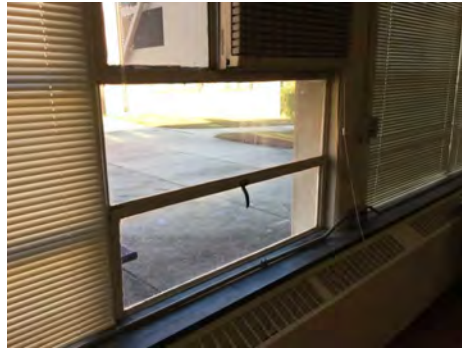
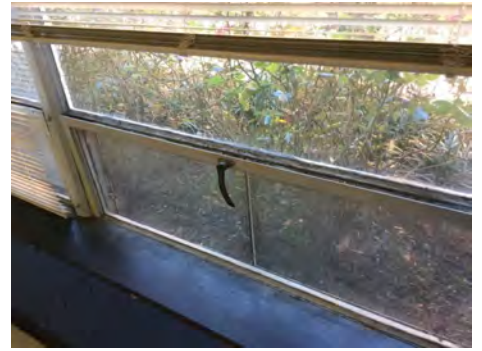
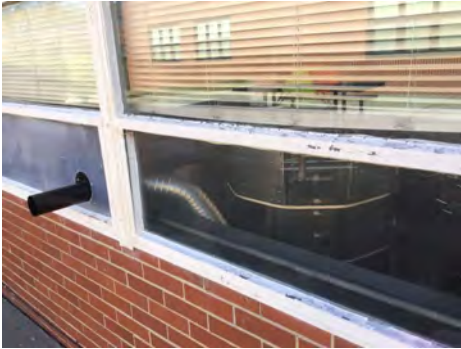
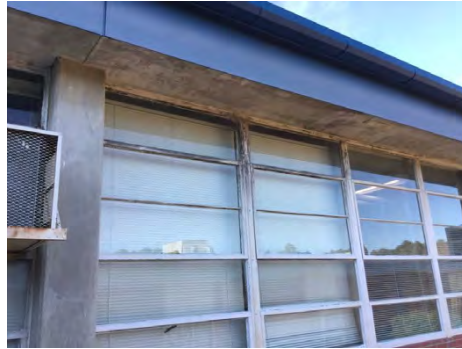
System: B2020 - Exterior Windows

Notes: The steel frame, operable, single pane windows are aged, rusted, not energy efficient, and should be replaced.

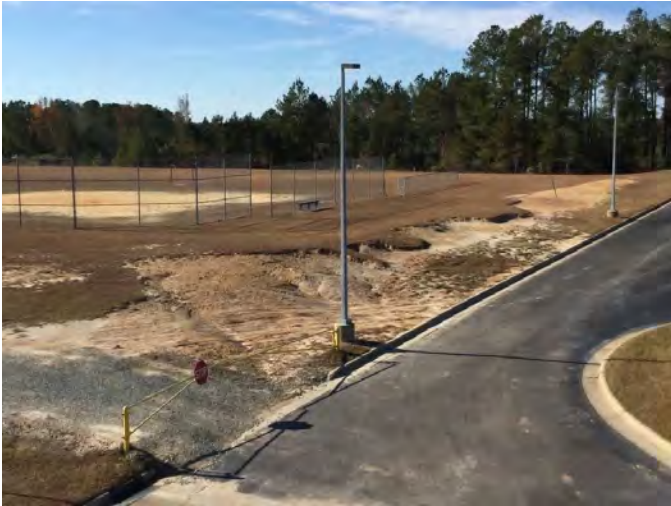
System: G4020 - Site Lighting

Location: Throughout
Distress: Beyond Service Life
Category: Deferred Maintenance
Priority: 3 - Necessary/Not Yet Critical (Years 2-5)
Correction: Renew System
Qty: 75,757.00
Unit of Measure: S.F.
Estimate: \$122,499.00
Assessor Name: Matt Mahaffey
Date Created: 12/09/2016

Notes: Site lighting is not adequate for the site and parking areas and should be upgraded.
