NC School District/430 Harnett County/High School

Star Academy

Campus Assessment Report

March 11, 2017

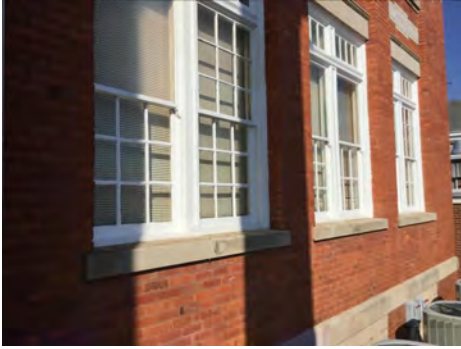
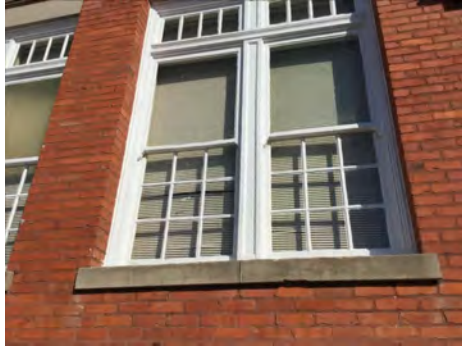
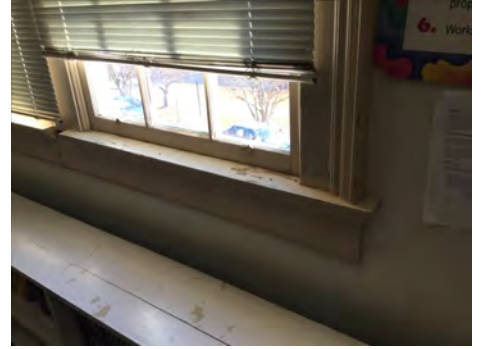
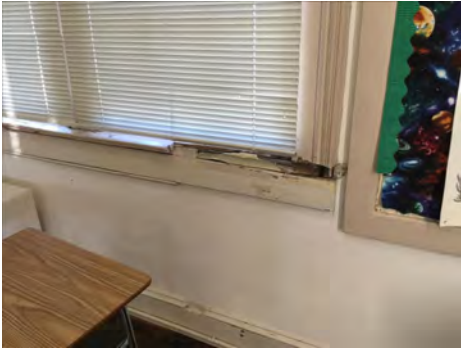
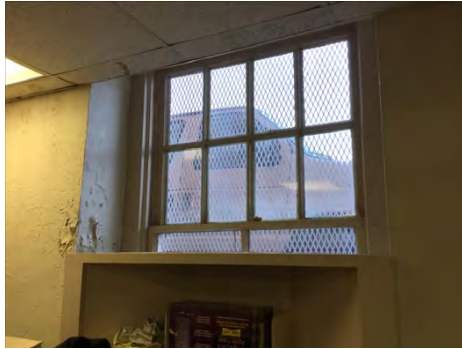
System: B2020 - Exterior Windows

Notes: The wood frame, operable, single pane windows are aged, damaged, not energy efficient, and should be replaced.

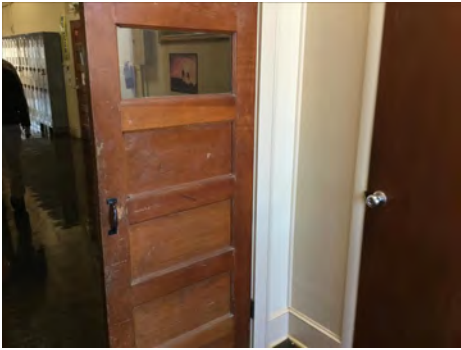
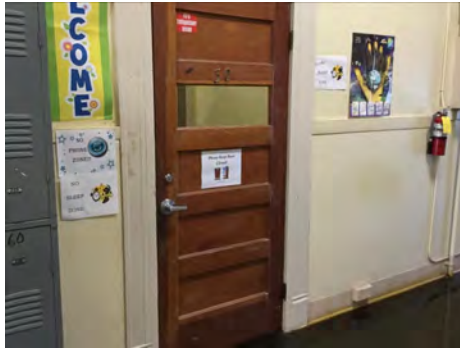
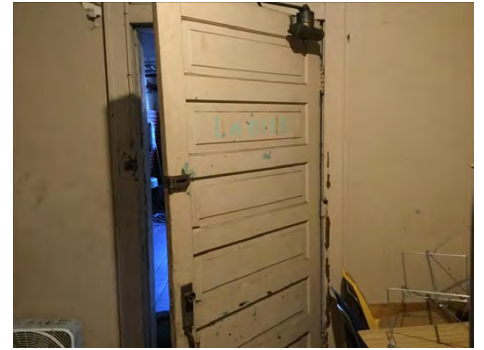
System: C1020 - Interior Doors

Notes: The interior doors are aged, failing, hardware is not ADA compliant and should be replaced.

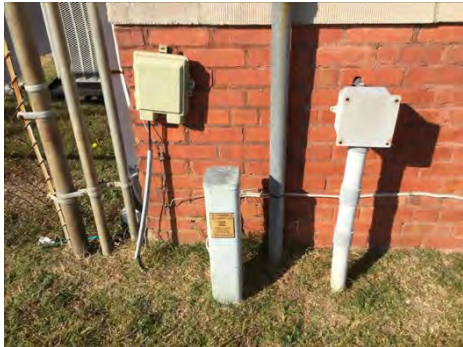
System: G4030 - Site Communications & Security

Location: Site
Distress: Inadequate
Category: Safety
Priority: 1 - Currently Critical (Immediate)
Correction: Renew System
Qty: 37,309.00
Unit of Measure: S.F.
Estimate: \$36,115.00
Assessor Name: Matt Mahaffey
Date Created: 11/22/2016

Notes: Site security system is missing and should be integrated into main building system.
