NC School District/520 Jones County/Elementary School

Trenton Elementary

Campus Assessment Report

March 11, 2017

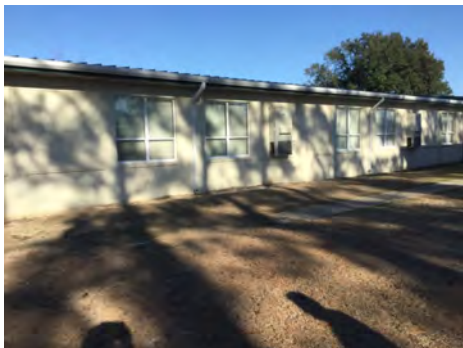
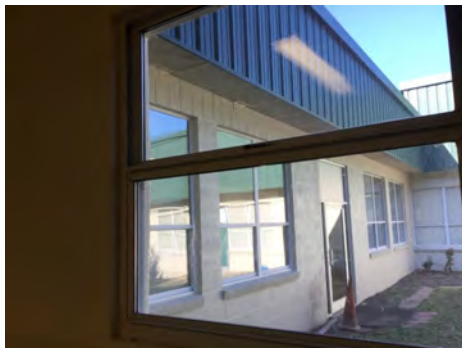
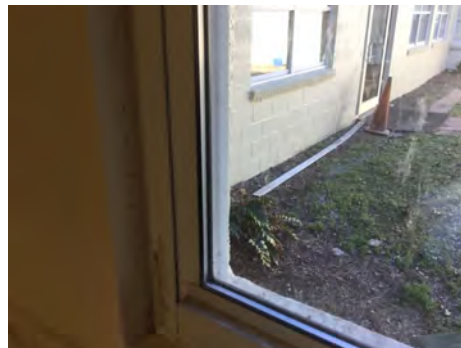
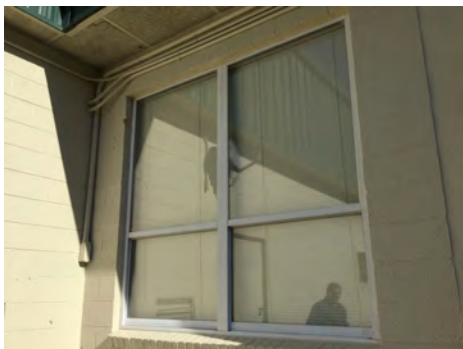
System: B2020 - Exterior Windows

Note: Assumed install date with installation of Bard HVAC units.

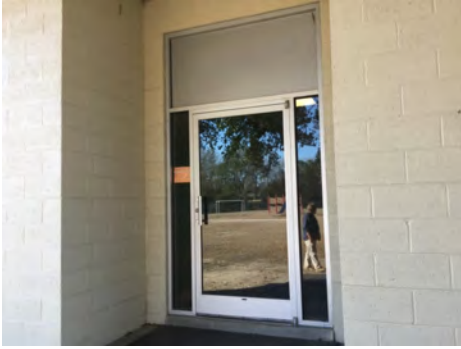
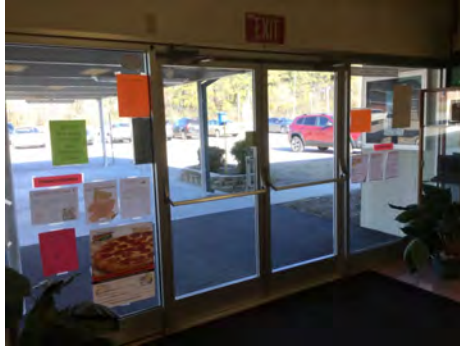
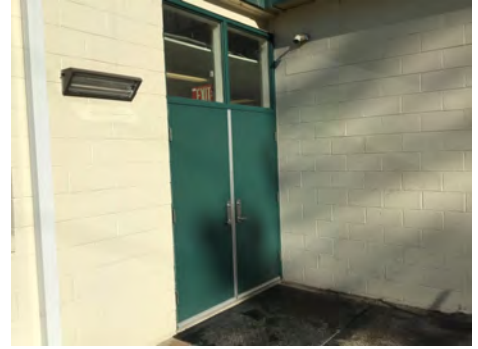
System: B2030 - Exterior Doors

Notes: Exterior doors are generally in fair condition and beyond their expected useful life. Direct exit doors at classrooms have reverse swing. System renewal is recommended.

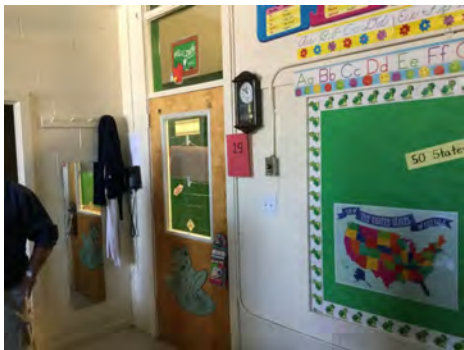
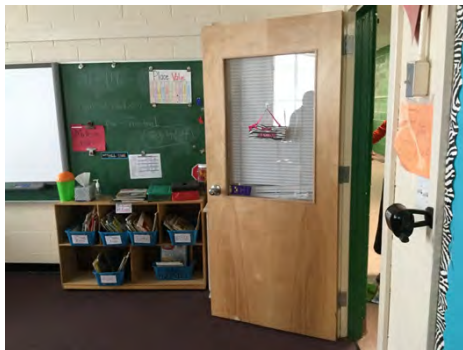
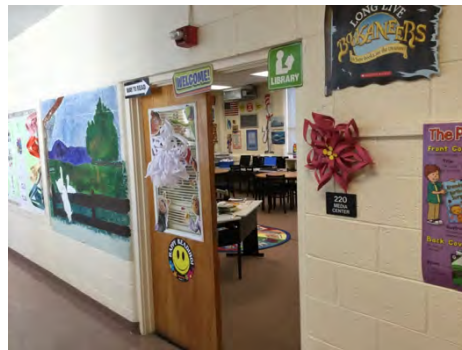
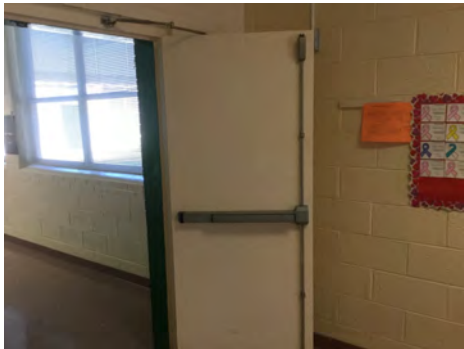
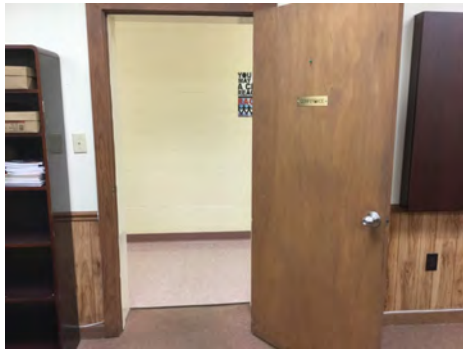
System: C1020 - Interior Doors

Notes: Interior doors are in aged condition and do not have ADA compliant hardware. System renewal is recommended.

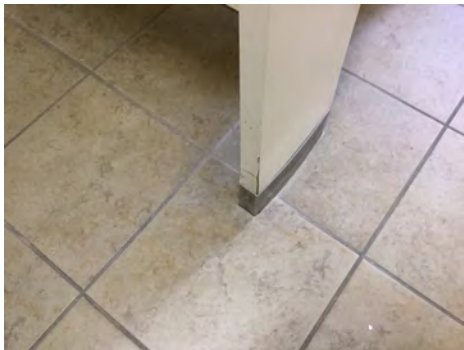
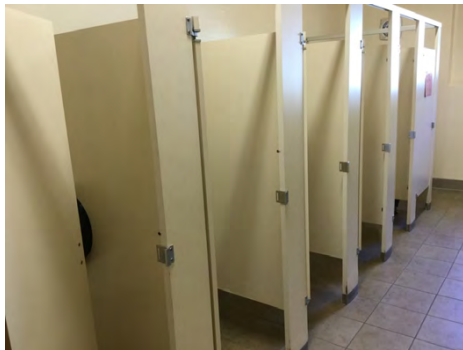
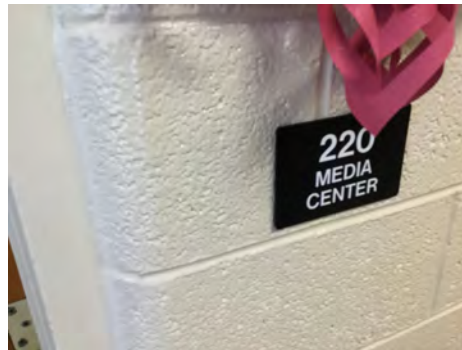
System: C1030 - Fittings

Notes: Fittings are generally beyond their expected useful life. Signage is not up to current codes. Toilet partitions are deteriorating.

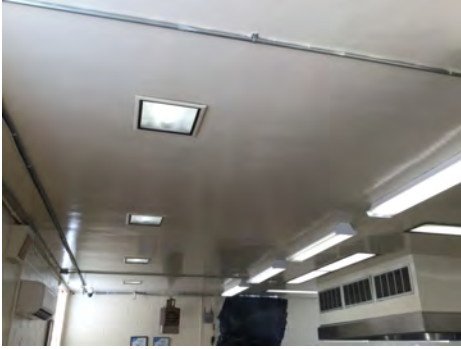
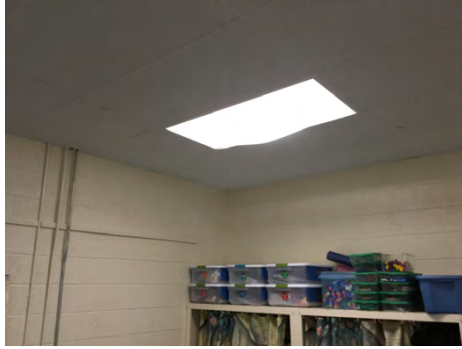
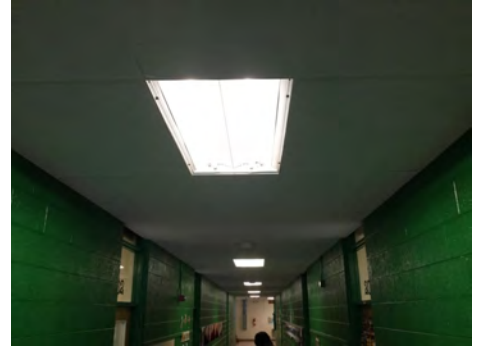
System: D5020 - Lighting

Notes: A lighting upgrade in 2011 replaced ballasts and lamps, but did not typically replace fixtures and the system is now considered expired with renewal recommended.

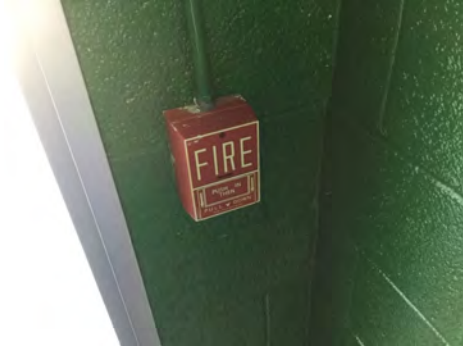
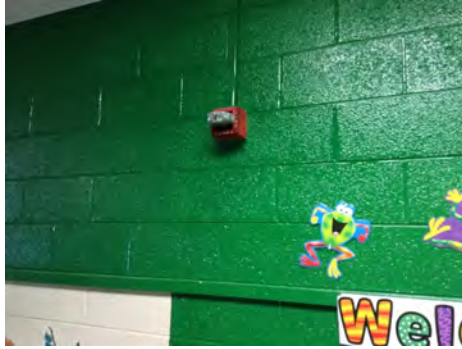
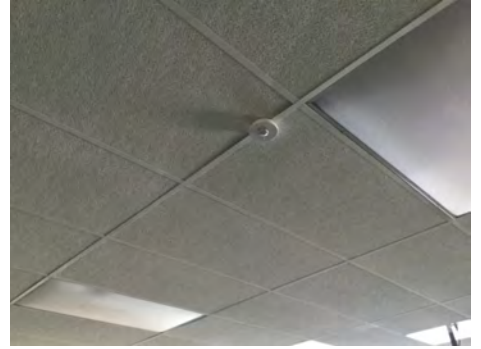
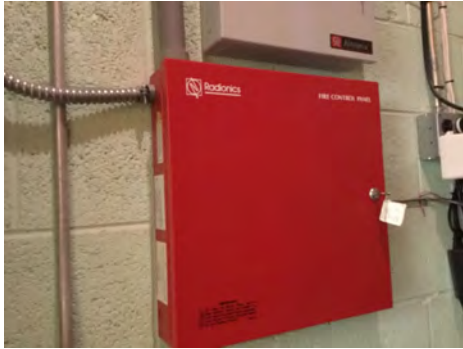
System: D5030910 - Fire Alarm Systems

Notes: The fire alarm system is of an unknown date, however is assumed to be beyond its expected life. Strobes and annunciators not seen in restrooms. System renewal is recommended.

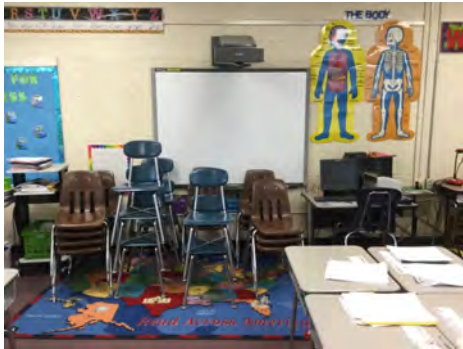
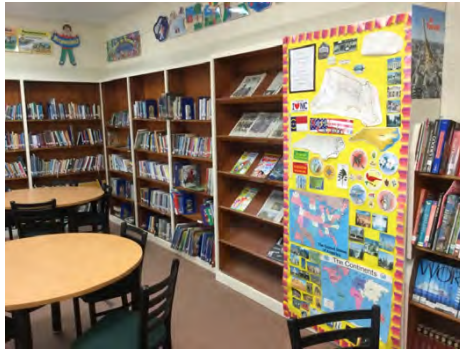
System: E1020 - Institutional Equipment

Notes: Institutional equipment is generally beyond its expected life. System renewal is recommended.

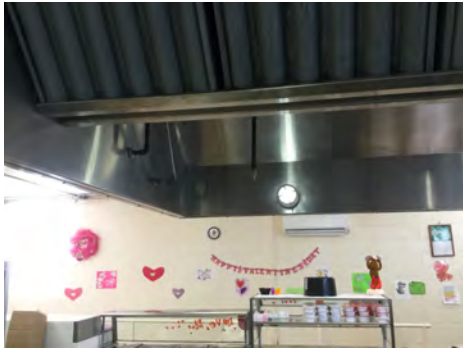
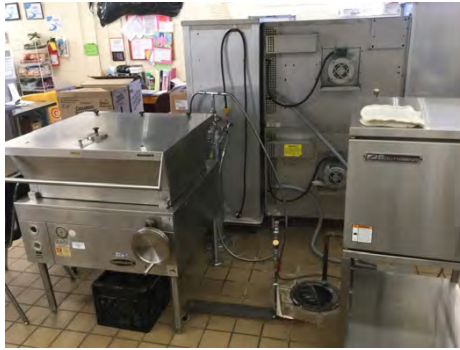
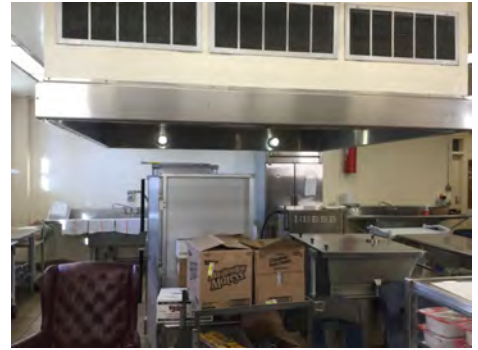
System: E1090 - Other Equipment

Notes: Kitchen equipment is generally well beyond its expected service life and should be replaced.

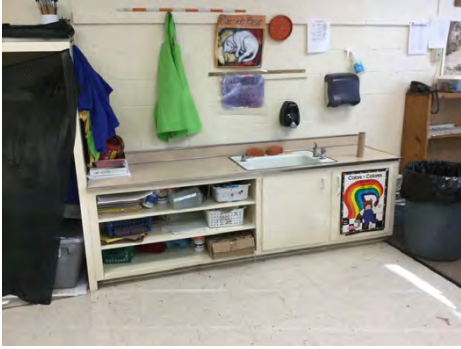
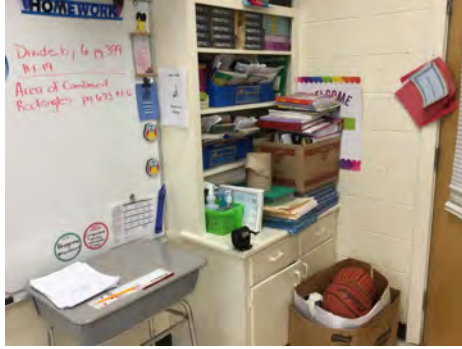
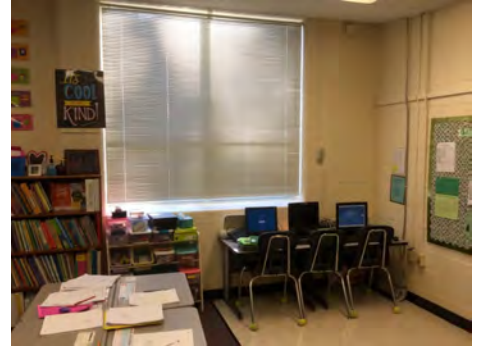
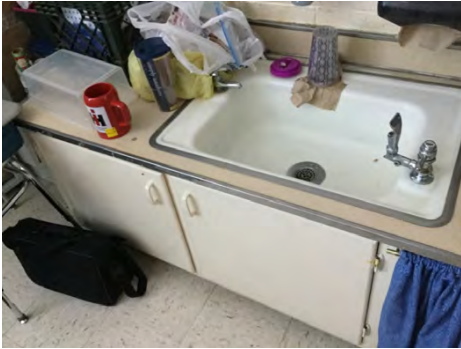
System: E2010 - Fixed Furnishings

Notes: Fixed furnishings are beyond their expected life and are in poor condition. System renewal is recommended.

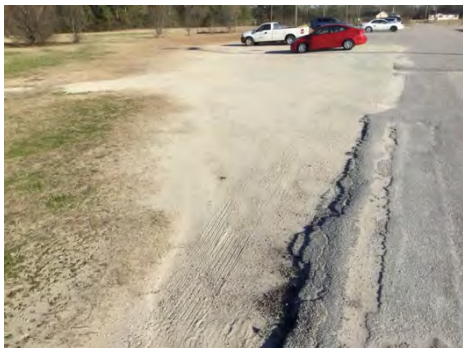
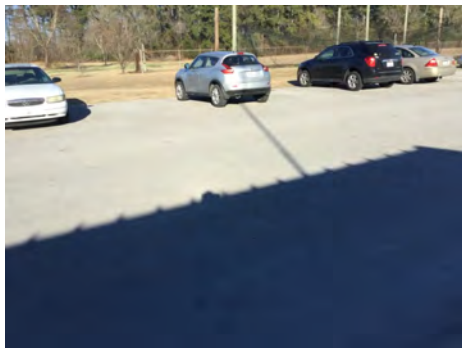
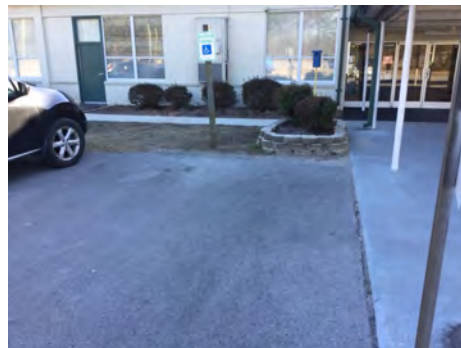
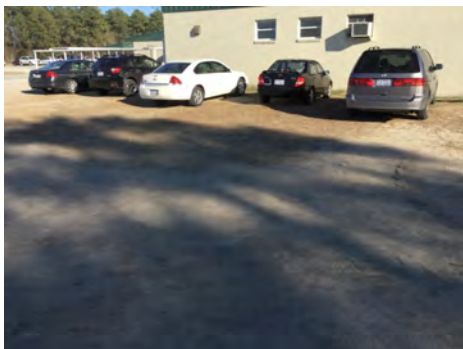
System: G2020 - Parking Lots

Notes: Parking lots are in fair condition with grainy surface. There are no curbs. There are insufficient paved spaces to accommodate daily needs Striping is faded or not present. ADA parking is inadequate. Fire lane designation is inadequate. System renewal is recommended.

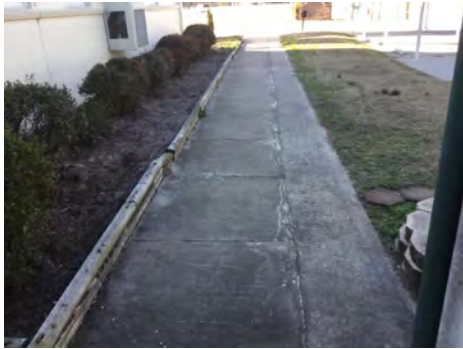
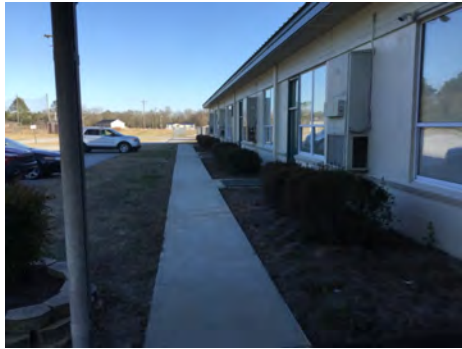
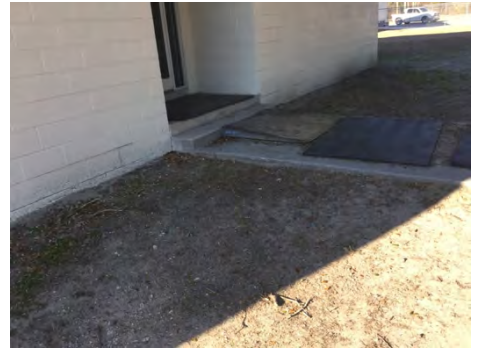
System: G2030 - Pedestrian Paving

Notes: Site sidewalks are in fair condition with some cracking and worn surfaces. The approach to the southeast exit used to access playgrounds is not accessible. System renewal is recommended.

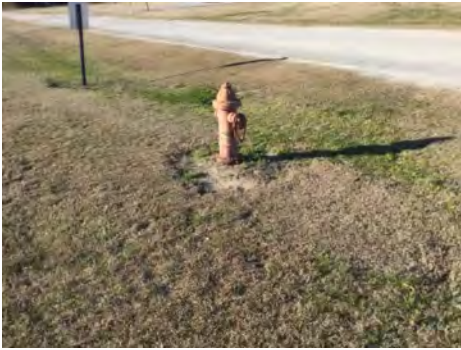
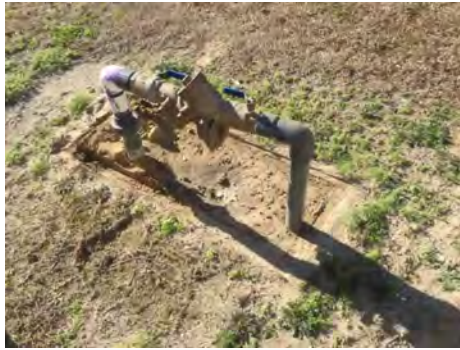
System: G3010 - Water Supply

Note: Assumed new lines installed with kitchen addition in 1970. There is a backflow preventer on site.

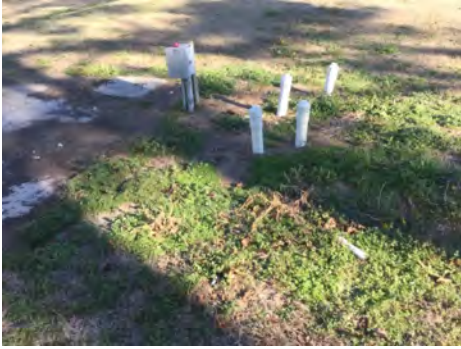
System: G3020 - Sanitary Sewer

Note: Septic system. Engineered system. Lines added 1990.

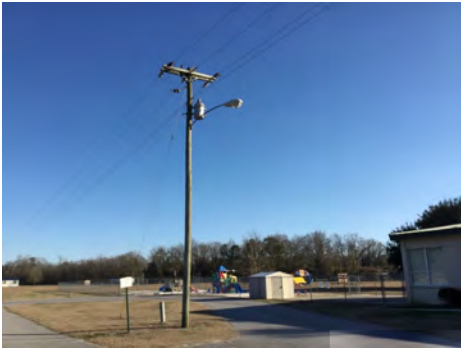
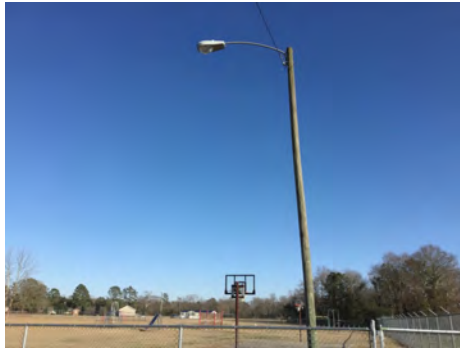
System: G4020 - Site Lighting

Notes: Site lighting coverage is inadequate. The system is beyond its expected life. System renewal is recommended.
