NC School District/430 Harnett County/High School

Triton High

Campus Assessment Report

March 11, 2017

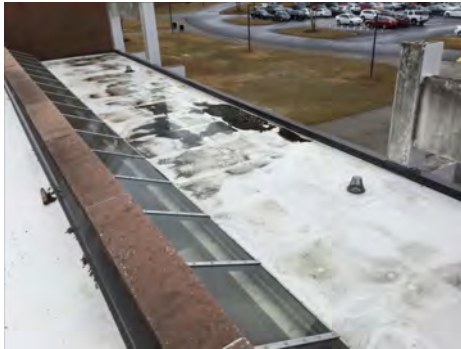
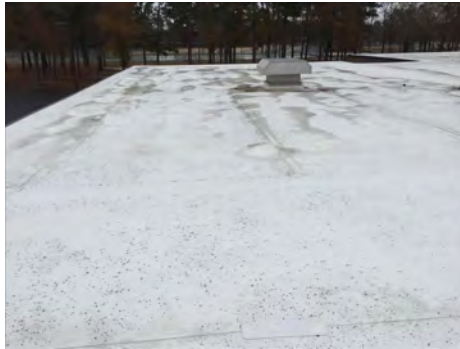
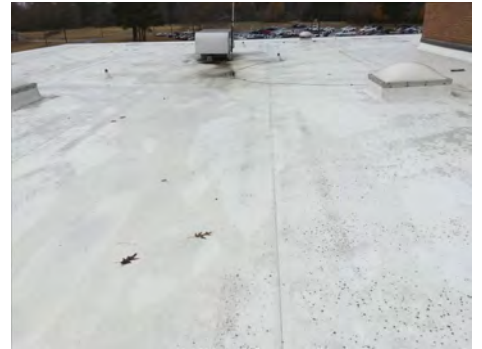
System: B3010120 - Single Ply Membrane

Note: Standing water issues, roof is not properly graded.

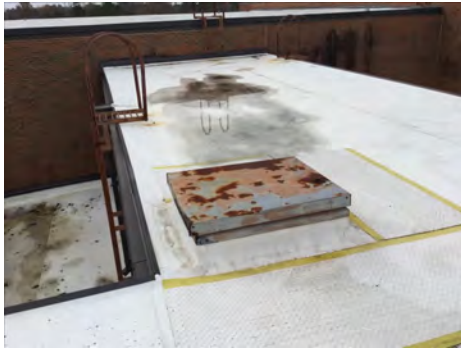
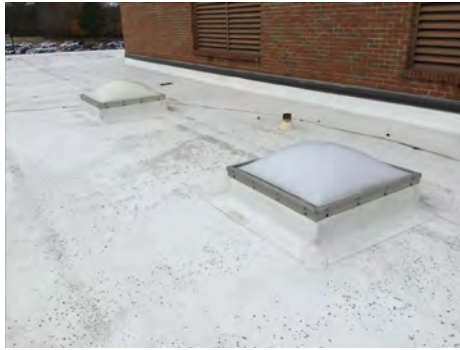
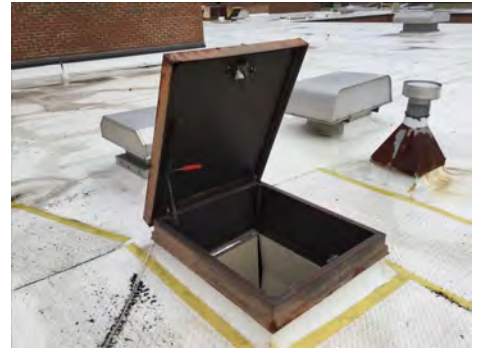
System: B3020 - Roof Openings

Note: The roof hatches are beyond their service life and need to be replaced. 3

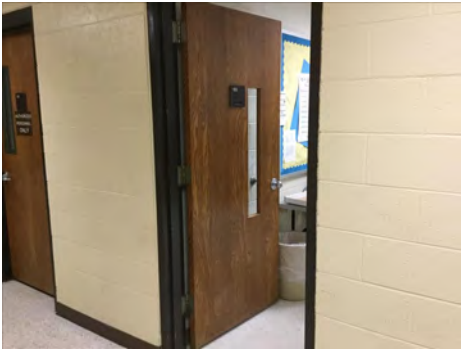
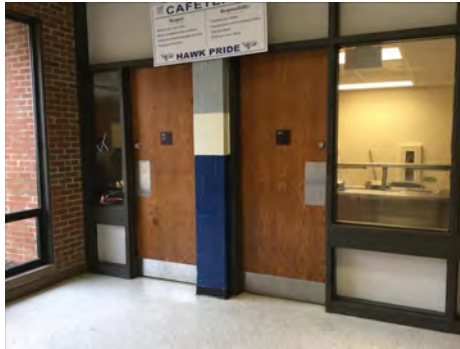
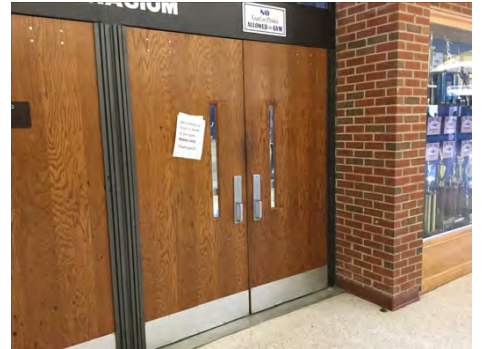
System: C1020 - Interior Doors

Note: The interior doors are beyond their service life and should be replaced.

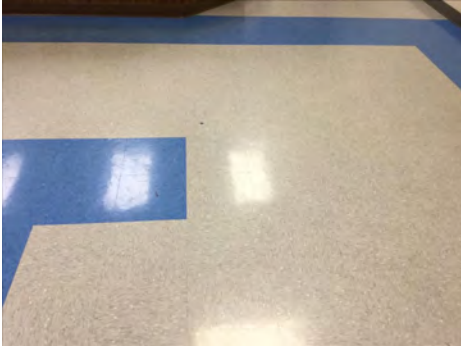
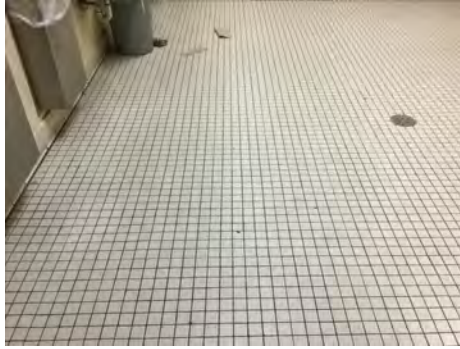
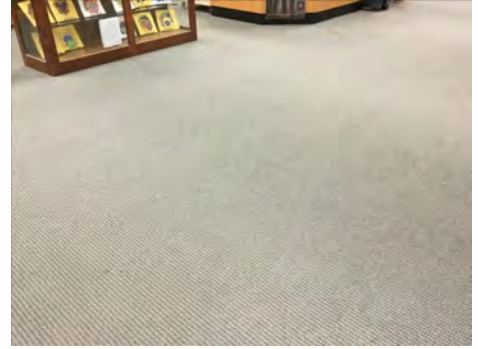
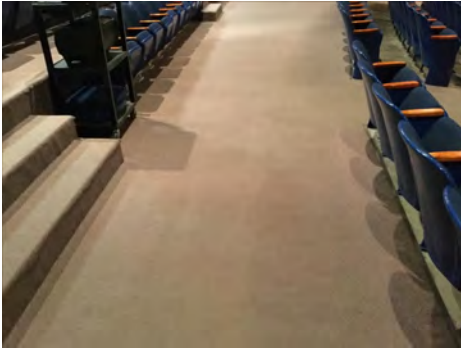
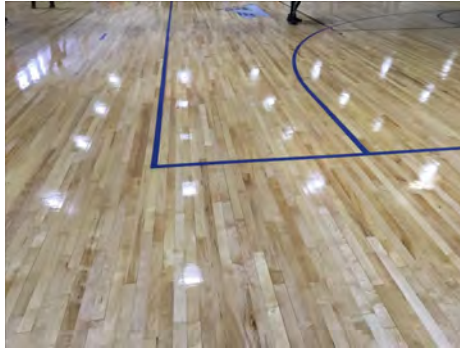
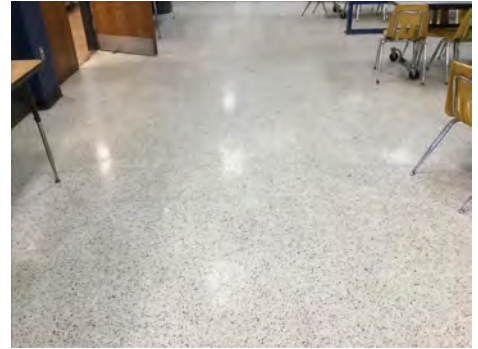
System: C3020 - Floor Finishes

Note: The carpet is beyond its service life and should be replaced.

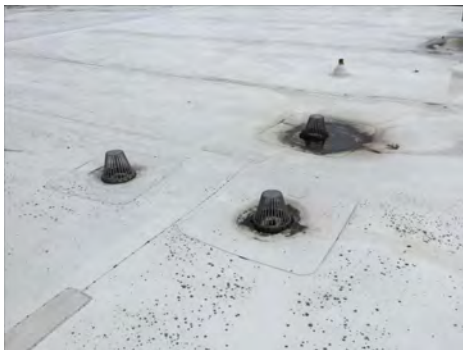
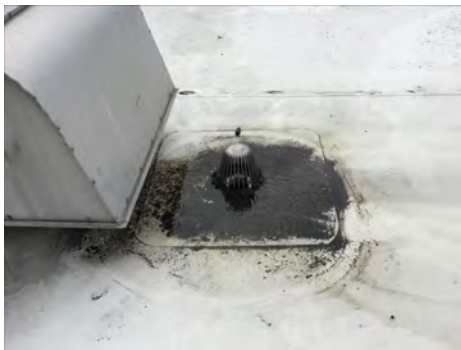
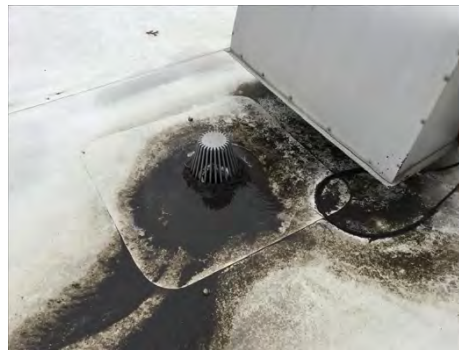
System: D2040 - Rain Water Drainage

Note: The rain water drainage system is beyond its service life and should be replaced.

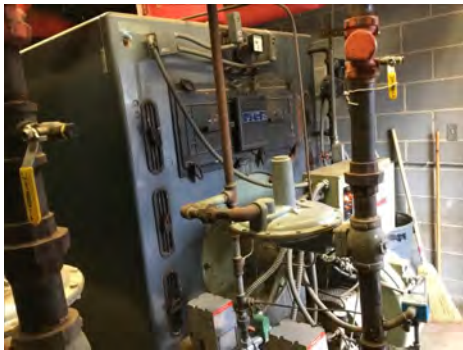
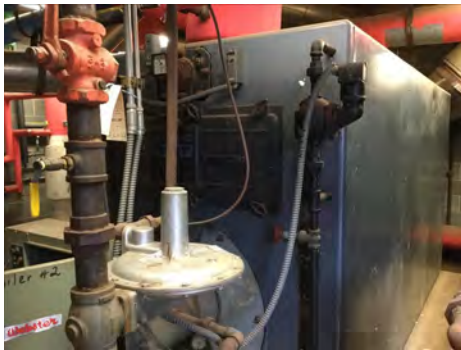
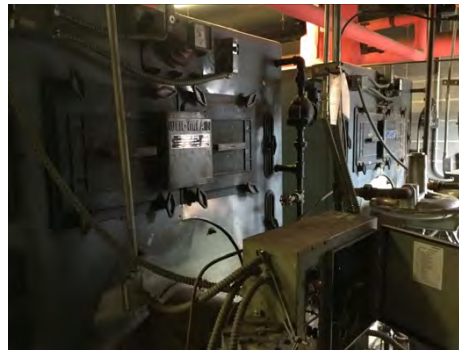
System: D3020 - Heat Generating Systems

Note: The natural gas boilers are beyond their service life and should be replaced.

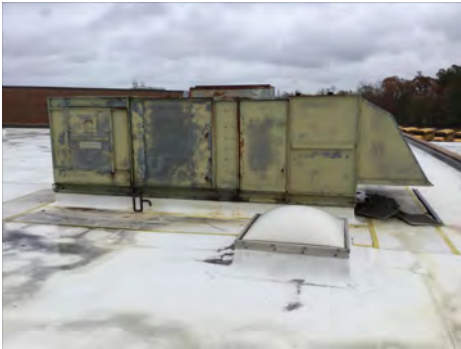
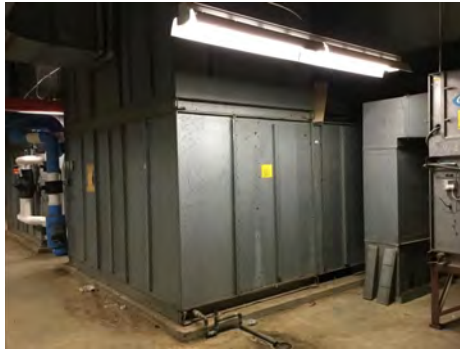
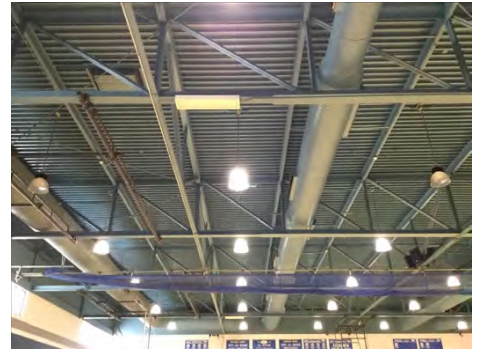
System: D3040 - Distribution Systems

Note: The rooftop units are beyond their service life and should be replaced.

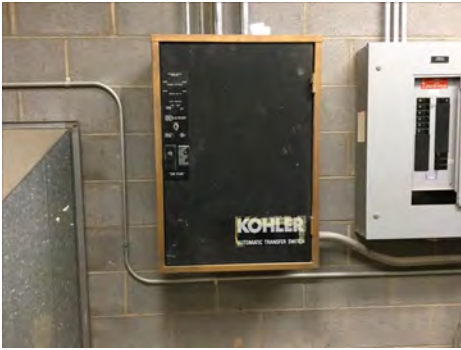
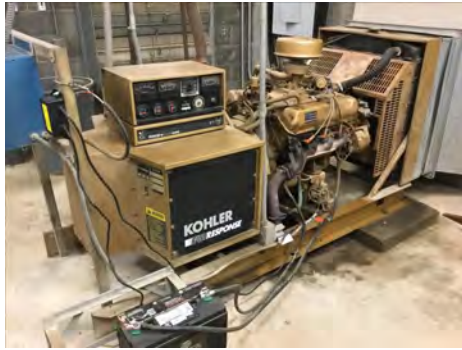
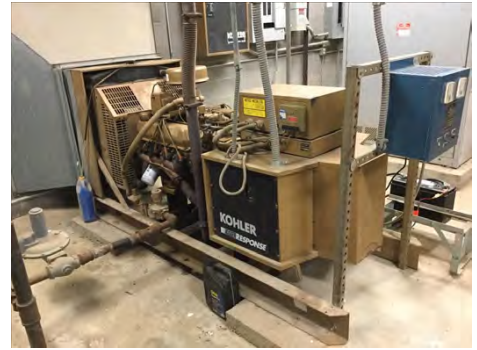
System: D5090 - Other Electrical Systems

Note: The generator system is beyond its service life and should be replaced.

Notes: The generator system is beyond its service life and should be replaced.

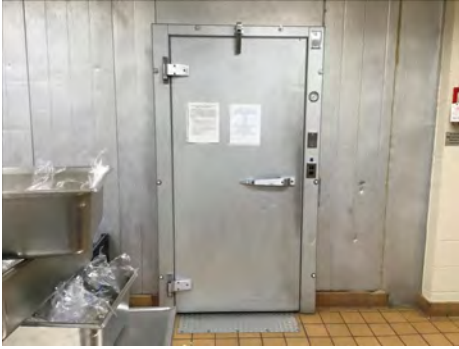
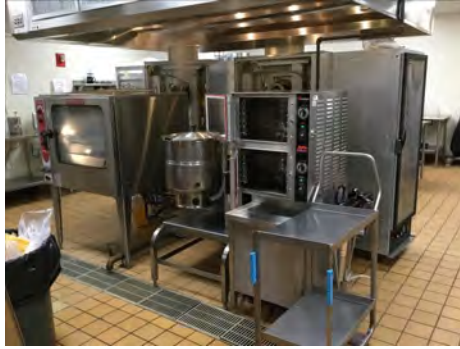
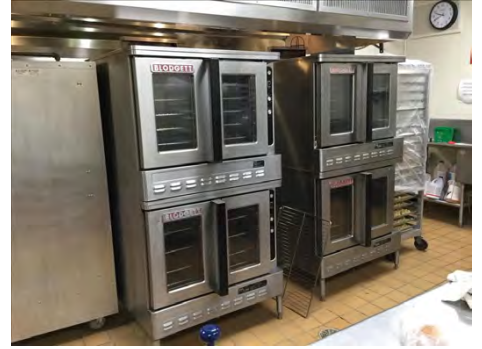
System: E1090 - Other Equipment

Note: The kitchen equipment is beyond its service life and should be replaced.

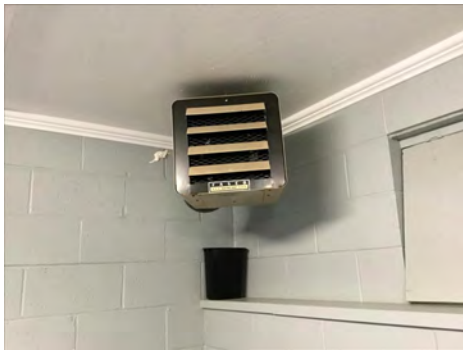
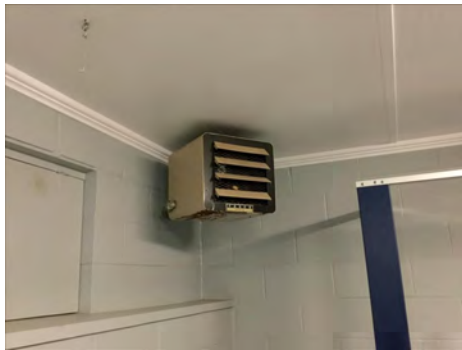
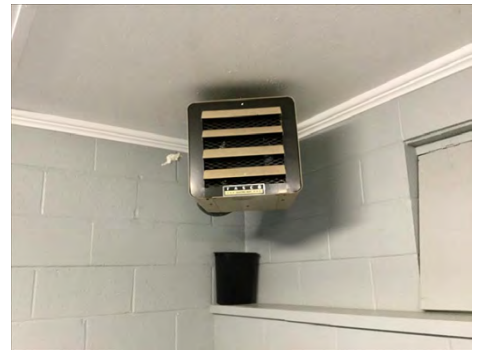
System: D3050 - Terminal & Package Units

Notes: The unit heaters are beyond their service life and should be replaced.

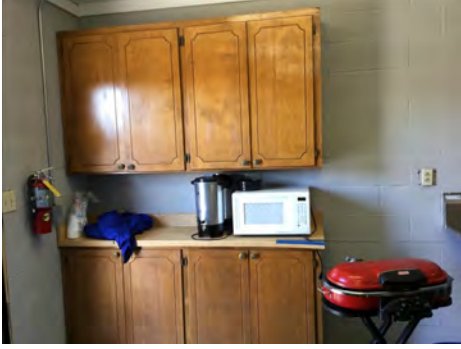
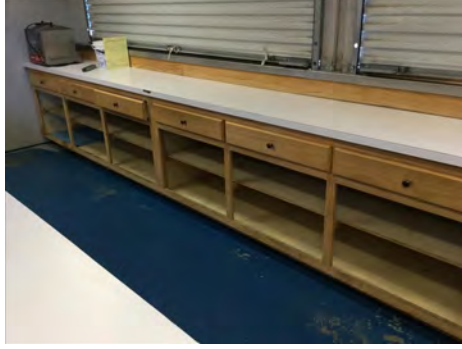
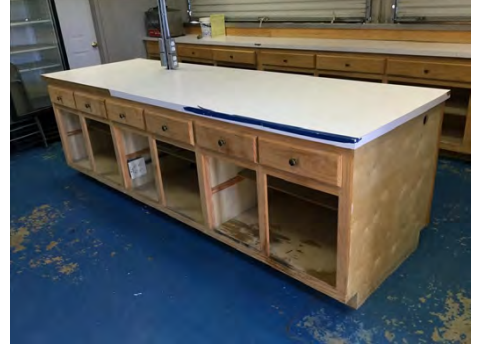
System: E2010 - Fixed Furnishings

Notes: The fixed furnishings are beyond their service life and should be replaced.

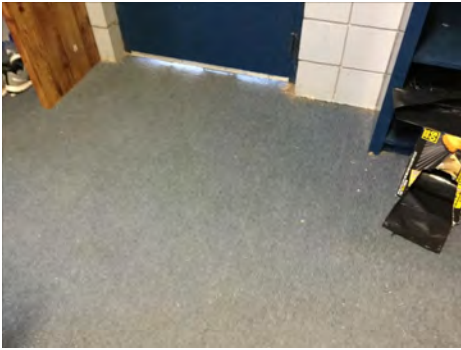
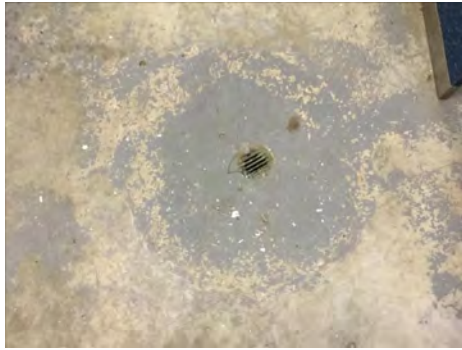
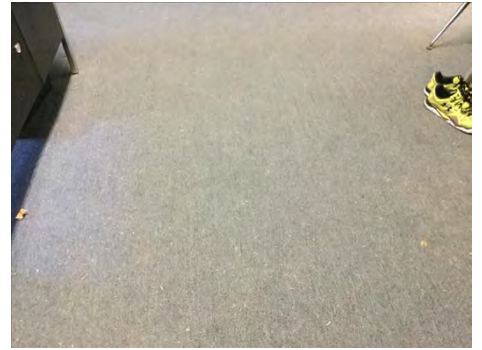
System: C3020 - Floor Finishes

Note: The epoxy and carpet are in poor condition and should be replaced.

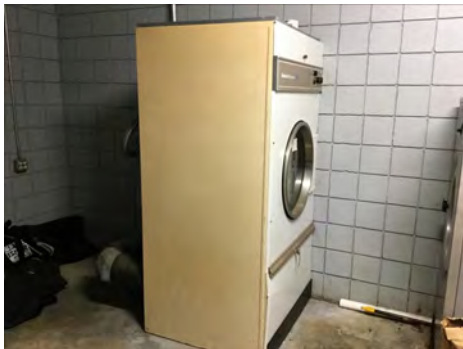
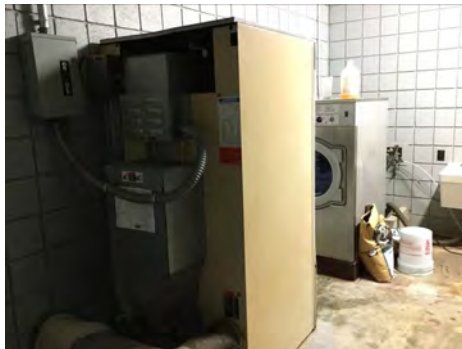
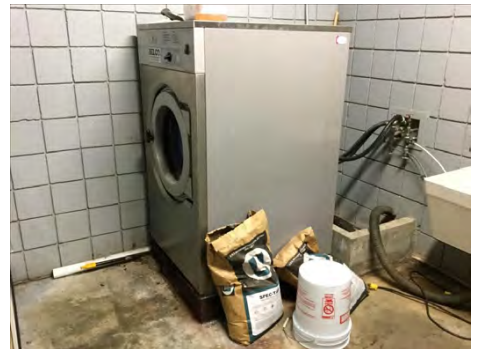
System: E1010 - Commercial Equipment

Note: The commercial equipment is beyond its service life and should be replaced.

Notes: The commercial equipment is beyond its service life and should be replaced.

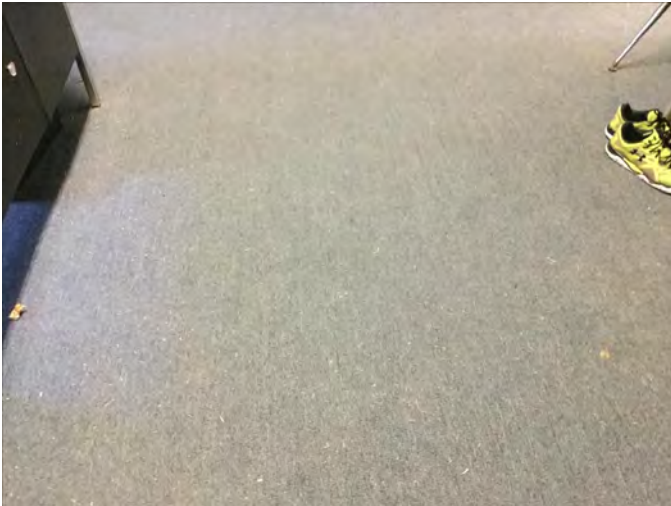
System: C3020 - Floor Finishes

Location: Throughout Building
Distress: Beyond Service Life
Category: Deferred Maintenance
Priority: 3 - Necessary/Not Yet Critical (Years 2-5)
Correction: Renew System
Qty: 3,200.00
Unit of Measure: S.F.
Estimate: \$73,286.00
Assessor Name: Somnath Das
Date Created: 11/30/2016

Notes: The epoxy and carpet are in poor condition and should be replaced.

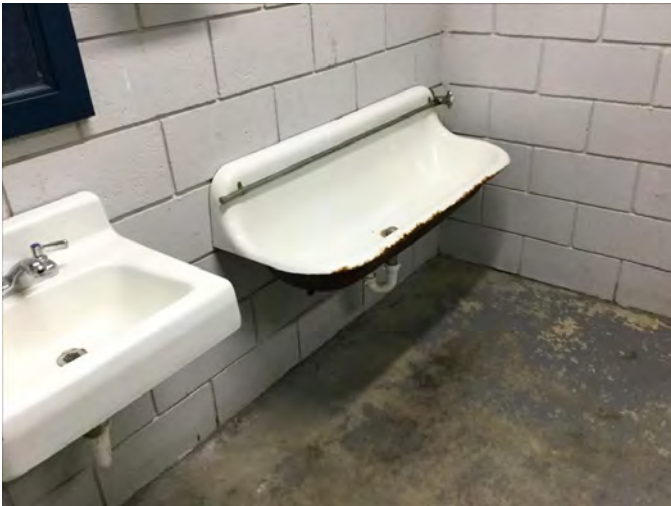
System: D2010 - Plumbing Fixtures

Location: Throughout Building
Distress: Beyond Service Life
Category: Deferred Maintenance
Priority: 3 - Necessary/Not Yet Critical (Years 2-5)
Correction: Renew System
Qty: 3,200.00
Unit of Measure: S.F.
Estimate: \$35,130.00
Assessor Name: Somnath Das
Date Created: 12/06/2016

Notes: The plumbing fixtures are beyond their service life and should be replaced.

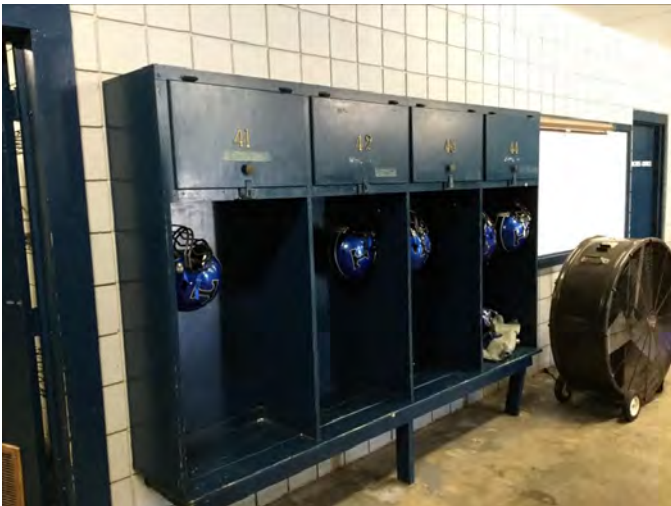
System: E2010 - Fixed Furnishings

Location: Throughout Building
Distress: Beyond Service Life
Category: Deferred Maintenance
Priority: 3 - Necessary/Not Yet Critical (Years 2-5)
Correction: Renew System
Qty: 3,200.00
Unit of Measure: S.F.
Estimate: \$17,882.00
Assessor Name: Somnath Das
Date Created: 12/06/2016

Notes: The fixed furnishings are beyond their service life and should be replaced.

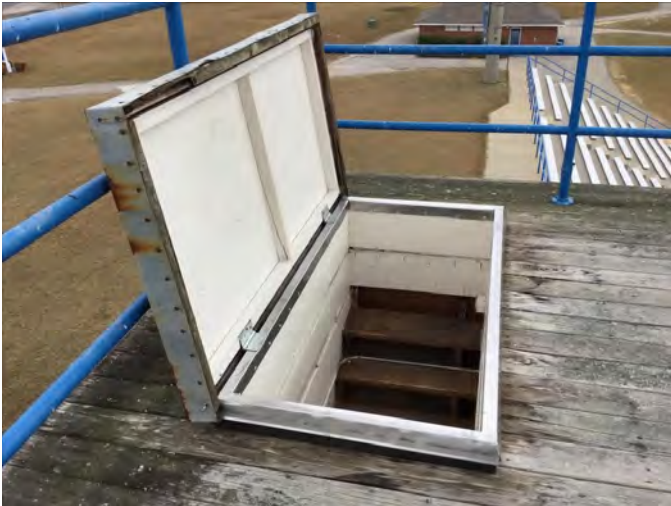
System: B3020 - Roof Openings

Location: Roof
Distress: Beyond Service Life
Category: Safety / Building Code Compliance
Priority: 3 - Necessary/Not Yet Critical (Years 2-5)
Correction: Renew System
Qty: 250.00
Unit of Measure: S.F.
Estimate: \$1,724.00
Assessor Name: Eduardo Lopez
Date Created: 12/06/2016

Notes: The roof hatch is beyond its service life and should be replaced with a OSHA complaint roof hatch.

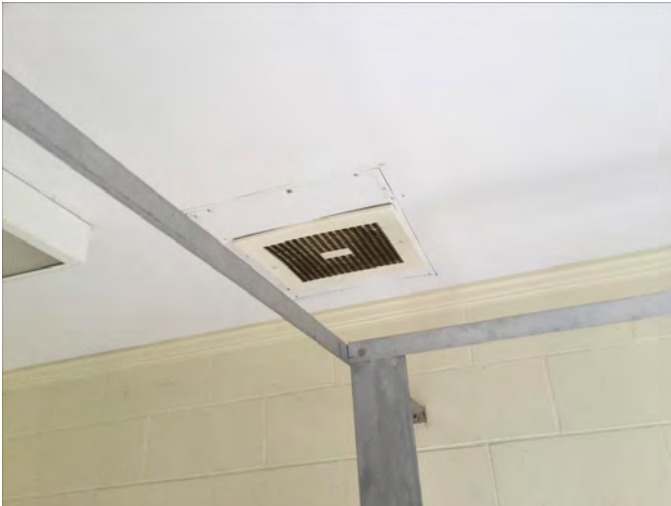
System: D3040 - Distribution Systems

Location: Throughout Building
Distress: Beyond Service Life
Category: Deferred Maintenance
Priority: 3 - Necessary/Not Yet Critical (Years 2-5)
Correction: Renew System
Qty: 550.00
Unit of Measure: S.F.
Estimate: \$3,237.00
Assessor Name: Eduardo Lopez
Date Created: 11/30/2016

Notes: The distribution systems are beyond their service life and should be replaced.

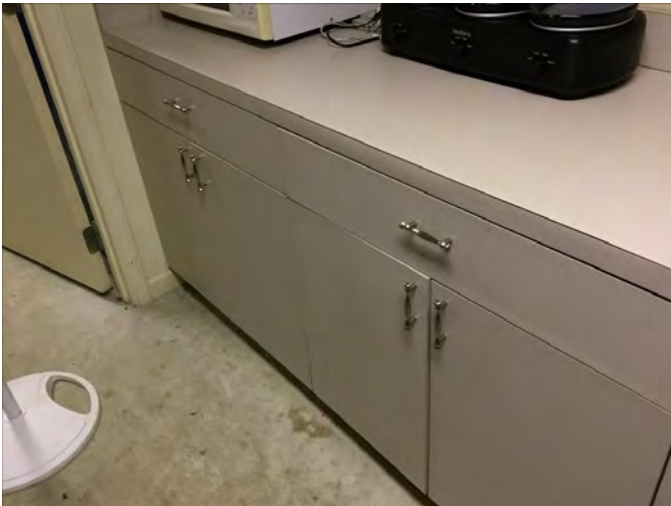
System: E2010 - Fixed Furnishings

Location: Throughout Building
Distress: Beyond Service Life
Category: Deferred Maintenance
Priority: 3 - Necessary/Not Yet Critical (Years 2-5)
Correction: Renew System
Qty: 550.00
Unit of Measure: S.F.
Estimate: \$3,073.00
Assessor Name: Eduardo Lopez
Date Created: 11/30/2016

Notes: The fixed furnishing is beyond its service life and should be replaced.

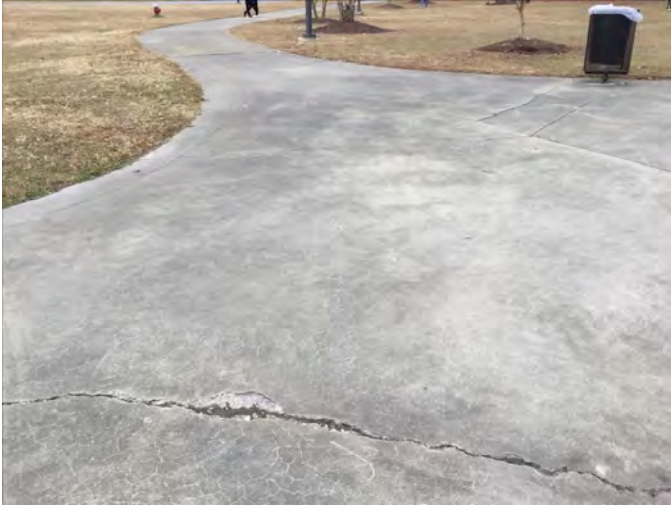
System: G2030 - Pedestrian Paving

Location: Site
Distress: Beyond Service Life
Category: Safety
Priority: 1 - Currently Critical (Immediate)
Correction: Renew System
Qty: 254,932.00
Unit of Measure: S.F.
Estimate: \$555,242.00
Assessor Name: Eduardo Lopez
Date Created: 11/30/2016

Notes: The pedestrian paving is beyond its service life and in some places they have become tripping hazards, the pedestrian paving needs to be repaved.

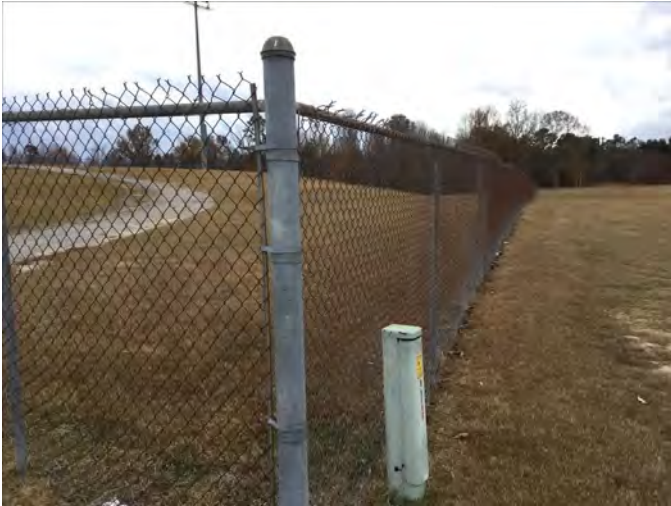
System: G2040105 - Fence & Guardrails

Location: Site
Distress: Beyond Service Life
Category: Deferred Maintenance
Priority: 3 - Necessary/Not Yet Critical (Years 2-5)
Correction: Renew System
Qty: 254,932.00
Unit of Measure: S.F.
Estimate: \$336,510.00
Assessor Name: Eduardo Lopez
Date Created: 11/30/2016

Notes: The fences and guardrails are either rusted or damaged and should be replaced.

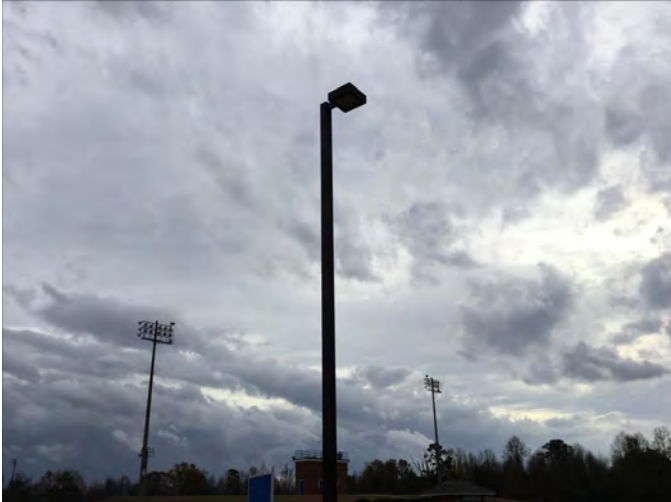
System: G4020 - Site Lighting

Location: Site
Distress: Beyond Service Life
Category: Deferred Maintenance / Energy
Priority: 3 - Necessary/Not Yet Critical (Years 2-5)
Correction: Renew System
Qty: 254,932.00
Unit of Measure: S.F.
Estimate: \$440,268.00
Assessor Name: Eduardo Lopez
Date Created: 11/30/2016

Notes: The site lighting is beyond its service life and should be replaced with energy efficient LED lighting.
