Wayne Avenue Elementary

Campus Assessment Report

March 11, 2017

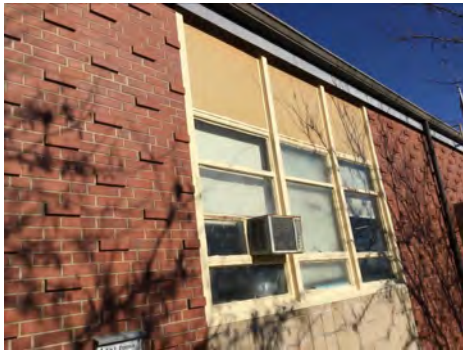
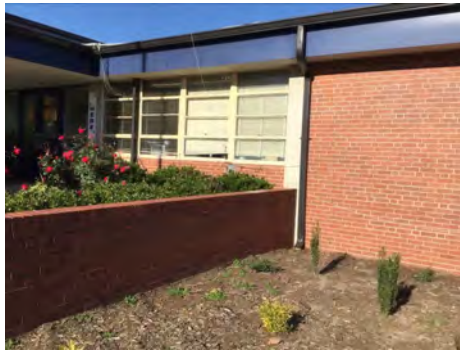
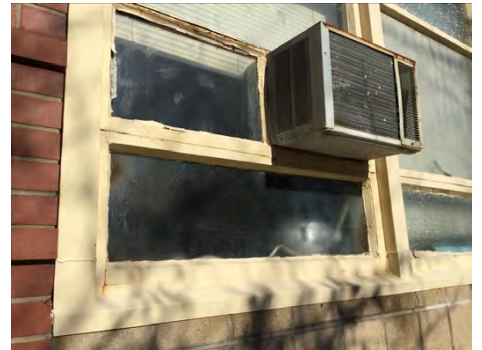
System: B2020 - Exterior Windows

Notes: The aluminum frame single pane windows are aged, rusted, not energy efficient, and should be replaced.

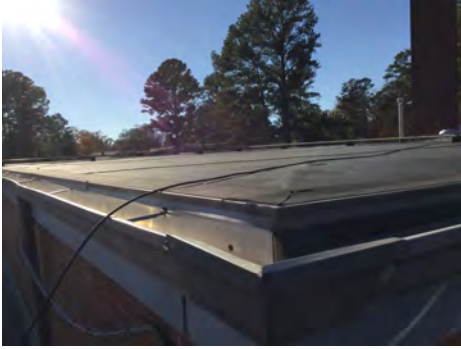
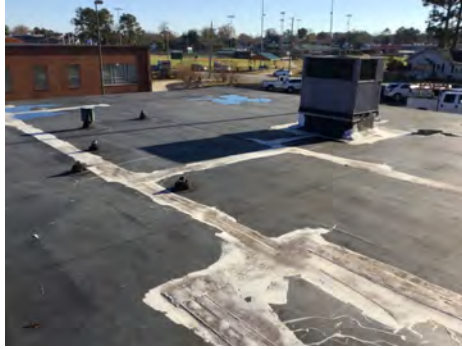
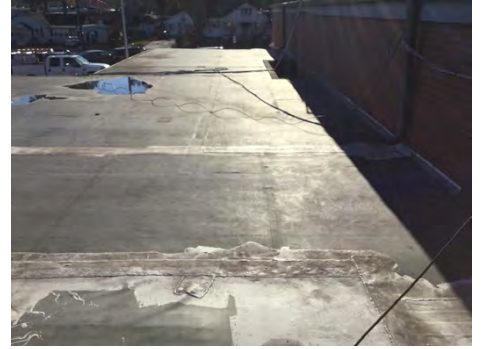
System: B3010120 - Single Ply Membrane

Location: Roof
Distress: Failing
Category: Deferred Maintenance
Priority: 3 - Necessary/Not Yet Critical (Years 2-5)
Correction: Renew System
Qty: 27,822.00
Unit of Measure: S.F.
Estimate: \$291,296.00
Assessor Name: Terence Davis
Date Created: 12/08/2016

Notes: The single ply adhered roof coverings are aging, showing signs of failure and should be replaced.

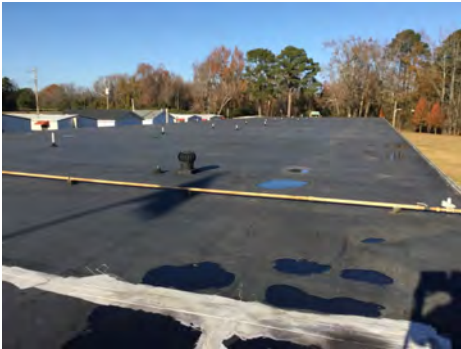
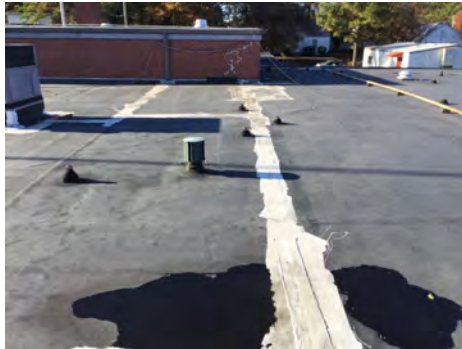
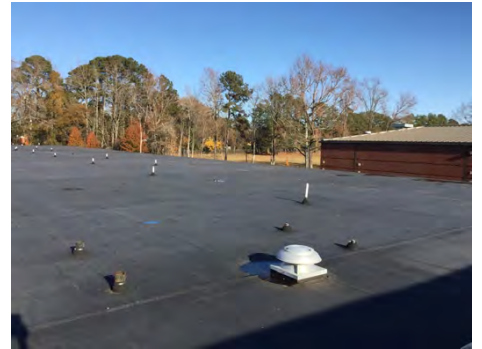
System: B3020 - Roof Openings

Notes: The roof openings should be inspected and repaired when the roof is replaced.

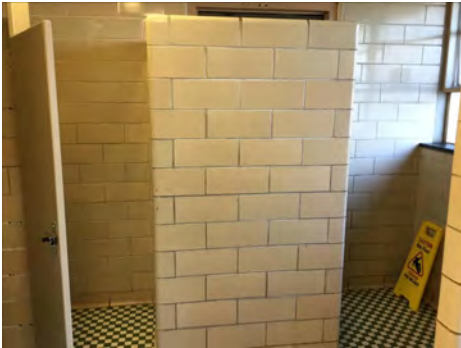
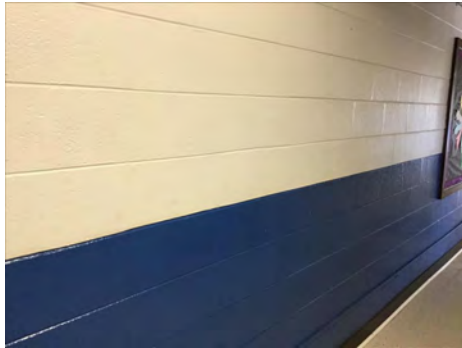
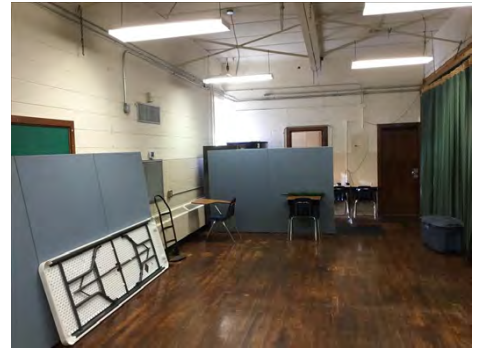
System: C3010 - Wall Finishes

Notes: The wall finishes are aged, scuffed, fading, stained, and should be re-painted.

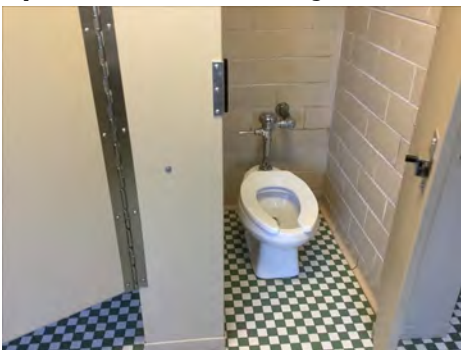
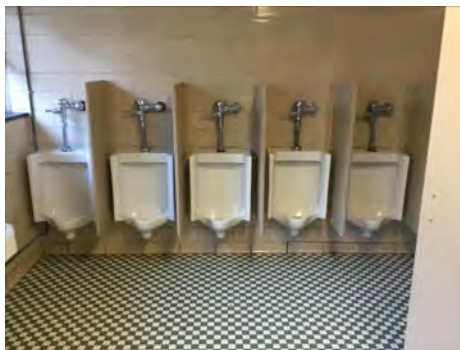
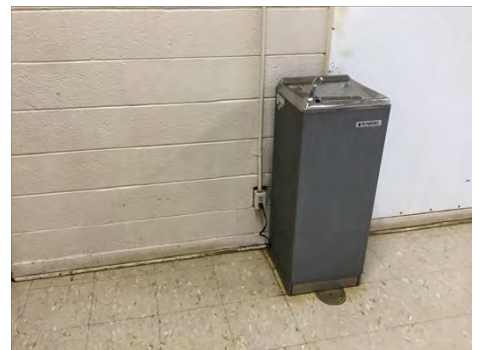
System: D2010 - Plumbing Fixtures

Notes: Plumbing fixtures are in operational conditions. However, they are aged, not ADA compliant and should be replaced with a low-flow water fixtures.

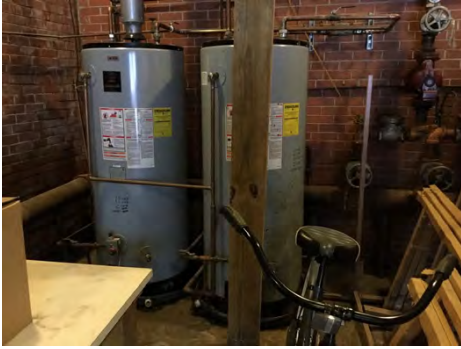
System: D2020 - Domestic Water Distribution

Notes: There are no reported issues or observed deficiencies with the domestic water piping. Due to the age of the pipe there can be internal pitting corrosion that may be a costly problem that leads to the formation of pinhole leaks and possible water contamination.

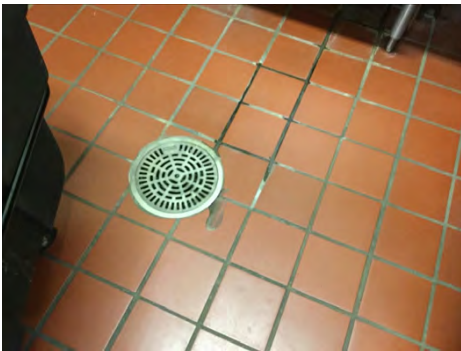
System: D2030 - Sanitary Waste

Notes: The sanitary waste system is aged and should be replaced.

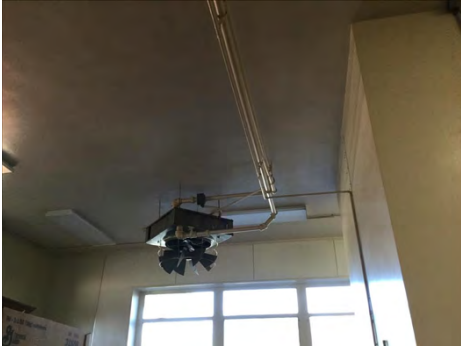
System: D3040 - Distribution Systems

Notes: The distribution system is aged, in marginal condition, and should be replaced.

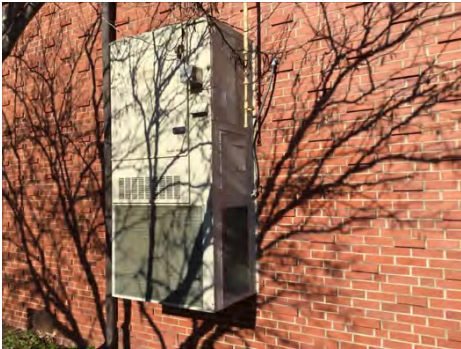
System: D3050 - Terminal & Package Units

Notes: The wall mounted Carrier DX condensing units are aged and should be scheduled for replacement.

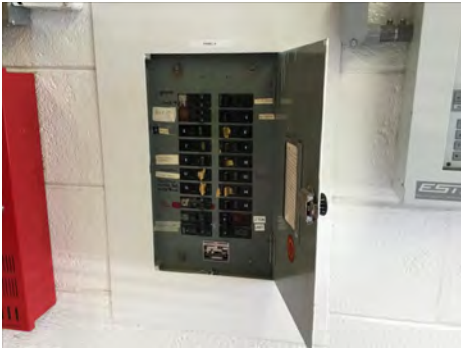
System: D5010 - Electrical Service/Distribution

Notes: The original electrical service is operating, maxed to capacity and should be replaced.

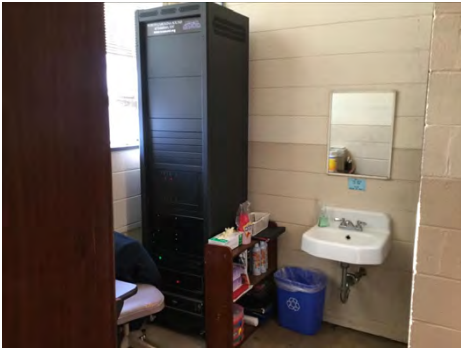
System: E1020 - Institutional Equipment

Notes: The Library Equipment, Theater Stage Equipment, Audio-visual Equipment, Other Institutional Equipment is operating but is aged, becoming logistically un-supportable, and should be replaced.

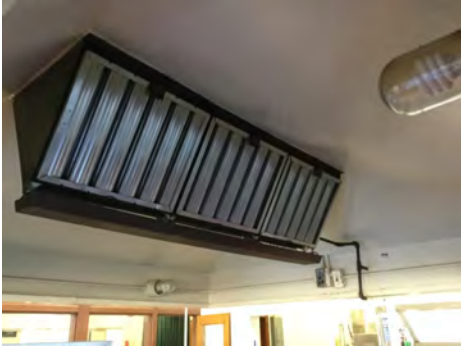
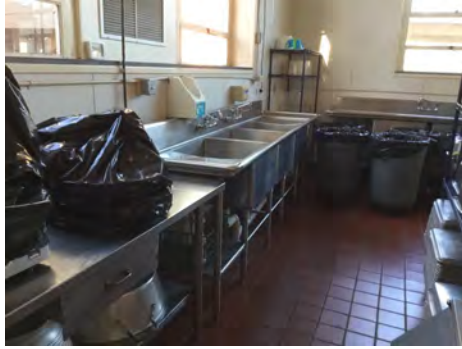
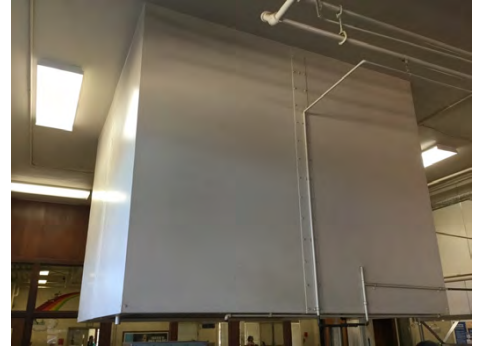
System: E1090 - Other Equipment

Notes: The Food Service Equipment is operating but is aged should be inspected and replaced or repaired as needed.

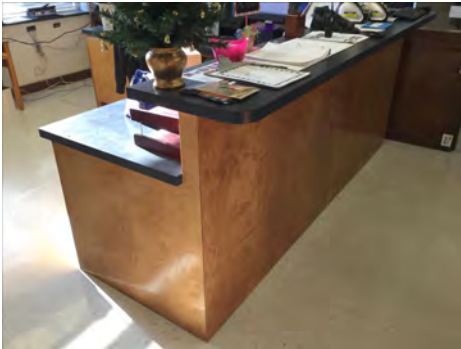
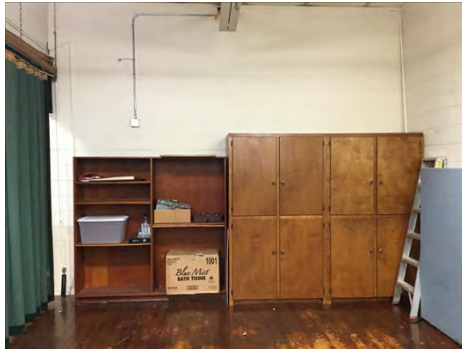
System: E2010 - Fixed Furnishings

Notes: The fixed furnishings are aged, in marginal condition, and should be replaced.
