NC School District/520 Jones County/High School

Jones Senior High

Campus Assessment Report

March 11, 2017

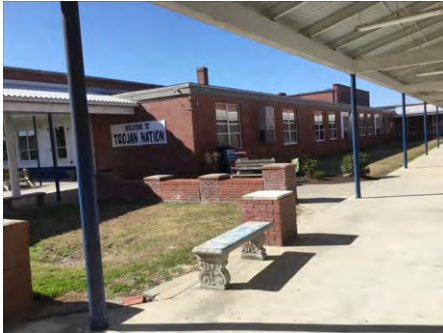
1). North Elevation - Feb 20, 2017

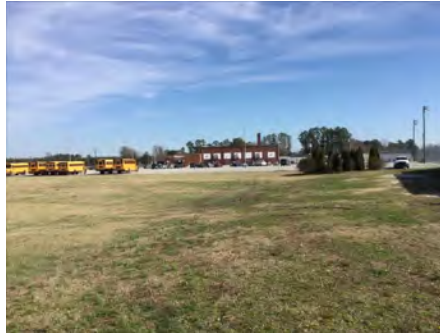
2). West Elevation - Feb 20, 2017

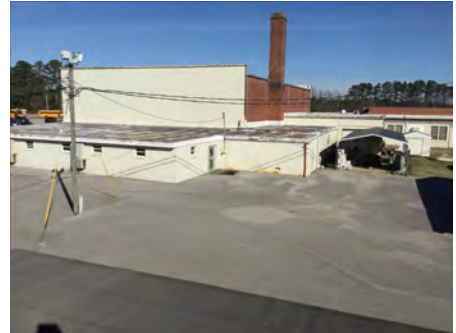
3). Partial South Elevation - Feb 20, 2017

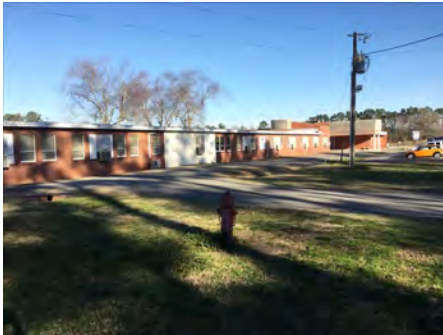
4). East Elevation - Feb 20, 2017

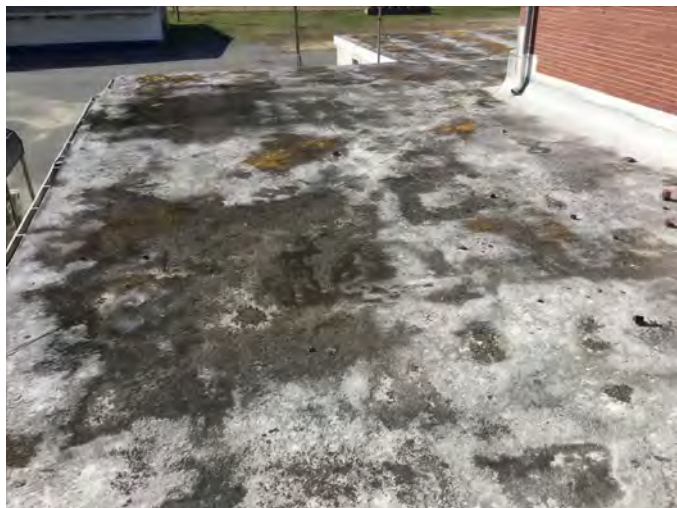
System: B3010105 - Built-Up

Location: Roof
Distress: Beyond Service Life
Category: Deferred Maintenance
Priority: 2 - Potentially Critical (Year 1)
Correction: Renew System
Qty: 35,465.00
Unit of Measure: S.F.
Estimate: \$438,028.00
Assessor Name: Terence Davis
Date Created: 02/17/2017

Notes: The majority of the building roof is foam over built-up roofing. The foam is in very poor condition with blistering, loss of coating, and UV damage to exposed foam. System replacement, including gutters and downspouts, is recommended.

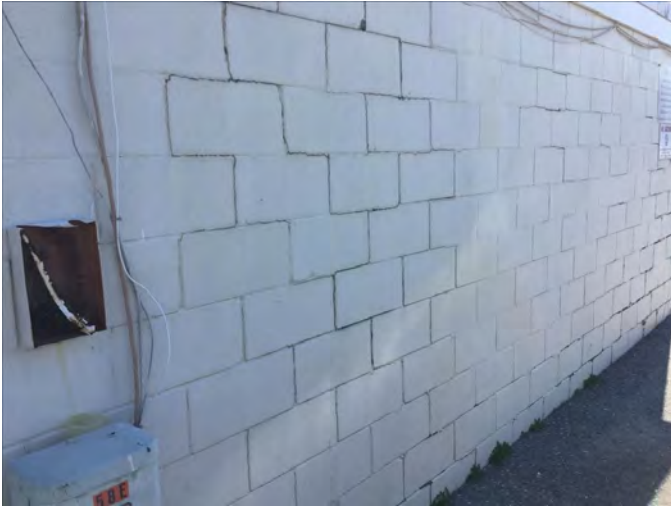
System: B2010 - Exterior Walls

Location: Exterior walls
Distress: Damaged
Category: Deferred Maintenance
Priority: 3 - Necessary/Not Yet Critical (Years 2-5)
Correction: Point clay brick wall, 1st floor
Qty: 50.00
Unit of Measure: C.S.F.
Estimate: \$75,108.00
Assessor Name: Terence Davis
Date Created: 02/20/2017

Notes: Exterior walls have some cracking, particularly at the locker room, which appears to an addition. Brick mortar is failing in some locations. Infilled windows at the gym are problematic. A general tune-up is recommended.

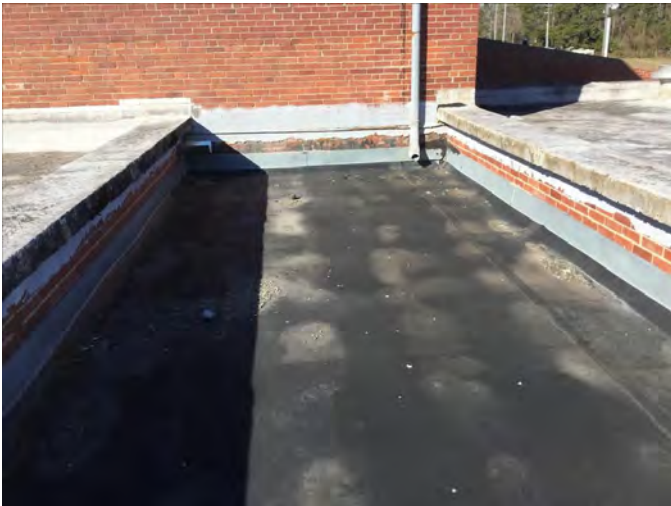
System: B3010120 - Single Ply Membrane

Location: Office wing
Distress: Beyond Service Life
Category: Deferred Maintenance
Priority: 3 - Necessary/Not Yet Critical (Years 2-5)
Correction: Renew System
Qty: 6,750.00
Unit of Measure: S.F.
Estimate: \$70,673.00
Assessor Name: Terence Davis
Date Created: 02/17/2017

Notes: The EPDM roof is beyond its expected useful life. Although no leaks were reported, system renewal is recommended to ensure the water tightness of the building envelope.

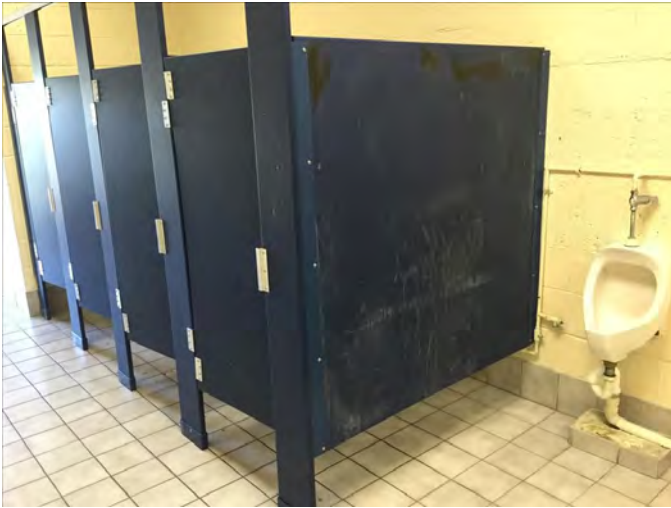
System: C1030 - Fittings

Location: Throughout the building
Distress: Beyond Service Life
Category: Deferred Maintenance
Priority: 3 - Necessary/Not Yet Critical (Years 2-5)
Correction: Renew System
Qty: 42,215.00
Unit of Measure: S.F.
Estimate: \$73,370.00
Assessor Name: Terence Davis
Date Created: 02/17/2017

Notes: Building fittings are of variable ages, but as a system are expired. Interior signage is not ADA code compliant. Restrooms are not typically ADA code compliant. System renewal is recommended.

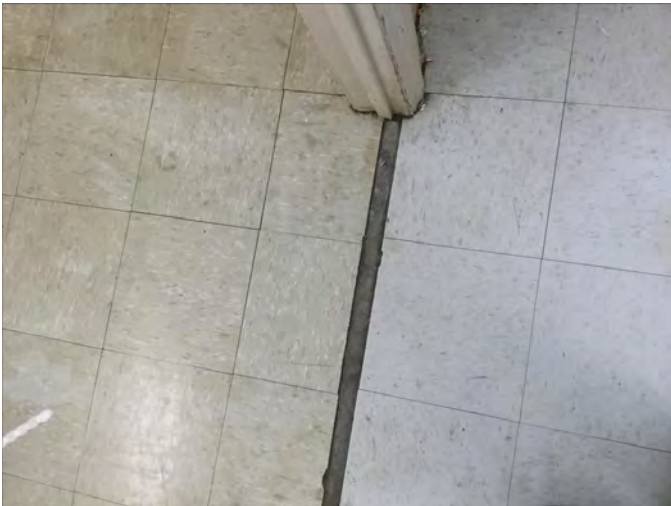
System: C3020 - Floor Finishes

Location: Throughout the building
Distress: Beyond Service Life
Category: Deferred Maintenance
Priority: 3 - Necessary/Not Yet Critical (Years 2-5)
Correction: Renew System
Qty: 42,215.00
Unit of Measure: S.F.
Estimate: \$544,236.00
Assessor Name: Terence Davis
Date Created: 02/17/2017

Notes: Floor finishes are generally beyond their expected useful life. Asbestos containing mastic is encapsulated beneath floor finishes. System renewal including complete abatement is recommended.

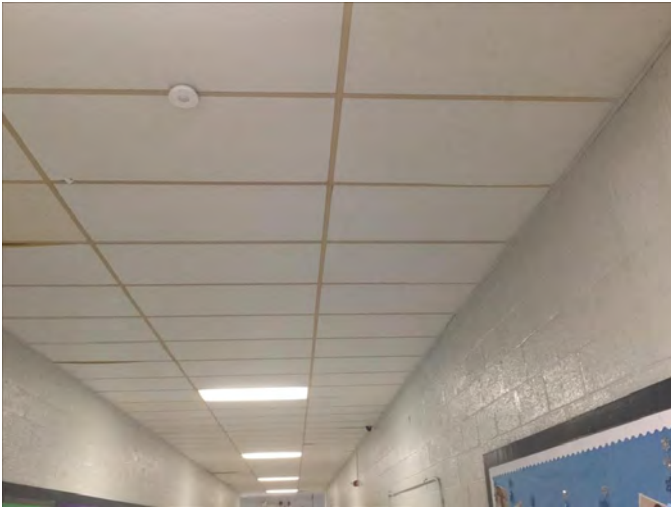
System: C3030 - Ceiling Finishes

Location: Throughout the building
Distress: Beyond Service Life
Category: Deferred Maintenance
Priority: 3 - Necessary/Not Yet Critical (Years 2-5)
Correction: Renew System
Qty: 42,215.00
Unit of Measure: S.F.
Estimate: \$524,732.00
Assessor Name: Terence Davis
Date Created: 02/17/2017

Notes: The ceiling tiles have been replaced as needed. However the grids are yellowed and many tiles are sagging or damaged. System renewal is recommended.

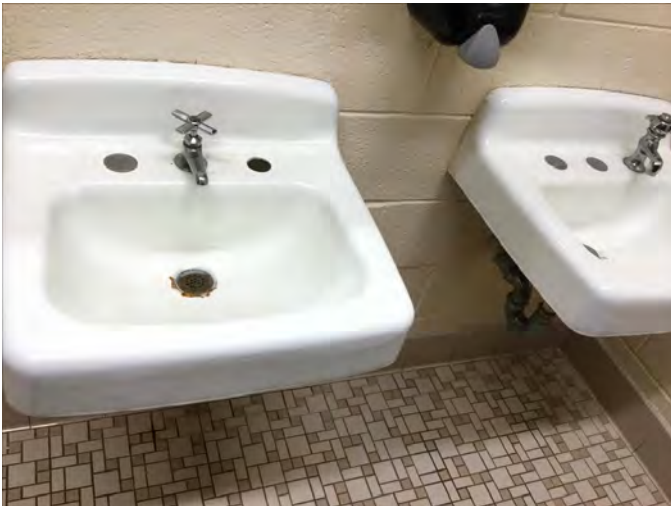
System: D2010 - Plumbing Fixtures

Location: Throughout the building
Distress: Beyond Service Life
Category: Deferred Maintenance
Priority: 3 - Necessary/Not Yet Critical (Years 2-5)
Correction: Renew System
Qty: 42,215.00
Unit of Measure: S.F.
Estimate: \$439,289.00
Assessor Name: Terence Davis
Date Created: 02/17/2017

Notes: It appears that many fixtures have been replaced, likely with the 1992 addition and general upgrade. Fixtures are not typically low-flow water saving styles. Many older fixtures are still present. In general, ADA compliance is lacking. System renewal is recommended.

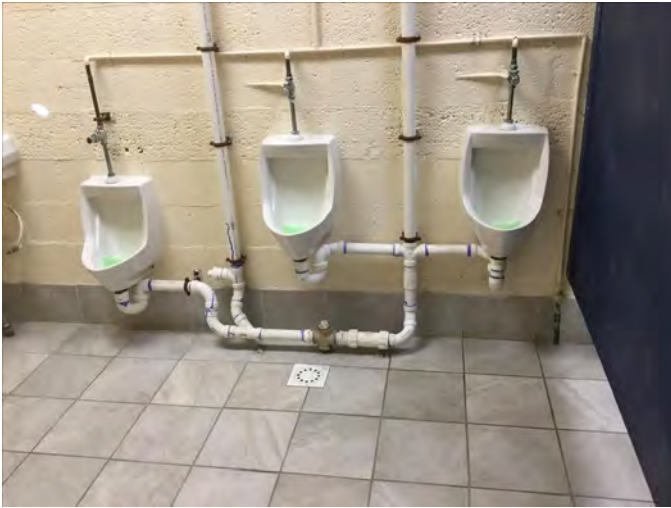
System: D2020 - Domestic Water Distribution

Location: Throughout the building
Distress: Beyond Service Life
Category: Deferred Maintenance
Priority: 3 - Necessary/Not Yet Critical (Years 2-5)
Correction: Renew System
Qty: 42,215.00
Unit of Measure: S.F.
Estimate: \$81,728.00
Assessor Name: Terence Davis
Date Created: 02/17/2017

Notes: Renovations have not been comprehensively made to the domestic water distribution system. System renewal is recommended.

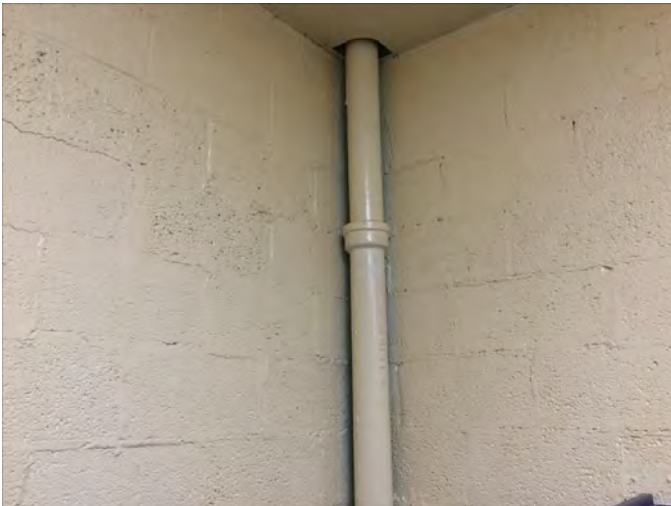
System: D2030 - Sanitary Waste

Location: Throughout the building
Distress: Beyond Service Life
Category: Deferred Maintenance
Priority: 3 - Necessary/Not Yet Critical (Years 2-5)
Correction: Renew System
Qty: 42,215.00
Unit of Measure: S.F.
Estimate: \$128,629.00
Assessor Name: Terence Davis
Date Created: 02/17/2017

Notes: The sanitary waste system as a whole is largely original with some surface retrofits. The system is expired and system renewal is recommended.

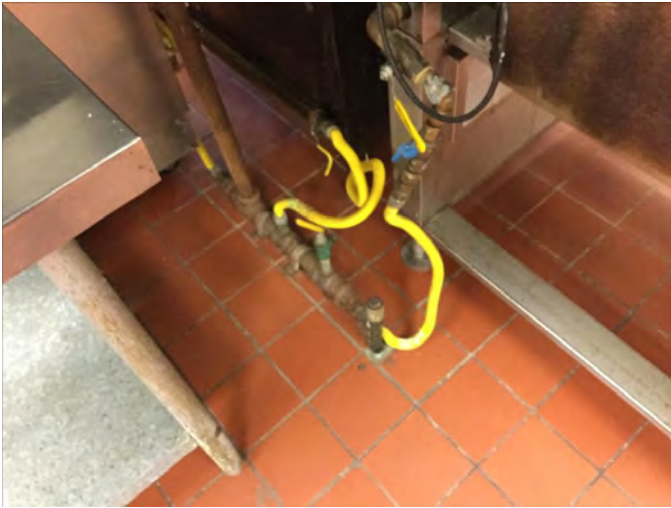
System: D2090 - Other Plumbing Systems -Propane

Location: Kitchen
Distress: Beyond Service Life
Category: Deferred Maintenance
Priority: 3 - Necessary/Not Yet Critical (Years 2-5)
Correction: Renew System
Qty: 42,215.00
Unit of Measure: S.F.
Estimate: \$7,430.00
Assessor Name: Terence Davis
Date Created: 02/17/2017

Notes: The propane piping system is expired. System renewal is recommended.

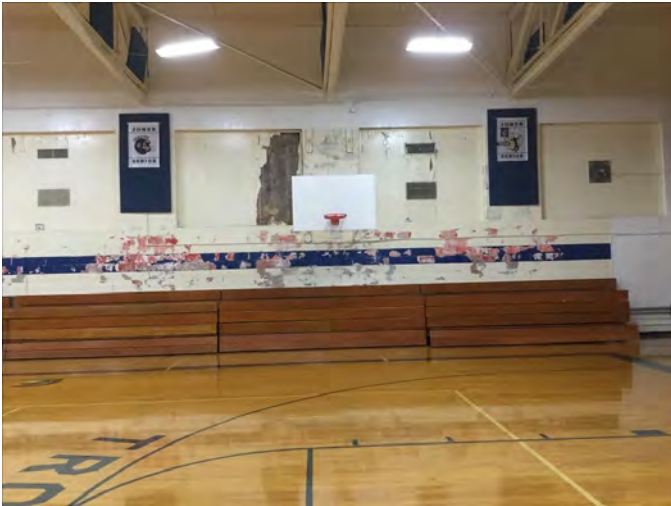
System: D3040 - Distribution Systems

Location: Throughout the building
Distress: Inadequate
Category: Deferred Maintenance
Priority: 3 - Necessary/Not Yet Critical (Years 2-5)
Correction: Renew System
Qty: 42,215.00
Unit of Measure: S.F.
Estimate: \$416,071.00
Assessor Name: Terence Davis
Date Created: 02/17/2017

Notes: HVAC distribution systems are both expired and inadequate. Wall mounted units in the gym do not provide adequate circulation. Toilet room exhaust systems are antiquated. Wall mounted units are fitted with ducts that they are not designed for, putting excess load on fan motors. The masonry shop does not have adequate filtration. System renewal is recommended.

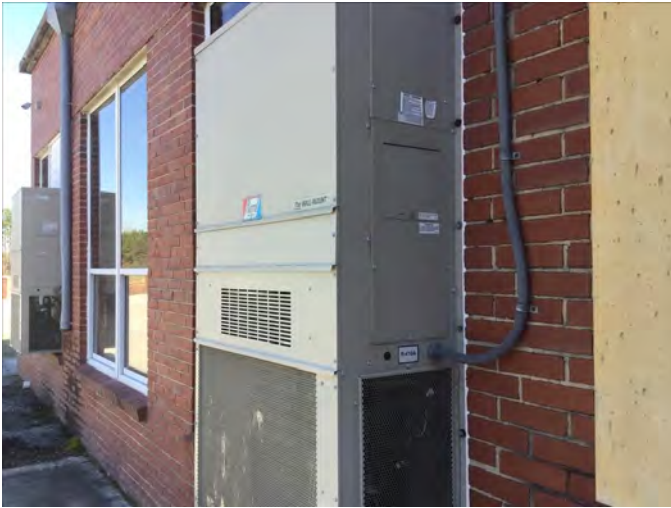
System: D3050 - Terminal & Package Units

Location: Throughout the building
Distress: Beyond Service Life
Category: Deferred Maintenance / Energy
Priority: 3 - Necessary/Not Yet Critical (Years 2-5)
Correction: Renew System
Qty: 42,215.00
Unit of Measure: S.F.
Estimate: \$907,834.00
Assessor Name: Terence Davis
Date Created: 02/17/2017

Notes: Wall mounted heat pumps have exceeded their useful life and are not energy efficient. Independent cooling is not provided for data rooms. System renewal is recommended.

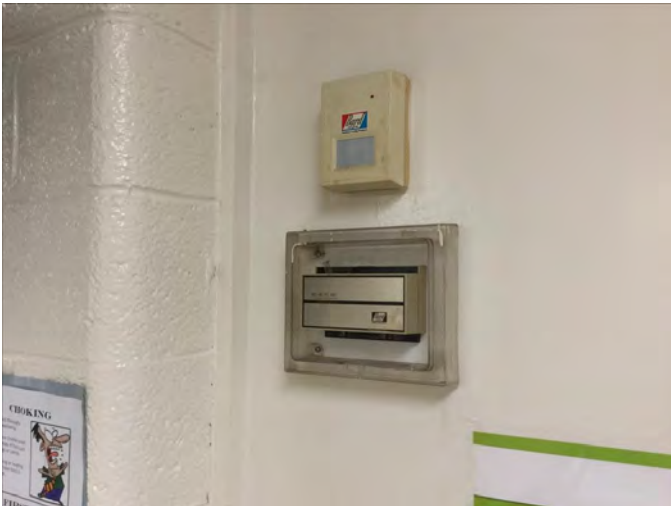
System: D3060 - Controls & Instrumentation

Location: Throughout the building
Distress: Beyond Service Life
Category: Deferred Maintenance
Priority: 3 - Necessary/Not Yet Critical (Years 2-5)
Correction: Renew System
Qty: 42,215.00
Unit of Measure: S.F.
Estimate: \$131,880.00
Assessor Name: Terence Davis
Date Created: 02/17/2017

Notes: Building controls are locally controlled and are obsolete, having been installed with the 1992 HVAC upgrade.. Installation of a modern digital system with remote monitoring and control capability for energy conservation is recommended.

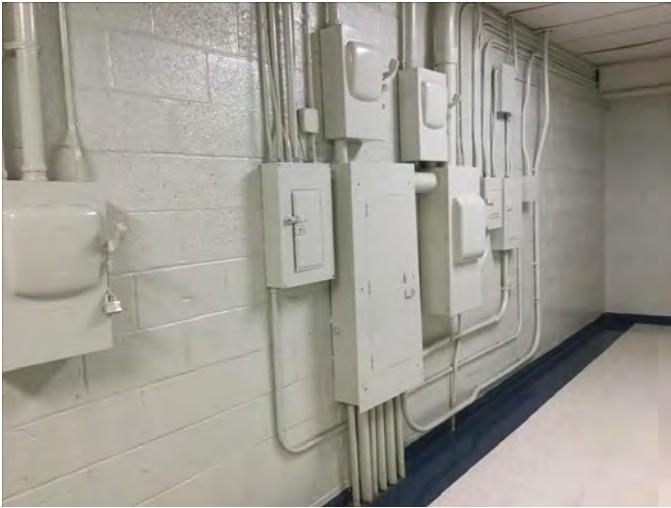
System: D5010 - Electrical Service/Distribution

Location: Main electrical service
Distress: Beyond Service Life
Category: Deferred Maintenance
Priority: 3 - Necessary/Not Yet Critical (Years 2-5)
Correction: Renew System
Qty: 42,215.00
Unit of Measure: S.F.
Estimate: \$78,942.00
Assessor Name: Terence Davis
Date Created: 02/17/2017

Notes: The main electrical service has been added on to, but has not been upgraded overall. Service is located in a corridor vs. a dedicated electrical equipment room. System renewal is recommended.

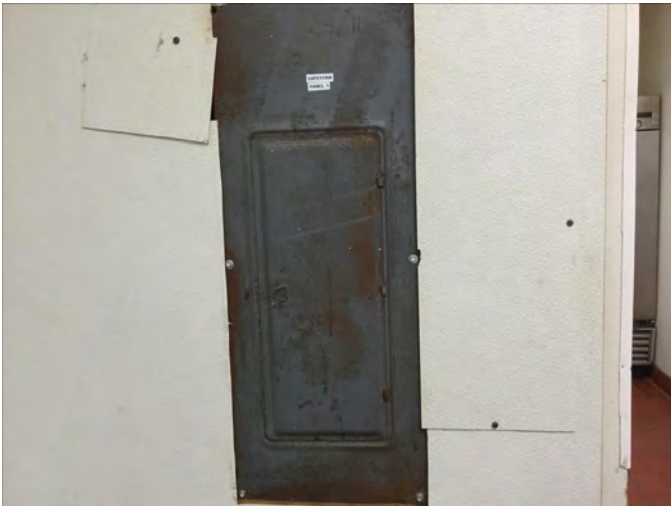
System: D5020 - Branch Wiring

Location: Throughout the building
Distress: Beyond Service Life
Category: Deferred Maintenance
Priority: 3 - Necessary/Not Yet Critical (Years 2-5)
Correction: Renew System
Qty: 42,215.00
Unit of Measure: S.F.
Estimate: \$226,146.00
Assessor Name: Terence Davis
Date Created: 02/17/2017

Notes: The branch wiring system has been added on to over the years, but a comprehensive upgrade has never been implemented. There are few spare circuits and circuits are overloaded. There are insufficient outlets to meet modern requirements. Equipment is obsolete.

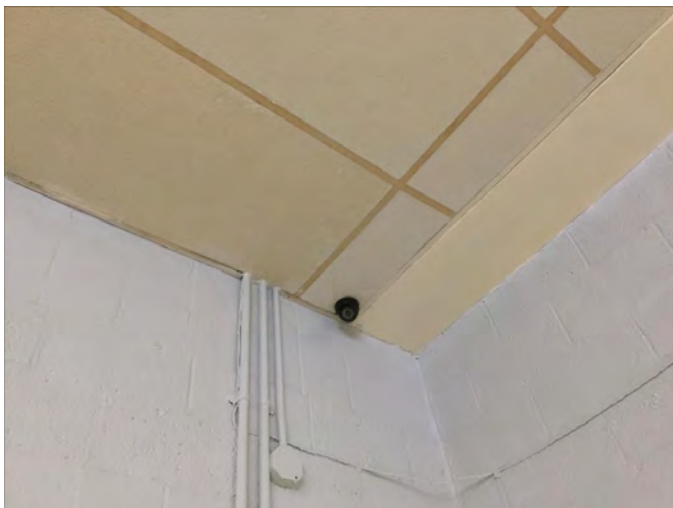
System: D5030810 - Security & Detection Systems

Location: Throughout the building
Distress: Beyond Service Life
Category: Deferred Maintenance
Priority: 3 - Necessary/Not Yet Critical (Years 2-5)
Correction: Renew System
Qty: 42,215.00
Unit of Measure: S.F.
Estimate: \$97,517.00
Assessor Name: Terence Davis
Date Created: 02/20/2017

Notes: Although reportedly only 10 years old, the security system is inadequate. It cannot be monitored properly in the principal's office. System renewal is recommended.

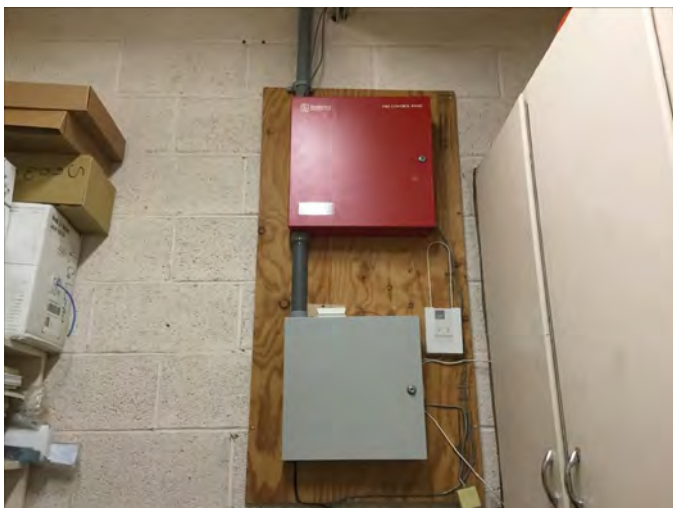
System: D5030910 - Fire Alarm Systems

Location: Throughout the building
Distress: Beyond Service Life
Category: Deferred Maintenance / Life Safety Code Compliance
Priority: 3 - Necessary/Not Yet Critical (Years 2-5)
Correction: Renew System
Qty: 42,215.00
Unit of Measure: S.F.
Estimate: \$177,852.00
Assessor Name: Terence Davis
Date Created: 02/17/2017

Notes: The fire alarm system is original and beyond its expected life. System renewal to current codes is recommended to ensure reliability of this life safety system.

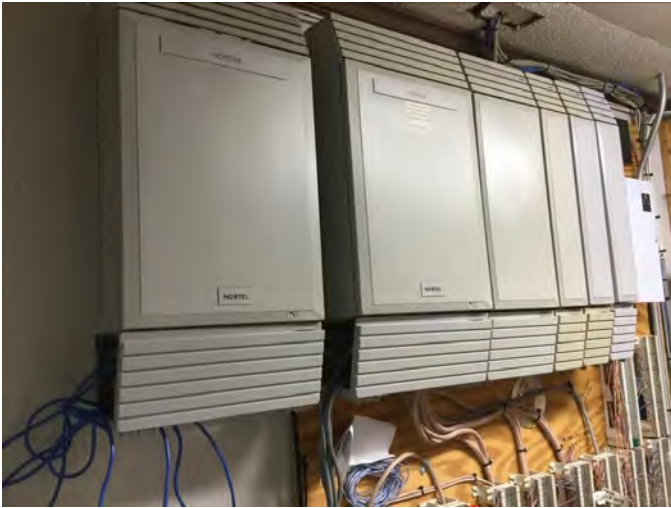
System: D5030920 - Data Communication

Location: Throughout the building
Distress: Beyond Service Life
Category: Deferred Maintenance
Priority: 3 - Necessary/Not Yet Critical (Years 2-5)
Correction: Renew System
Qty: 42,215.00
Unit of Measure: S.F.
Estimate: \$228,468.00
Assessor Name: Terence Davis
Date Created: 02/17/2017

Notes: The telephone system dates to the early '90s. The PA system is through the phone system. System renewal is recommended.

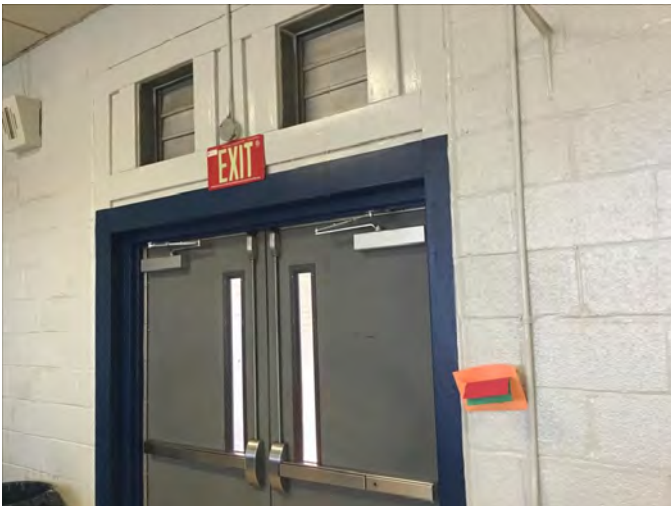
System: D5090 - Other Electrical Systems

Location: Throughout the building
Distress: Beyond Service Life
Category: Deferred Maintenance
Priority: 3 - Necessary/Not Yet Critical (Years 2-5)
Correction: Renew System
Qty: 42,215.00
Unit of Measure: S.F.
Estimate: \$33,899.00
Assessor Name: Terence Davis
Date Created: 02/17/2017

Notes: Egress lighting is beyond its expected useful life. System renewal, including review of distribution/adequacy of the system is recommended.

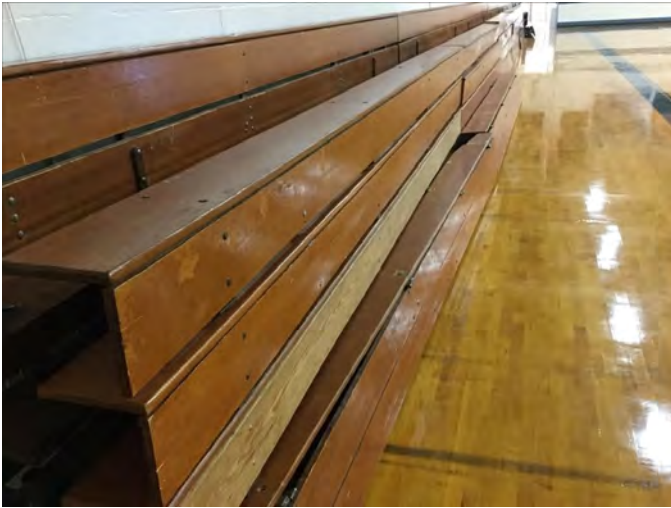
System: E1020 - Institutional Equipment

Location: Throughout the building
Distress: Beyond Service Life
Category: Deferred Maintenance
Priority: 3 - Necessary/Not Yet Critical (Years 2-5)
Correction: Renew System
Qty: 42,215.00
Unit of Measure: S.F.
Estimate: \$648,718.00
Assessor Name: Terence Davis
Date Created: 02/17/2017

Notes: Institutional equipment is generally beyond its expected useful life. System renewal is recommended.

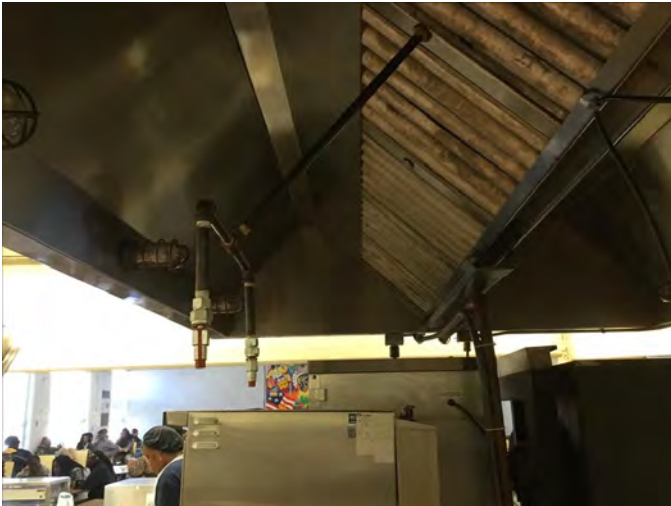
System: E1090 - Other Equipment

Location: Kitchen
Distress: Beyond Service Life
Category: Deferred Maintenance
Priority: 3 - Necessary/Not Yet Critical (Years 2-5)
Correction: Renew System
Qty: 42,215.00
Unit of Measure: S.F.
Estimate: \$266,081.00
Assessor Name: Terence Davis
Date Created: 02/17/2017

Notes: Kitchen equipment is generally beyond its expected useful life. System renewal is recommended.

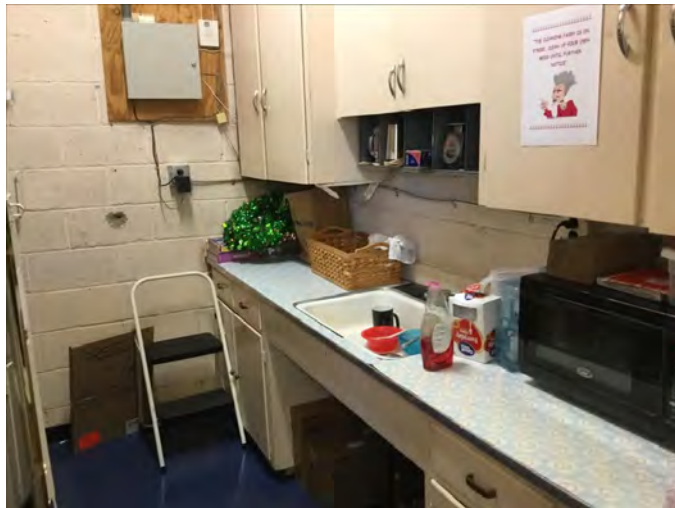
System: E2010 - Fixed Furnishings

Location: Throughout the building
Distress: Beyond Service Life
Category: Deferred Maintenance
Priority: 3 - Necessary/Not Yet Critical (Years 2-5)
Correction: Renew System
Qty: 42,215.00
Unit of Measure: S.F.
Estimate: \$247,507.00
Assessor Name: Terence Davis
Date Created: 02/17/2017

Notes: Fixed furnishing are typically original and in fair to poor condition. System renewal is recommended.

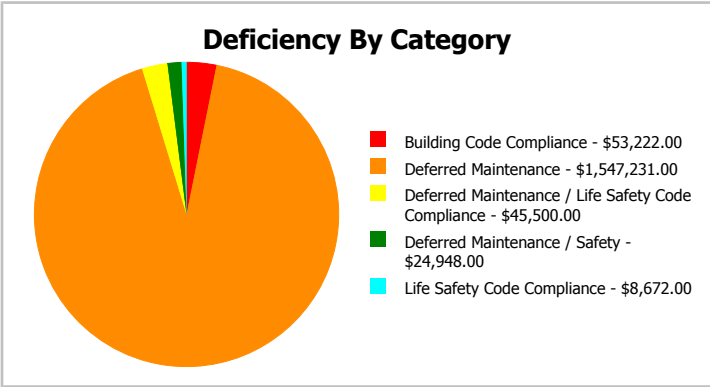
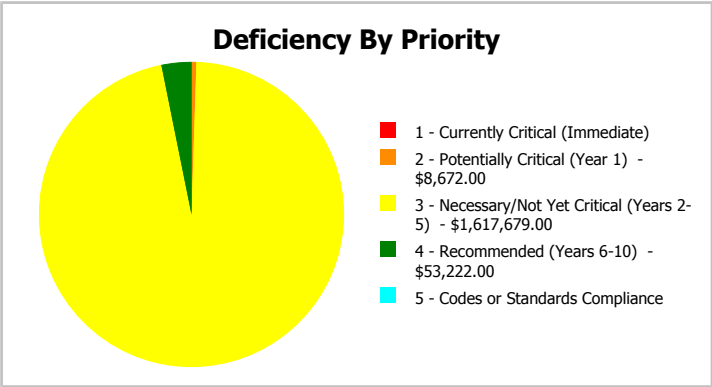
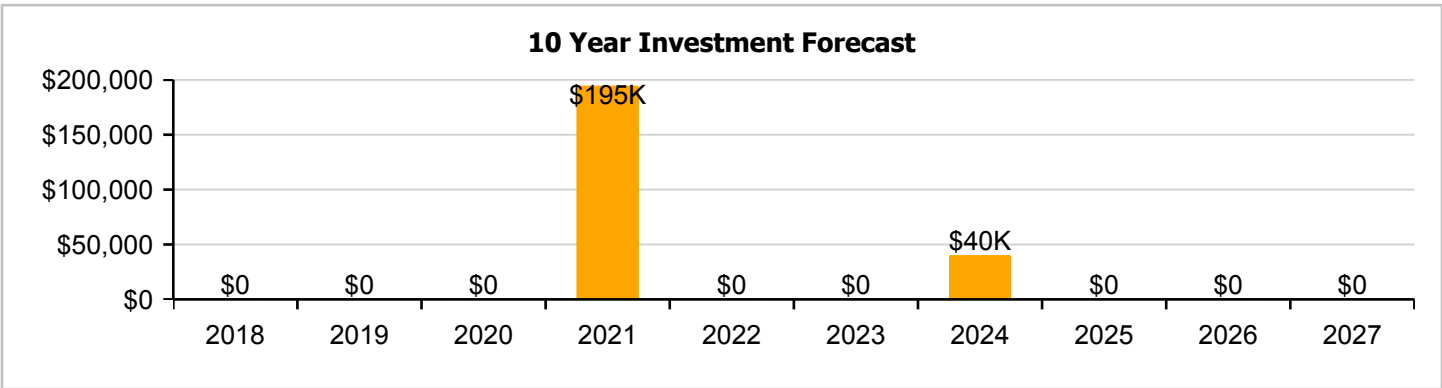
Dashboard Summary

Function:	HS -High School	Gross Area:	10,800
Year Built:	1969	Last Renovation:	
Repair Cost:	\$1,679,573	Replacement Value:	\$2,158,704
FCI:	77.80 %	RSLI%:	12.91 %

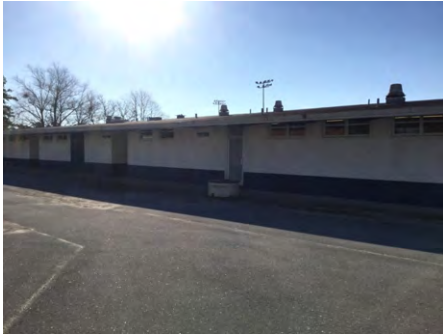
1). North Elevation - Feb 20, 2017

The photo album consists of the various cardinal directions of the building..

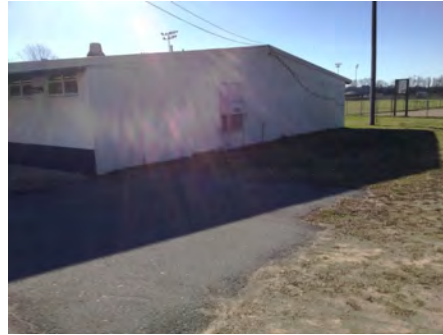
2). West Elevation - Feb 20, 2017

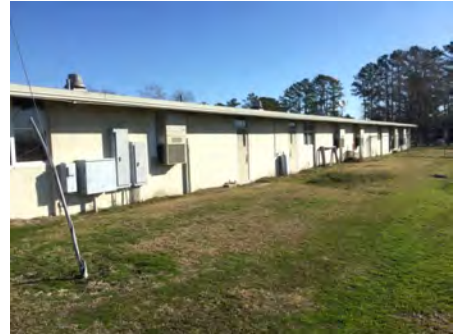
3). South Elevation - Feb 20, 2017

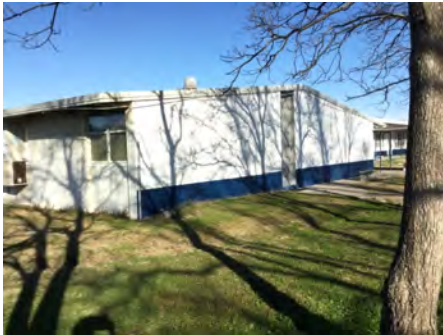
4). East Elevation - Feb 20, 2017

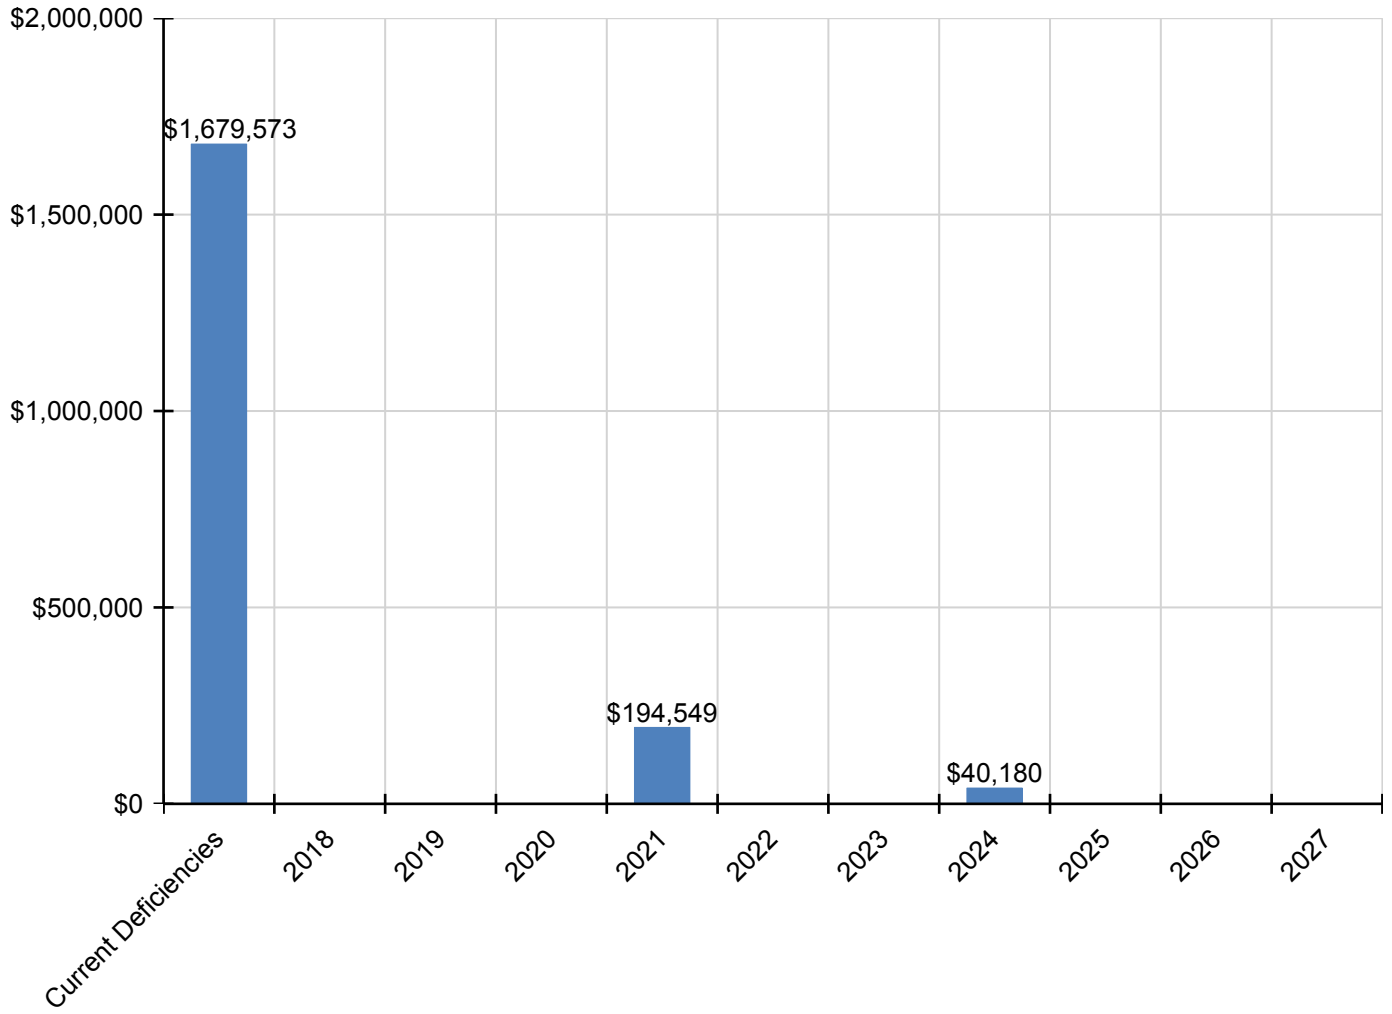
Forecasted Capital Renewal Requirement

The following chart shows the current building deficiencies and forecasting capital renewal or sustainment requirements over the next ten years.

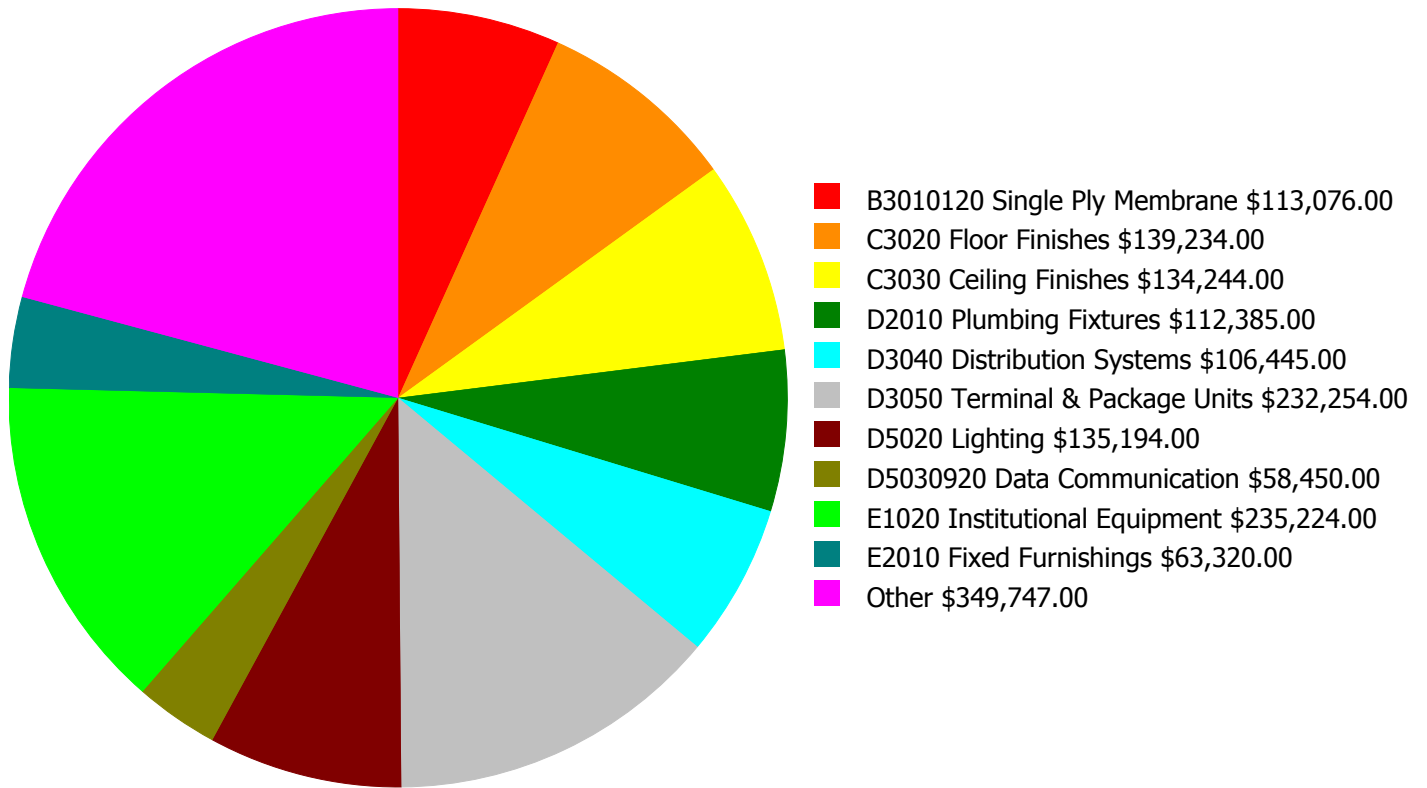
Deficiency Summary by System

Current deficiencies included assemblies that have reached or exceeded their design life or components of the assemblies that are in need of repair. Assemblies that have reached their design life are identified as current deficiencies and assigned the distress 'Beyond Useful Life'. The following chart lists all current deficiencies associated with this facility.

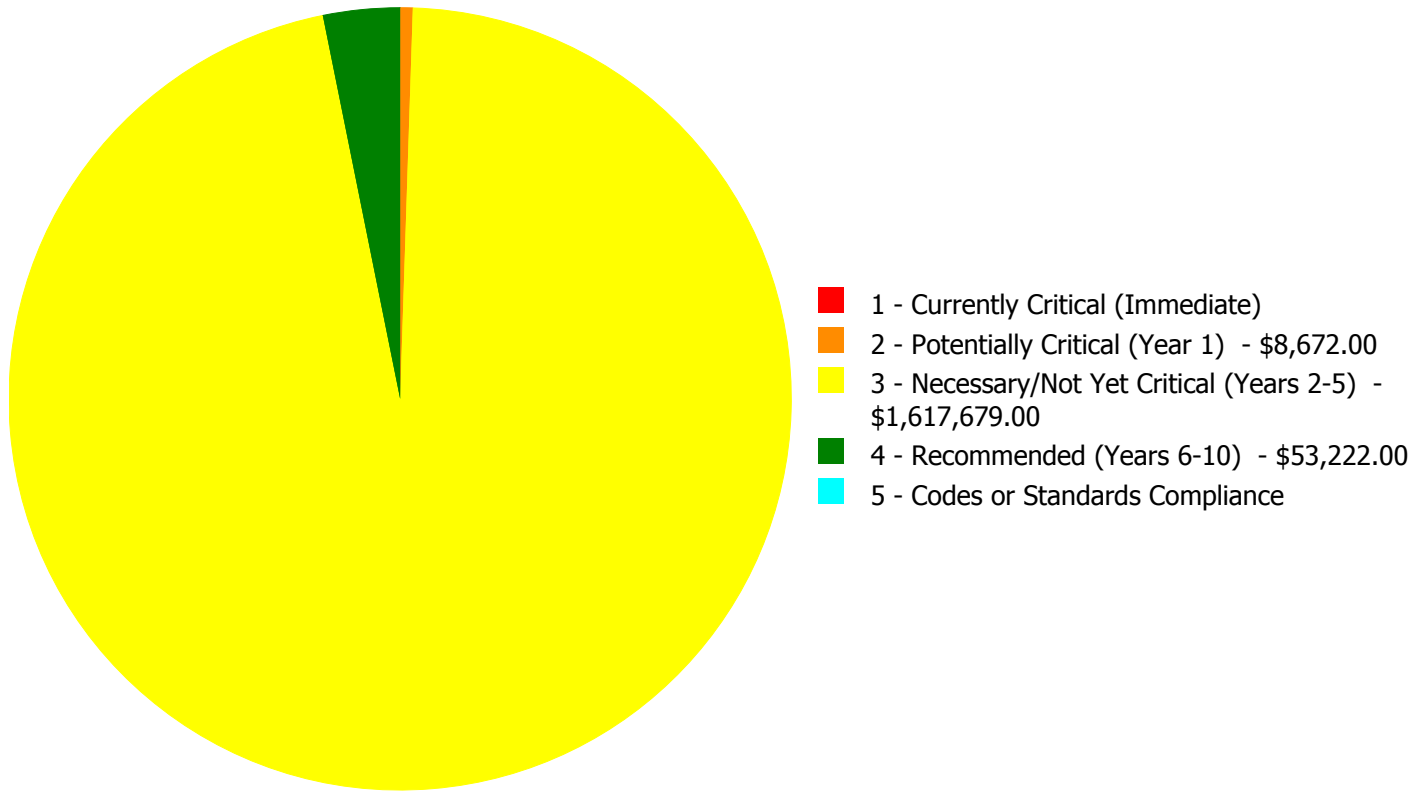
Deficiency Summary by Priority

The following chart shows the total repair costs broken down by priority. Assessors assigned deficiencies within eCOMET to one of the following priority categories:

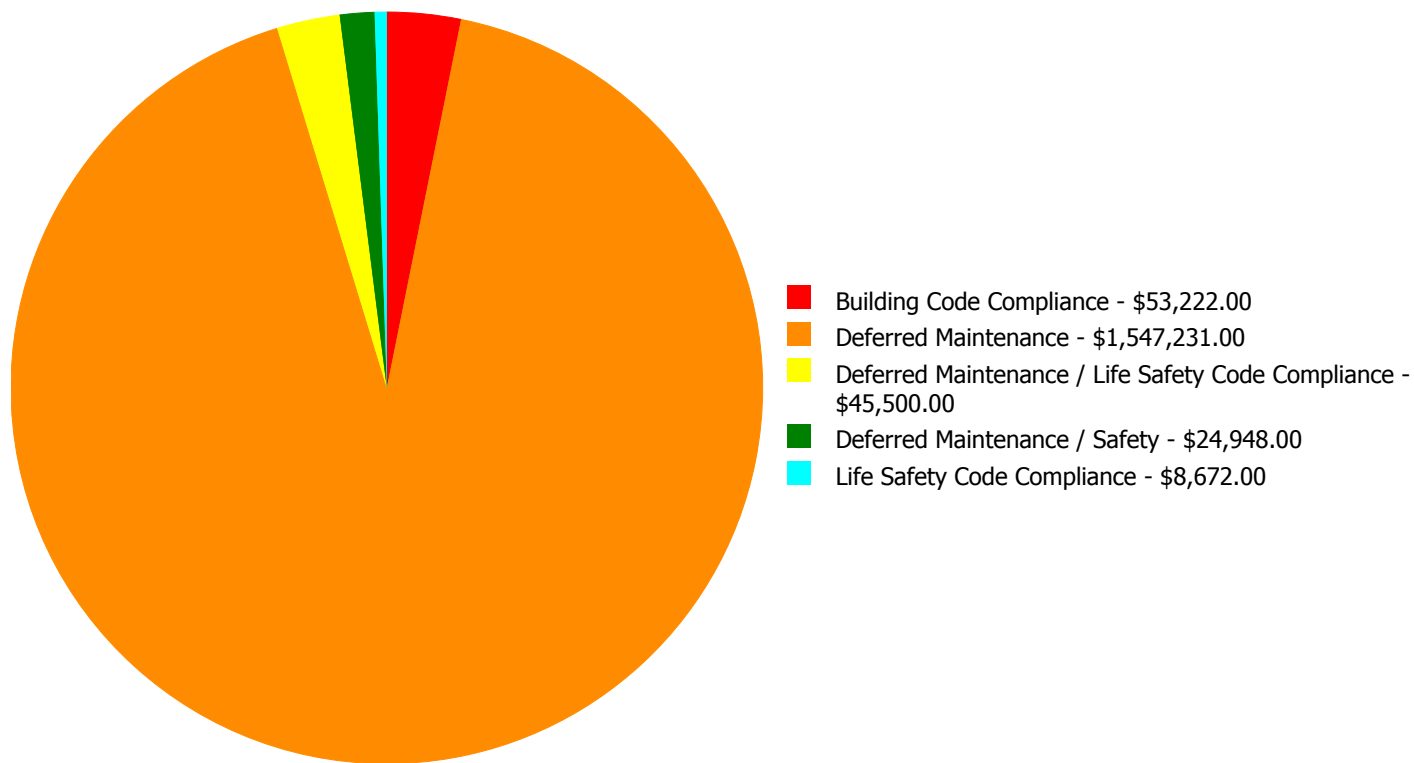
Deficiency Summary by Category

The following chart shows the total repair costs broken down by deficiency categories. Assessors assigned deficiencies to one of the following categories:

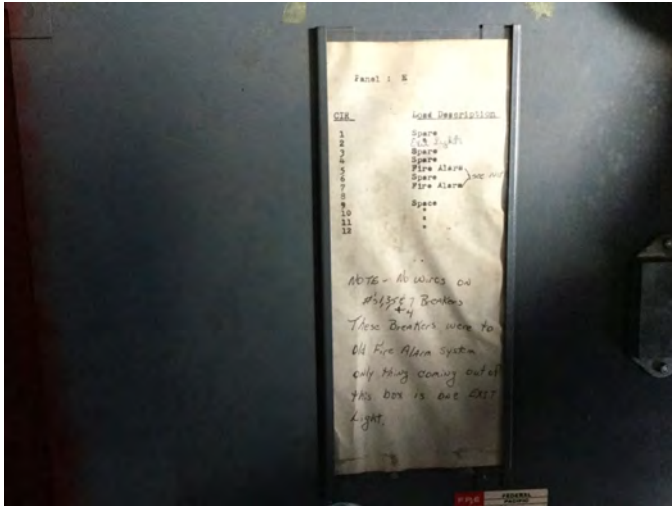
System: D5090 - Other Electrical Systems

Location: Throughout the building

Distress: Missing

Notes: No emergency egress lighting was found in this building. Installation of emergency lighting is recommended.

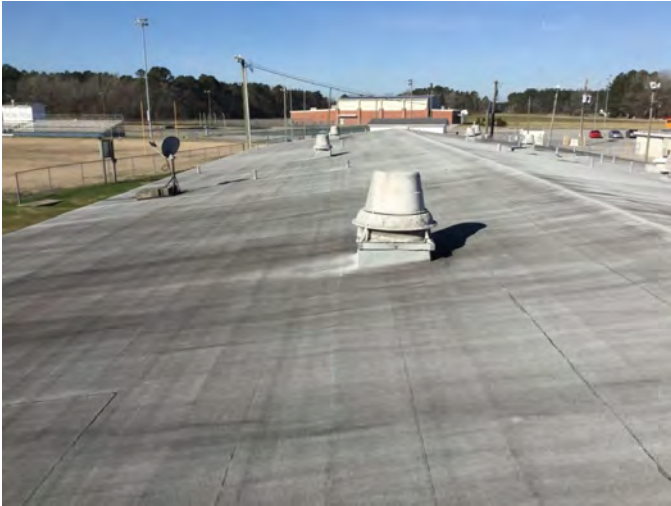
System: B3010120 - Single Ply Membrane

Location: Roof
Distress: Beyond Service Life
Category: Deferred Maintenance
Priority: 3 - Necessary/Not Yet Critical (Years 2-5)
Correction: Renew System
Qty: 10,800.00
Unit of Measure: S.F.
Estimate: \$113,076.00
Assessor Name: Terence Davis
Date Created: 02/17/2017

Notes: Though no active leaks are reported or observed, the roof membrane is beyond its expected useful life. System renewal is recommended.

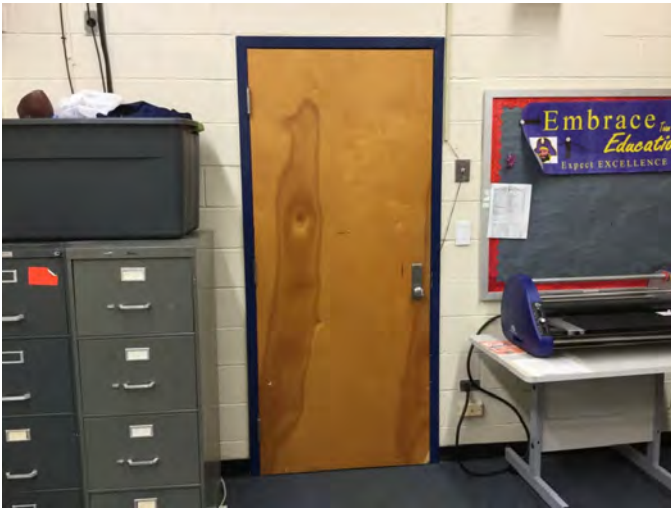
System: C1020 - Interior Doors

Location: Throughout the building
Distress: Beyond Service Life
Category: Deferred Maintenance
Priority: 3 - Necessary/Not Yet Critical (Years 2-5)
Correction: Renew System
Qty: 10,800.00
Unit of Measure: S.F.
Estimate: \$31,007.00
Assessor Name: Terence Davis
Date Created: 02/17/2017

Notes: Interior doors are beyond their expected useful life and typically do not have ADA compliant hardware. System renewal is recommended.

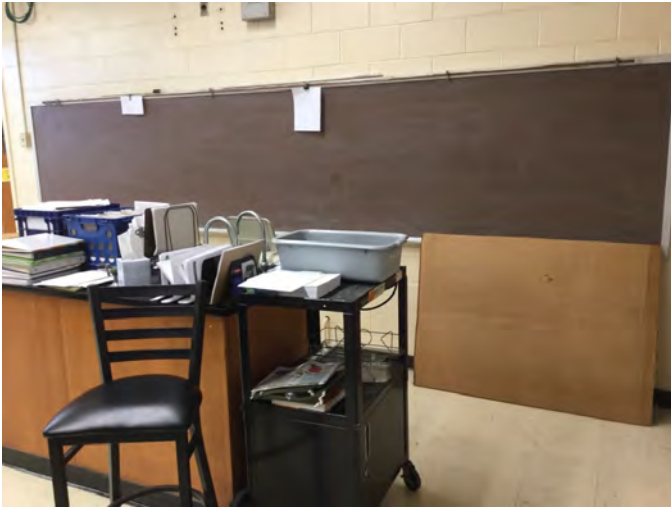
System: C1030 - Fittings

Location: Throughout the building
Distress: Beyond Service Life
Category: Deferred Maintenance
Priority: 3 - Necessary/Not Yet Critical (Years 2-5)
Correction: Renew System
Qty: 10,800.00
Unit of Measure: S.F.
Estimate: \$18,770.00
Assessor Name: Terence Davis
Date Created: 02/17/2017

Notes: Fittings are typically beyond their expected useful life. Signage and toilet rooms are not ADA compliant. System renewal is recommended.

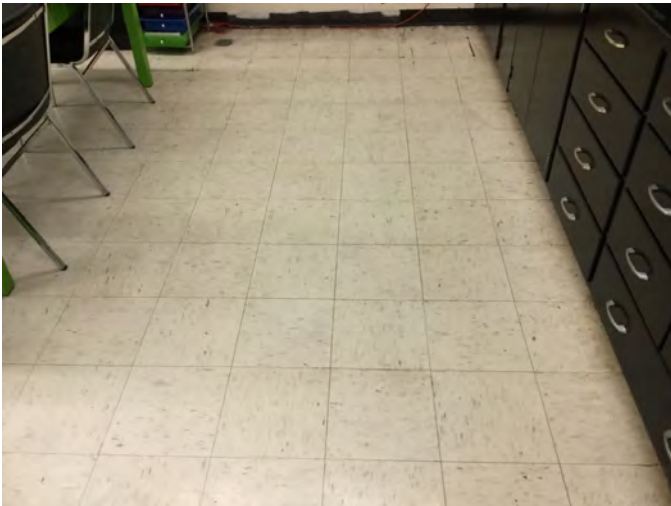
System: C3020 - Floor Finishes

Location: Throughout the building
Distress: Beyond Service Life
Category: Deferred Maintenance
Priority: 3 - Necessary/Not Yet Critical (Years 2-5)
Correction: Renew System
Qty: 10,800.00
Unit of Measure: S.F.
Estimate: \$139,234.00
Assessor Name: Terence Davis
Date Created: 02/17/2017

Notes: Floor finishes are generally beyond their expected useful life. Asbestos containing mastic is encapsulated beneath floor finishes. System renewal including complete abatement is recommended.

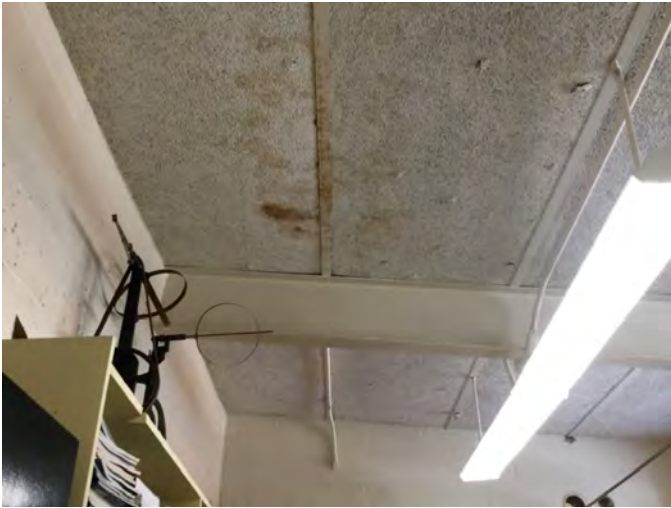
System: C3030 - Ceiling Finishes

Location: Throughout the building
Distress: Beyond Service Life
Category: Deferred Maintenance
Priority: 3 - Necessary/Not Yet Critical (Years 2-5)
Correction: Renew System
Qty: 10,800.00
Unit of Measure: S.F.
Estimate: \$134,244.00
Assessor Name: Terence Davis
Date Created: 02/17/2017

Notes: Ceiling finishes are in fair to poor condition. System renewal is recommended.

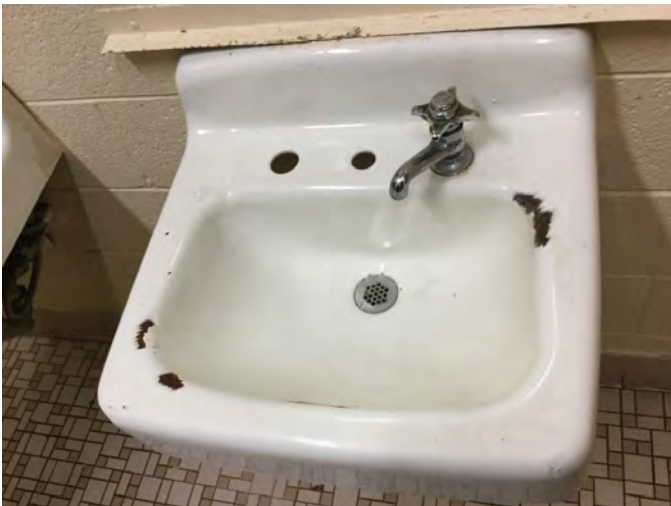
System: D2010 - Plumbing Fixtures

Location: Throughout the building
Distress: Beyond Service Life
Category: Deferred Maintenance
Priority: 3 - Necessary/Not Yet Critical (Years 2-5)
Correction: Renew System
Qty: 10,800.00
Unit of Measure: S.F.
Estimate: \$112,385.00
Assessor Name: Terence Davis
Date Created: 02/17/2017

Notes: Plumbing fixtures are in operational conditions. However, they are aged, not ADA compliant and should be replaced with low-flow water fixtures.

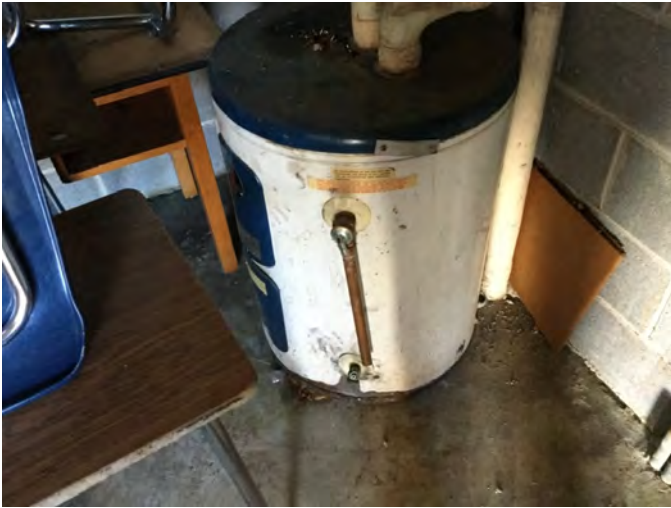
System: D2020 - Domestic Water Distribution

Location: Throughout the building
Distress: Beyond Service Life
Category: Deferred Maintenance
Priority: 3 - Necessary/Not Yet Critical (Years 2-5)
Correction: Renew System
Qty: 10,800.00
Unit of Measure: S.F.
Estimate: \$20,909.00
Assessor Name: Terence Davis
Date Created: 02/17/2017

Notes: The domestic water distribution system is largely original and beyond its expected life. System renewal is recommended.

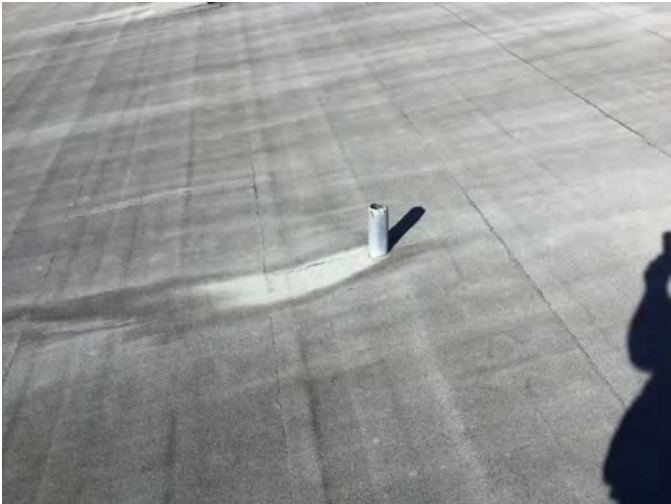
System: D2030 - Sanitary Waste

Location: Throughout the building
Distress: Beyond Service Life
Category: Deferred Maintenance
Priority: 3 - Necessary/Not Yet Critical (Years 2-5)
Correction: Renew System
Qty: 10,800.00
Unit of Measure: S.F.
Estimate: \$32,908.00
Assessor Name: Terence Davis
Date Created: 02/17/2017

Notes: The sanitary waste system is beyond its expected life. Though no active problems were observed or reported, renewal to ensure system integrity is recommended.

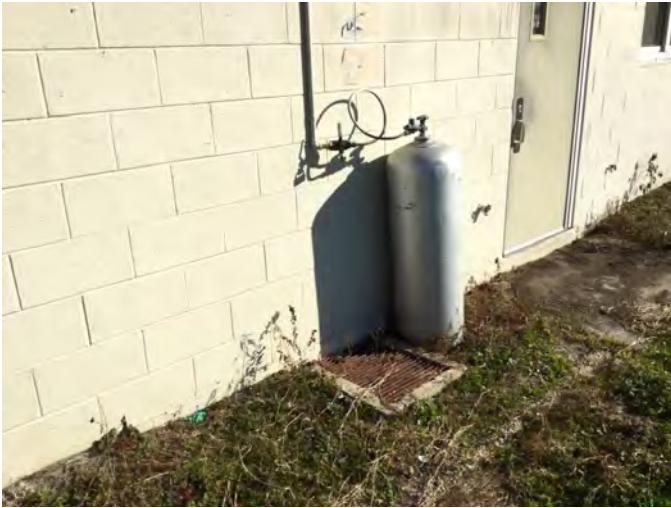
System: D2090 - Other Plumbing Systems

Location: Science labs
Distress: Beyond Service Life
Category: Deferred Maintenance
Priority: 3 - Necessary/Not Yet Critical (Years 2-5)
Correction: Renew System
Qty: 10,800.00
Unit of Measure: S.F.
Estimate: \$2,020.00
Assessor Name: Terence Davis
Date Created: 03/02/2017

Notes: Propane distribution systems are beyond their expected life. System renewal is recommended.
