NC School District/520 Jones County/High School

Jones Senior High

Campus Assessment Report

March 11, 2017

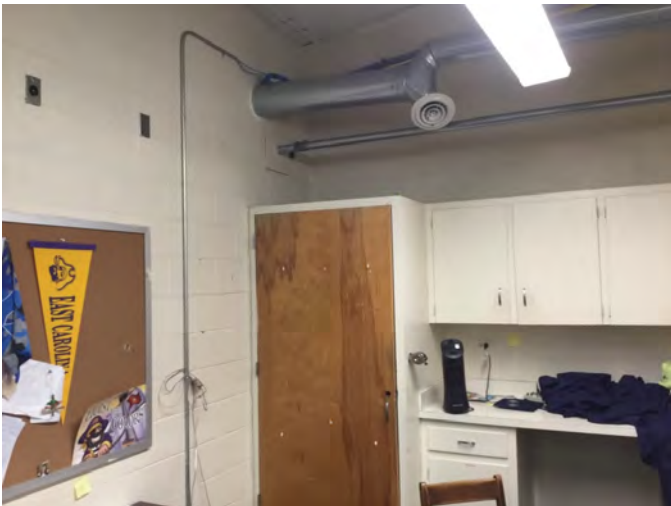
System: D3040 - Distribution Systems

Location: Throughout the building
Distress: Beyond Service Life
Category: Deferred Maintenance
Priority: 3 - Necessary/Not Yet Critical (Years 2-5)
Correction: Renew System
Qty: 10,800.00
Unit of Measure: S.F.
Estimate: \$106,445.00
Assessor Name: Terence Davis
Date Created: 02/17/2017

Notes: HVAC distribution systems are beyond their expected useful life. System renewal is recommended.

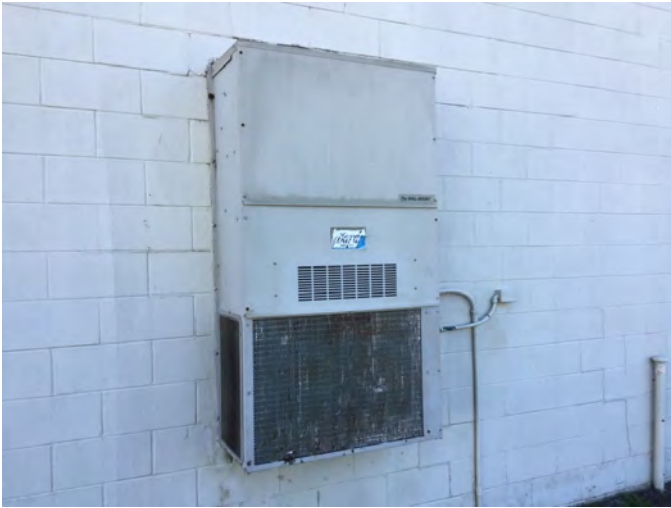
System: D3050 - Terminal & Package Units

Location: Throughout the bulding
Distress: Beyond Service Life
Category: Deferred Maintenance
Priority: 3 - Necessary/Not Yet Critical (Years 2-5)
Correction: Renew System
Qty: 10,800.00
Unit of Measure: S.F.
Estimate: \$232,254.00
Assessor Name: Terence Davis
Date Created: 02/17/2017

Notes: Wall mounted heat pumps have exceeded their useful life and are not energy efficient. Independent cooling is not provided for data rooms. System renewal is recommended.

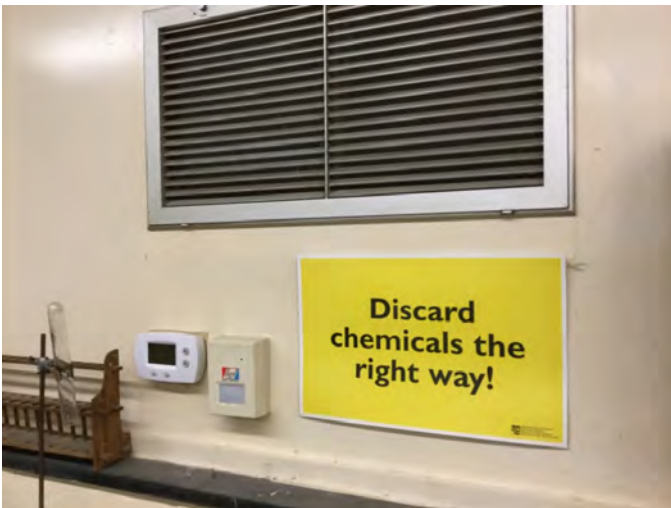
System: D3060 - Controls & Instrumentation

Location: Throughout the building
Distress: Beyond Service Life
Category: Deferred Maintenance
Priority: 3 - Necessary/Not Yet Critical (Years 2-5)
Correction: Renew System
Qty: 10,800.00
Unit of Measure: S.F.
Estimate: \$33,739.00
Assessor Name: Terence Davis
Date Created: 02/17/2017

Notes: Building controls are locally controlled and are obsolete, having been installed with the 1992 HVAC upgrade.. Installation of a modern digital system with remote monitoring and control capability for energy conservation is recommended.

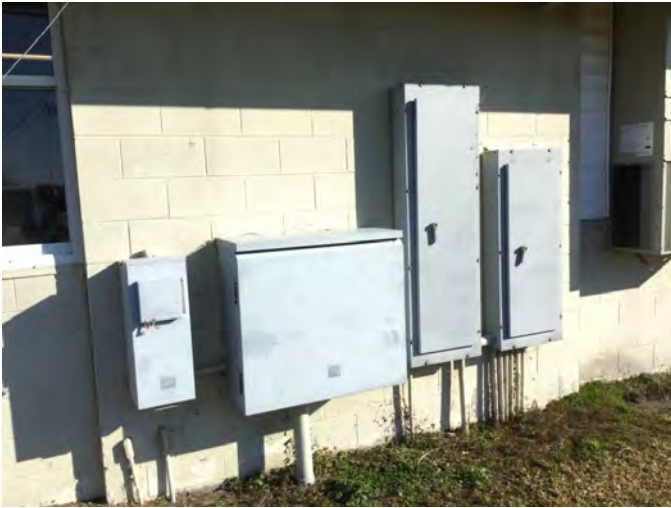
System: D5010 - Electrical Service/Distribution

Location: MDP
Distress: Beyond Service Life
Category: Deferred Maintenance
Priority: 3 - Necessary/Not Yet Critical (Years 2-5)
Correction: Renew System
Qty: 10,800.00
Unit of Measure: S.F.
Estimate: \$20,196.00
Assessor Name: Terence Davis
Date Created: 02/17/2017

Notes: The electric service was added onto for the 1992 HVAC upgrade, but the original system has never been replaced and is beyond its expected service life. System renewal is recommended.

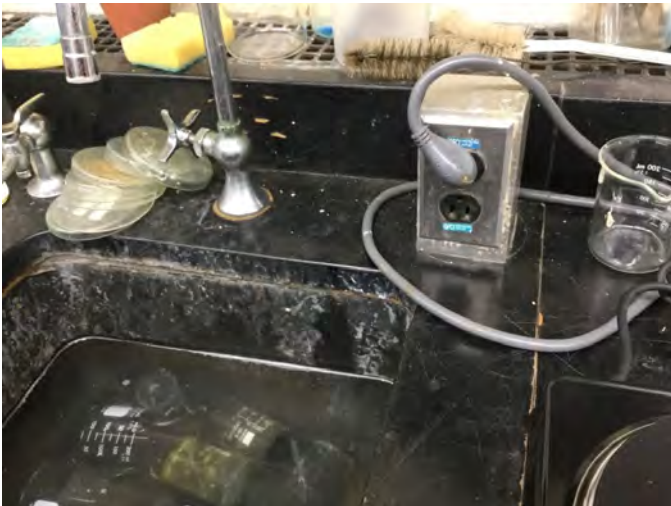
System: D5020 - Branch Wiring

Location: Throughout the building
Distress: Beyond Service Life
Category: Deferred Maintenance
Priority: 3 - Necessary/Not Yet Critical (Years 2-5)
Correction: Renew System
Qty: 10,800.00
Unit of Measure: S.F.
Estimate: \$57,856.00
Assessor Name: Terence Davis
Date Created: 02/17/2017

Notes: The branch wiring system is largely original and beyond its expected life. Circuits are overloaded. System renewal is recommended.

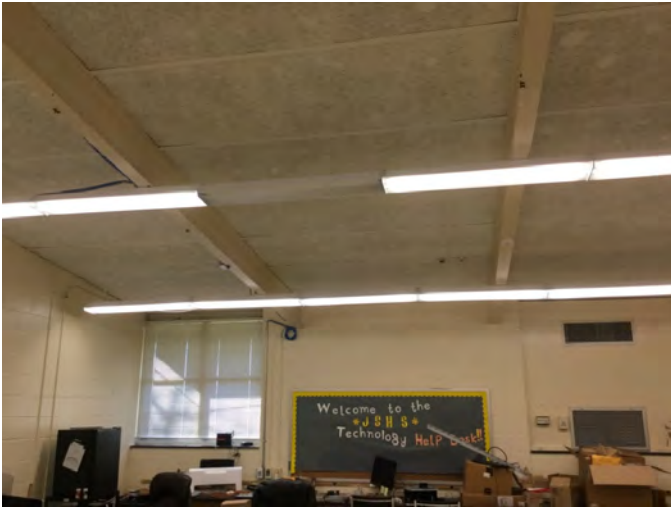
System: D5020 - Lighting

Location: Throughout the building
Distress: Beyond Service Life
Category: Deferred Maintenance
Priority: 3 - Necessary/Not Yet Critical (Years 2-5)
Correction: Renew System
Qty: 10,800.00
Unit of Measure: S.F.
Estimate: \$135,194.00
Assessor Name: Terence Davis
Date Created: 02/17/2017

Notes: Although fixtures have been retrofitted w// T-8 lamps, the lighting system is largely original and beyond its expected life. System renewal is recommended.

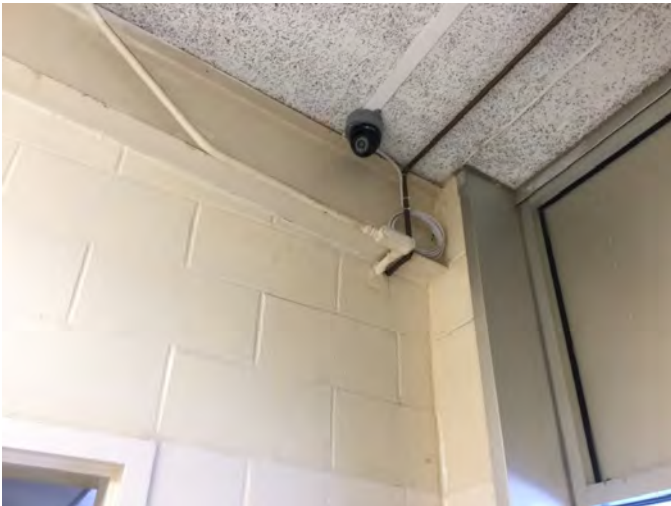
System: D5030810 - Security & Detection Systems

Location: Throughout the building
Distress: Inadequate
Category: Deferred Maintenance / Safety
Priority: 3 - Necessary/Not Yet Critical (Years 2-5)
Correction: Renew System
Qty: 10,800.00
Unit of Measure: S.F.
Estimate: \$24,948.00
Assessor Name: Terence Davis
Date Created: 02/20/2017

Notes: Although reportedly only 10 years old, the security system is inadequate. It cannot be monitored properly in the principal's office. System renewal is recommended.

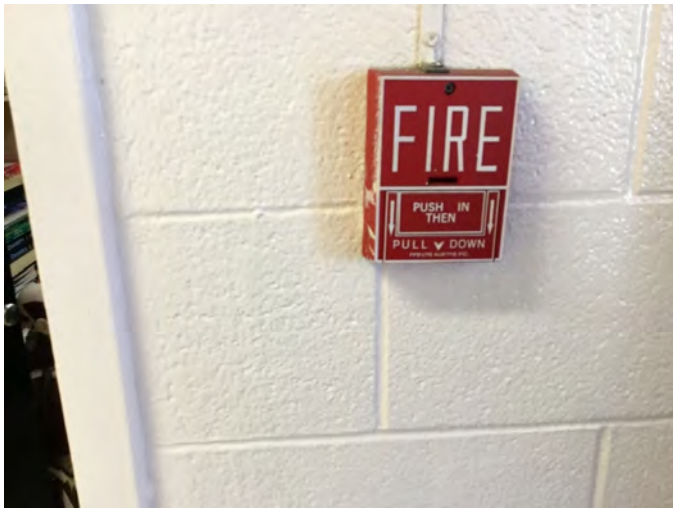
System: D5030910 - Fire Alarm Systems

Location: Throughout the building
Distress: Beyond Service Life
Category: Deferred Maintenance / Life Safety Code Compliance
Priority: 3 - Necessary/Not Yet Critical (Years 2-5)
Correction: Renew System
Qty: 10,800.00
Unit of Measure: S.F.
Estimate: \$45,500.00
Assessor Name: Terence Davis
Date Created: 02/17/2017

Notes: The fire alarm system is beyond its expected life. System renewal is recommended to ensure reliability and code compliance of this life safety system.

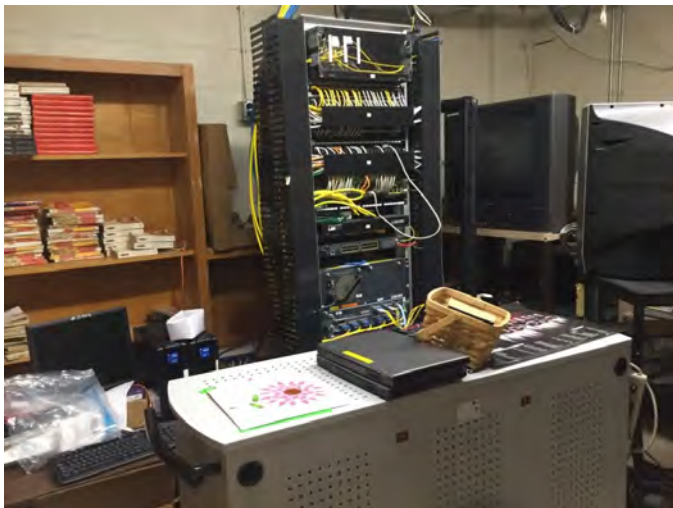
System: D5030920 - Data Communication

Location: Throughout the building
Distress: Beyond Service Life
Category: Deferred Maintenance
Priority: 3 - Necessary/Not Yet Critical (Years 2-5)
Correction: Renew System
Qty: 10,800.00
Unit of Measure: S.F.
Estimate: \$58,450.00
Assessor Name: Terence Davis
Date Created: 02/17/2017

Notes: Data and communications systems are beyond their expected service life. System renewal is recommended.

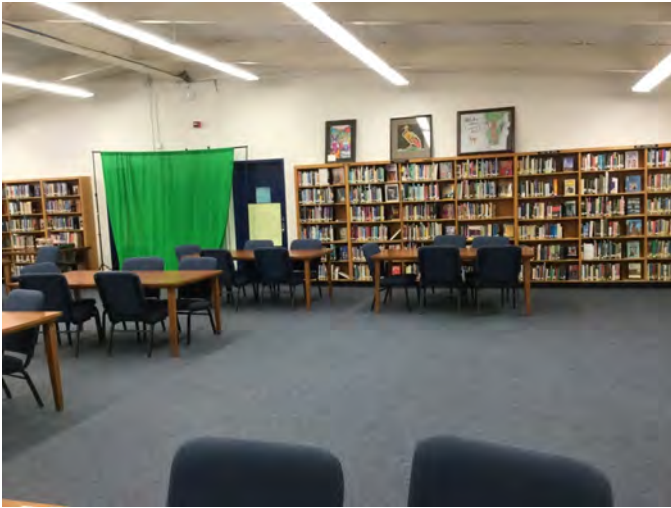
System: E1020 - Institutional Equipment

Location: Library, Science Classrooms
Distress: Beyond Service Life
Category: Deferred Maintenance
Priority: 3 - Necessary/Not Yet Critical (Years 2-5)
Correction: Renew System
Qty: 10,800.00
Unit of Measure: S.F.
Estimate: \$235,224.00
Assessor Name: Terence Davis
Date Created: 02/17/2017

Notes: Institutional equipment is original and in fair to poor condition. System renewal is recommended.

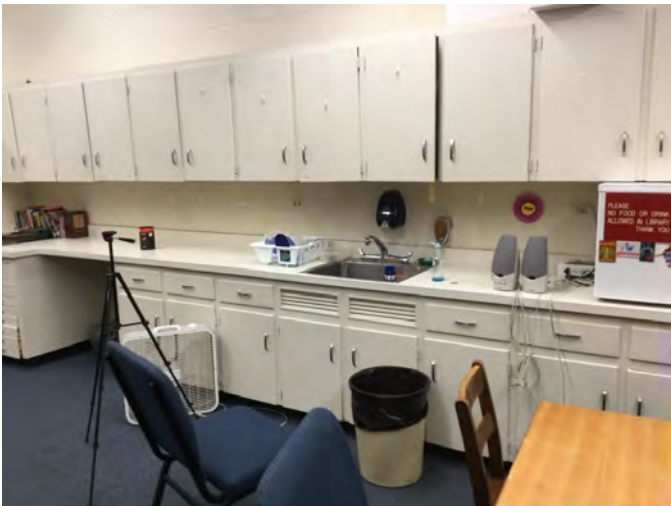
System: E2010 - Fixed Furnishings

Location: Library workroom
Distress: Beyond Service Life
Category: Deferred Maintenance
Priority: 3 - Necessary/Not Yet Critical (Years 2-5)
Correction: Renew System
Qty: 10,800.00
Unit of Measure: S.F.
Estimate: \$63,320.00
Assessor Name: Terence Davis
Date Created: 02/17/2017

Notes: Fixed furnishings are beyond their expected life and are in fair to poor condition. System renewal is recommended.

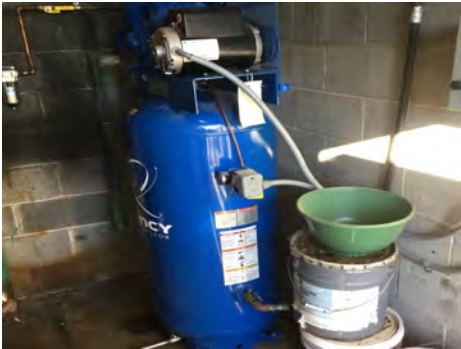
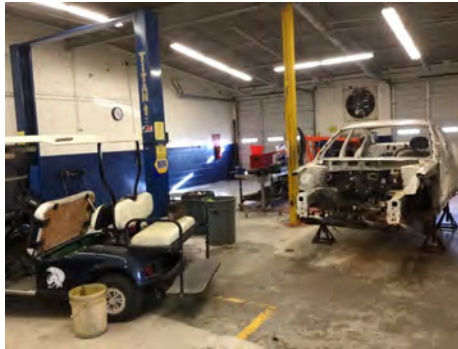
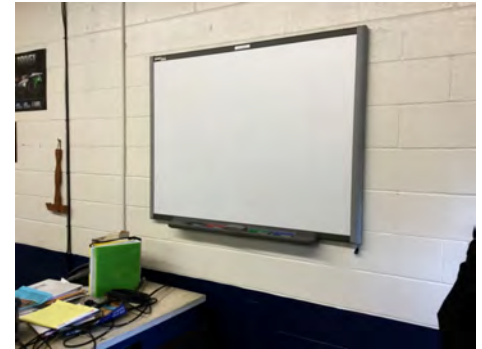
System: E1020 - Institutional Equipment

Note: Shop equipment is up to date

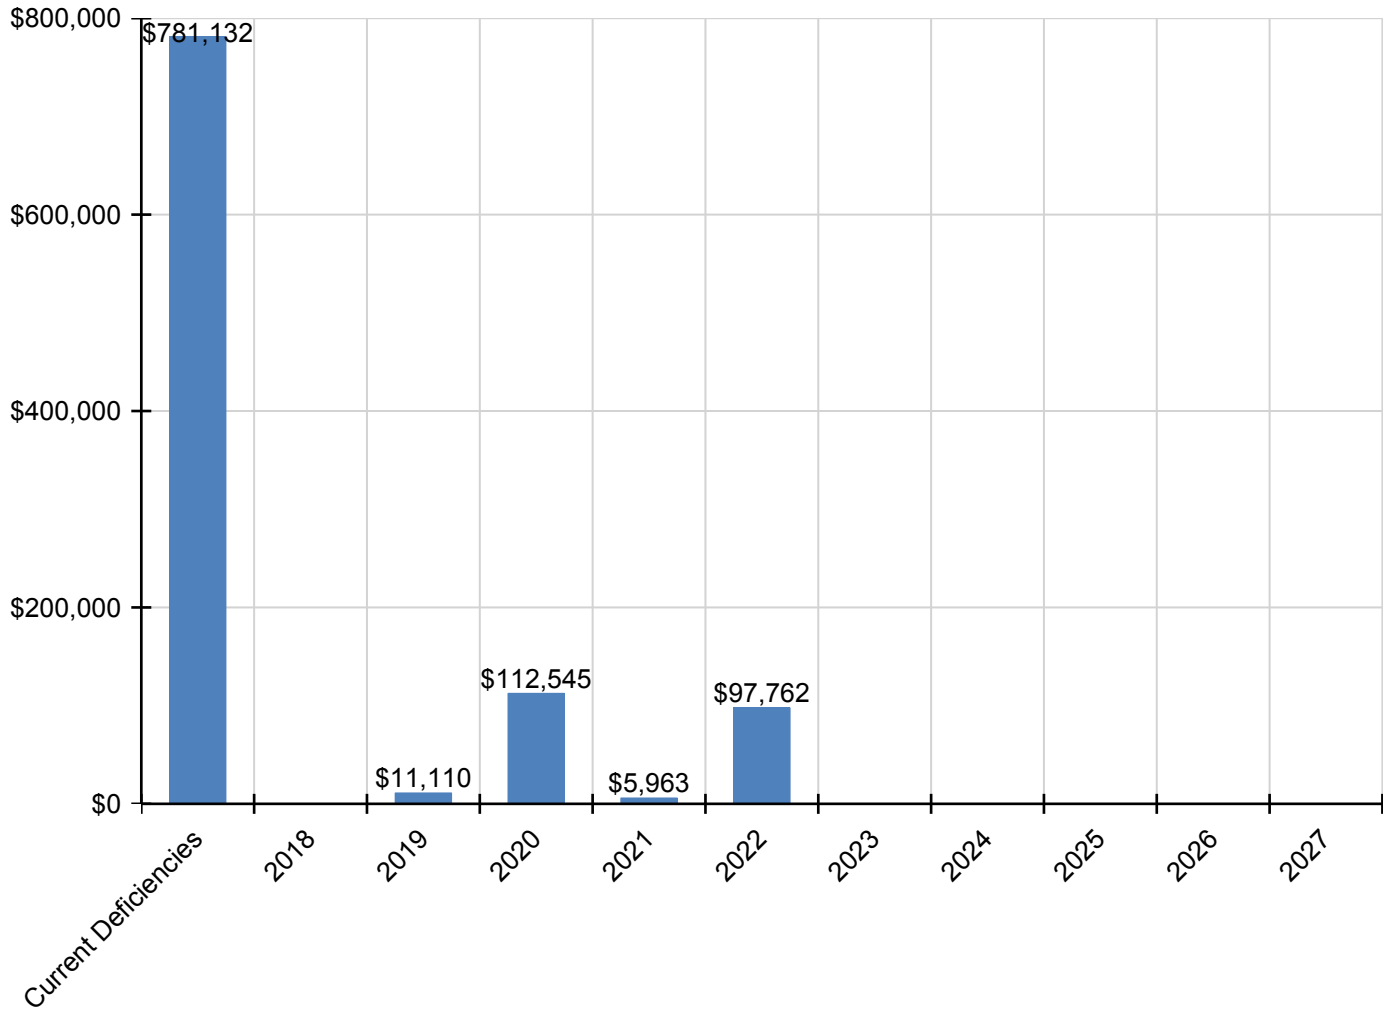
Forecasted Capital Renewal Requirement

The following chart shows the current building deficiencies and forecasting capital renewal or sustainment requirements over the next ten years.

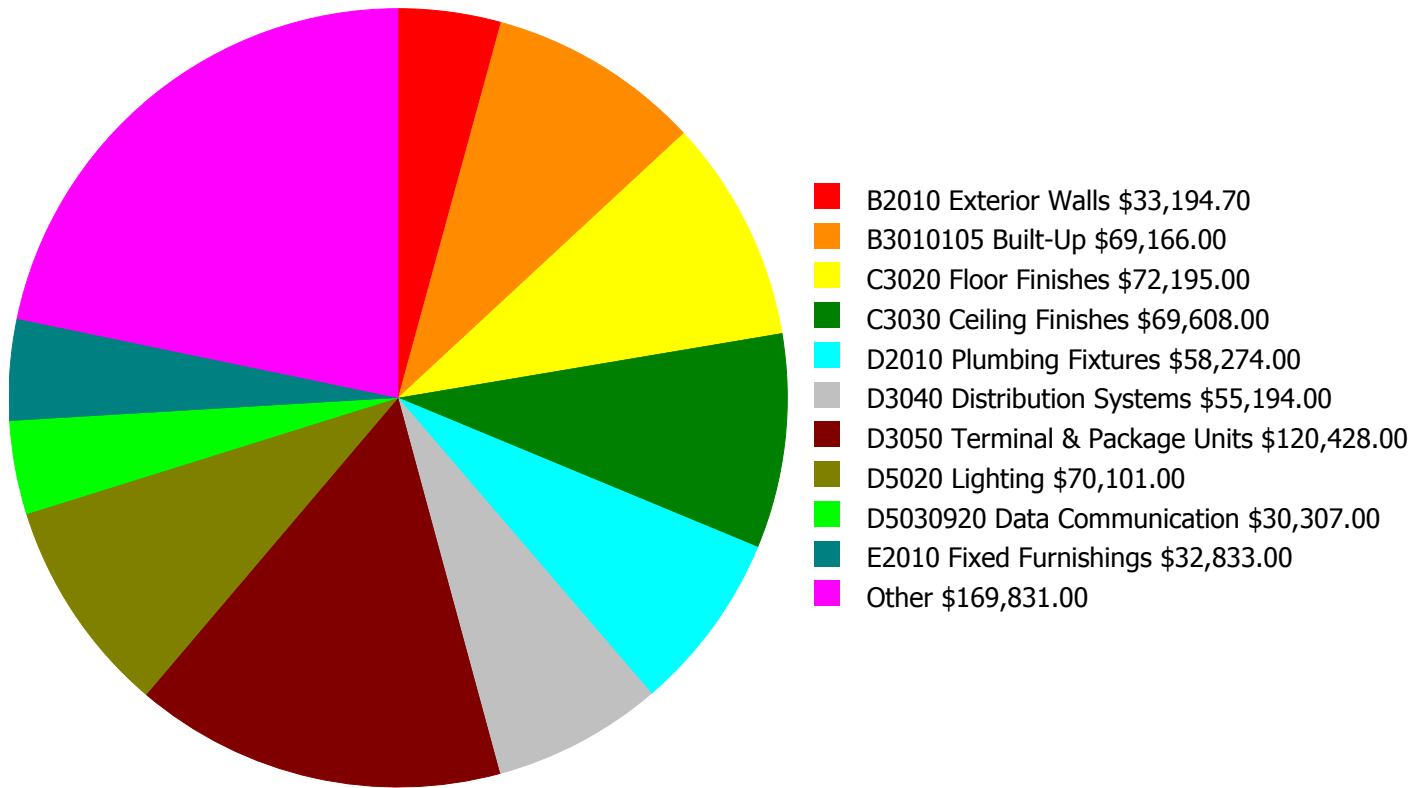
Deficiency Summary by System

Current deficiencies included assemblies that have reached or exceeded their design life or components of the assemblies that are in need of repair. Assemblies that have reached their design life are identified as current deficiencies and assigned the distress 'Beyond Useful Life'. The following chart lists all current deficiencies associated with this facility.

Budget Estimate Total: \$781,131.70

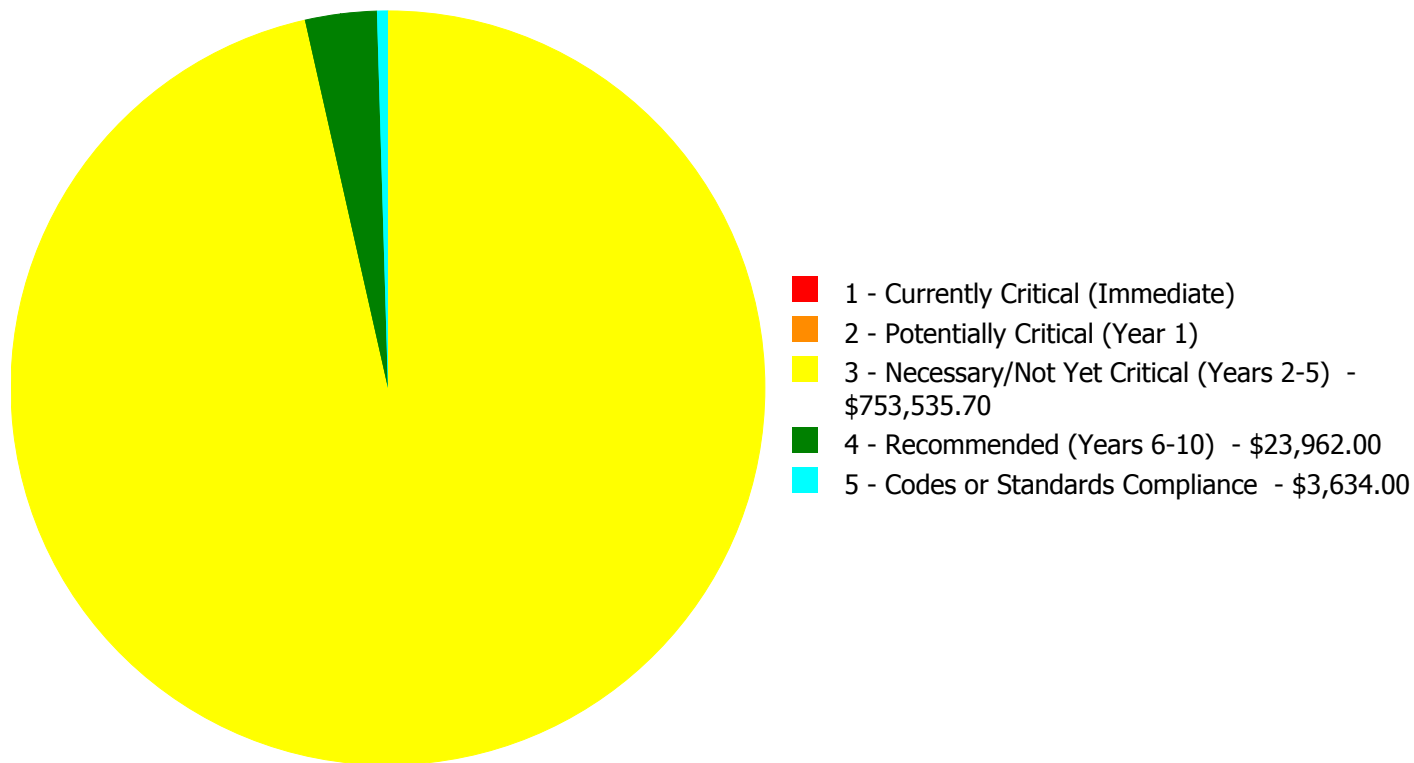
Deficiency Summary by Priority

The following chart shows the total repair costs broken down by priority. Assessors assigned deficiencies within eCOMET to one of the following priority categories:

Budget Estimate Total: \$781,131.70

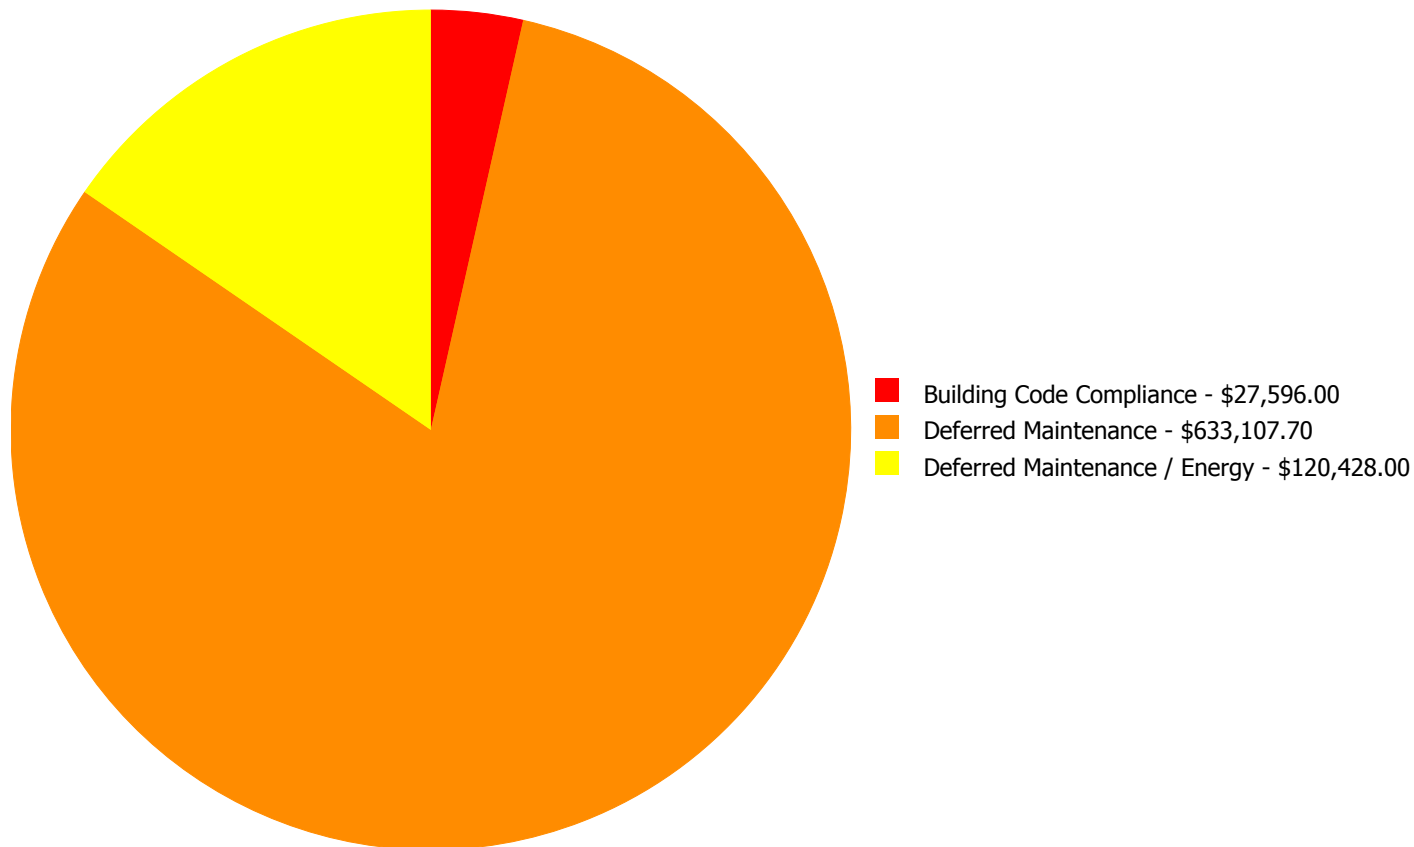
Deficiency Summary by Category

The following chart shows the total repair costs broken down by deficiency categories. Assessors assigned deficiencies to one of the following categories:

Budget Estimate Total: \$781,131.70

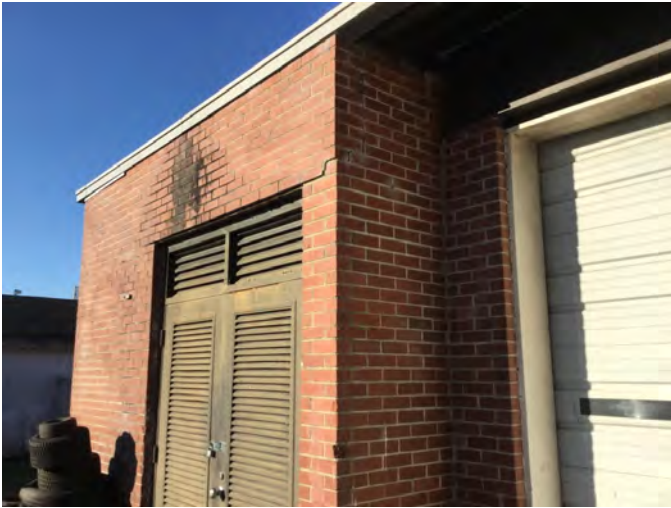
System: B2010 - Exterior Walls

Location: Exterior walls
Distress: Damaged
Category: Deferred Maintenance
Priority: 3 - Necessary/Not Yet Critical (Years 2-5)
Correction: Point clay brick wall, 1st floor
Qty: 20.00
Unit of Measure: C.S.F.
Estimate: \$33,194.70
Assessor Name: Terence Davis
Date Created: 02/21/2017

Notes: Exterior walls are in need of repairs, particularly around the compressor room.

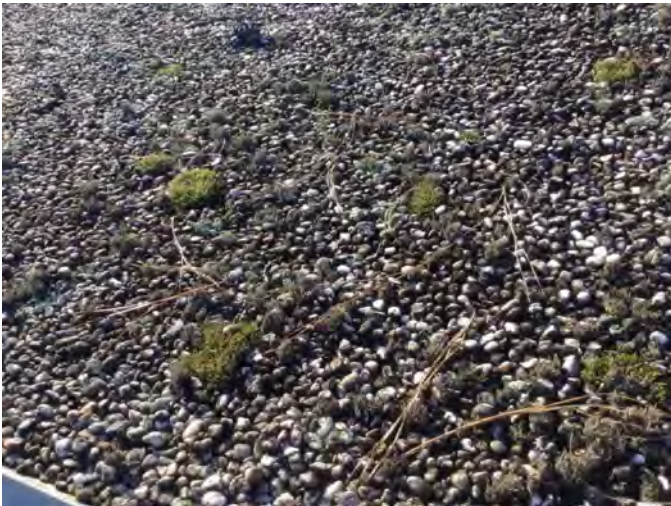
System: B3010105 - Built-Up

Location: Roof
Distress: Beyond Service Life
Category: Deferred Maintenance
Priority: 3 - Necessary/Not Yet Critical (Years 2-5)
Correction: Renew System
Qty: 5,600.00
Unit of Measure: S.F.
Estimate: \$69,166.00
Assessor Name: Terence Davis
Date Created: 02/17/2017

Notes: The roof covering is beyond its expected useful life. System renewal including gutters and downspouts is recommended.

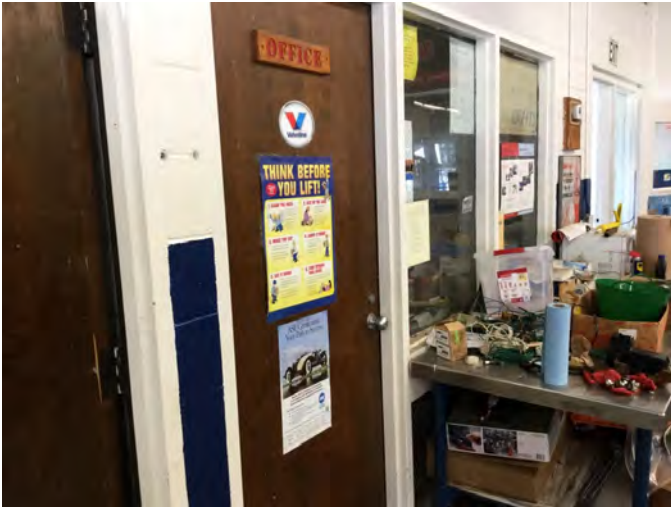
System: C1020 - Interior Doors

Location: Throughout the building
Distress: Beyond Service Life
Category: Deferred Maintenance
Priority: 3 - Necessary/Not Yet Critical (Years 2-5)
Correction: Renew System
Qty: 5,600.00
Unit of Measure: S.F.
Estimate: \$16,078.00
Assessor Name: Terence Davis
Date Created: 02/17/2017

Notes: Interior doors are typically original and in worn condition. Doors do not have ADA compliant hardware. System renewal is recommended.

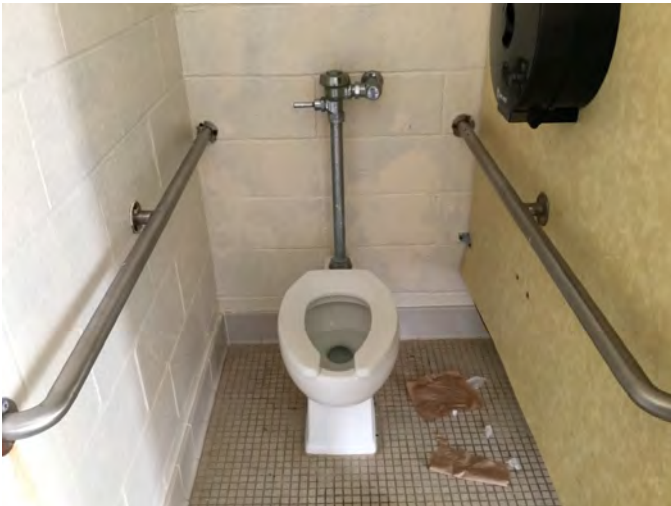
System: C1030 - Fittings

Location: Throughout the building
Distress: Beyond Service Life
Category: Deferred Maintenance
Priority: 3 - Necessary/Not Yet Critical (Years 2-5)
Correction: Renew System
Qty: 5,600.00
Unit of Measure: S.F.
Estimate: \$9,733.00
Assessor Name: Terence Davis
Date Created: 02/17/2017

Notes: Fittings are in fair to poor condition. Signage and toilet rooms are not code compliant. System renewal is recommended.

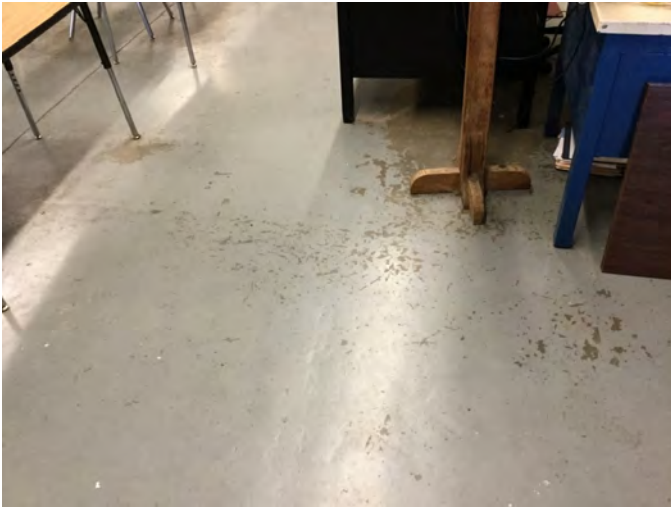
System: C3020 - Floor Finishes

Location: Throughout the building
Distress: Beyond Service Life
Category: Deferred Maintenance
Priority: 3 - Necessary/Not Yet Critical (Years 2-5)
Correction: Renew System
Qty: 5,600.00
Unit of Measure: S.F.
Estimate: \$72,195.00
Assessor Name: Terence Davis
Date Created: 02/17/2017

Notes: Floor finishes are beyond their expected useful life and in worn condition. System renewal is recommended.

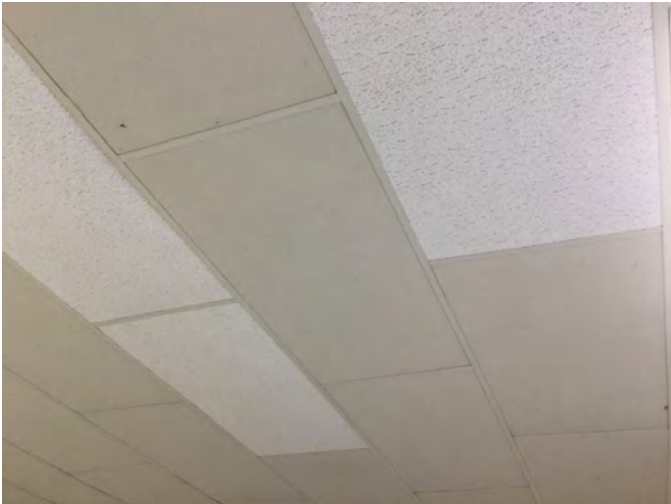
System: C3030 - Ceiling Finishes

Location: Throughout the building
Distress: Beyond Service Life
Category: Deferred Maintenance
Priority: 3 - Necessary/Not Yet Critical (Years 2-5)
Correction: Renew System
Qty: 5,600.00
Unit of Measure: S.F.
Estimate: \$69,608.00
Assessor Name: Terence Davis
Date Created: 02/17/2017

Notes: Ceilings are beyond their expected life and in fair to poor condition. System renewal is recommended.

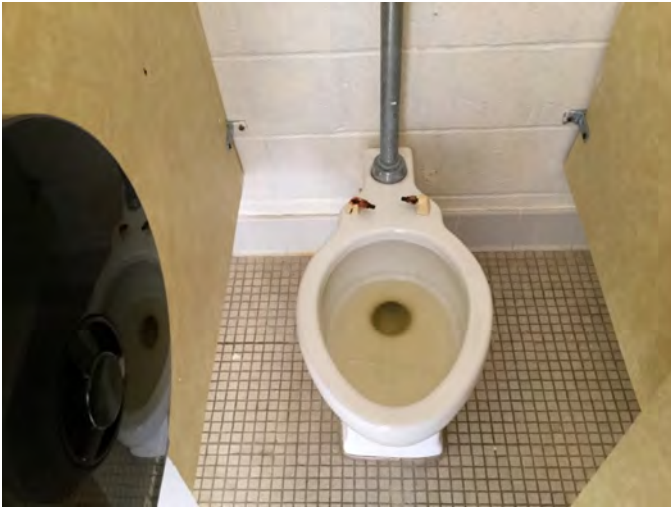
System: D2010 - Plumbing Fixtures

Location: Restrooms, shops
Distress: Beyond Service Life
Category: Deferred Maintenance
Priority: 3 - Necessary/Not Yet Critical (Years 2-5)
Correction: Renew System
Qty: 5,600.00
Unit of Measure: S.F.
Estimate: \$58,274.00
Assessor Name: Terence Davis
Date Created: 02/17/2017

Notes: Plumbing fixtures are in poor conditions and beyond their expected useful life. Restrooms and the drinking fountain are not ADA compliant. System renewal is recommended.

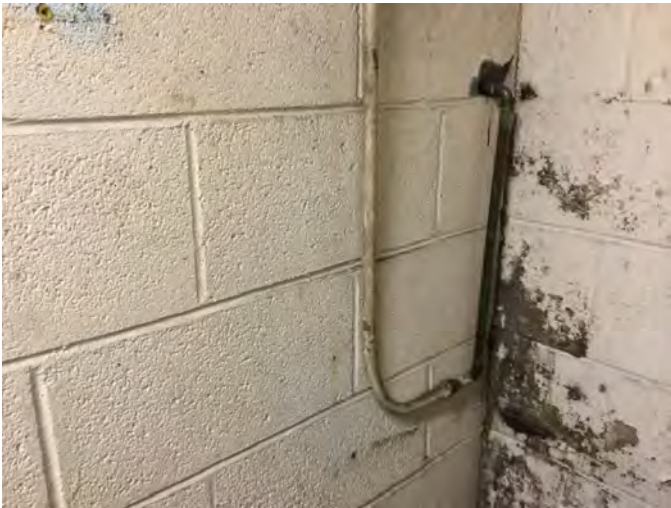
System: D2020 - Domestic Water Distribution

Location: Restrooms and shops
Distress: Beyond Service Life
Category: Deferred Maintenance
Priority: 3 - Necessary/Not Yet Critical (Years 2-5)
Correction: Renew System
Qty: 5,600.00
Unit of Measure: S.F.
Estimate: \$10,842.00
Assessor Name: Terence Davis
Date Created: 02/17/2017

Notes: The domestic water distribution system is aged and should be replaced.

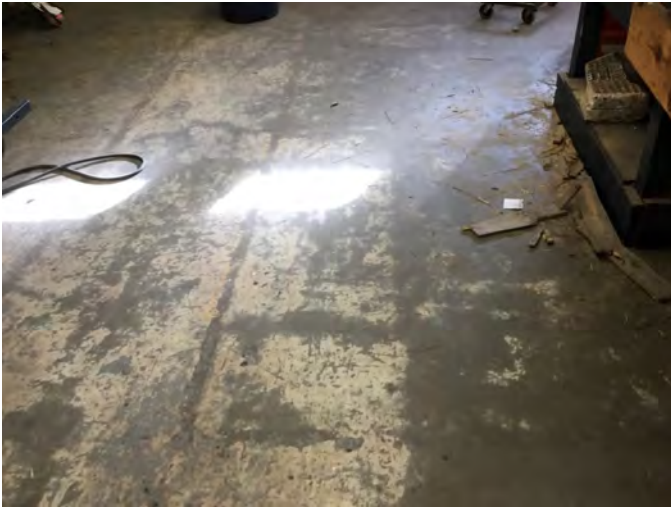
System: D2030 - Sanitary Waste

Location: Throughout the building
Distress: Beyond Service Life
Category: Deferred Maintenance
Priority: 3 - Necessary/Not Yet Critical (Years 2-5)
Correction: Renew System
Qty: 5,600.00
Unit of Measure: S.F.
Estimate: \$17,063.00
Assessor Name: Terence Davis
Date Created: 02/17/2017

Notes: The building sanitary waste system is original and beyond its expected useful life. There is no floor drain with an oil separator in the automotive shop. System renewal is recommended.

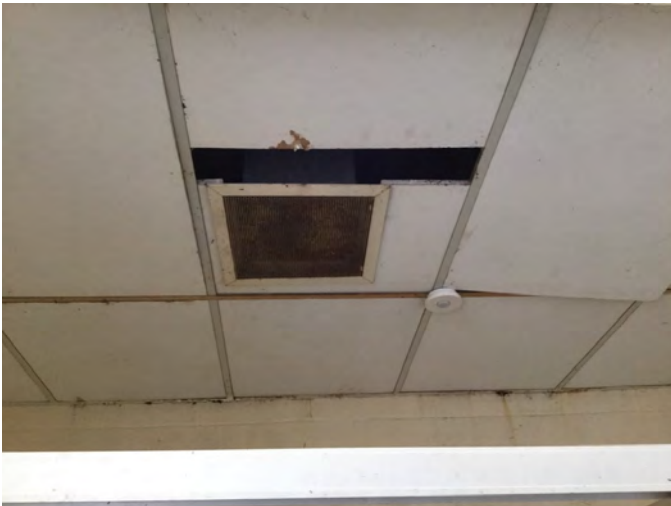
System: D3040 - Distribution Systems

Location: Throughout the building
Distress: Beyond Service Life
Category: Deferred Maintenance
Priority: 3 - Necessary/Not Yet Critical (Years 2-5)
Correction: Renew System
Qty: 5,600.00
Unit of Measure: S.F.
Estimate: \$55,194.00
Assessor Name: Terence Davis
Date Created: 02/17/2017

Notes: HVAC distribution systems are well beyond their expected useful life. System renewal is recommended.

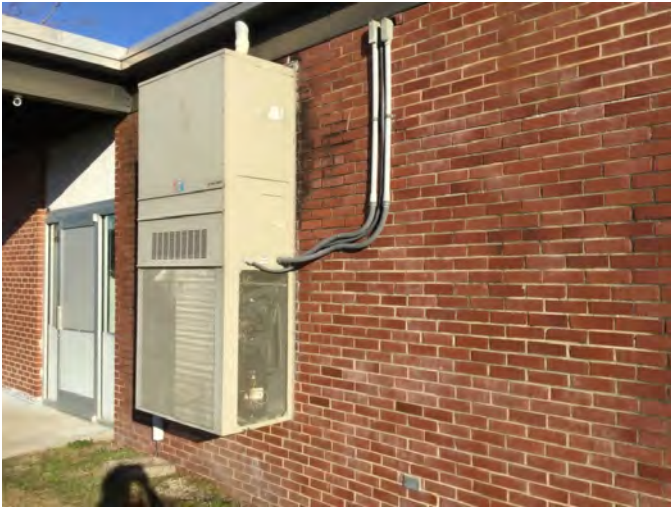
System: D3050 - Terminal & Package Units

Location: Throughout the buiding
Distress: Beyond Service Life
Category: Deferred Maintenance / Energy
Priority: 3 - Necessary/Not Yet Critical (Years 2-5)
Correction: Renew System
Qty: 5,600.00
Unit of Measure: S.F.
Estimate: \$120,428.00
Assessor Name: Terence Davis
Date Created: 02/17/2017

Notes: Wall mounted heat pumps and room air conditioning units are beyond their expected service life. System renewal with a more energy efficient system is recommended.

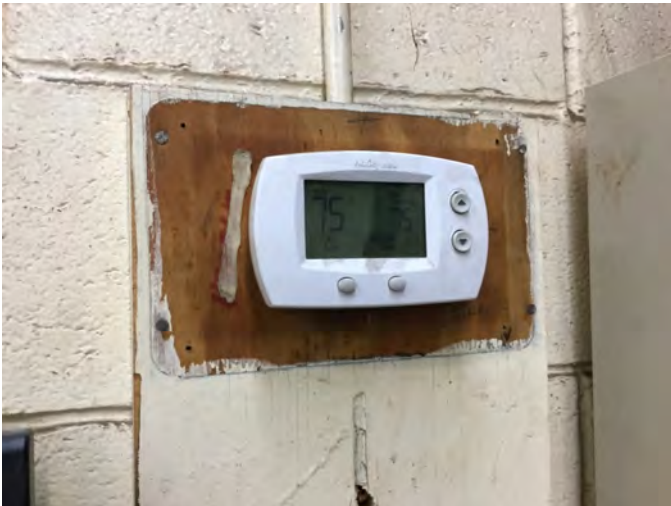
System: D3060 - Controls & Instrumentation

Location: Throughout the building
Distress: Beyond Service Life
Category: Deferred Maintenance
Priority: 3 - Necessary/Not Yet Critical (Years 2-5)
Correction: Renew System
Qty: 5,600.00
Unit of Measure: S.F.
Estimate: \$17,494.00
Assessor Name: Terence Davis
Date Created: 02/17/2017

Notes: Building controls are locally controlled. Installation of a modern digital system with remote monitoring and control capability for energy conservation is recommended.

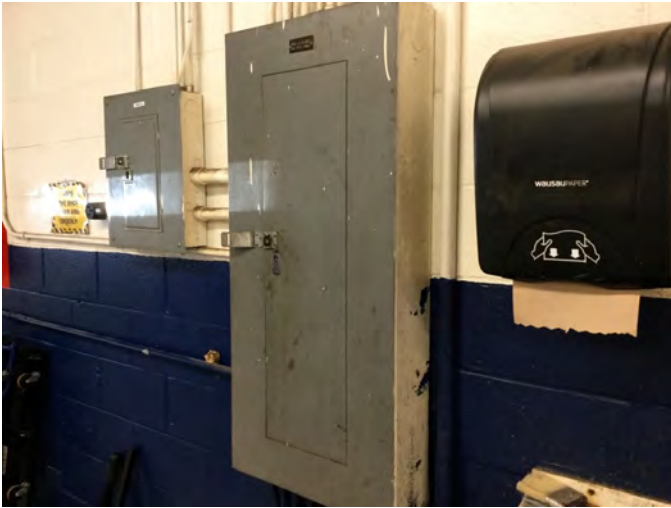
System: D5020 - Branch Wiring

Location: Throughout the building
Distress: Beyond Service Life
Category: Deferred Maintenance
Priority: 3 - Necessary/Not Yet Critical (Years 2-5)
Correction: Renew System
Qty: 5,600.00
Unit of Measure: S.F.
Estimate: \$29,999.00
Assessor Name: Terence Davis
Date Created: 02/17/2017

Notes: The branch wiring system is largely original and beyond its expected life. Circuits are overloaded. System renewal is recommended.

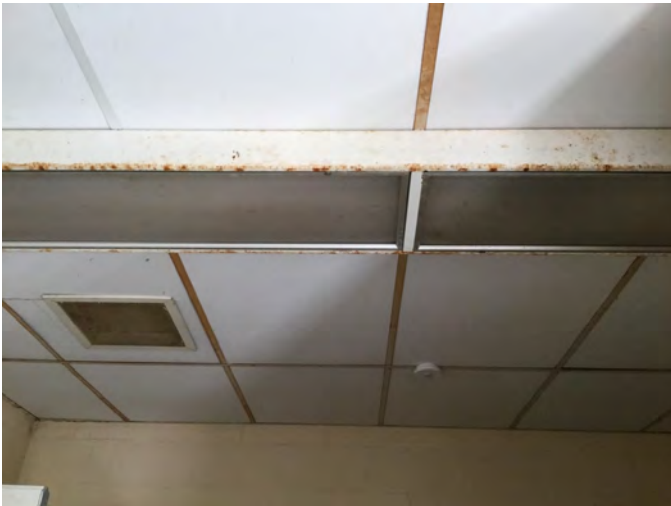
System: D5020 - Lighting

Location: Throughout the building
Distress: Beyond Service Life
Category: Deferred Maintenance
Priority: 3 - Necessary/Not Yet Critical (Years 2-5)
Correction: Renew System
Qty: 5,600.00
Unit of Measure: S.F.
Estimate: \$70,101.00
Assessor Name: Terence Davis
Date Created: 02/17/2017

Notes: Although fixtures have been retrofitted w// T-8 lamps, the lighting system is largely original and beyond its expected life. System renewal is recommended.

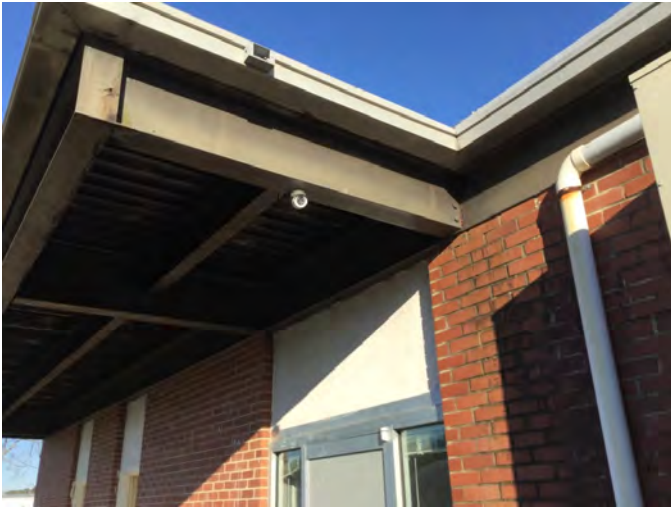
System: D5030810 - Security & Detection Systems

Location: Throughout the building
Distress: Inadequate
Category: Deferred Maintenance
Priority: 3 - Necessary/Not Yet Critical (Years 2-5)
Correction: Renew System
Qty: 5,600.00
Unit of Measure: S.F.
Estimate: \$12,936.00
Assessor Name: Terence Davis
Date Created: 02/17/2017

Notes: Although reportedly only 10 years old, the security system is inadequate. It cannot be monitored properly in the principal's office. System renewal is recommended.

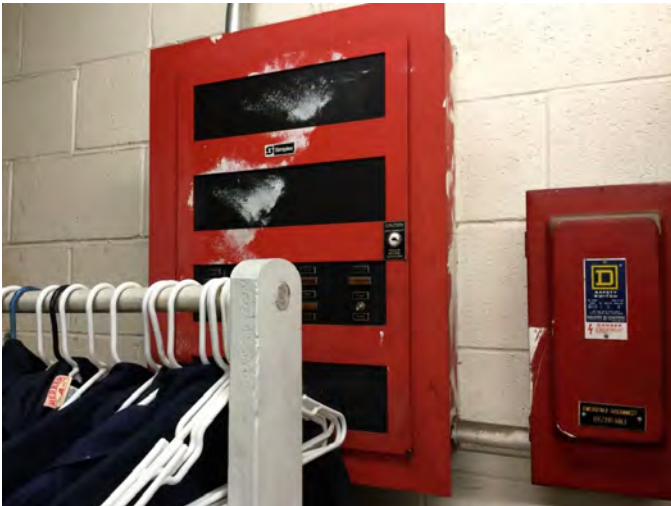
System: D5030910 - Fire Alarm Systems

Location: Throughout the building
Distress: Beyond Service Life
Category: Deferred Maintenance
Priority: 3 - Necessary/Not Yet Critical (Years 2-5)
Correction: Renew System
Qty: 5,600.00
Unit of Measure: S.F.
Estimate: \$23,593.00
Assessor Name: Terence Davis
Date Created: 02/17/2017

Notes: The fire alarm system is beyond its expected life. System renewal is recommended to ensure reliability of this life safety system.

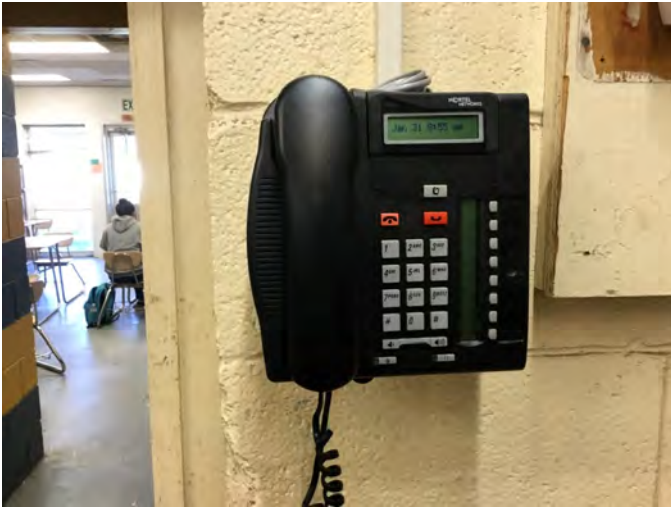
System: D5030920 - Data Communication

Location: Throughout the building
Distress: Beyond Service Life
Category: Deferred Maintenance
Priority: 3 - Necessary/Not Yet Critical (Years 2-5)
Correction: Renew System
Qty: 5,600.00
Unit of Measure: S.F.
Estimate: \$30,307.00
Assessor Name: Terence Davis
Date Created: 02/17/2017

Notes: Data and communications systems are beyond their expected service life. System renewal is recommended.

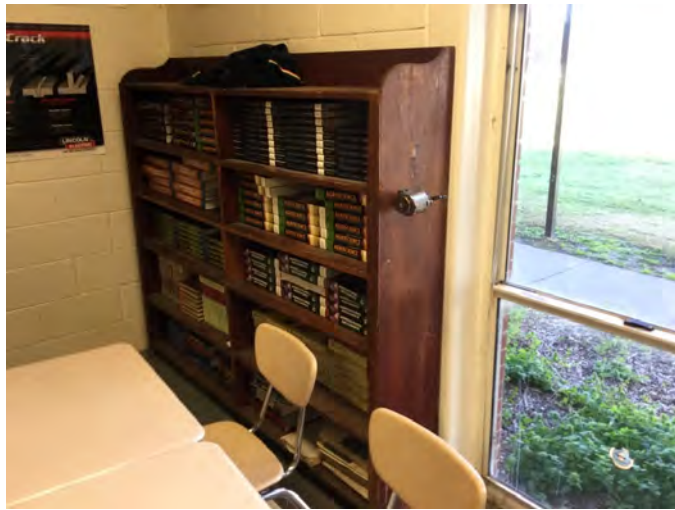
System: E2010 - Fixed Furnishings

Location: Throughout the building
Distress: Beyond Service Life
Category: Deferred Maintenance
Priority: 3 - Necessary/Not Yet Critical (Years 2-5)
Correction: Renew System
Qty: 5,600.00
Unit of Measure: S.F.
Estimate: \$32,833.00
Assessor Name: Terence Davis
Date Created: 02/17/2017

Notes: Fixed furnishings are beyond their expected life. System renewal is recommended.

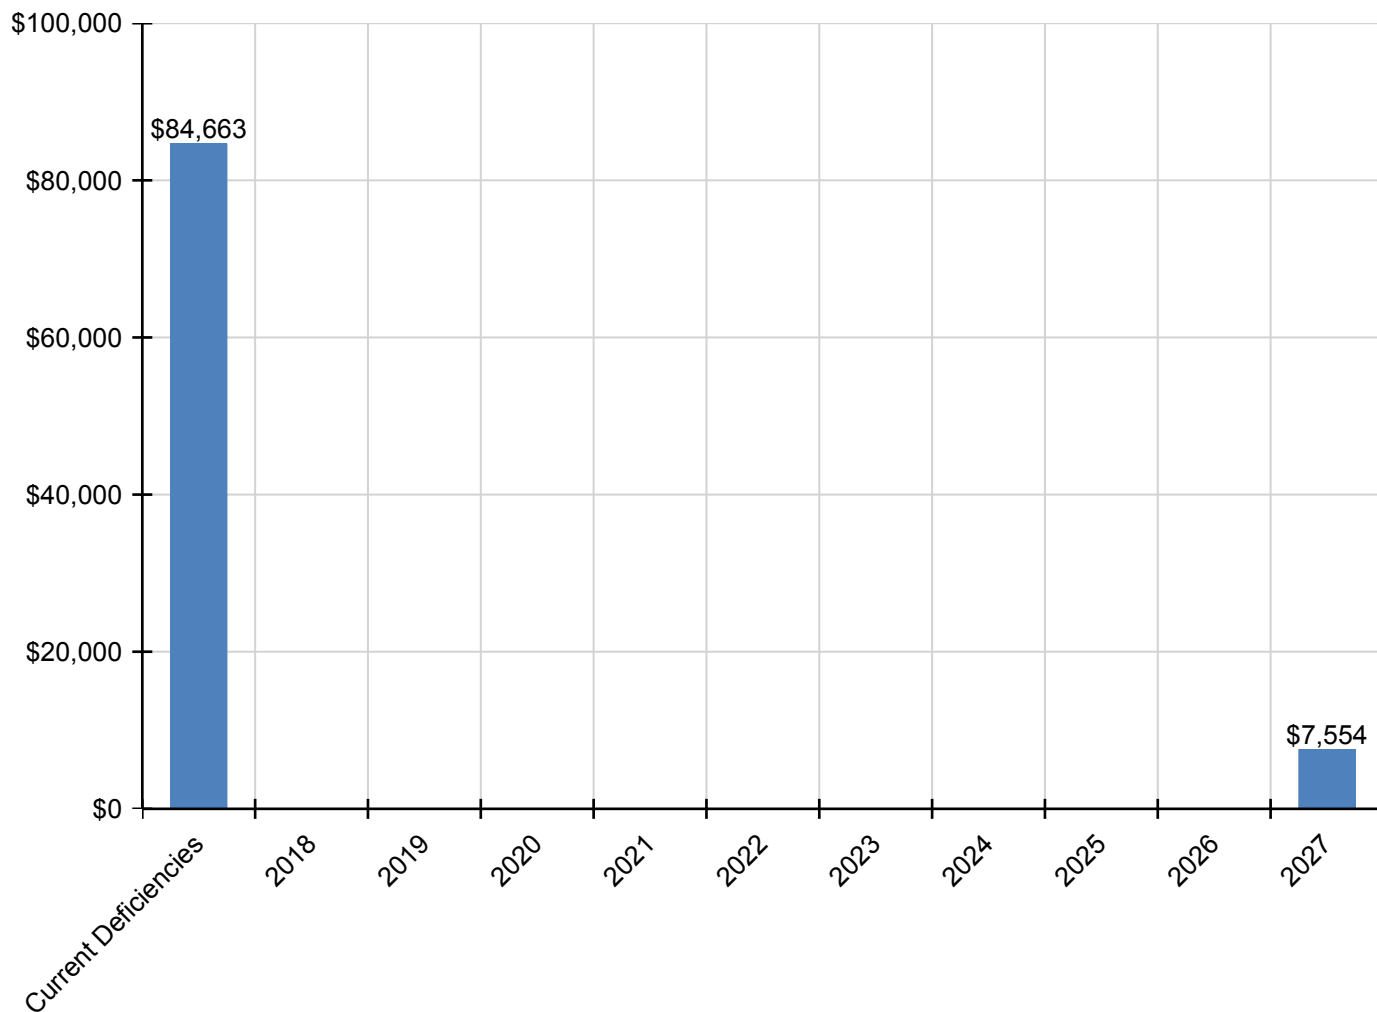
Forecasted Capital Renewal Requirement

The following chart shows the current building deficiencies and forecasting capital renewal or sustainment requirements over the next ten years.

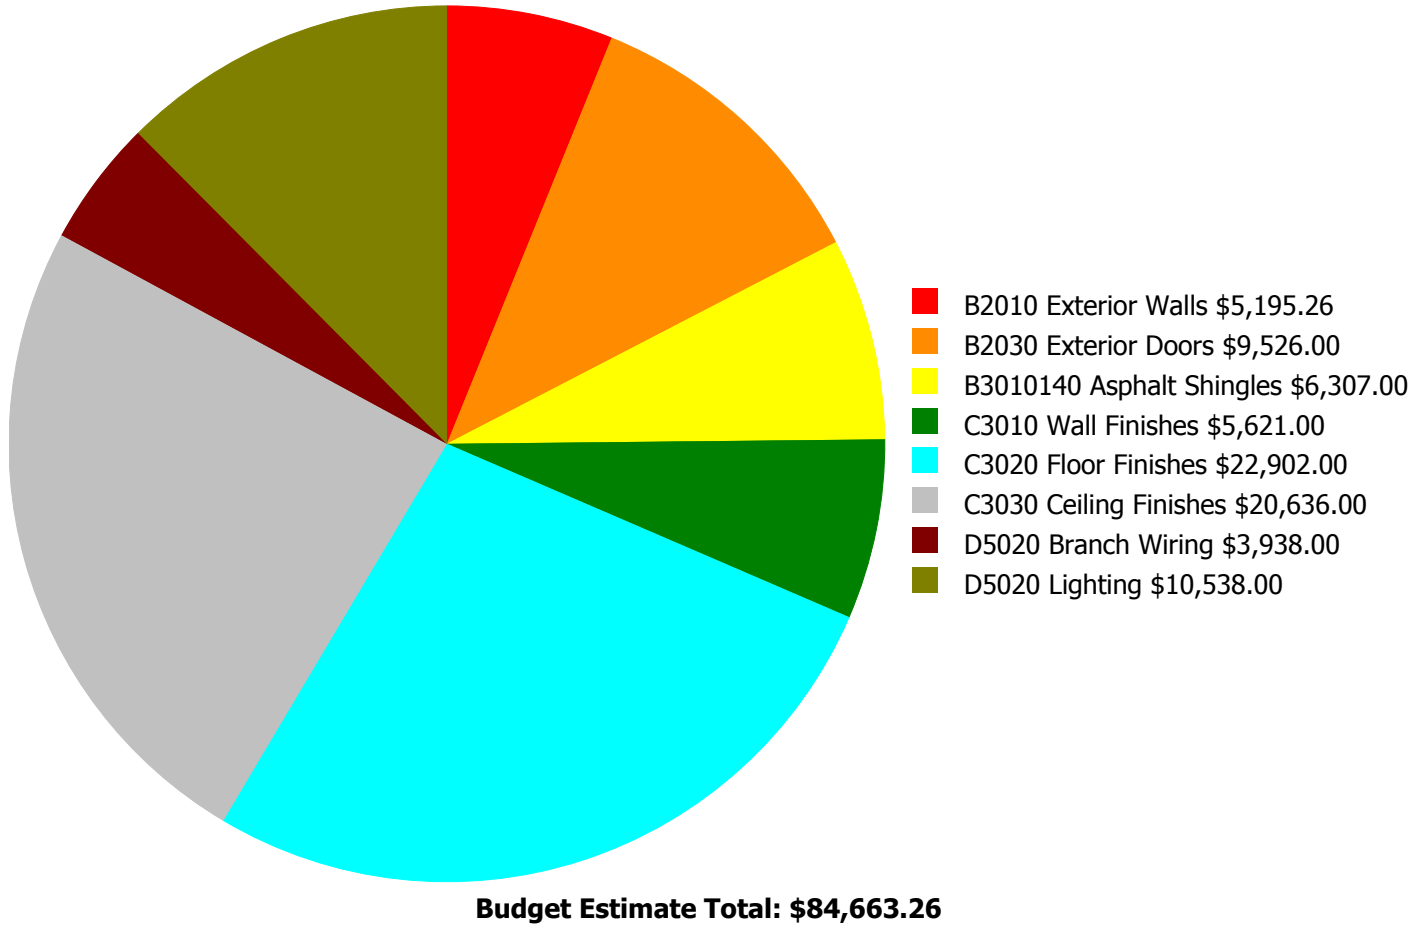
Deficiency Summary by System

Current deficiencies included assemblies that have reached or exceeded their design life or components of the assemblies that are in need of repair. Assemblies that have reached their design life are identified as current deficiencies and assigned the distress 'Beyond Useful Life'. The following chart lists all current deficiencies associated with this facility.

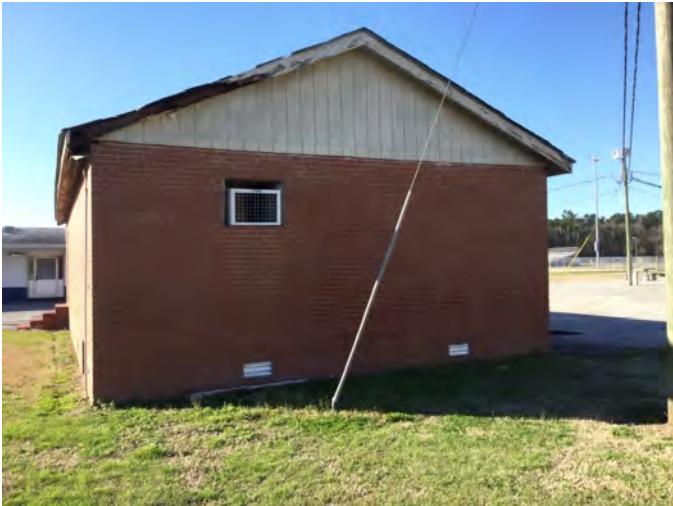
System: B2010 - Exterior Walls

Location: Gable ends and eaves
Distress: Damaged
Category: Deferred Maintenance
Priority: 3 - Necessary/Not Yet Critical (Years 2-5)
Correction: Spray refinish wood siding - 2nd floor
Qty: 2.00
Unit of Measure: C.S.F.
Estimate: \$5,195.26
Assessor Name: Ann Buerger Linden
Date Created: 02/21/2017

Notes: Gable ends are in need of painting. Fascia boards need to be replaced. Infill opening where room air conditioner is removed.
